RICE OPERATING COMPANY
JUNCTION BOX DISCLOSURE* REPORT

BOX LOCATION							BOX DIMENSIONS IN FEET		
SWD SYSTEM	JUNCTION	UNIT	SECTION	TOWNSHIP	RANGE	COUNTY	Length	Width	Depth
Blinebry-Drinkard (BD)	C-32 vent	C	32	22S	38E	Lea	48"	4'10"	1'6"
							Moved 26' North

BD C-32 Vent

UL/C Sec.32 (T22S-R38E)

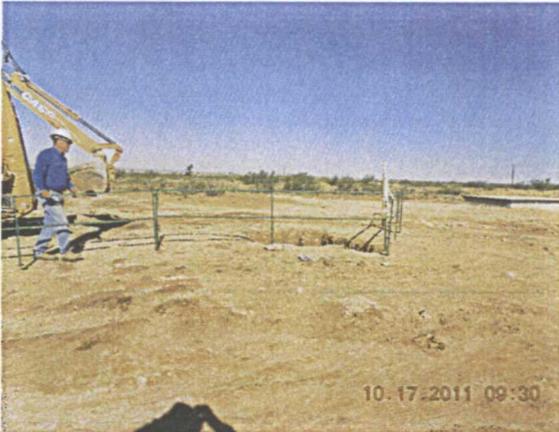
10/17/2011

Site prior, facing west

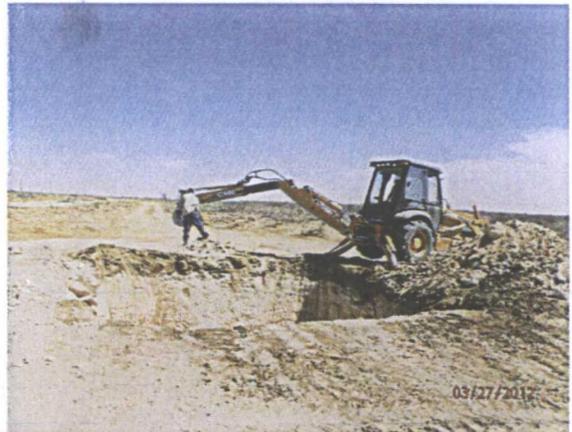
Collecting sample, facing south 3/27/2012

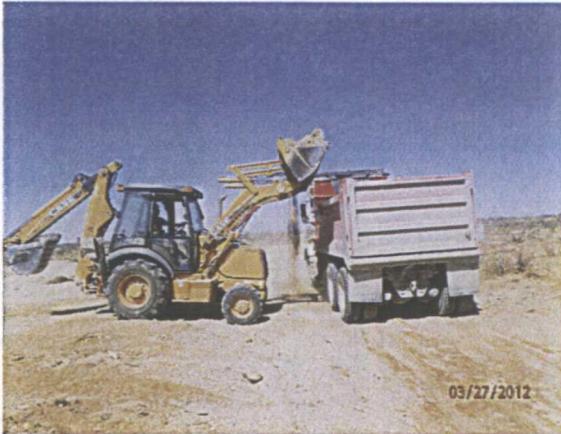
3/27/2012

Exporting soil, facing north

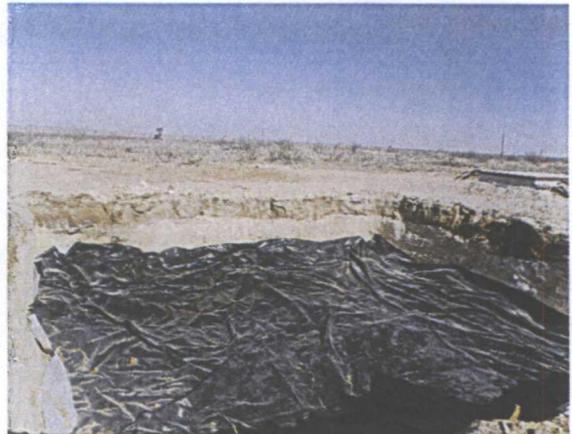
Installing 30'x30' liner @ 6' bgs, facing west
3/28/2012

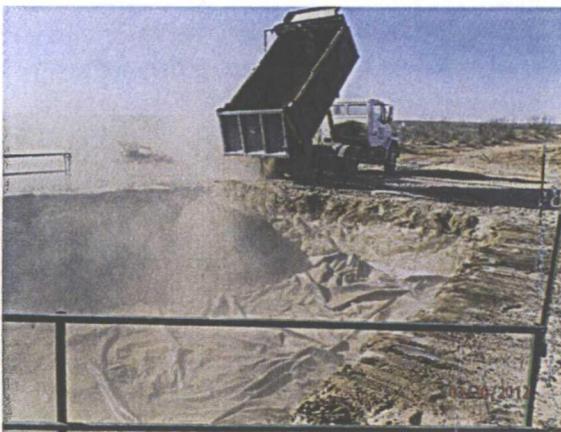
4/2/2012

Importing soil, facing south

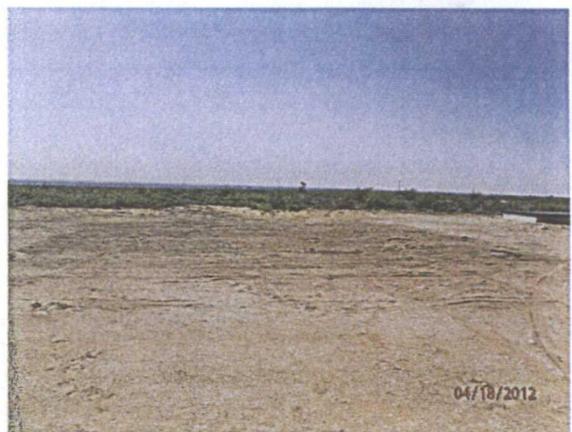
4/18/2012

Site complete, facing west

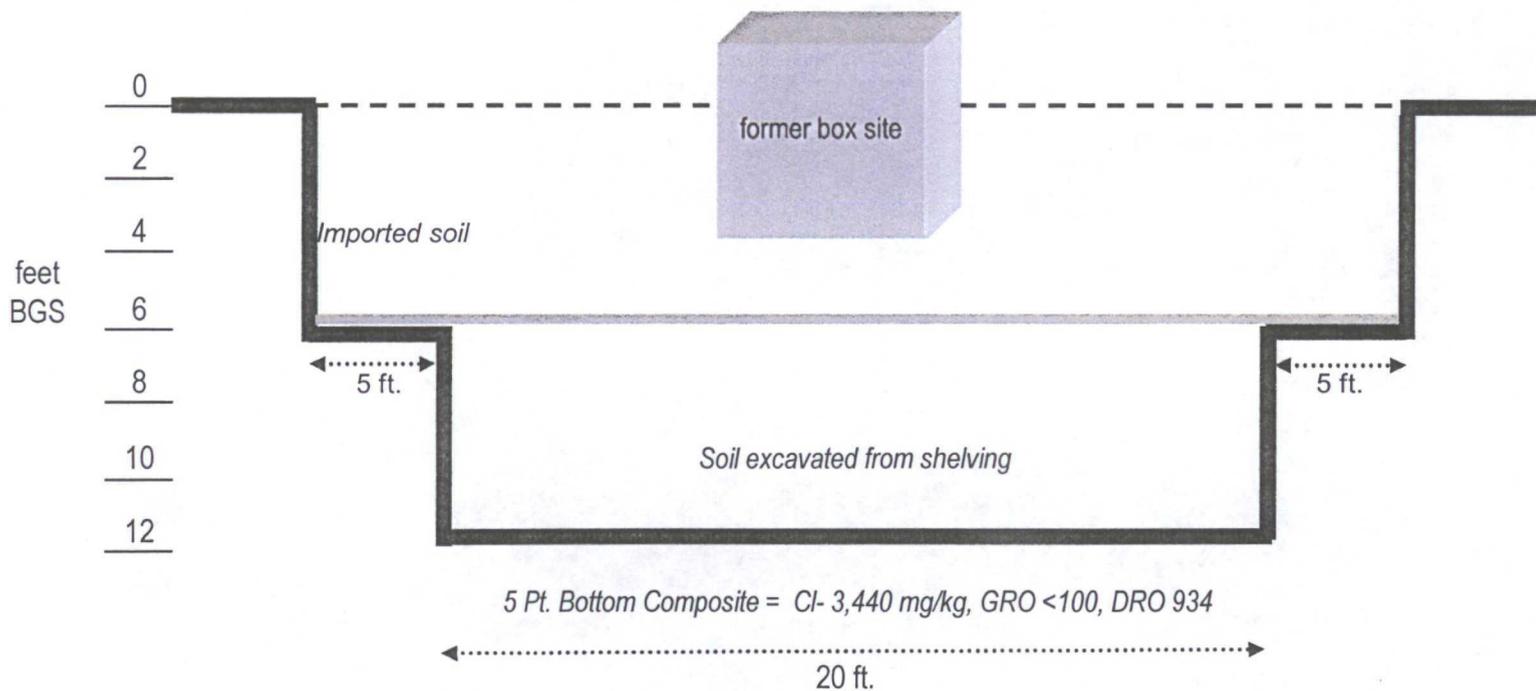
Excavation Cross-Section

BD C-32 vent
Unit 'C', Sec. 32, T22S, R38E

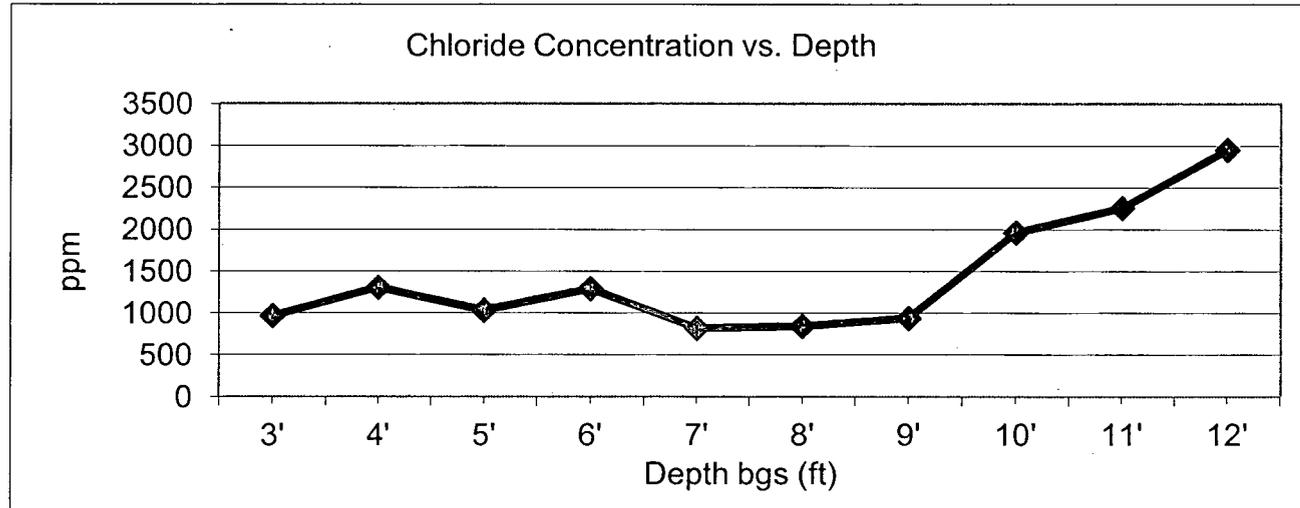
Backhoe samples at the junction (source)

Depth bgs (ft)	[Cl] ppm
3'	965
4'	1306
5'	1031
6'	1290
7'	818
8'	840
9'	938
10'	1962
11'	2257
12'	2955

Groundwater = 114 ft

LOCATION	DEPTH	mg/kg
4 wall comp.	n/a	1,366
bottom comp.	12'	2,328
backfill comp.	n/a	1,654
background	6"	757
vertical delineation trench at junction (source)	3'	965
	4'	1,306
	5'	1,031
	6'	1,290
	7'	818
	8'	840
	9'	938
	10'	1,962
	11'	2,257
	12'	2,955
