BD H-36 vent
2012

RICE OPERATING COMPANY JUNCTION BOX DISCLOSURE* REPORT

BOX LOCATION							Oil Conservation Division 1000 S. St. Francis Drive		
SWD SYSTEM	JUNCTION	UNIT	SECTION	TOWNSHIP	RANGE	COUNTY	BOX DIMENSIONS - FEET		
Blinebry-Drinkard (BD)	H-36 vent	H	36	22S	37E	Lea	Length 4'	Width 5'	Depth 3'
							Eliminated

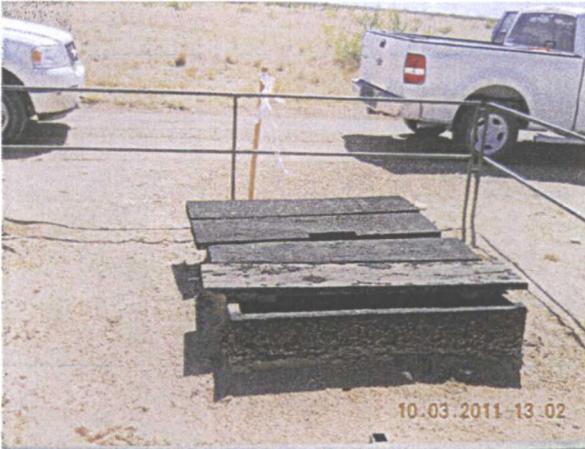
10/3/2011

Site prior, facing north

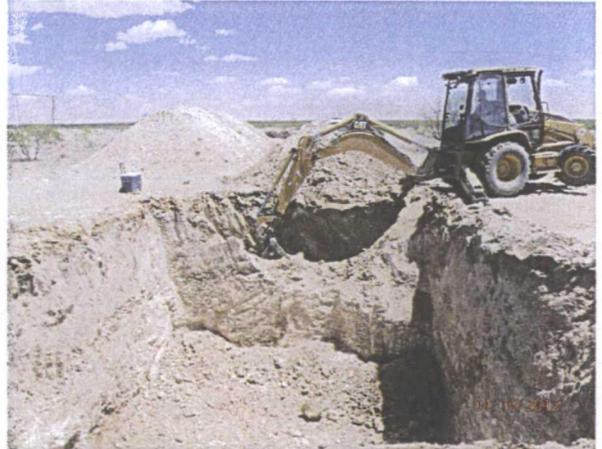
4/16/2012

Excavating site, facing east

General Description of Remedial Action: This junction box was eliminated during the pipeline replacement/upgrade program. After the former junction box was removed, an investigation was conducted using a backhoe to collect soil samples at regular intervals producing a 30x20x12 ft deep excavation. Chloride field tests performed on soil samples did not decrease with depth. Organic vapors were measured using a PID which yielded low concentrations. The excavated soil was blended on site and representative composite samples of the excavation bottom, the excavation walls, and the blended backfill were sent to a commercial laboratory for analysis of chloride and TPH. A total of 344 yards of blended backfill was transported to a NMOCD approved disposal facility. The excavation was backfilled to 6 ft. below ground surface (BGS). On 4/23/2012, a 30x20 ft. 20-mil reinforced liner was installed at 6 ft. BGS and the remainder of the excavation was backfilled with clean imported soil to ground surface and contoured to the surrounding area. On 4/25/2012, the site was seeded with a blend of native vegetation and is expected to return to a productive capacity at a normal rate. NMOCD was notified of potential groundwater impact on 2/20/2013.

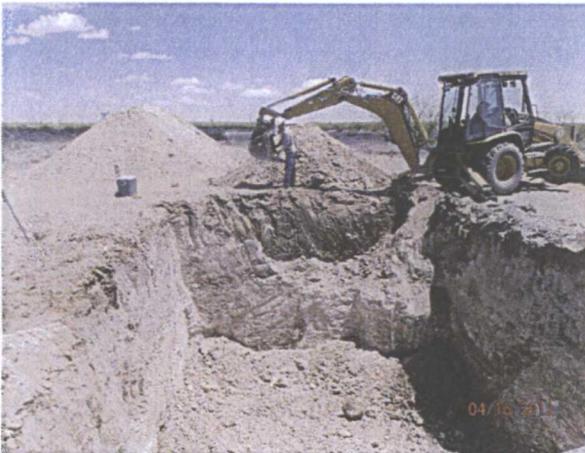
4/16/2012

Collecting sample, facing east

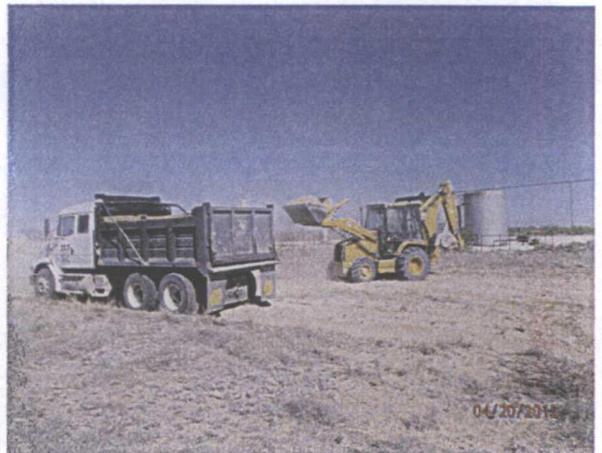
4/20/2012

Exporting soil, facing southeast

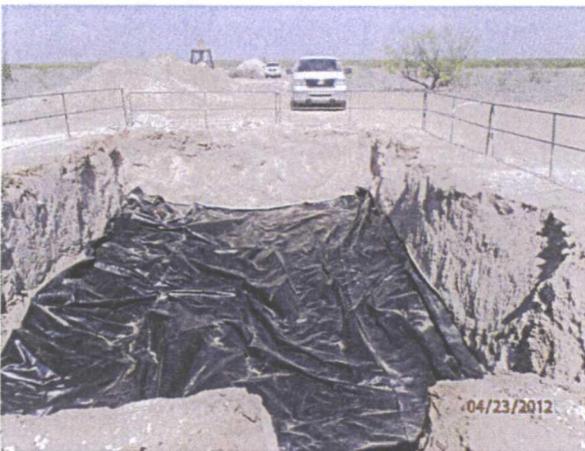
4/23/2012

Installing 30x20, 20 mil reinforced liner @
6' bgs, facing east

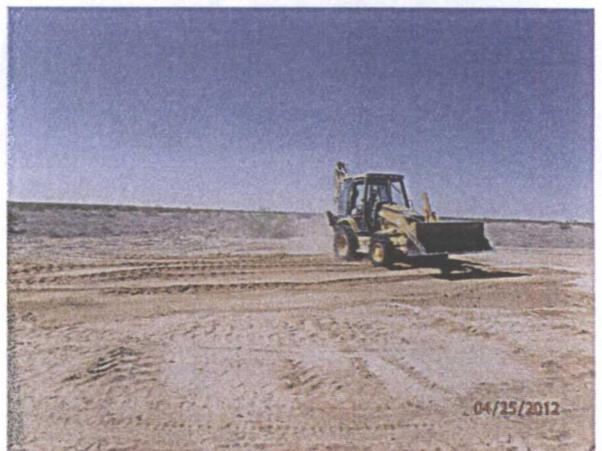
4/25/2012

Site complete, facing south

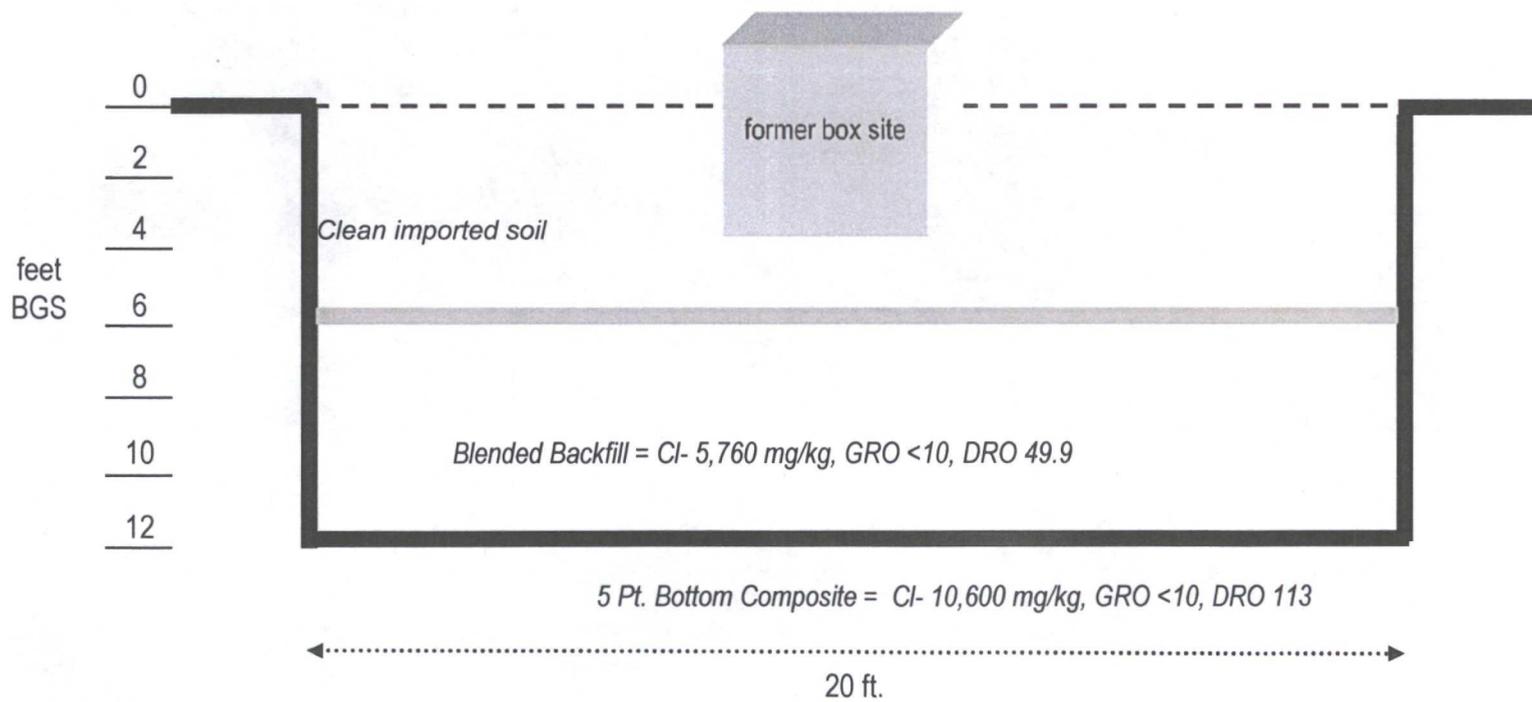
Excavation Cross-Section

BD H-36 vent
Unit 'H', Sec. 36, T22S, R37E

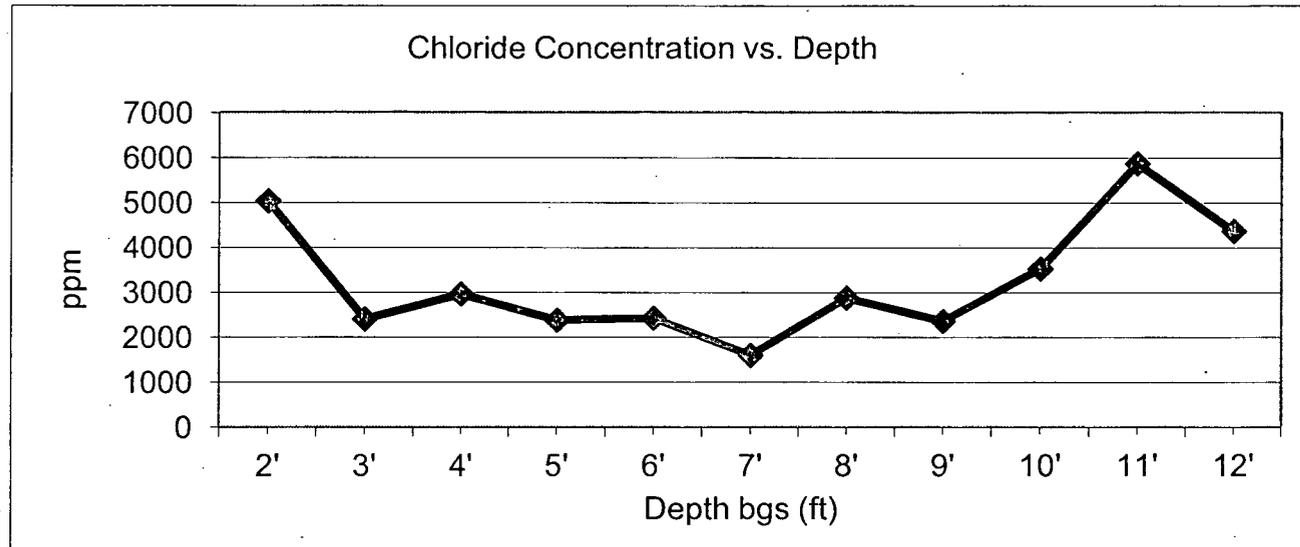
Backhoe samples at the junction (source)

Depth bgs (ft)	[Cl] ppm
2'	5041
3'	2411
4'	2970
5'	2390
6'	2433
7'	1607
8'	2885
9'	2366
10'	3537
11'	5881
12'	4378

Groundwater = 41 ft
