RICE OPERATING COMPANY
JUNCTION BOX DISCLOSURE* REPORT

SWD SYSTEM	JUNCTION	UNIT	SECTION	TOWNSHIP	RANGE	COUNTY	BOX DIMENSIONS	FEET Drive
Blinebry-Drinkard (BD)	H-36-2 vent	H	36	22S	37E	Lea	Length 5'2"	Width 6'4"
							Moved 48' East

BD H-36-2 VENT

UL/H SECTION 36
T-22-S R-37-E
LEA COUNTY, NM

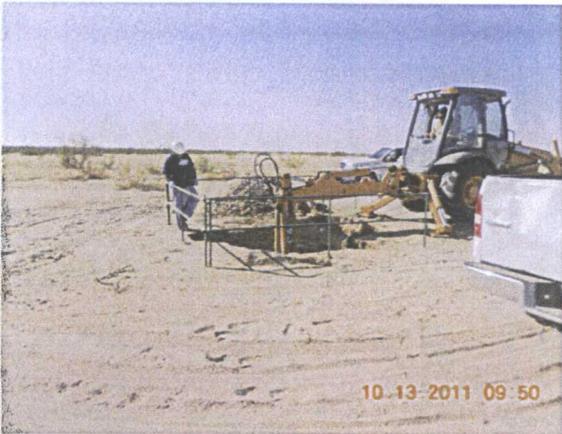
Digging vertical, facing south 10/13/2011

General Description of Remedial Action: An investigation was conducted using a backhoe to collect soil samples at regular intervals, producing a 20x20x12 ft deep excavation. Chloride field tests were performed on soil samples which yielded elevated concentrations. Organic vapors were measured using a PID which yielded low concentrations. The excavated soil was blended on site and representative composite samples of the excavation bottom, the excavation walls and the blended backfill were sent to a commercial laboratory for analysis of chloride and TPH. Sample analysis showed elevated chloride concentrations. A total of 236 yards of excavated soil from was the shelf was properly disposed of at a NMOCD approved disposal facility. A 6 ft. deep shelf was excavated, extending 5 ft. out from the East, West and South walls, making the excavation dimensions 30x25x6 ft deep. The excavated soil was used to backfill the the excavation to a depth of 6 ft. below ground surface (BGS). On 4/27/2012, a 20-mil reinforced plastic liner was installed at 6 ft. BGS. The remaining excavation was backfilled with clean imported soil to ground surface and contoured to the surrounding area. On 4/30/2012, the site was seeded with a blend of native vegetation and is expected to return to a productive capacity at a normal rate. A new water tight junction box was built 48 ft. east. NMOCD was notified of potential groundwater impact on 9/25/2012.

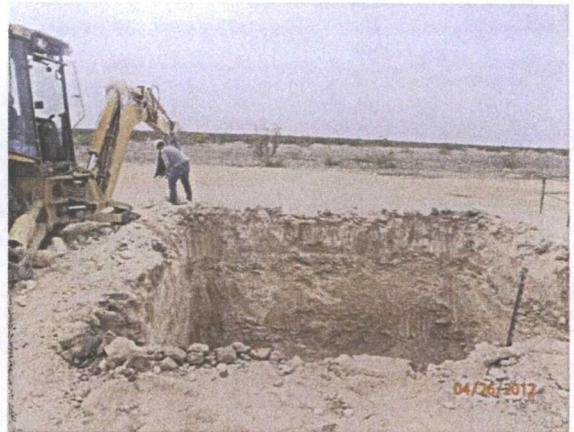
Collecting sample, facing south 4/26/2012

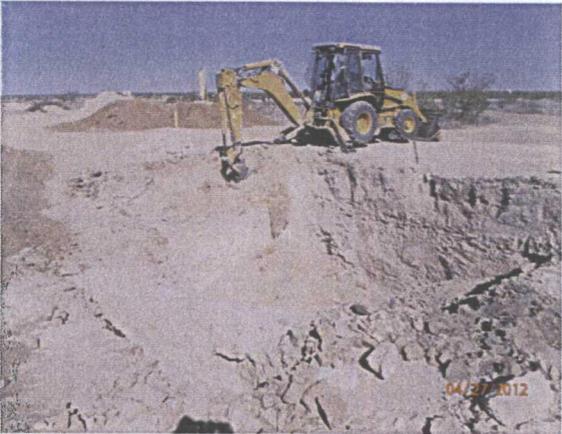
Excavating shelf, facing northwest 4/27/2012

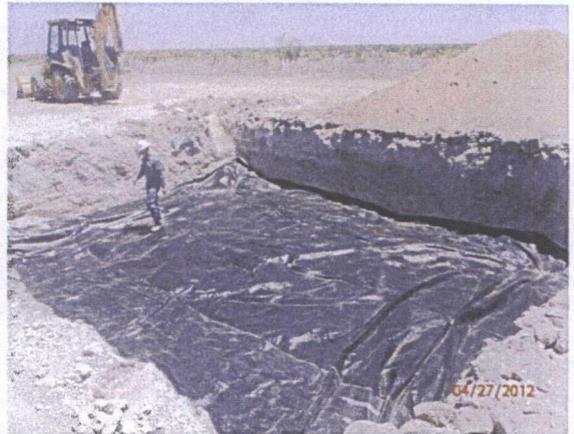
Installing liner, facing southeast 4/27/2012

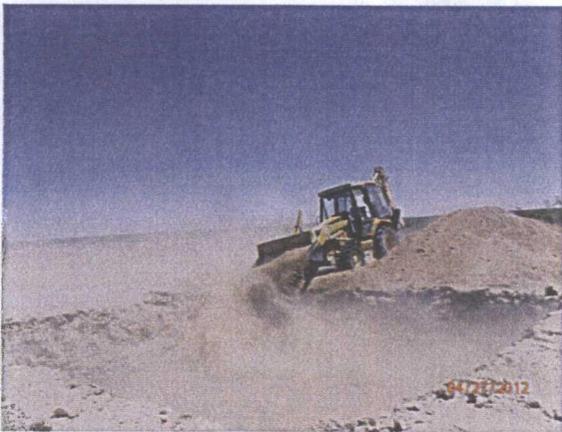
Backfilling site with imported soil, facing southeast 4/27/2012

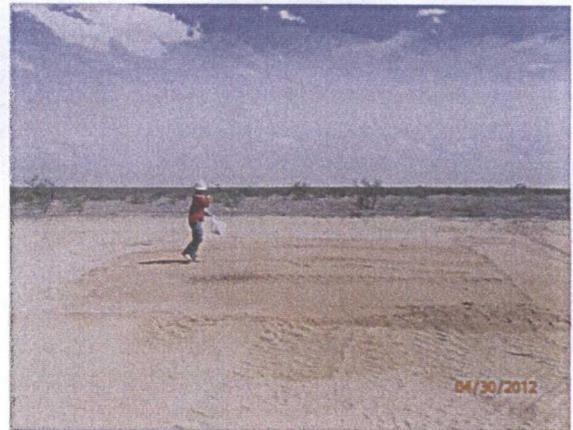
Seeding site, facing south 4/30/2012
