BD J-36 vent
2012

RICE OPERATING COMPANY JUNCTION BOX DISCLOSURE* REPORT

BOX LOCATION							BOX DIMENSIONS, FEET		
SWD SYSTEM	JUNCTION	UNIT	SECTION	TOWNSHIP	RANGE	COUNTY	Length	Width	Depth
Blinebry-Drinkard (BD)	J-36 vent	J	36	22S	37E	Lea	5'	5'	3'
							Eliminated

General Description of Remedial Action: This junction box was eliminated during the pipeline replacement/upgrade program. After the former junction box was removed, an investigation was conducted using a backhoe to collect soil samples at regular intervals producing a 20x20x12 ft deep excavation. Chloride field tests performed on soil samples did not decrease with depth. Organic vapors were measured using a PID which yielded elevated concentrations. The excavated soil was blended on site, and representative composite samples of the excavation bottom, the excavation walls, and the blended backfill were sent to a commercial laboratory for analysis of chloride and TPH. A total of 264 yards of blended backfill was transported to a NMOCD approved disposal facility. Shelves 5 ft. wide were excavated into the north, south, east and west walls to a depth of 6 ft., expanding the excavation length and width to 30x30 ft. The exc

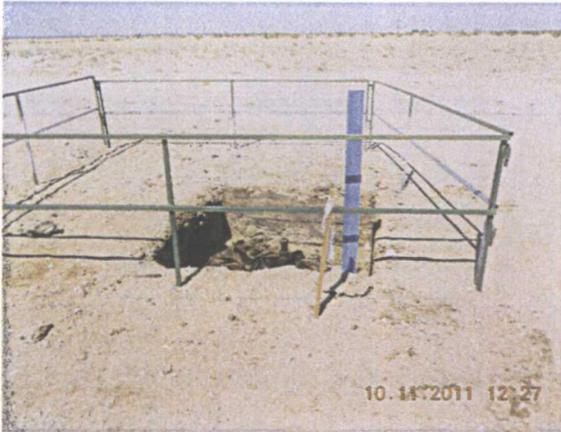
10/11/2011

Site prior, facing south

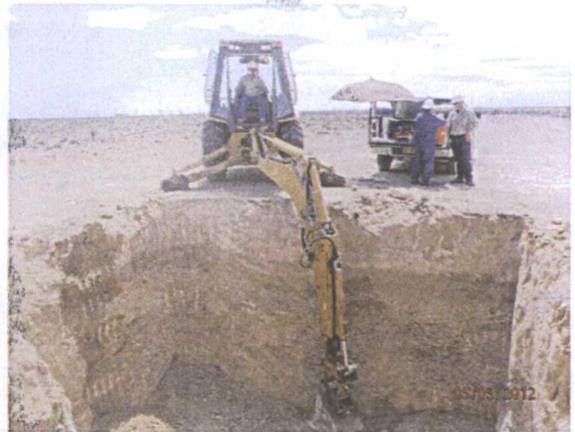
5/3/2012

Excavating site, facing west

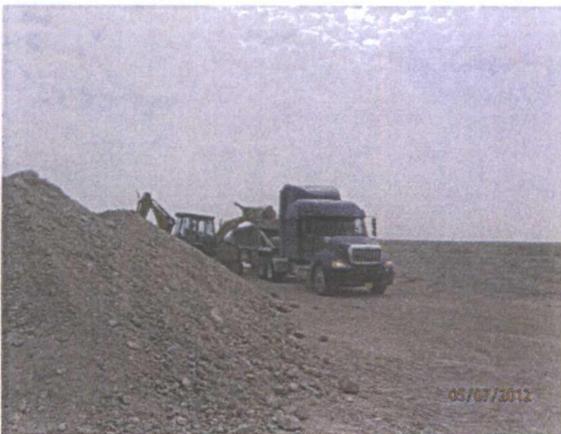
5/7/2012

Exporting soil, facing west

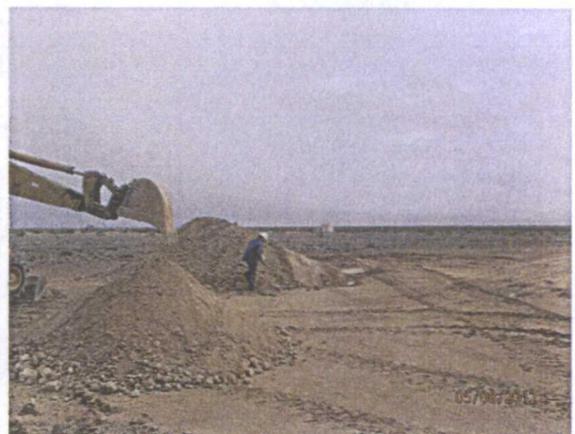
5/8/2012

Collecting sample, facing northeast

Procure 5-point composite sample of bottom and 4-point composite sample of sidewalls. TPH and Chloride laboratory test results completed by using an approved lab and testing procedures pursuant to NMOCD guidelines.

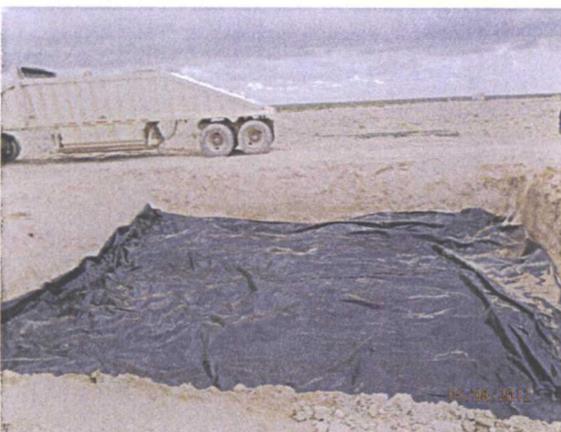
5/8/2012

Installing 30x30' 20 mil liner @ 6' bgs,
facing south

On 5/8/2012, a 30x30 ft. 20-mil reinforced liner was installed at 6 ft. BGS and the excavation was backfilled with clean imported soil to ground surface and contoured to the surrounding area. On 5/11/2012, the site was seeded with a blend of native vegetation and is expected to return to a productive capacity at a normal rate. NMOCD was notified of potential groundwater impact on 3/1/2013.

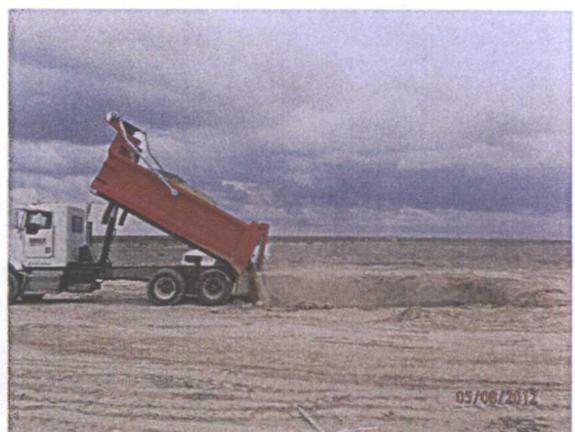
5/8/2012

Importing soil, facing south

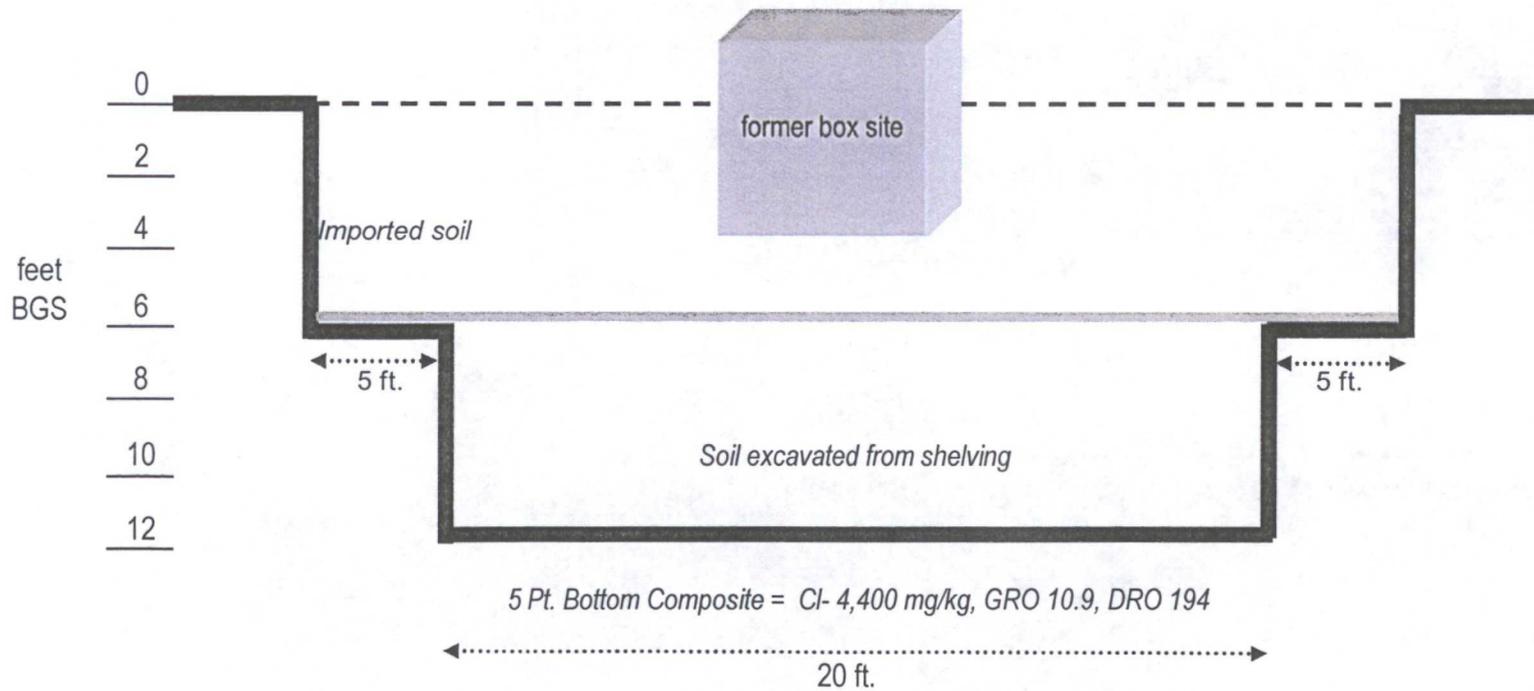
Excavation Cross-Section

BD J-36 vent
Unit 'J', Sec. 36, T22S, R37E

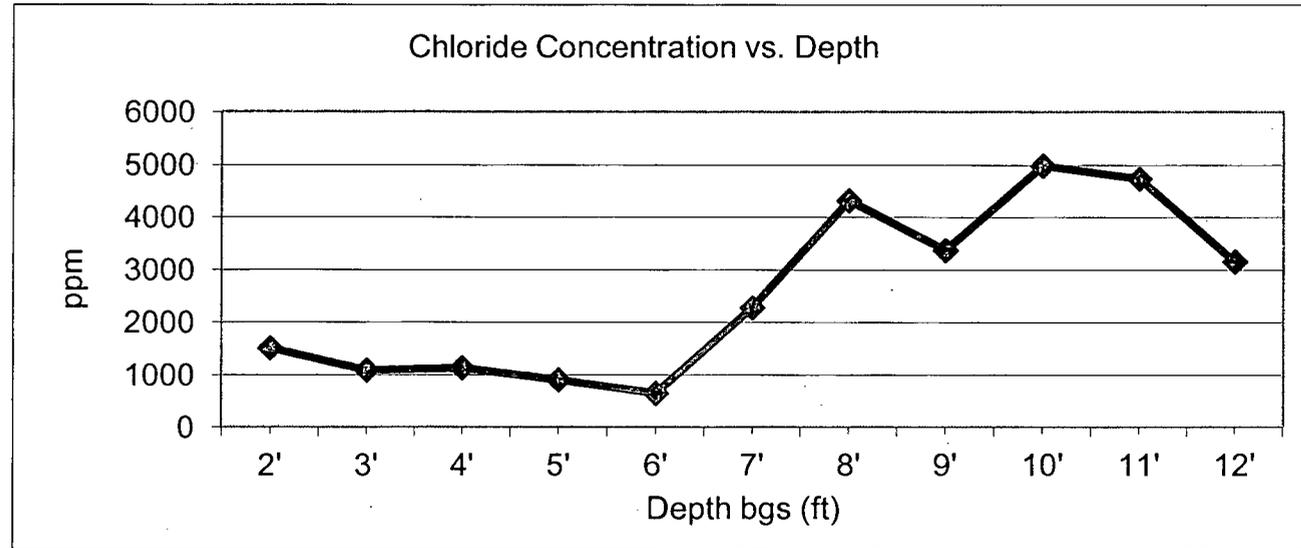
Backhoe samples at the junction (source)

Depth bgs (ft)	[Cl ⁻] ppm
2'	1508
3'	1086
4'	1132
5'	903
6'	649
7'	2283
8'	4321
9'	3376
10'	4987
11'	4741
12'	3162

Groundwater = 40 ft

LOCATION	DEPTH	mg/kg
4 wall comp.	n/a	1,334
bottom comp.	12'	2,195
backfill comp.	n/a	1,980
background	6"	53
vertical delineation trench at junction (source)	2'	1,508
	3'	1,086
	4'	1,132
	5'	903
	6'	649
	7'	2,283
	8'	4,321
	9'	3,376
	10'	4,987
	11'	4,741
12'	3,162
