BD K-36 vent
2012

RICE OPERATING COMPANY JUNCTION BOX DISCLOSURE* REPORT

SWD SYSTEM	JUNCTION	UNIT	SECTION	TOWNSHIP	RANGE	COUNTY	BOX DIMENSIONS - FEET		
							Length 4'	Width 5'	Depth 3'
Blinebry-Drinkard (BD)	K-36 vent	K	36	22S	37E	Lea	Eliminated

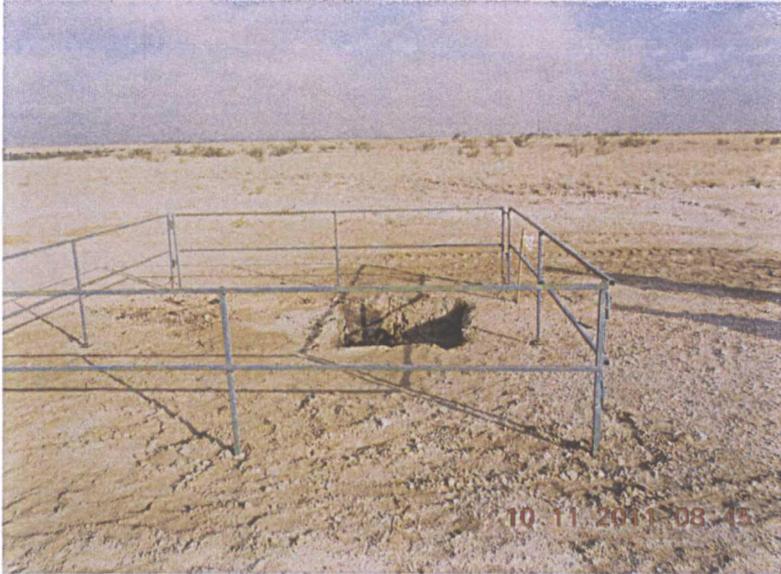
Site prior, facing north

10/11/2011

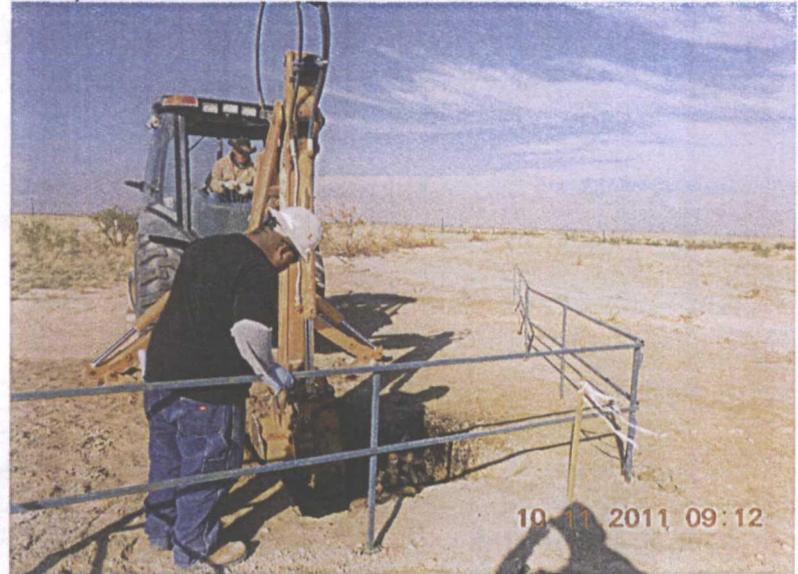
Excavating site, facing west

10/11/2011

General Description of Remedial Action: This junction box was addressed during the pipeline replacement/upgrade program. After the former junction box was removed, an investigation was conducted using a backhoe to produce a 7X3X12-ft. deep excavation. Chloride field tests performed on soil samples showed elevated concentrations. Organic vapors were measured using a PID which yielded generally low concentrations. A total of 112 cubic yards of excavated soil was hauled to a NMOCD approved facility for disposal. The excavation was backfilled with imported soil to ground surface and contoured to the surrounding area. On 8/21/2012, the site was seeded with a blend of native vegetation and is expected to return to a productive capacity at a normal rate. NMOCD was notified of potential groundwater impact on 11/19/2012.

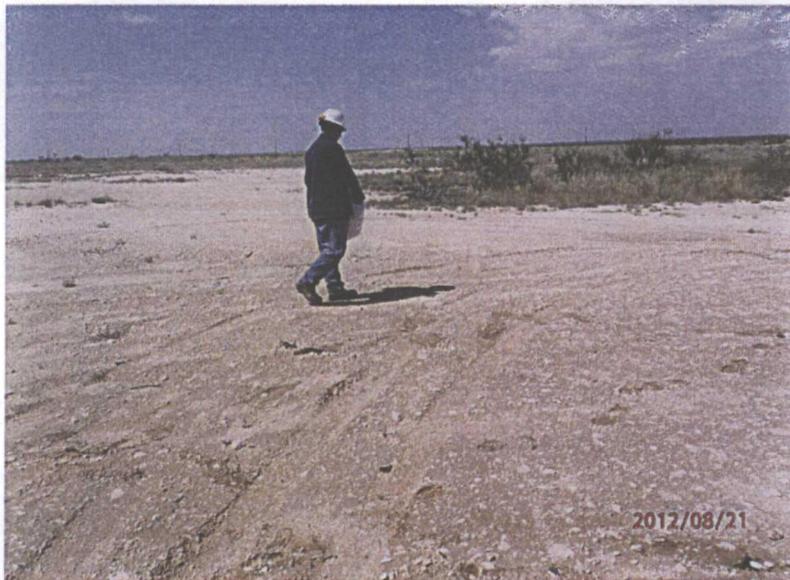
Seeding site, facing east

8/21/2012

Custom seed mix <input checked="" type="checkbox"/>	Prescribed mix <input type="checkbox"/>	Seed mix name:	1 lb. Blue Grama and 1 lb. Side Oats Grama	Seeding date: 8/21/2012
Broadcast <input checked="" type="checkbox"/>	Method: Hand Broadcast			
Soil conditions during seeding: Dry <input checked="" type="checkbox"/> Damp <input type="checkbox"/> Wet <input type="checkbox"/>				
Photos attached <input type="checkbox"/>	Observations: Seed was raked into soil.			
Number of photos:

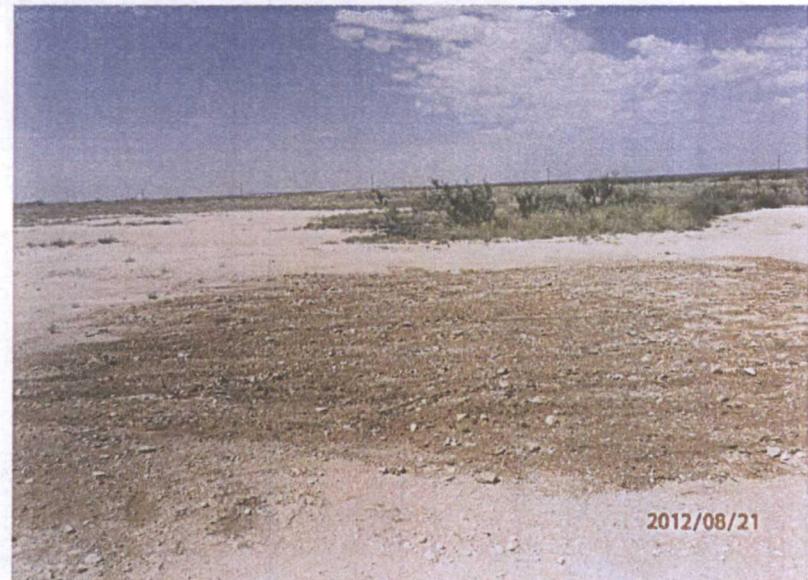
Site complete, facing north

8/21/2012

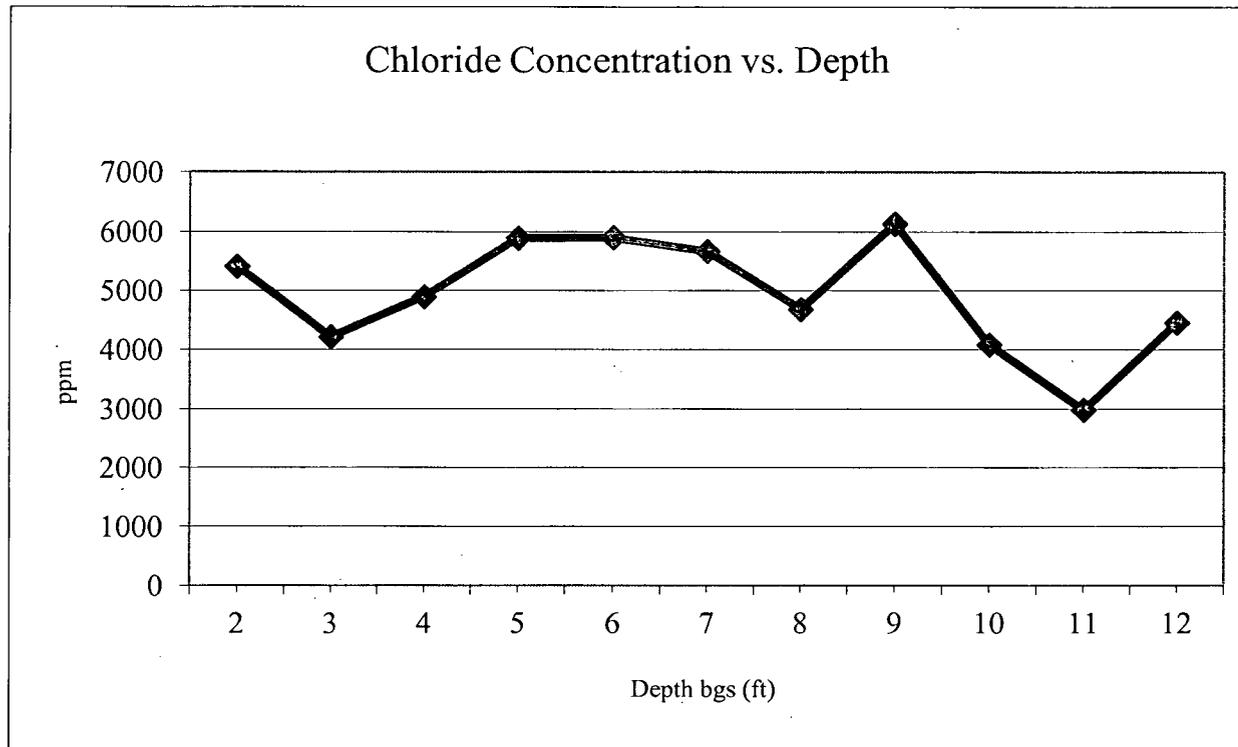
CHLORIDE CONCENTRATION CURVE

Backhoe samples at junction (source)

Depth bgs (ft)	[Cl ⁻], ppm
2	5410
3	4214
4	4893
5	5891
6	5900
7	5668
8	4683
9	6134
10	4084
11	2985
12	4456

Groundwater = 41 ft

LOCATION	DEPTH	(ppm)	(mg/kg)
background	6"	14.6	52
vertical delineation trench at 5' W of source	2'	2.3	5,410
	3'	22.2	4,214
	4'	97.7	4,893
	5'	9.1	5,891
	6'	6.0	5,900
	7'	8.8	5,668
	8'	40.6	4,683
	9'	48.8	6,134
	10'	64.5	4,084
	11'	33.4	2,985
	12'	21.4	4,456
