RICE OPERATING COMPANY
JUNCTION BOX DISCLOSURE* REPORT

BOX LOCATION							Oil Conservation Division		
SWD SYSTEM	JUNCTION	UNIT	SECTION	TOWNSHIP	RANGE	COUNTY	BOX DIMENSIONS, FEET		
Blinebry-Drinkard (BD)	O-29 EOL	O	29	22S	38E	Lea	Length 5'	Width 5'	Depth 4'
							Eliminated

BD O-29 EOL

Unit O, Section 29, T22S, R38E

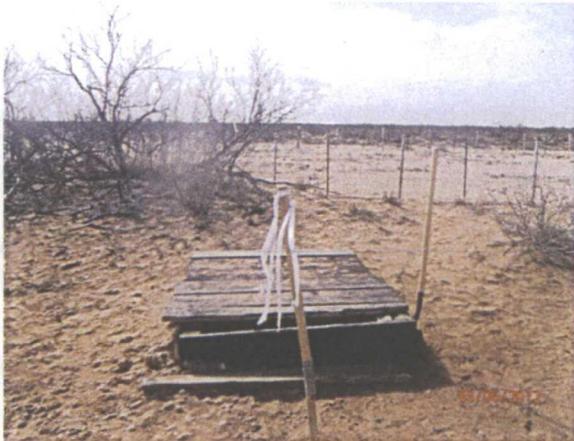
Site prior to excavation, facing south 3/6/2012

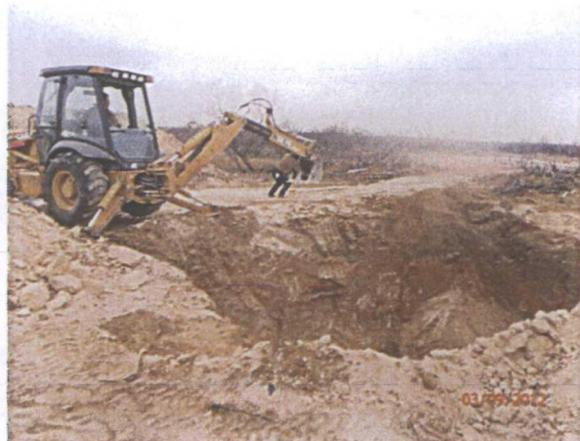
Collecting sample, facing east 3/9/2012

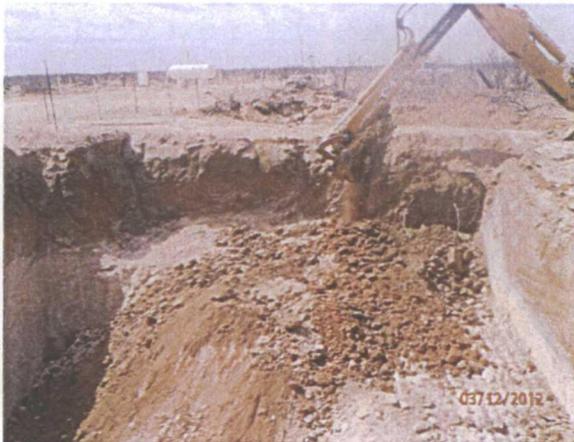
Expanding 20'x20' to 30'x25' with 5' deep shelves, facing west 3/12/2012

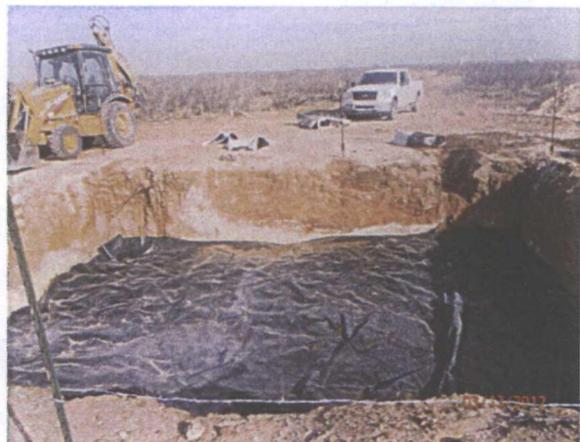
Installed 30'x25' 20 mil reinforced liner, facing northwest 3/13/2012

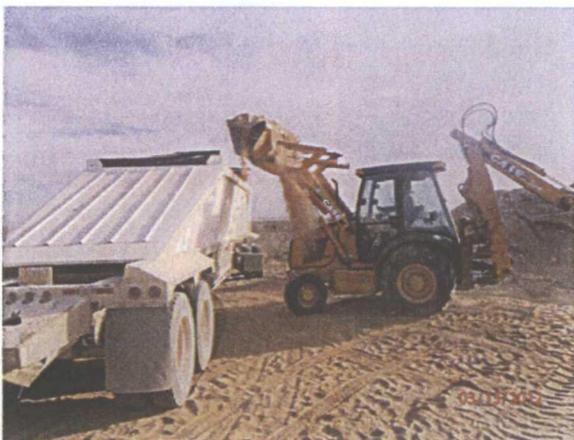
Exporting soil, facing east 3/13/2012

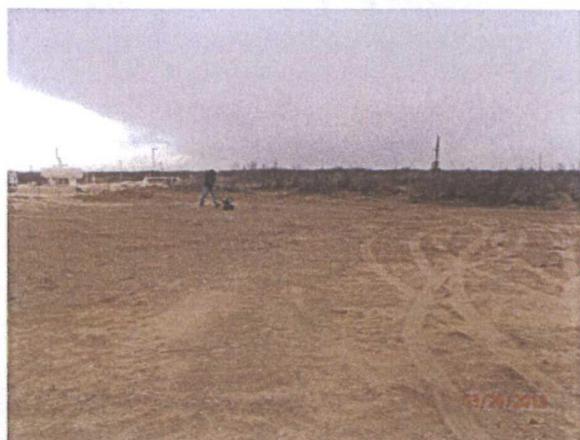
Seeding site, facing southwest 3/20/2012

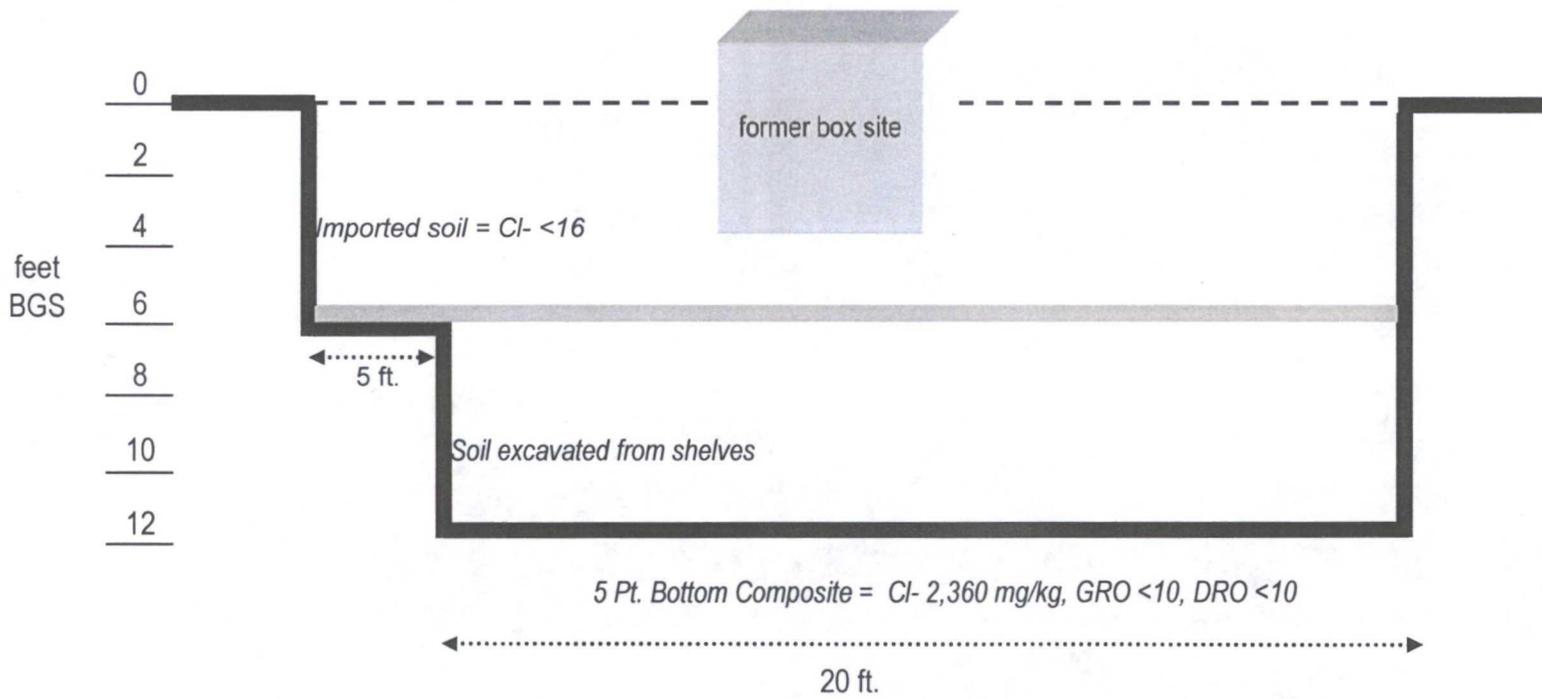
Excavation Cross-Section

BD O-29 EOL
Unit 'O', Sec. 29, T22S, R38E

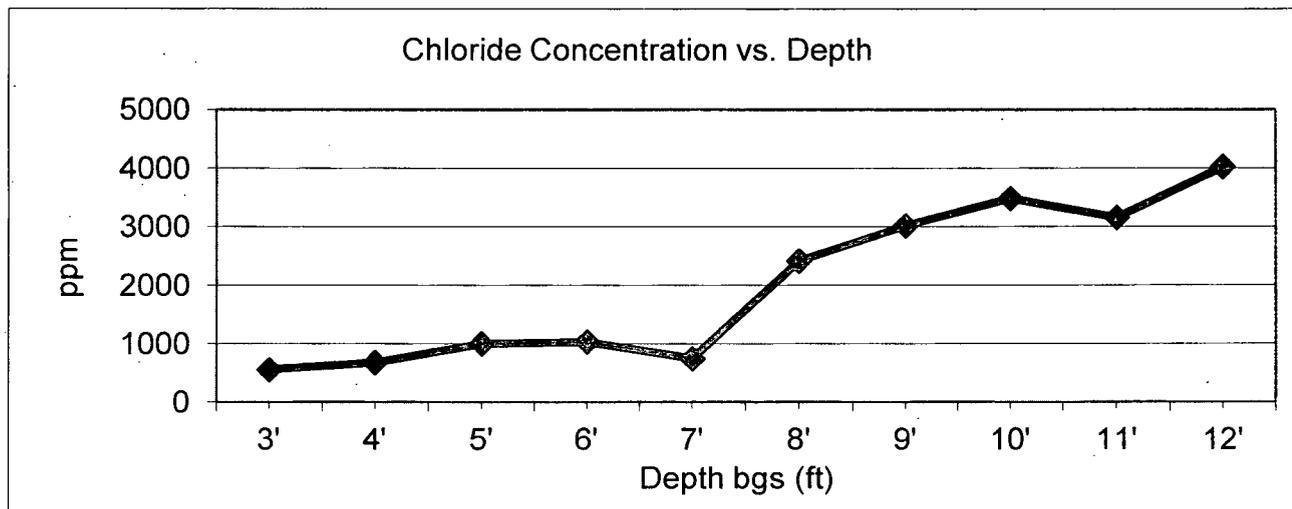
Backhoe samples at the junction (source)

Depth bgs (ft)	[Cl ⁻] ppm
3'	554
4'	677
5'	1000
6'	1033
7'	746
8'	2415
9'	3018
10'	3482
11'	3158
12'	4025

Groundwater = 124 ft
