EME A-18 EOL

CLOSURE

RE: Termination Request
EME A-18 EOL: UL/A, Sec. 18, T19S, R37E
RICE Operating Company – Eunice Monument Eumont SWD System

RICE OPERATING COMPANY
JUNCTION BOX FINAL REPORT

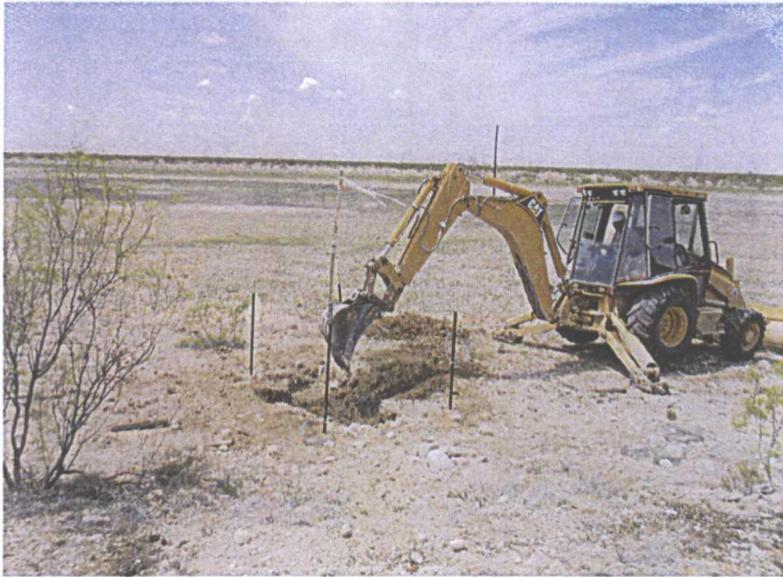
4/10/2012

Excavating site, facing west

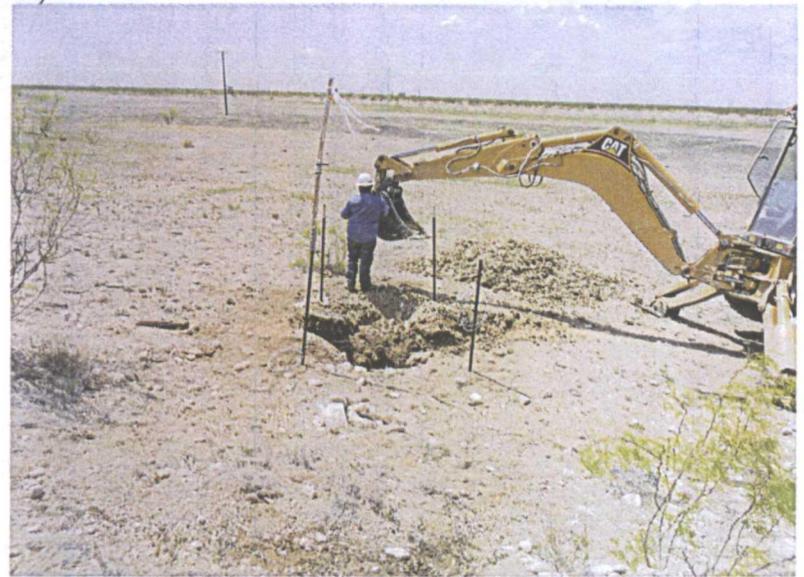
4/10/2012

Collecting sample, facing west

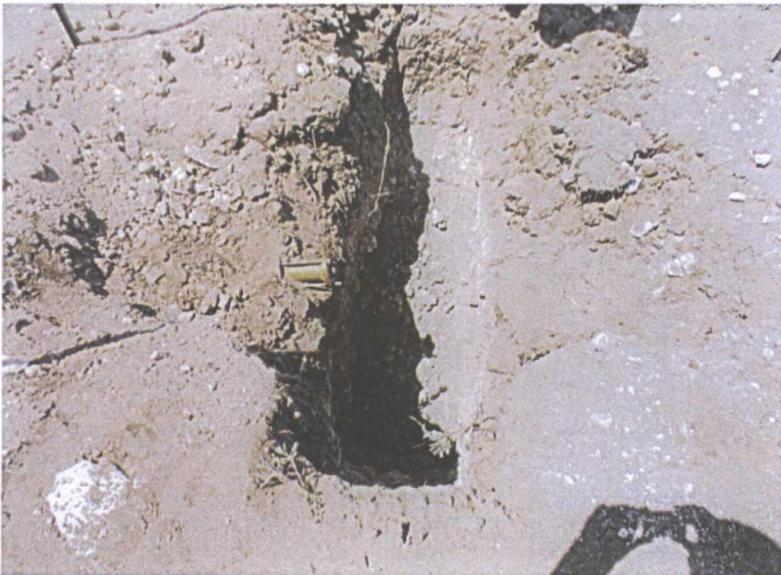
4/10/2012

Completed excavation

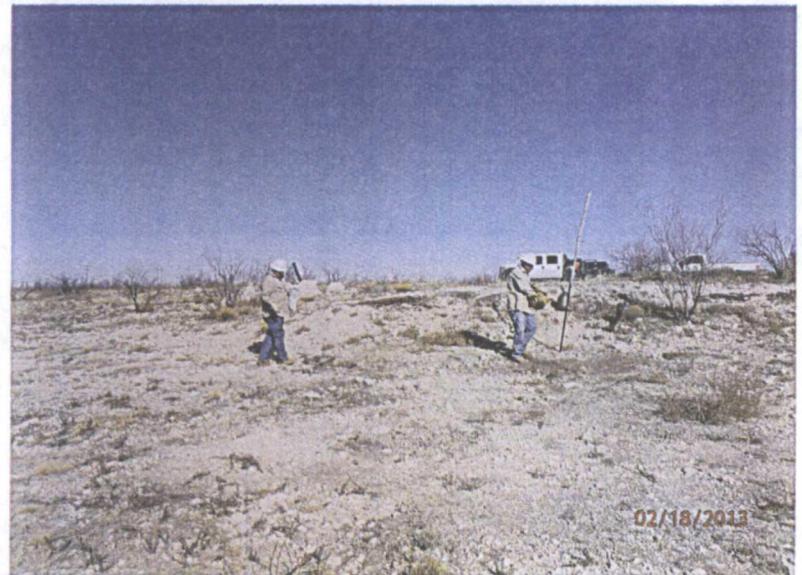
2/18/2013

Seeding site, facing east

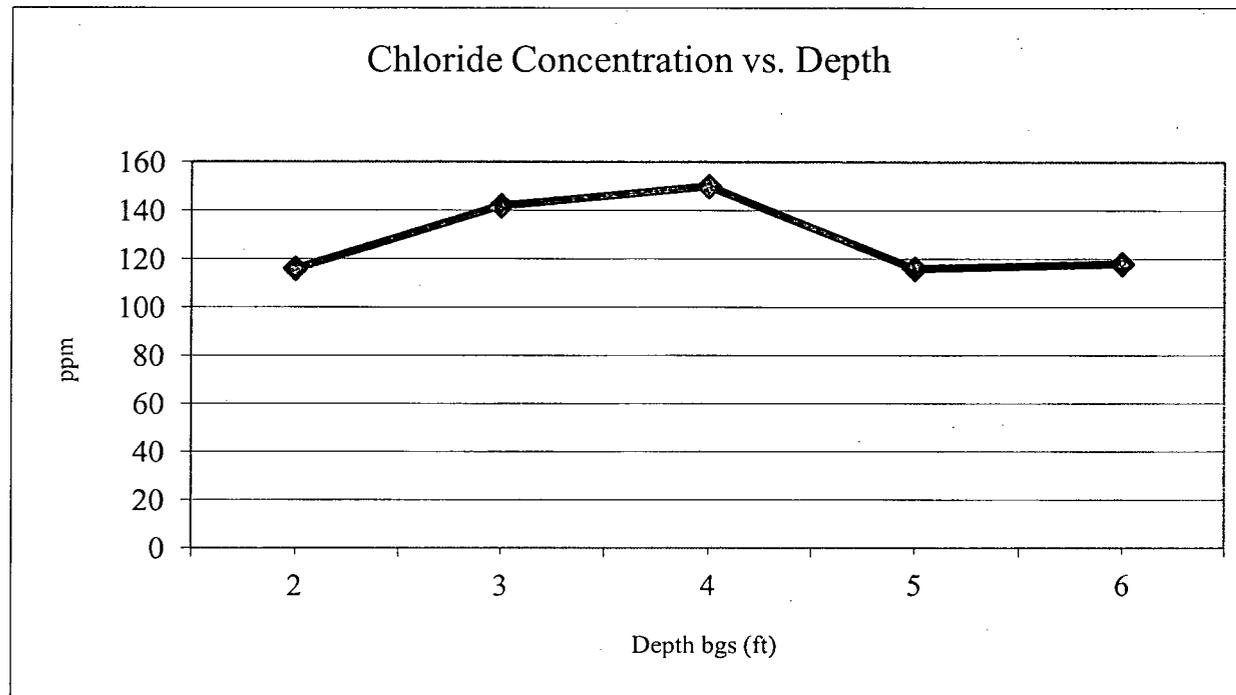
CHLORIDE CONCENTRATION CURVE

Backhoe samples at junction (source)

Depth bgs (ft)	[Cl] ppm
2	116
3	142
4	150
5	116
6	118

Groundwater = 54 ft
