EME E-14 EOL

CLOSURE

RE: Termination Request
EME E-14 EOL: UL/E, Sec. 14, T21S, R36E
RICE Operating Company – Eunice Monument Eumont SWD System

**RICE OPERATING COMPANY
JUNCTION BOX FINAL REPORT**

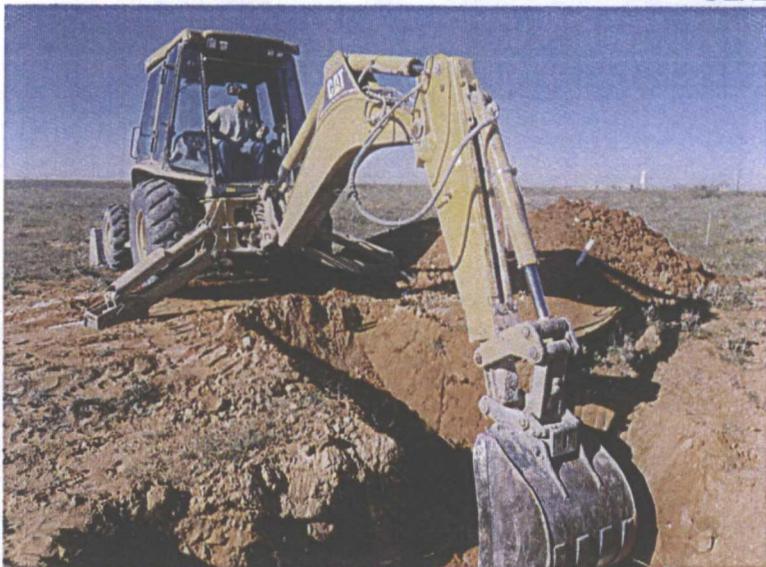
Excavating site, facing south

11/14/2012

General Description of Remedial Action: This junction and line were eliminated during the pipeline replacement/upgrade program. After the former junction box was removed, an investigation was conducted using a backhoe to collect soil samples at regular intervals, creating a 7x3x10 ft. deep excavation. Chloride field tests performed on each sample yielded low concentrations. Organic vapors were measured using a PID which yielded low concentrations. The deepest sample, 10 ft. below ground surface (BGS) was sent to a commercial laboratory for analysis of chloride and TPH, which confirmed low concentrations of each. The excavation was backfilled with excavated soil to ground surface and contoured to the surrounding area. On 11/15/2012, the site was seeded with a blend of native vegetation and is expected to return to a productive capacity at a normal rate.

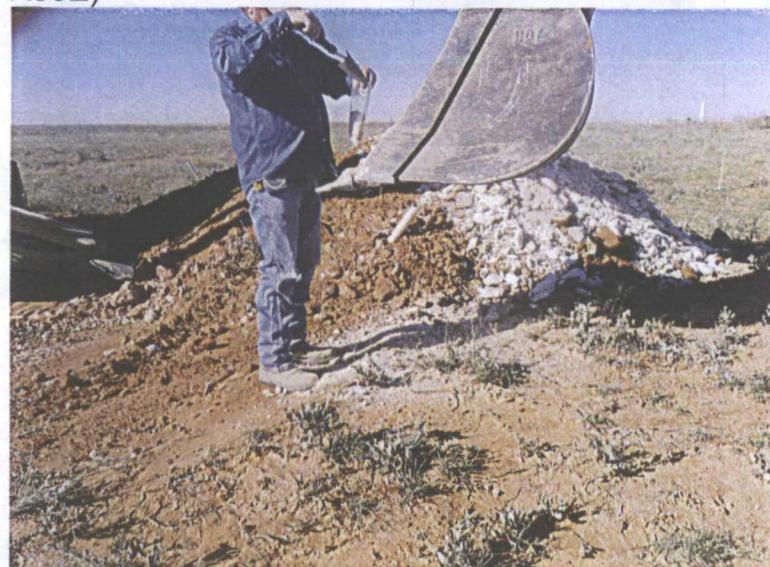
Collecting sample, facing south

11/14/2012

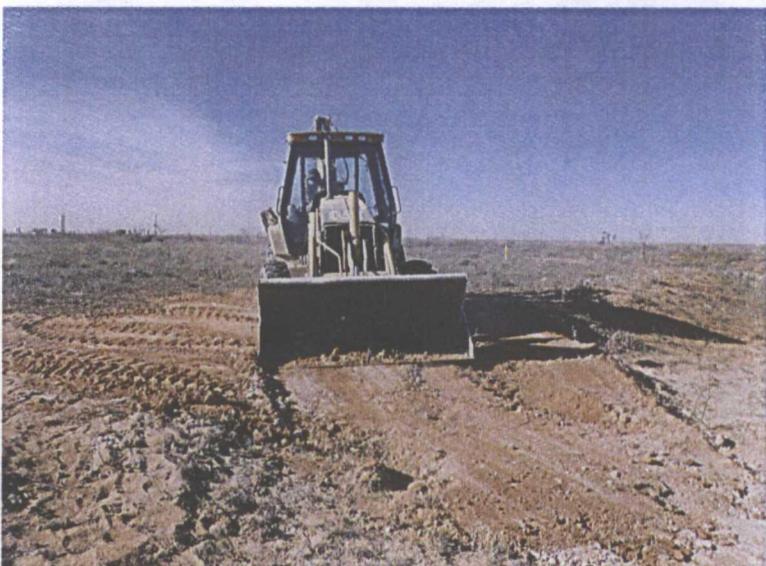
Backfilling site, facing south

11/14/2012

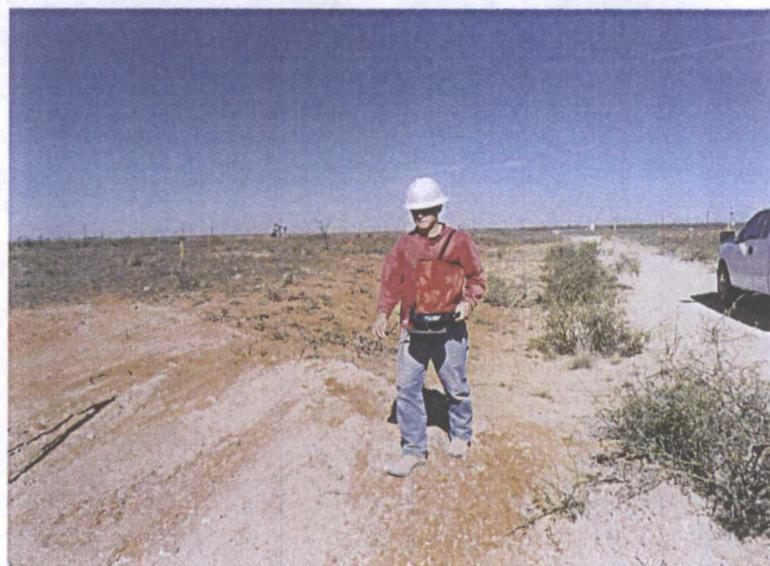
Seeding Site, facing north

11/15/2012

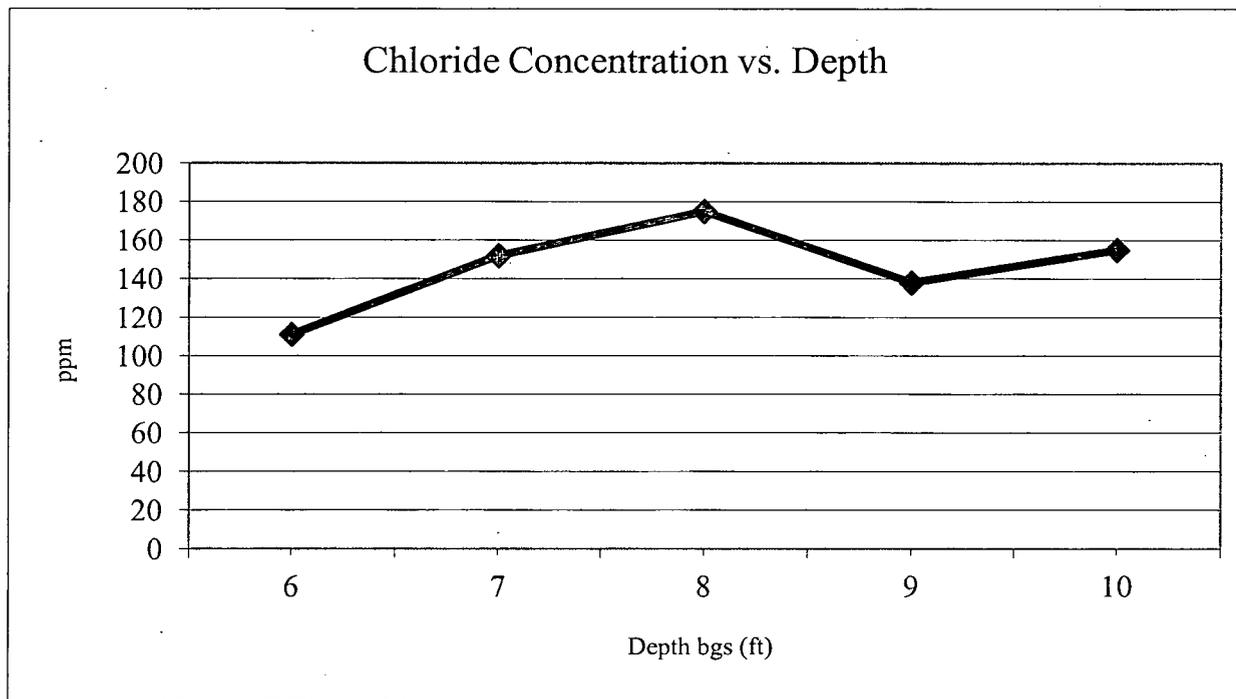
EME E-14 EOL

Backhoe samples at junction (source)

Depth bgs (ft)	Cl ⁻ (ppm)
6	111
7	152
8	175
9	138
10	155

Groundwater = 150 ft.

CHLORIDE FIELD TESTS		
LOCATION	DEPTH	mg/kg
vertical delineation trench at the junction (source)	6'	111
	7'	152
	8'	175
	9'	138
	10'	155
