EME H-4 EOL

RE: Termination Request
EME H-4 EOL: UL/H, Sec. 4, T20S, R37E
RICE Operating Company – Eunice Monument Eumont SWD System

**RICE OPERATING COMPANY
JUNCTION BOX FINAL REPORT**

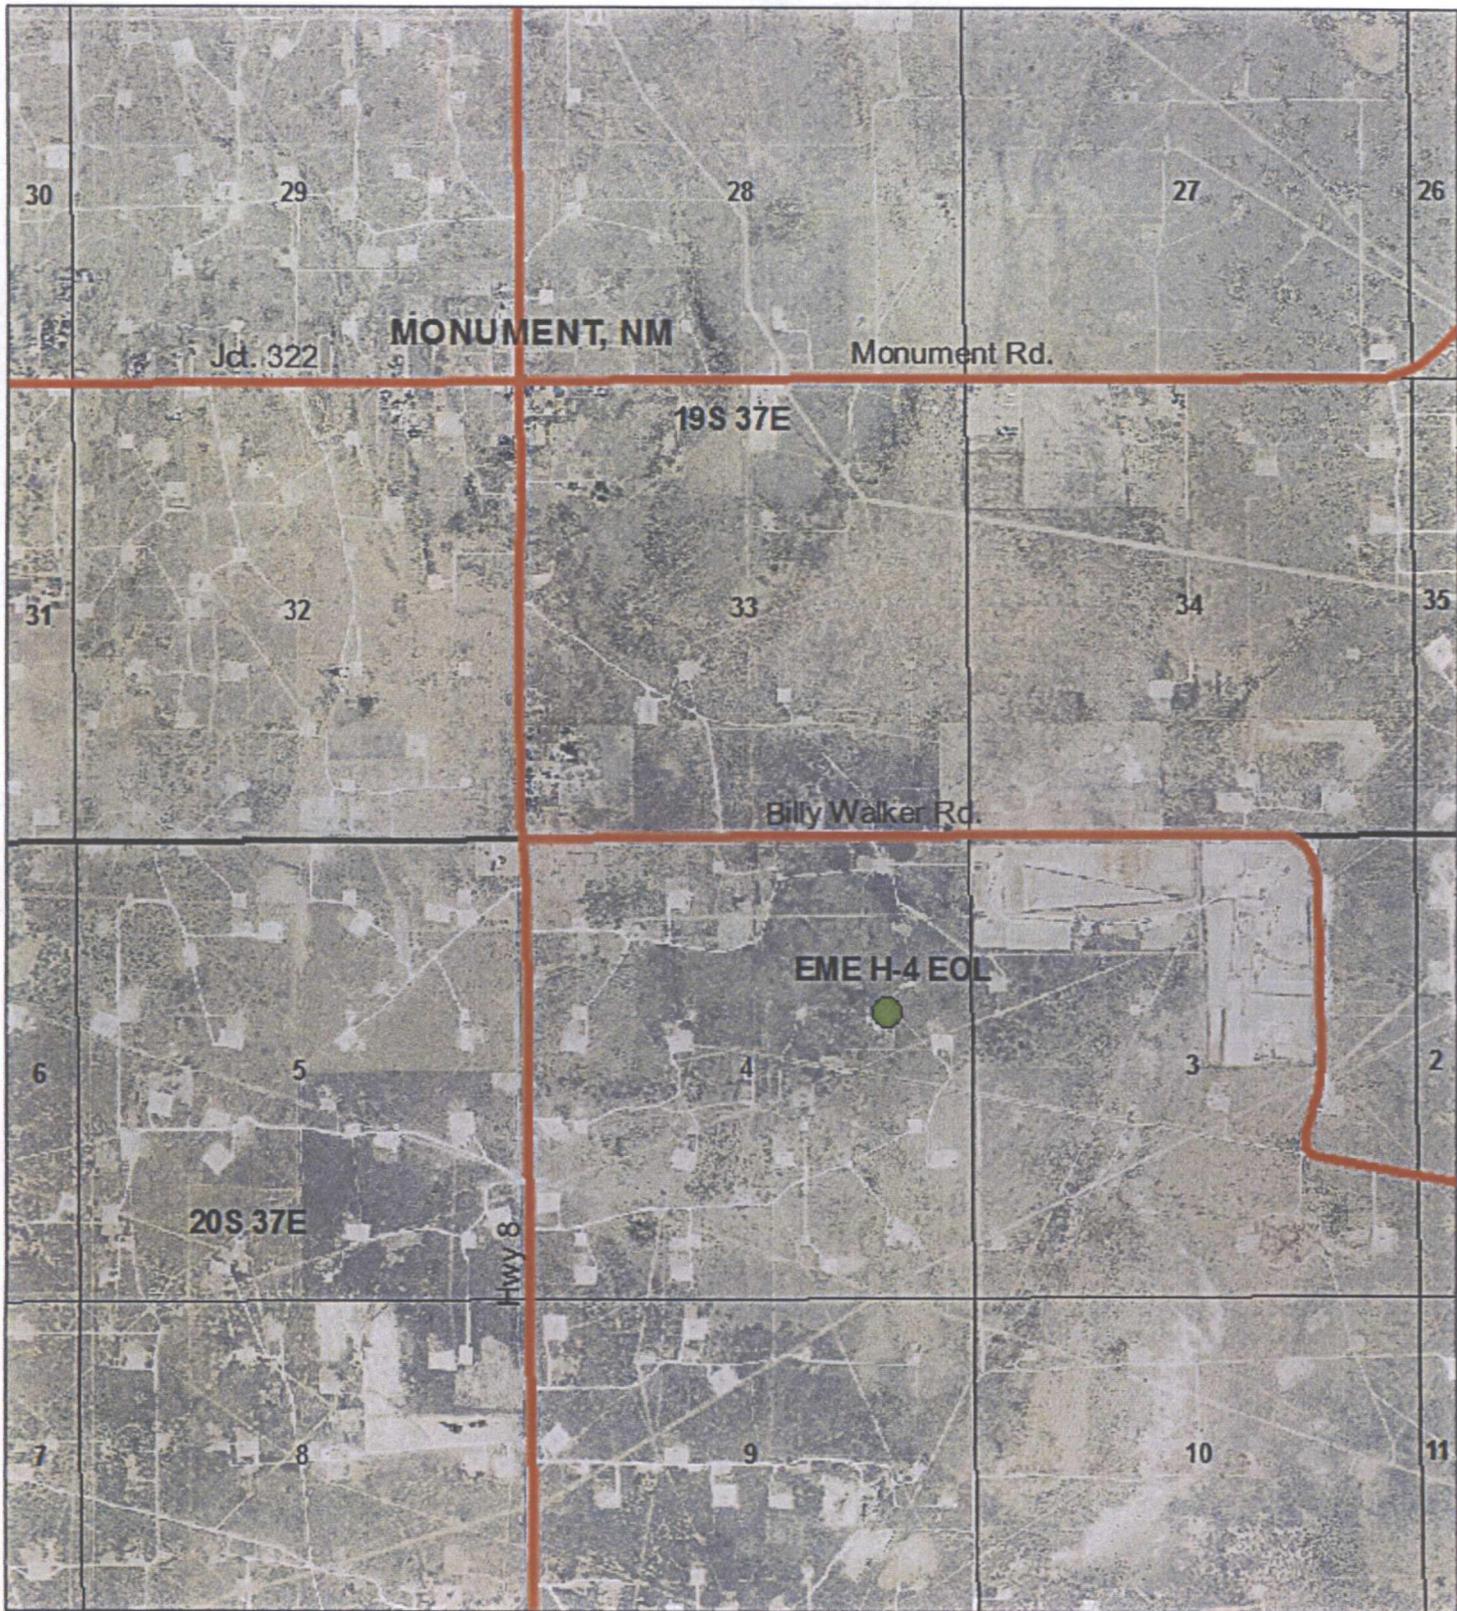
EME H-4 EOL

UL/H SECTION 4
T-20-S R-37-E
LEA COUNTY, NM

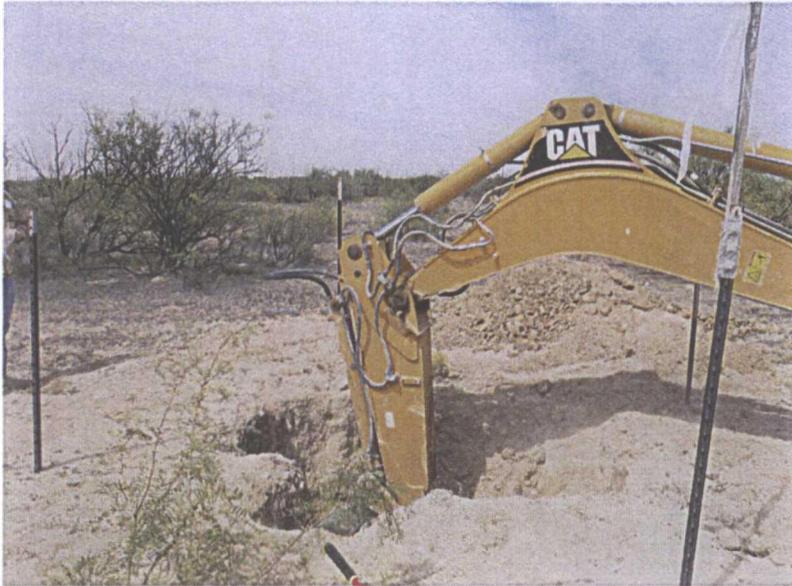
9/17/2012

Excavating site, facing east

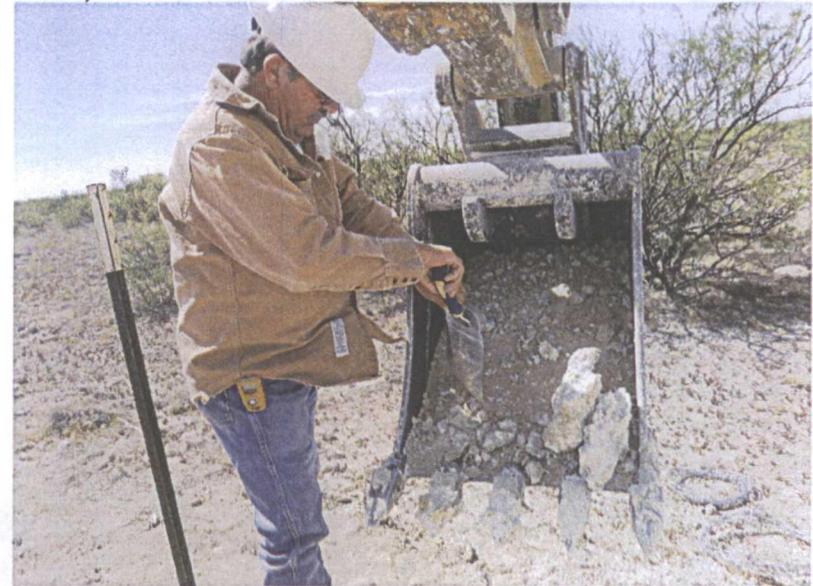
9/17/2012

Collecting sample, facing south

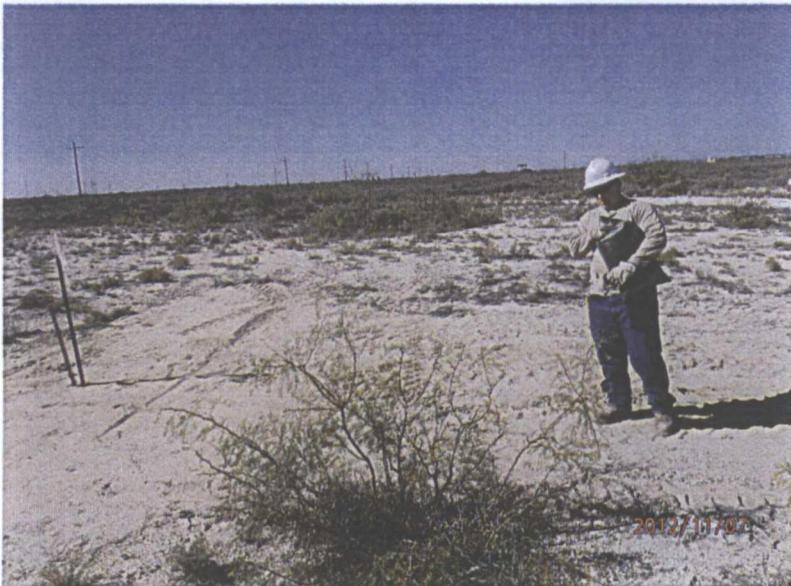
11/7/2012

Seeding Site, facing west

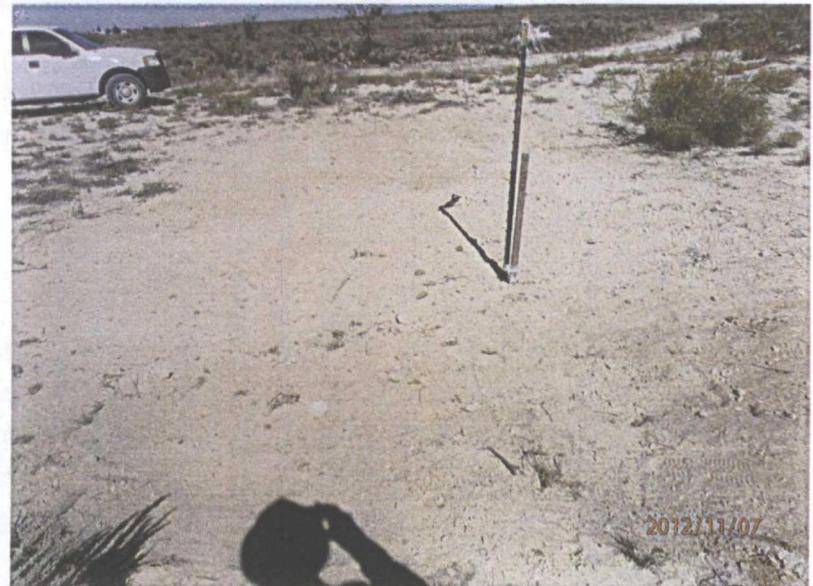
11/7/2012

Site complete, facing north

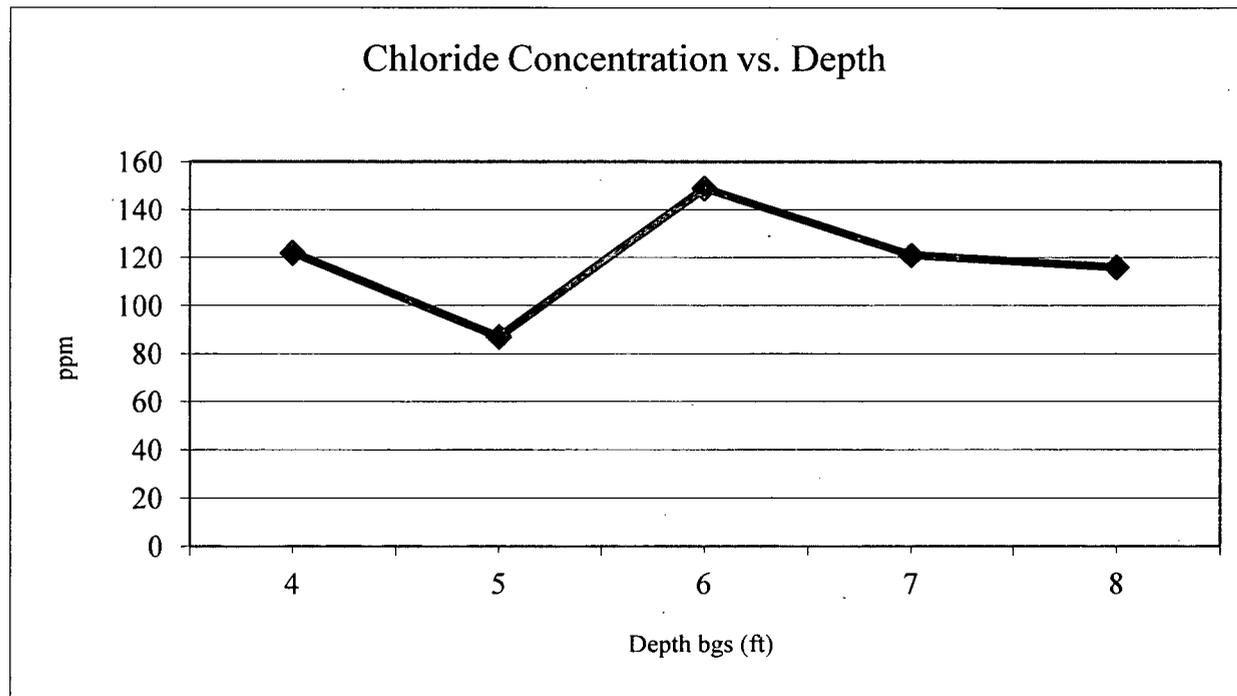
CHLORIDE CONCENTRATION CURVE

Backhoe samples at junction.(source)

Depth bgs (ft)	[Cl ⁻] ppm
4	122
5	87
6	149
7	121
8	116

Groundwater = 31 ft
