1R427-397

EME Jct. T-6

RE: Termination Request  
EME Jct. T-6: UL/T, Sec. 6, T21S, R36E  
RICE Operating Company – Eunice Monument Eumont SWD System

RICE OPERATING COMPANY  
JUNCTION BOX FINAL REPORT

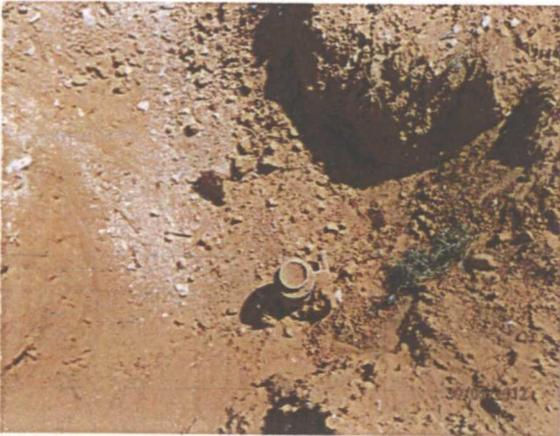
Site prior

5/30/2012

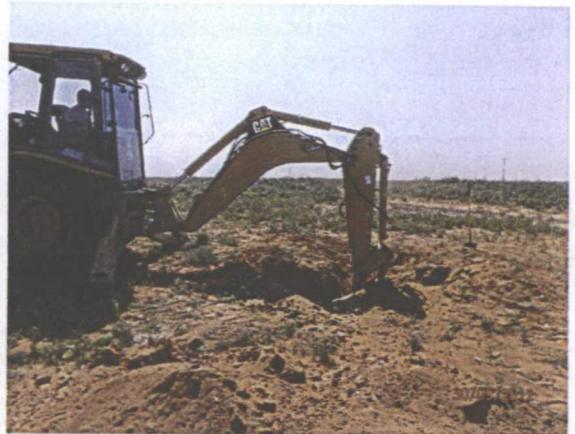
Excavating site, facing south

5/30/2012

**General Description of Remedial Action:** This junction was eliminated during the pipeline replacement/upgrade program. After the former junction box was removed, an investigation was conducted using a backhoe to collect soil samples at regular intervals, creating a 3x7x9 ft. deep excavation. Chloride field tests performed on each sample yielded concentrations similar to that of the background sample. The deepest sample, 8 ft. below ground surface (BGS) was sent to a commercial laboratory for analysis of chloride and TPH, which confirmed low concentrations of each. The excavation was backfilled with excavated soil to ground surface and contoured to the surrounding area. On 11/7/2012, the site was seeded with a blend of native vegetation and is expected to return to a productive capacity at a normal rate.

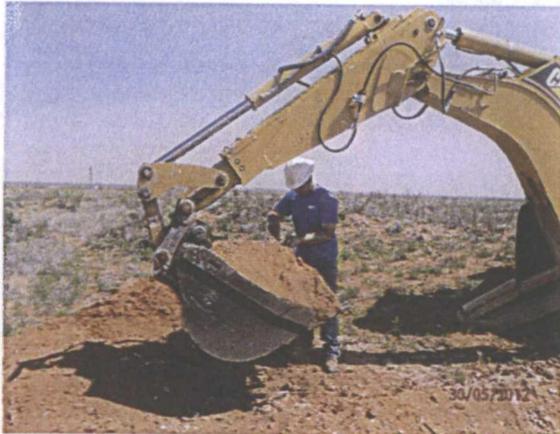
Collecting sample, facing north

5/30/2012

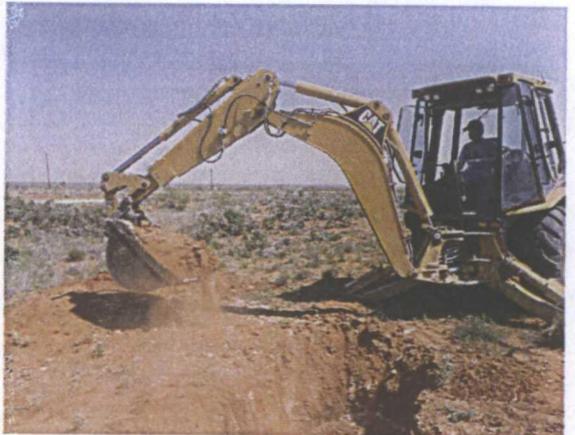
Backfilling site, facing north

5/30/2012

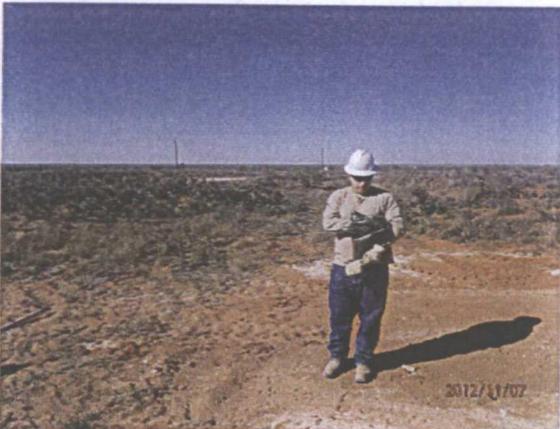
Seeding site, facing north

11/7/2012

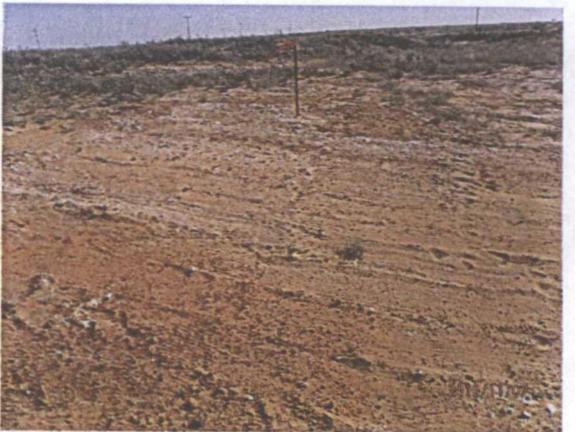
Site Complete, facing south

11/7/2012

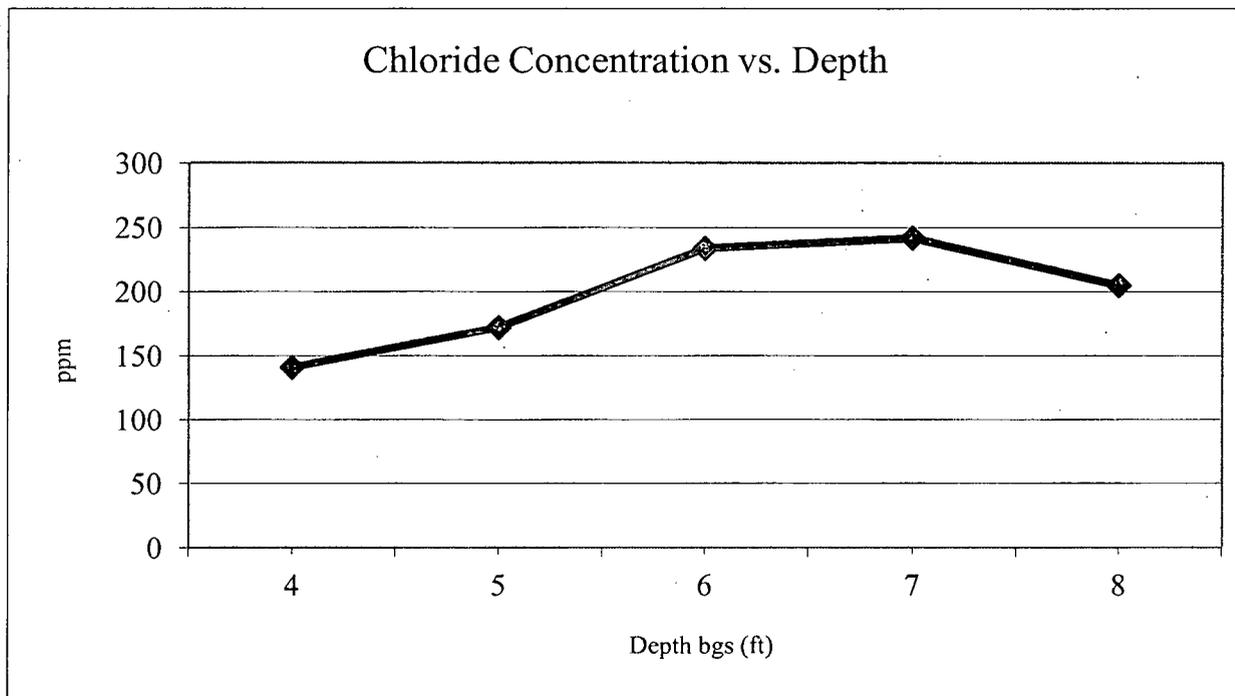
# EME Jct. T-6

*Backhoe samples at junction (source)*

Depth bgs (ft)	[Cl <sup>-</sup> ] ppm
4	141
5	172
6	234
7	242
8	205

Groundwater = 152 ft
