EME M-25 EOL RECEIVED

RE: Termination Request
EME M-25 EOL: UL/M, Sec. 25, T20S, R36E
RICE Operating Company – Eunice Monument Eumont SWD System

**RICE OPERATING COMPANY
JUNCTION BOX FINAL REPORT**

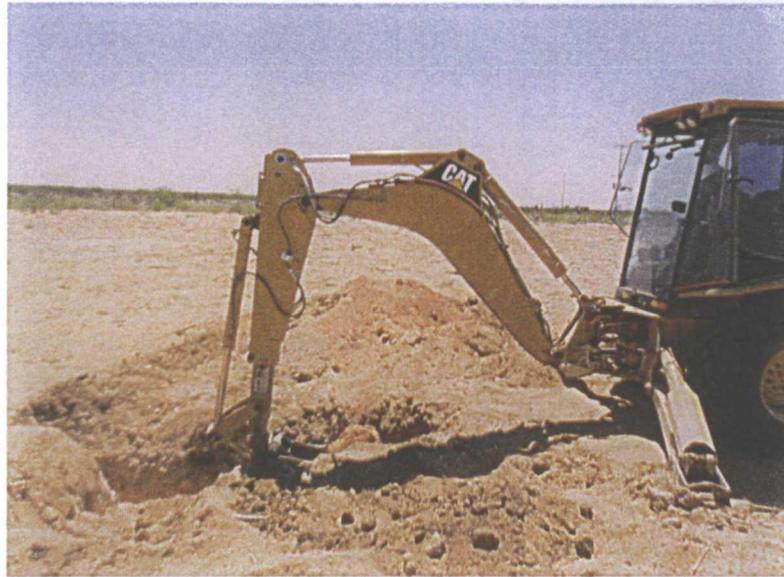
4/18/2012

Excavating site

General Description of Remedial Action: This junction and line were eliminated during the pipeline replacement/upgrade program. After the former junction box was removed, an investigation was conducted using a backhoe to collect soil samples at regular intervals, creating a 3x7x7 ft. deep excavation. Chloride field tests performed on each sample yielded concentrations similar to that of the background sample. The deepest sample, 7 ft. below ground surface (BGS) was sent to a commercial laboratory for analysis of chloride and TPH, which confirmed low concentrations of each. The excavation was backfilled with excavated soil to ground surface and contoured to the surrounding area. On 8/13/2012, the site was seeded with a blend of native vegetation and is expected to return to a productive capacity at a normal rate.

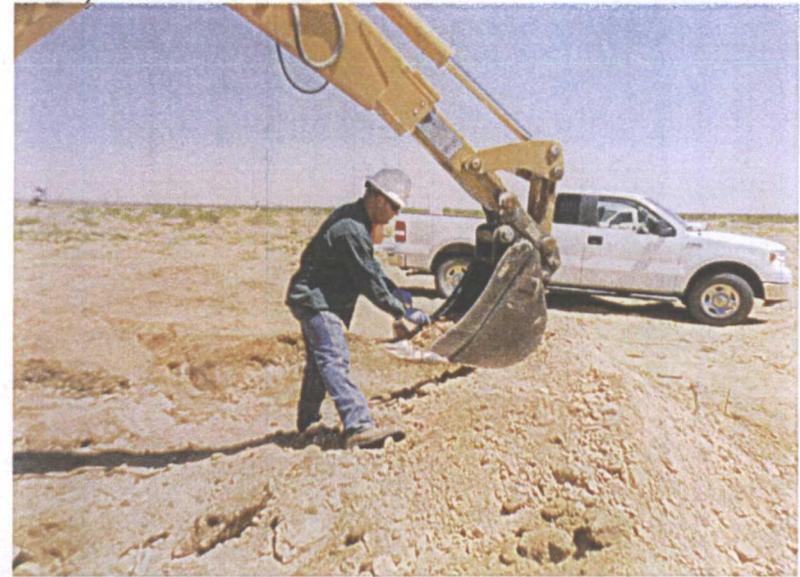
4/18/2012

Collecting sample

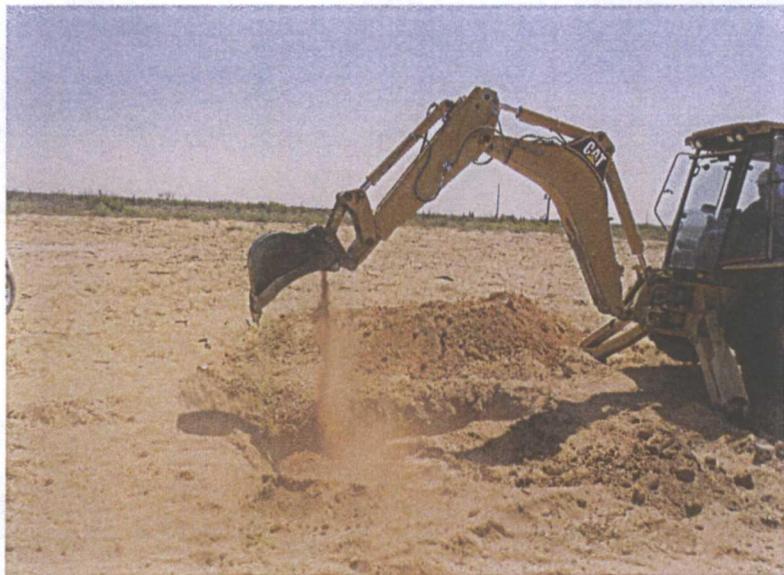
4/18/2012

Backfilling site

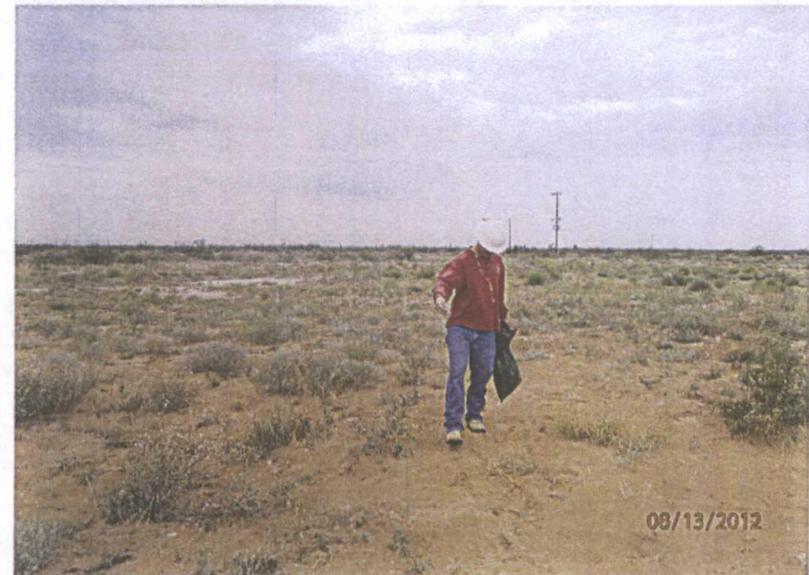
Seeding site

Custom seed mix <input checked="" type="checkbox"/>	Prescribed mix <input type="checkbox"/>	Seed mix name: 4 lbs. Blue Grama and 4 lbs. Side Oats Grama grass seed	Seeding date: 8/13/2012
Broadcast <input checked="" type="checkbox"/>			
Method: Hand broadcast			
Soil conditions during seeding: Dry <input checked="" type="checkbox"/> Damp <input type="checkbox"/> Wet <input type="checkbox"/>			
Photos attached <input type="checkbox"/>	Observations: Grass seed was raked into the soil		
Number of photos:

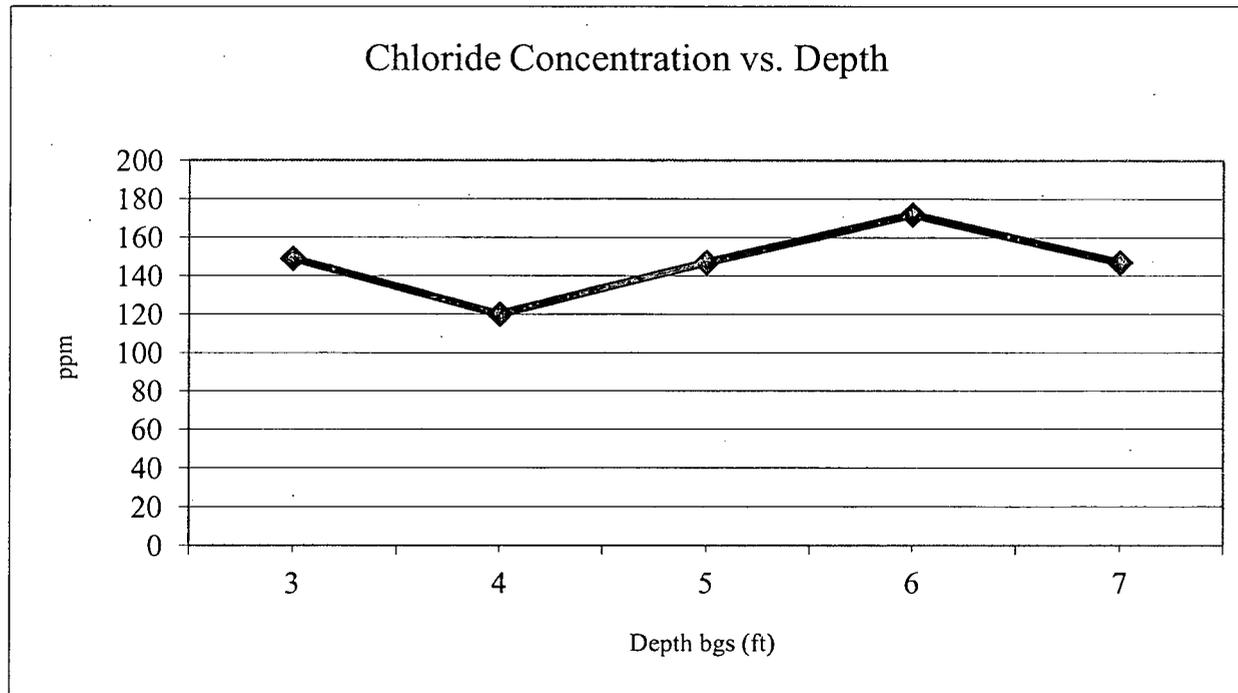
EME M-25 EOL

Backhoe samples at junction (source)

Depth bgs (ft)	[Cl ⁻] ppm
3	149
4	120
5	147
6	172
7	147

Groundwater = 107 ft

CHLORIDE FIELD TESTS		
LOCATION	DEPTH	mg/kg
background	6"	116
vertical delineation trench at the junction (source)	3'	149
	4'	120
	5'	147
	6'	172
	7'	147
