RE: Termination Request
EME N-23 EOL: UL/N, Sec. 23, T20S, R36E
RICE Operating Company – Eunice Monument Eumont SWD System

**RICE OPERATING COMPANY
JUNCTION BOX FINAL REPORT**

EME N-23 EOL

UL/N Sec. 23 (T20S-R36E)

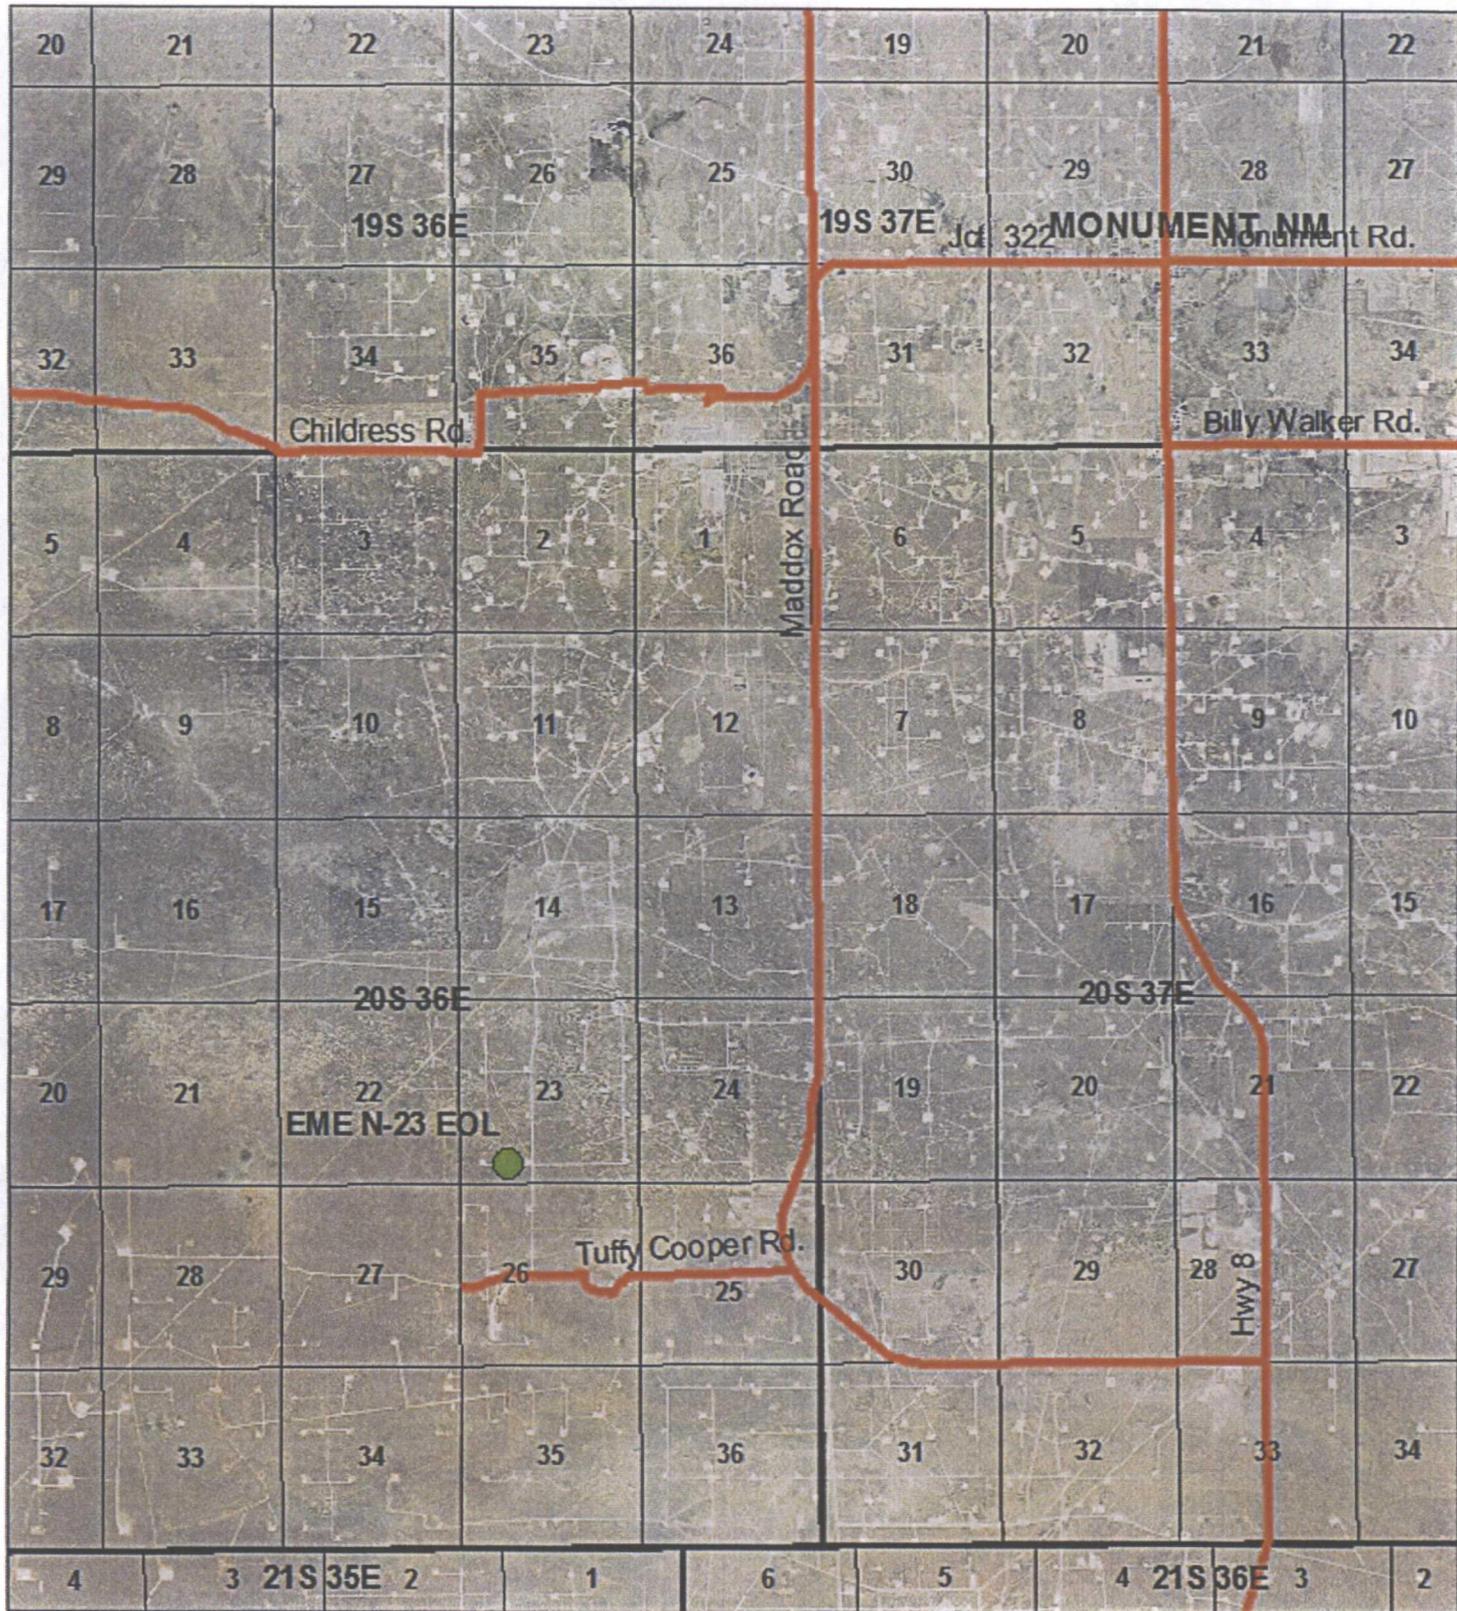
**EME N-23
EOL**

UL/N SECTION 23
T-20-S R-36-E
LEA COUNTY, NM

Drawing date: 11/7/12
Drafted by: Tony Grieco

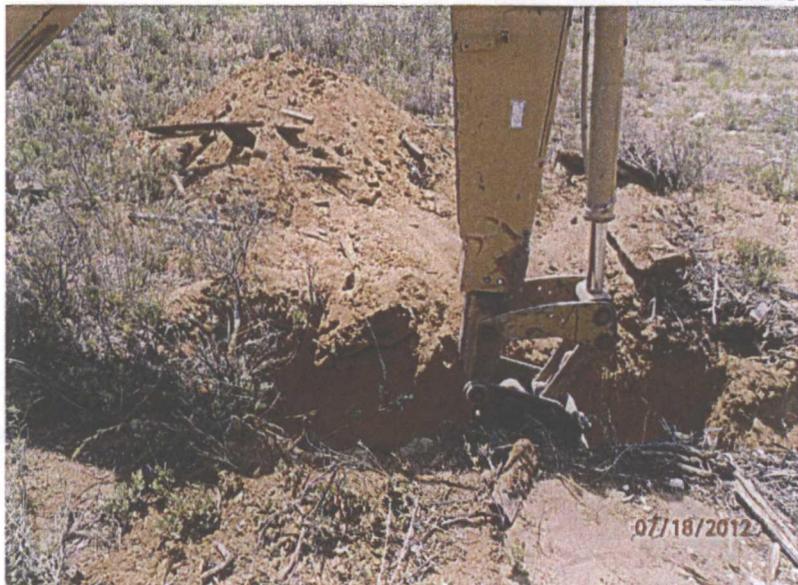
7/18/2012

Excavating site

General Description of Remedial Action: This junction and line were eliminated during the pipeline replacement/upgrade program. After the former junction box was removed, an investigation was conducted using a backhoe to collect soil samples at regular intervals, creating a 3x7x7 ft. deep excavation. Chloride field tests performed on each sample yielded concentrations similar to that of the background sample. The deepest sample, 7 ft. below ground surface (BGS) was sent to a commercial laboratory for analysis of chloride and TPH, which confirmed low concentrations of each. The excavation was backfilled with excavated soil to ground surface and contoured to the surrounding area. On 7/18/2012, the site was seeded with a blend of native vegetation and is expected to return to a productive capacity at a normal rate.

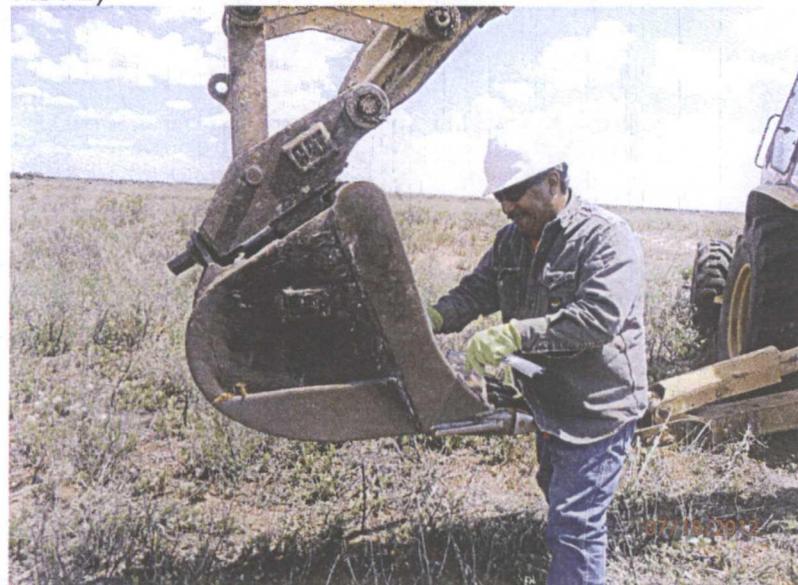
7/18/2012

Collecting sample

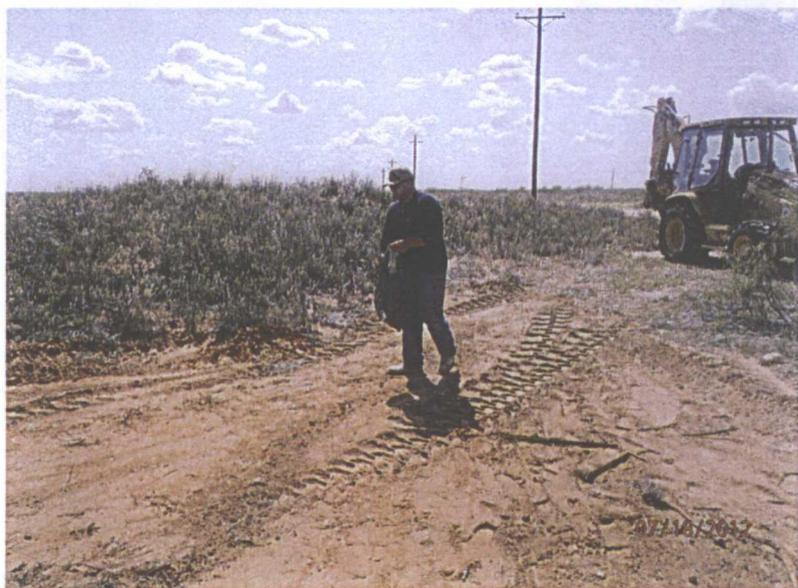
7/18/2012

Seeding site

Custom seed mix <input checked="" type="checkbox"/>	Prescribed mix <input type="checkbox"/>	Seed mix name: 4 LBS. BLUE GRAMA, 4 LBS. SIDEOATS GRAMA
Seeding date: 7-18-2012		
Broadcast <input checked="" type="checkbox"/>		
Method: Hand Broadcast		
Soil conditions during seeding: Dry <input checked="" type="checkbox"/> Damp <input type="checkbox"/> Wet <input type="checkbox"/>		
Photos attached <input checked="" type="checkbox"/>	Observations: Grass seed was raked into the soil	
Number of photos:

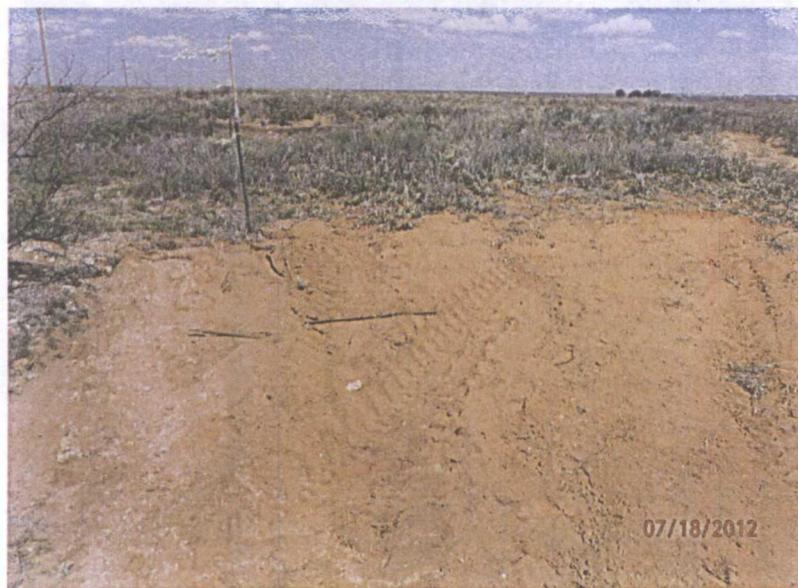
7/18/2012

Site complete

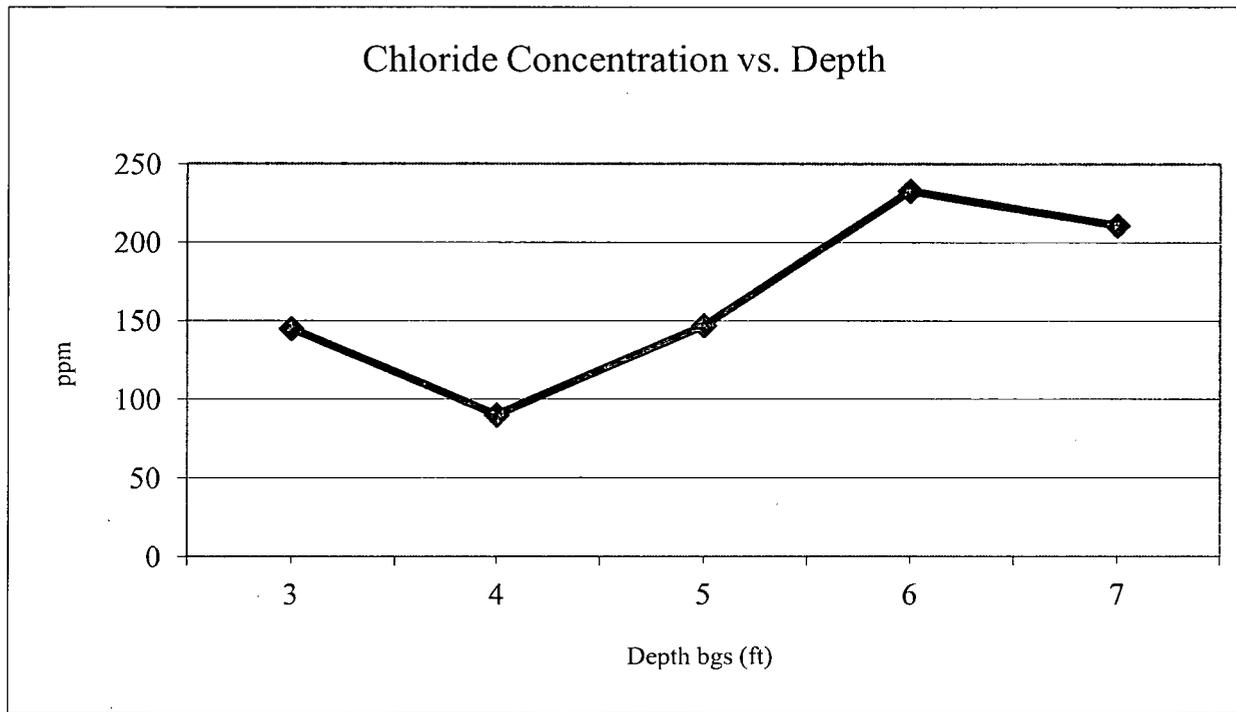
EME N-23 EOL

Backhoe samples at junction (source)

Depth bgs (ft)	[Cl ⁻] ppm
3	145
4	90
5	147
6	233
7	211

Groundwater = 159 ft

CHLORIDE FIELD TESTS		
LOCATION	DEPTH	mg/kg
background	6"	118
vertical delineation trench at the junction (source)	3'	145
	4'	90
	5'	147
	6'	233
	7'	211
