RE: Termination Request  
BD C-32 EOL: UL/C, Sec. 32, T22S, R38E  
RICE Operating Company – Blinebry-Drinkard SWD System

**RICE OPERATING COMPANY  
JUNCTION BOX FINAL REPORT**

## BD C-32 EOL

UL/C SECTION 32  
T-22-S R-38-E  
LEA COUNTY, NM

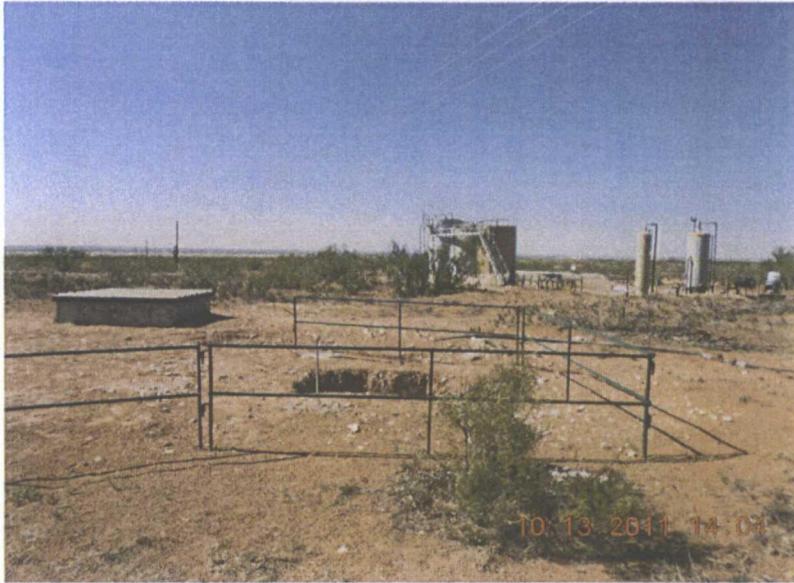
10/13/2011

Site prior, facing west

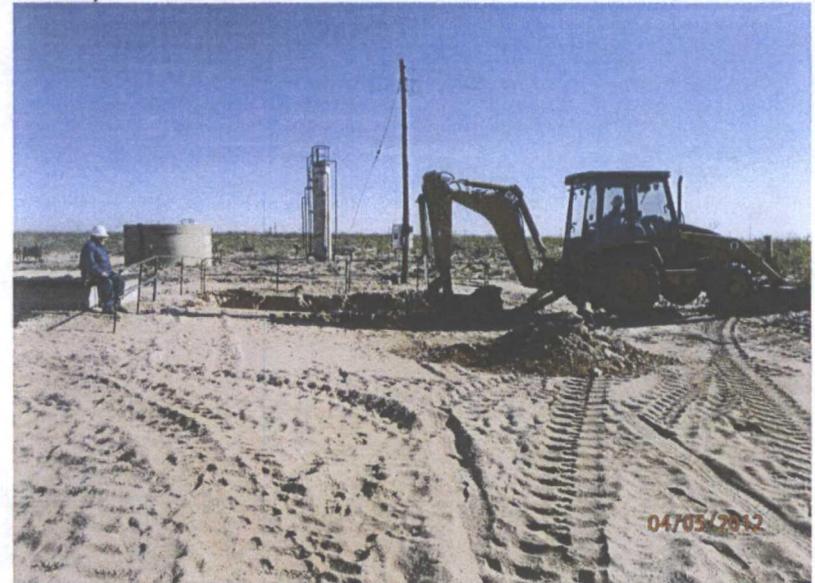
4/5/2012

Excavating site, facing south

**General Description of Remedial Action:** This junction and line were removed during the pipeline replacement/upgrade program. After the former junction box was removed, an investigation was conducted using a backhoe to collect soil samples at regular intervals, creating a 20x20x12 ft. deep excavation. Chloride field tests performed on soil samples yielded slightly elevated concentrations. Organic vapors were measured using a PID which yielded low concentrations. The excavated soil was blended on site and representative composite samples of the excavation bottom, the excavation walls, and the blended backfill were sent to a commercial laboratory for analysis of chloride and TPH, which confirmed low concentrations of each. The excavation was backfilled with excavated soil to ground surface and contoured to the surrounding area. On 2/20/2013, the site was seeded with a blend of native vegetation and is expected to return to a productive capacity at a normal rate. A new water tight junction box was built 15 ft east.

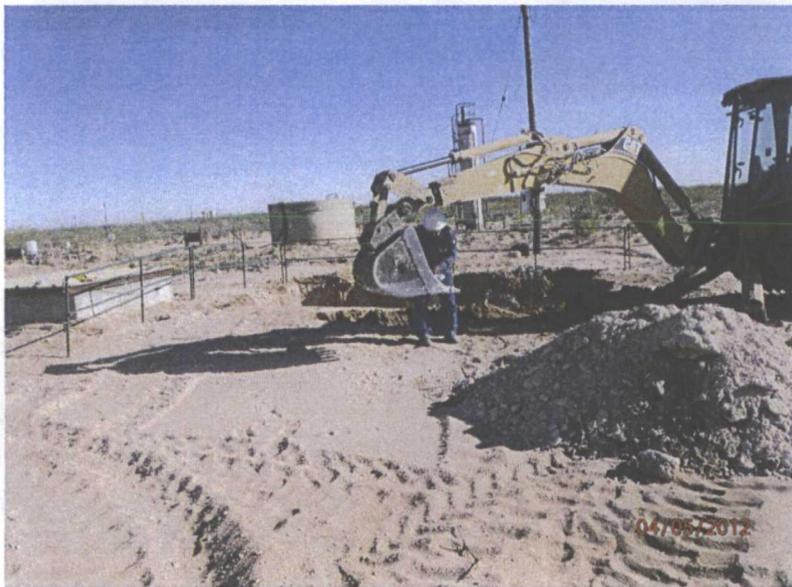
4/5/2012

Collecting sample, facing south

Procure 5-point composite sample of bottom and 4-point composite sample of sidewalls. TPH and Chloride laboratory test results completed by using an approved lab and testing procedures pursuant to NMOCD guidelines.

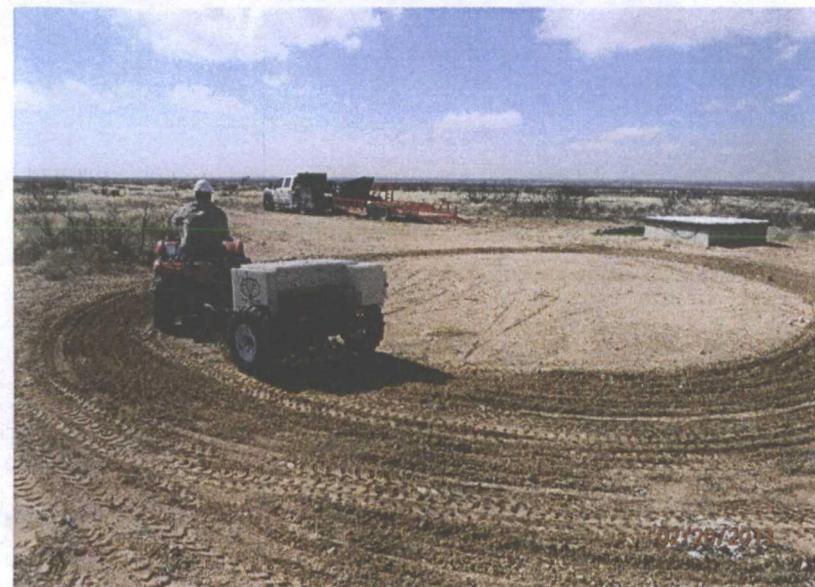
Seeding site

Custom seed mix <input checked="" type="checkbox"/>	Prescribed mix <input type="checkbox"/>	Seed mix name: 2.5 lbs. Boyd Johnson Mix	Seeding date: 2/20/2013
Broadcast <input checked="" type="checkbox"/>			
Method: Mechanical Seeder			
Soil conditions during seeding: Dry <input checked="" type="checkbox"/> Damp <input type="checkbox"/> Wet <input type="checkbox"/>			
Photos attached <input type="checkbox"/>	Observations:		
Number of photos:

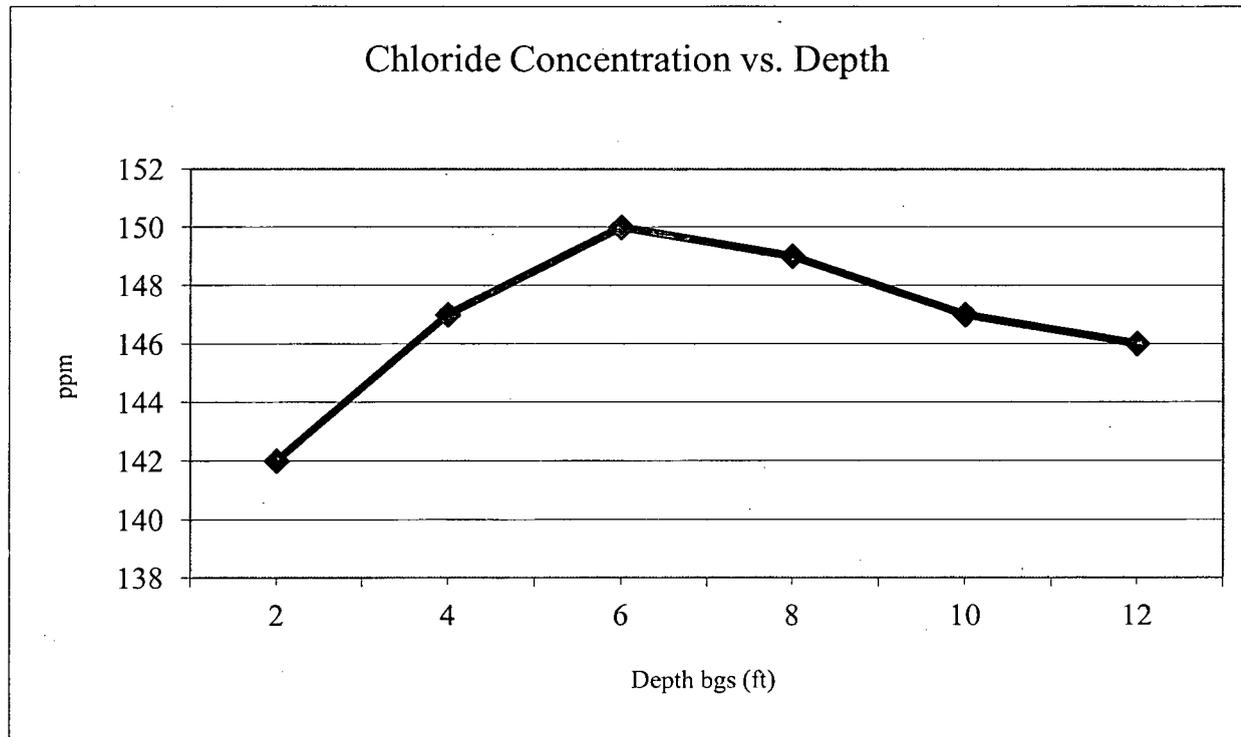
# BD C-32 EOL

Backhoe samples at 10' South of junction (source)

Depth bgs. (ft)	[Cl] ppm
2	142
4	147
6	150
8	149
10	147
12	146

Groundwater = 44 ft
