**RE: Corrective Action Plan (CAP) Report and Termination Request
Rice Operating Company – BD SWD System
BD G-16 vent (1R426-29): UL/G sec. 16 T22S R37E**

CAP Report

BD G-16 vent (1R426-29)
Unit G, Section 16, T22S, R37E

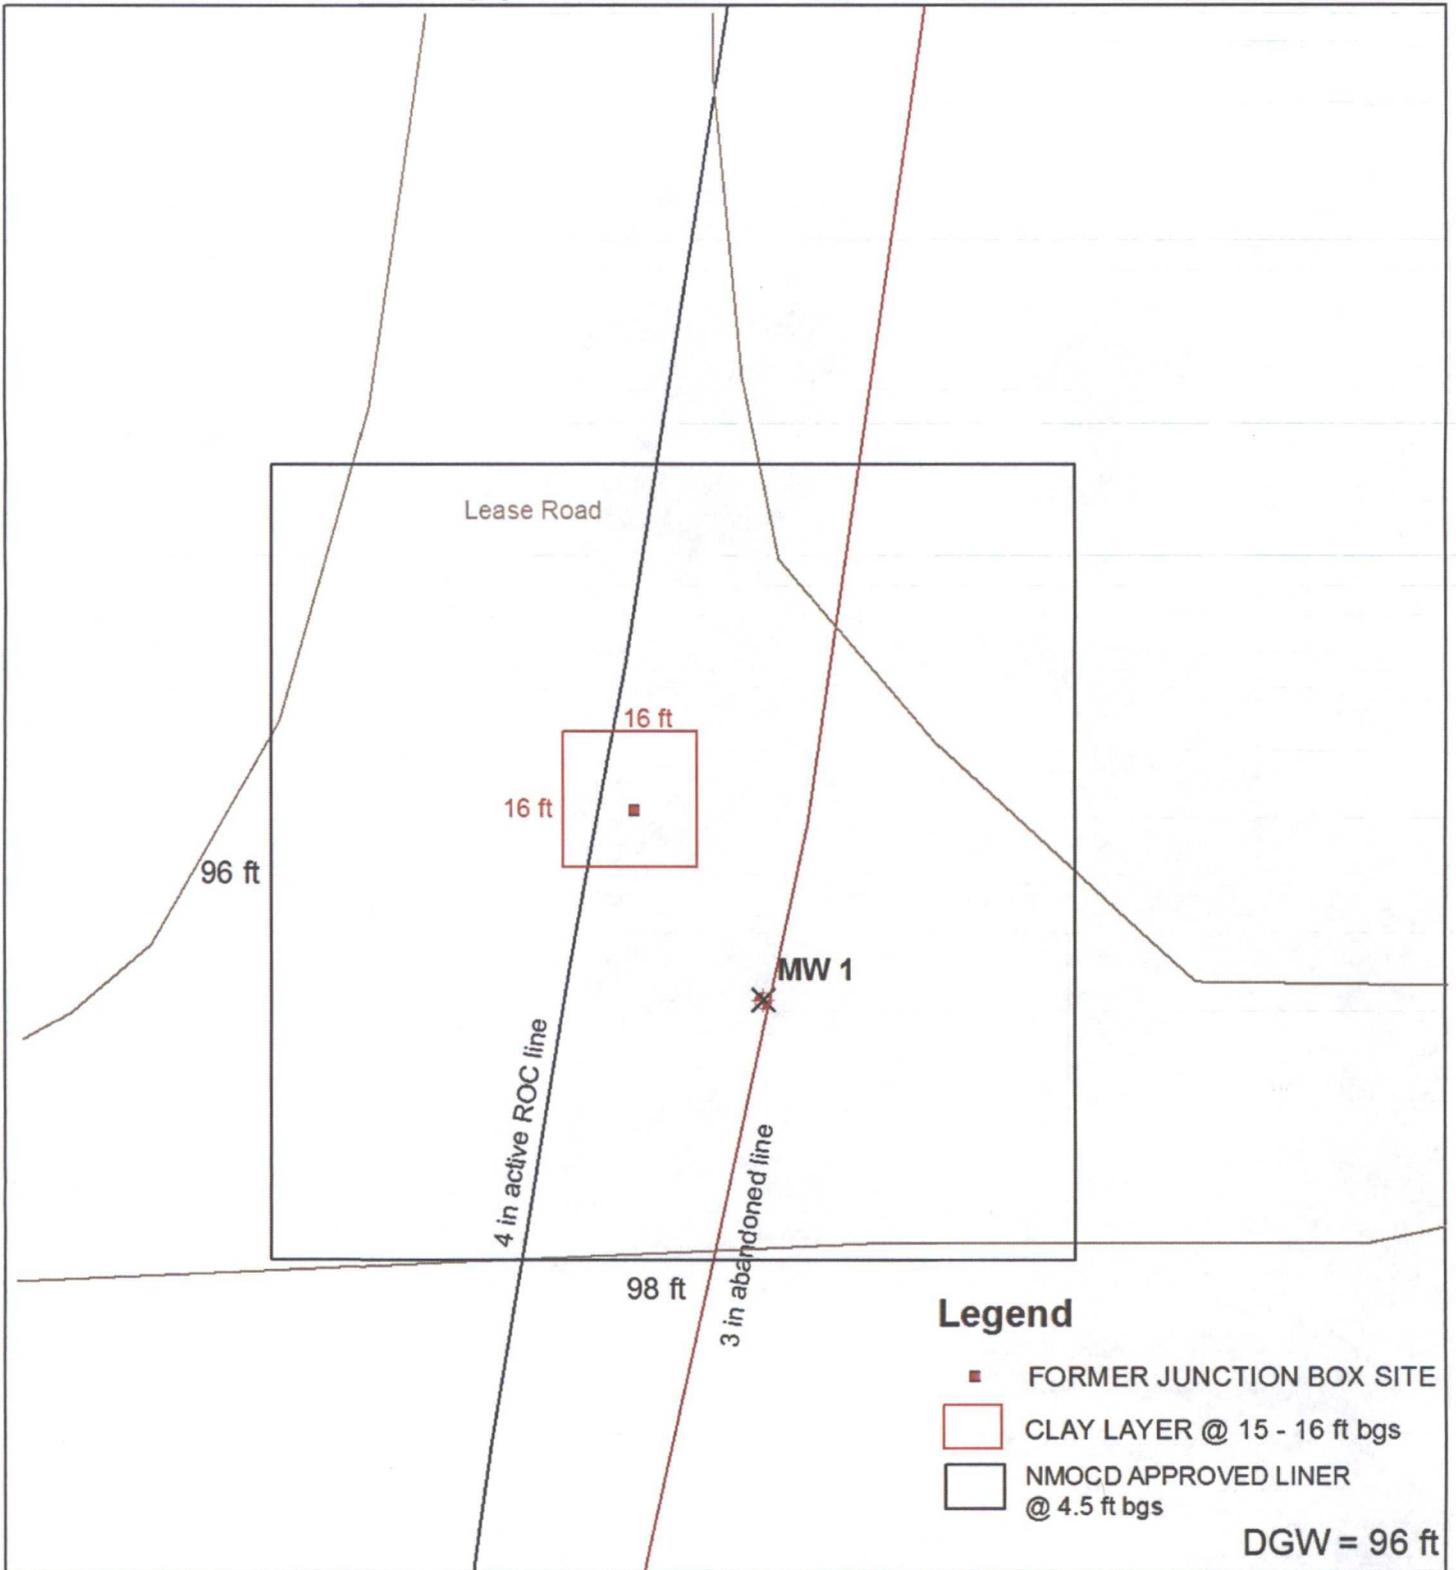
Figure 2

NMOCD Approved Liner and P&A of MW-1

- FORMER JUNCTION BOX SITE
- CLAY LAYER @ 15 - 16 ft bgs
- NMOCD APPROVED LINER @ 4.5 ft bgs

DGW = 96 ft

On June 11th, 2012, RECS personnel were on site to plug and abandon MW-1 with a 1-3% bentonite/concrete slurry with a 3 foot concrete cap (Figure 2). Documentation of this activity can be found in Appendix A.

Beginning on February 5th, 2013, RECS personnel were on site to begin the excavation for 20-mil reinforced poly liner installation (Figure 2). The site was excavated to 96 ft x 98 ft to a depth of 5 ft. A total of 2,540 yards of excavated soil was taken to a NMOCD approved facility for disposal. Imported blow sand was used to pad the bottom of the excavation to protect the liner from punctures. A sample of the blow sand was field tested for hydrocarbons and returned a result of 3 ppm. The sample was then taken to a commercial laboratory for analysis of chlorides and TPH, which returned results of non-detect.

The liner was installed and properly seated into the excavation at approximately 4.5 ft bgs. The remainder of the blow sand was used to pad above the liner. Caliche was imported to the site and used to backfill the excavation up to 1 ft bgs. A sample of the caliche was field tested for hydrocarbons and returned a result of 0 ppm. The sample was then taken to a commercial laboratory for analysis of chlorides and TPH, which returned results of non-detect. Topsoil was imported to backfill the site to the surface and contour it to the surrounding location. A sample of the topsoil was field tested for hydrocarbons and returned a result of 3.0 ppm. The sample was taken to a commercial laboratory for analysis of chlorides and TPH which returned results of non-detect. Base coarse was imported to the site to rebuild and repair the lease roads. A sample of the base coarse was field tested for hydrocarbons and returned a result of 5.8 ppm. The sample was taken to a commercial laboratory and tested for chlorides and hydrocarbons, which returned a chloride result of 96 mg/kg and a TPH result of non-detect. The base coarse was water packed to provide a stable foundation for the lease road.

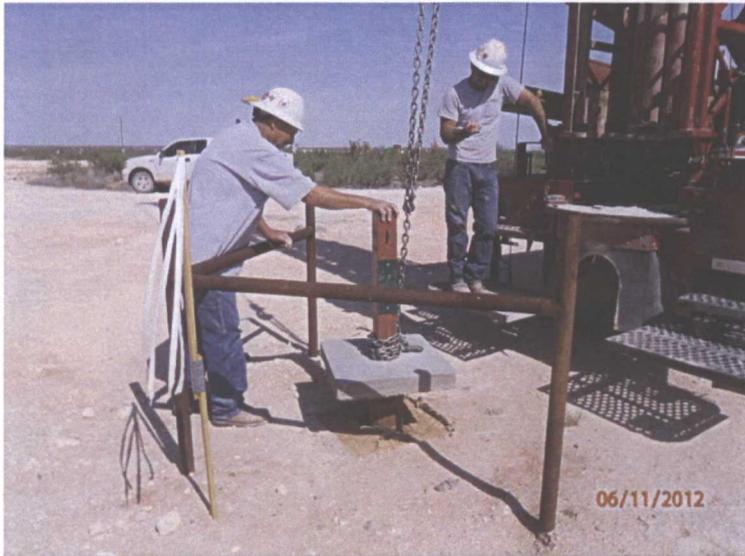
Pulling MW-1, facing west

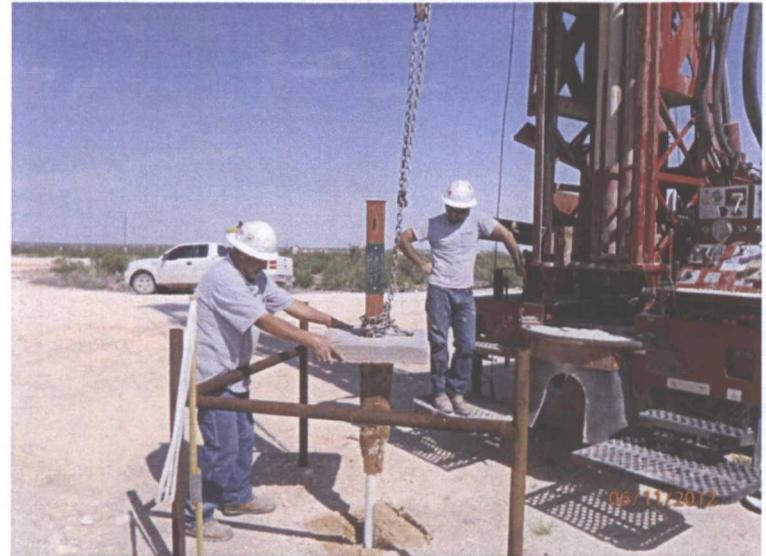
Pulling MW-1, facing west

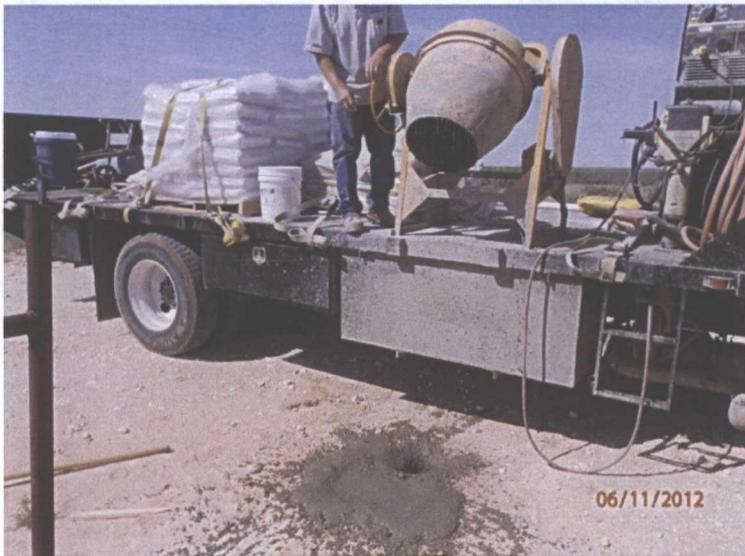
Installing the 3 ft concrete cap, facing SW

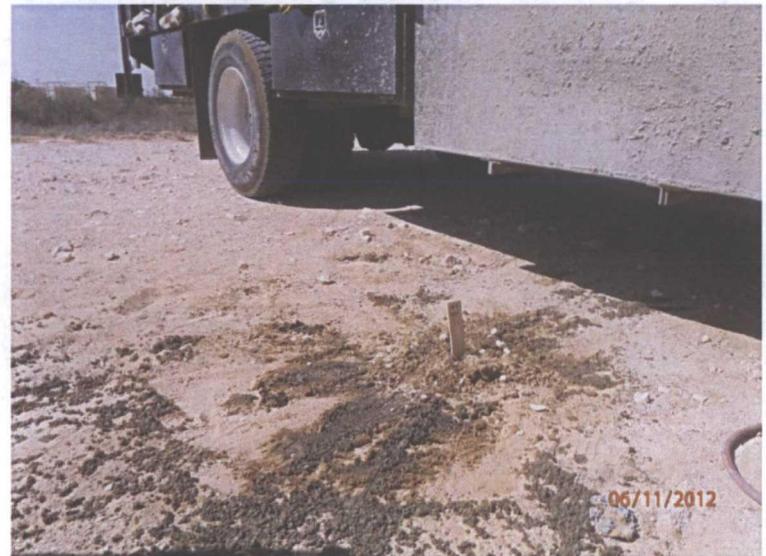
Plug and abandon of MW-1 complete, facing S

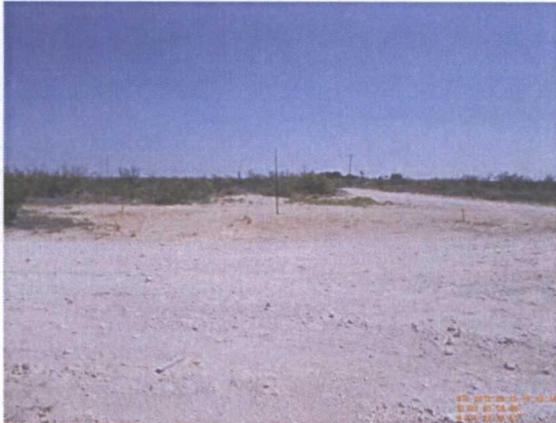
site prior, facing east 9/19/2012

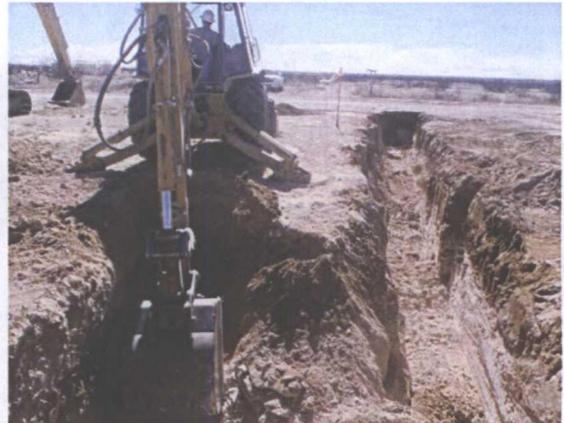
beginning the excavation, facing south
2/6/2013

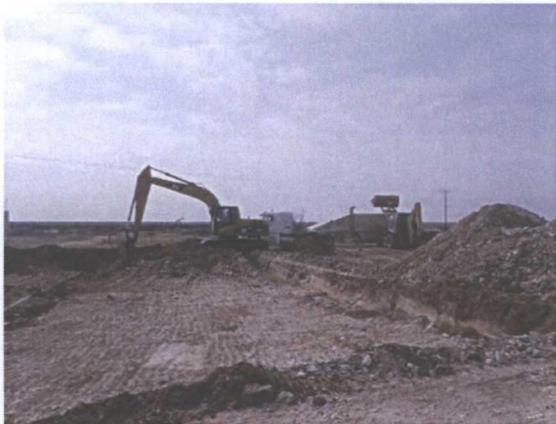
excavating and exporting the excavated soil,
facing south 2/15/2013

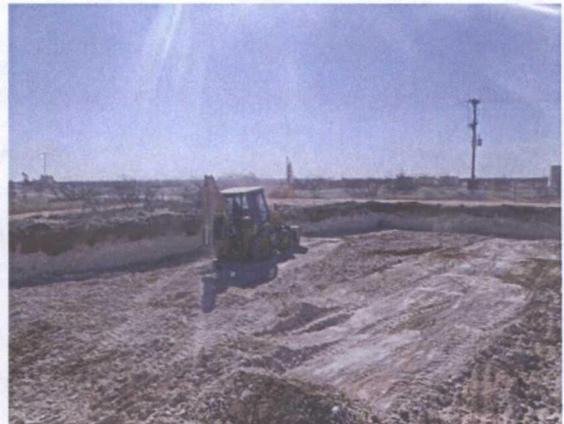
completing the 98x96-ft excavation to a depth
of 5 ft bgs, facing southeast 2/18/2013

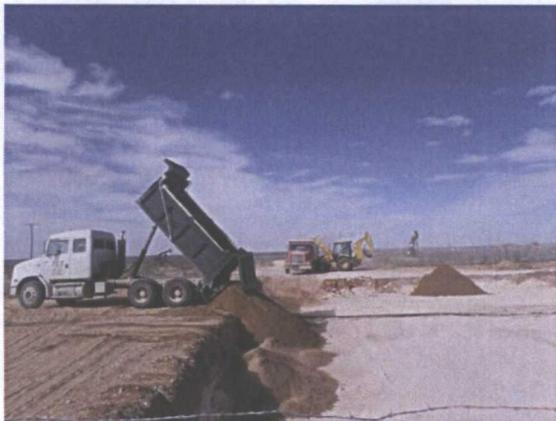
importing blow sand, facing west 2/19/2013

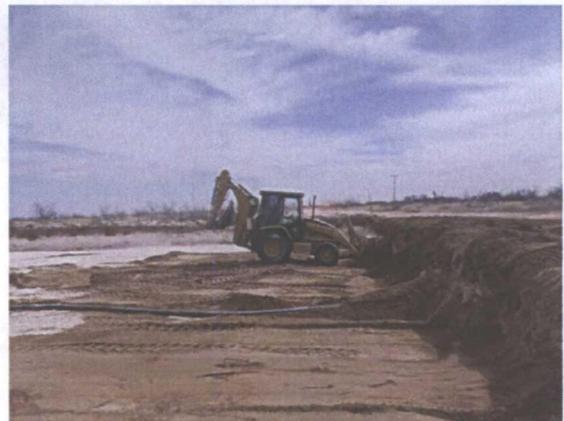
padding the bottom of the excavation with
blow sand, facing east 2/19/2013

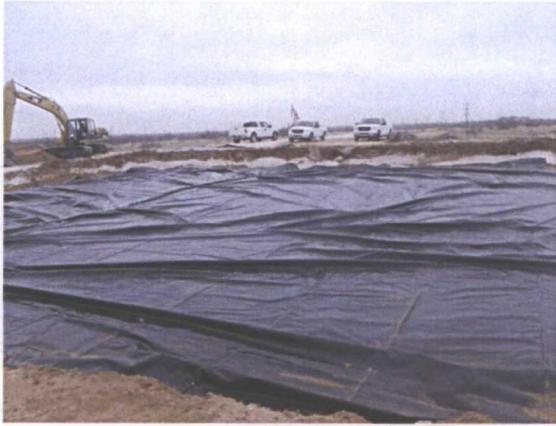
98x96-ft, 20-mil reinforced liner installed at 4.5 ft bgs, facing north 2/19/2013

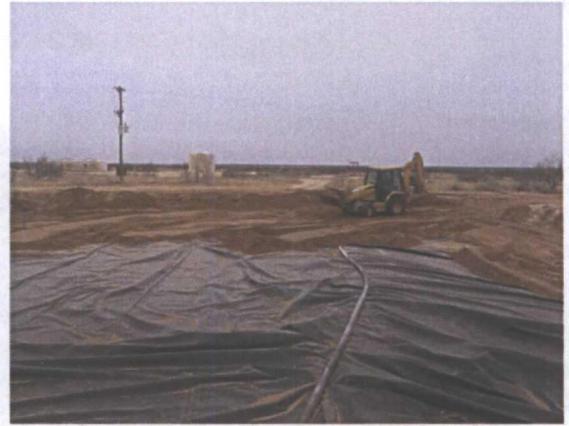
padding above the liner with blow sand, facing south 2/19/2013

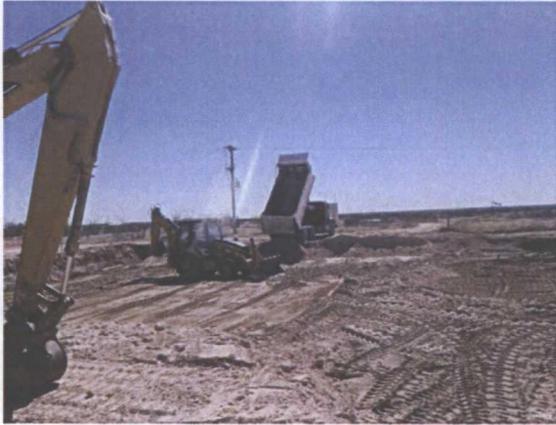
importing and backfilling the excavation with caliche, facing south 2/21/2013

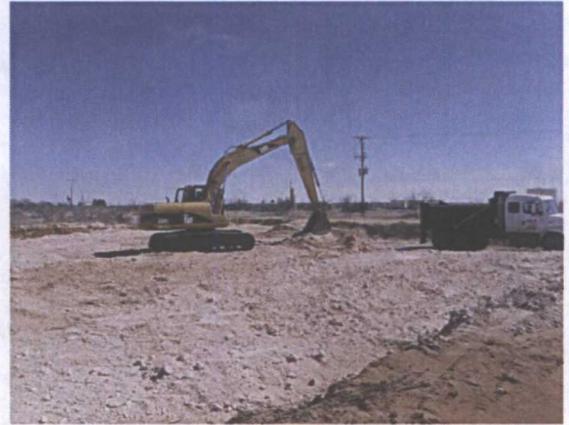
backfilling with caliche, facing south 2/27/2013

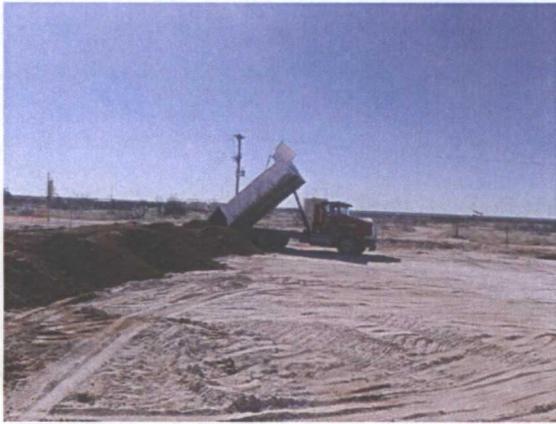
importing top soil, facing south 3/1/2013

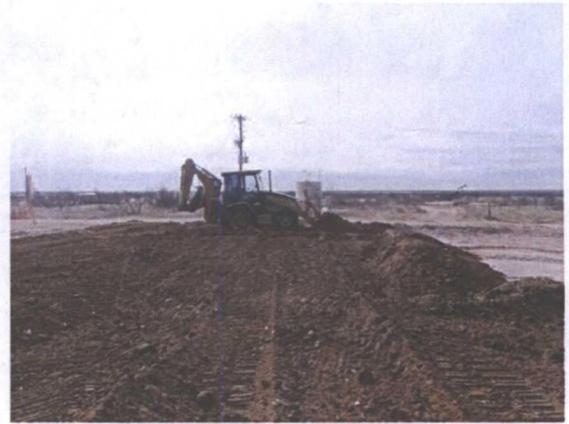
spreading top soil, facing south 3/4/2013

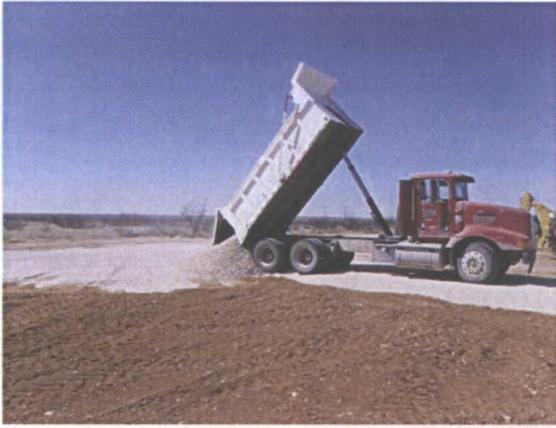
importing base coarse to repair the lease road,
facing west 3/5/2013

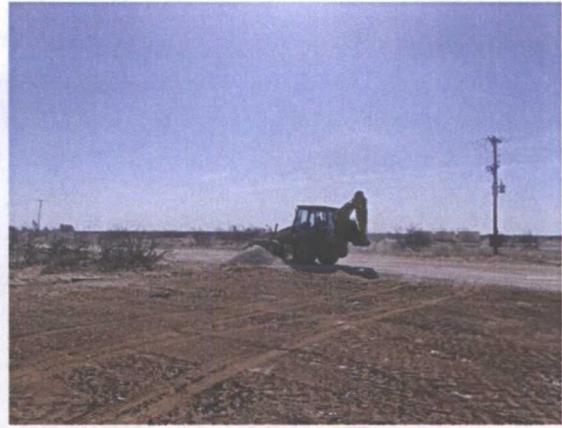
repairing the lease road with imported base
coarse, facing south 3/5/2013

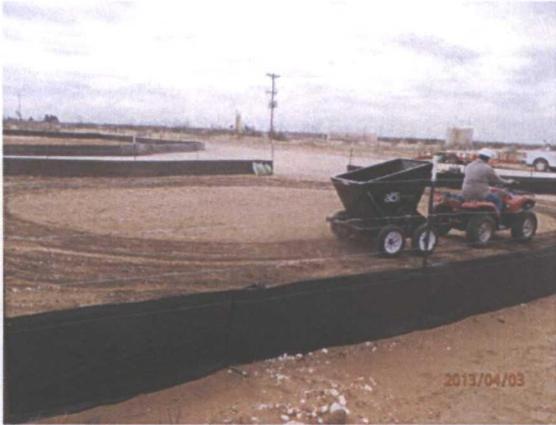
spreading amendments, facing south 4/3/2013

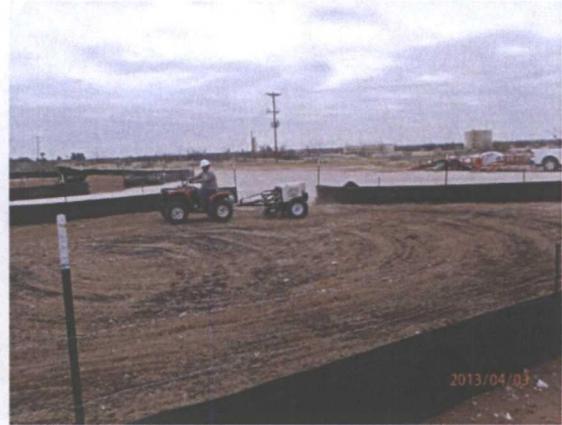
spreading seed, facing south 4/3/2013

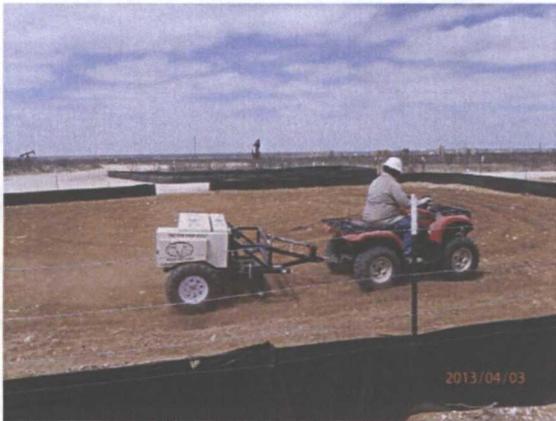
spreading seed, facing west 4/3/2013

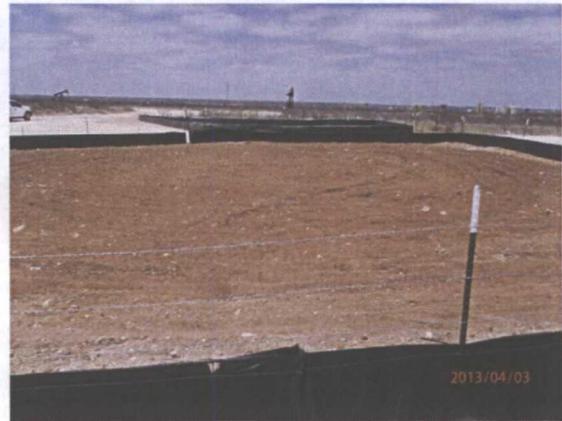
site complete, facing west 4/3/2013
