RE: Termination Request  
EME H-23 EOL: UL/H, Sec. 23, T20S, R36E  
RICE Operating Company – Eunice Monument Eumont SWD System

**RICE OPERATING COMPANY  
JUNCTION BOX CLOSURE REPORT**

# EME H-23 EOL

UL/H SECTION 23  
T-20-S R-36-E  
LEA COUNTY, NM

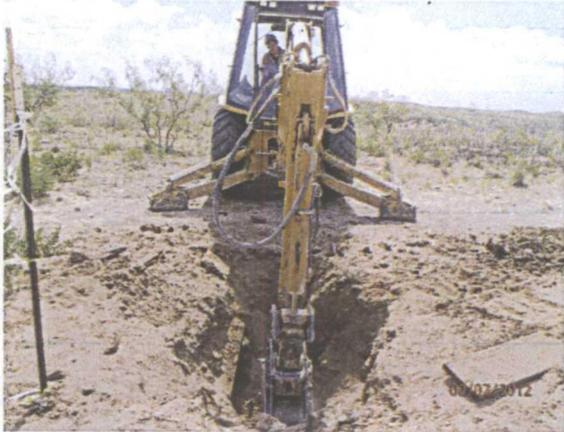
7/2/2012

Excavating site

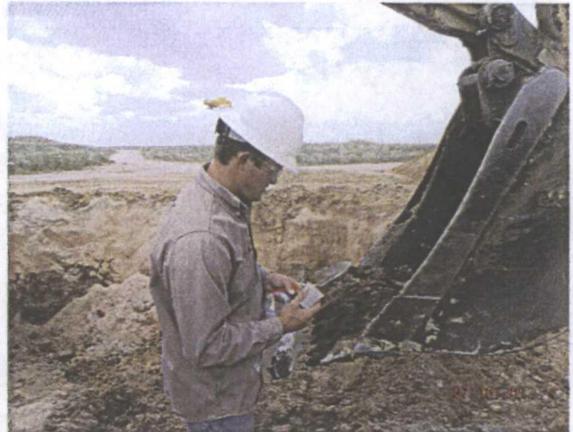
7/16/2012

Collecting sample

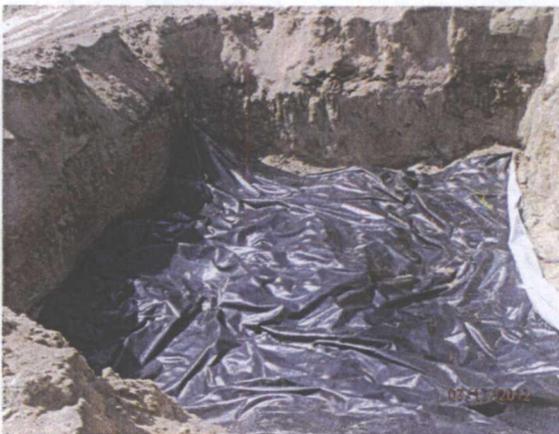
7/17/2012

Installing 30'x30'x12' liner @ 12' bgs

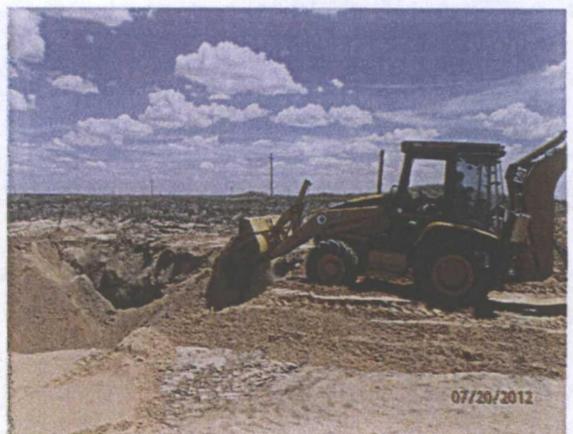
7/20/2012

Backfilling site

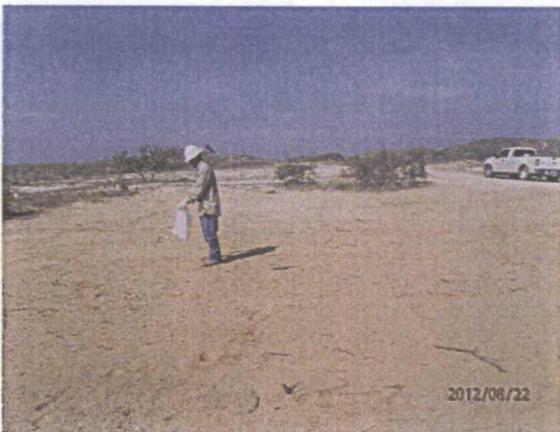
8/22/2012

Seeding site

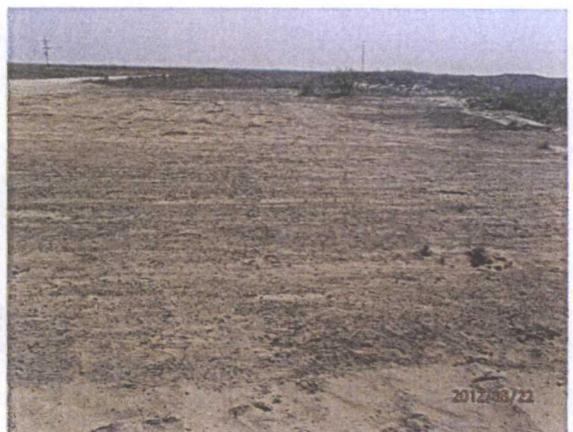
8/22/2012

Site completed

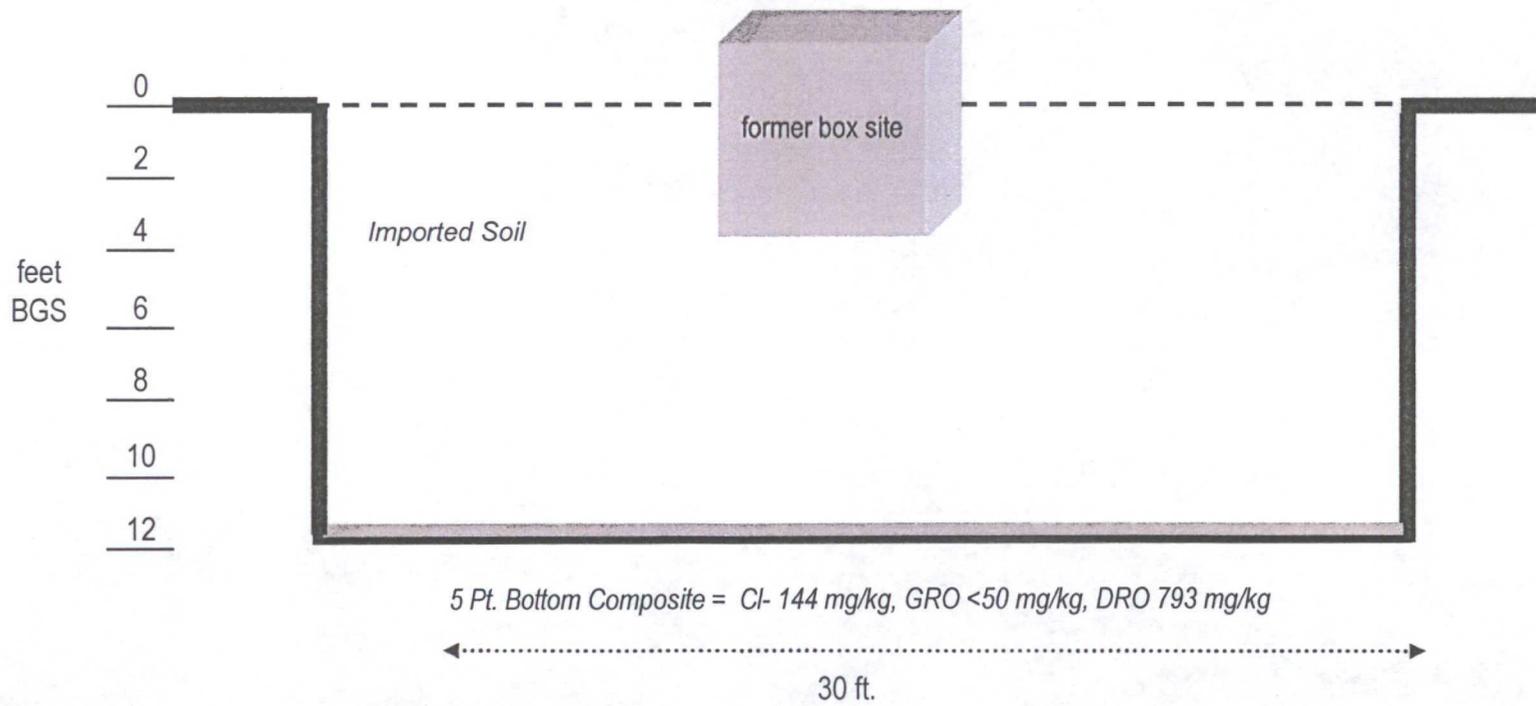
### Excavation Cross-Section

EME H-23 EOL  
Unit 'H', Sec. 23, T20S, R36E

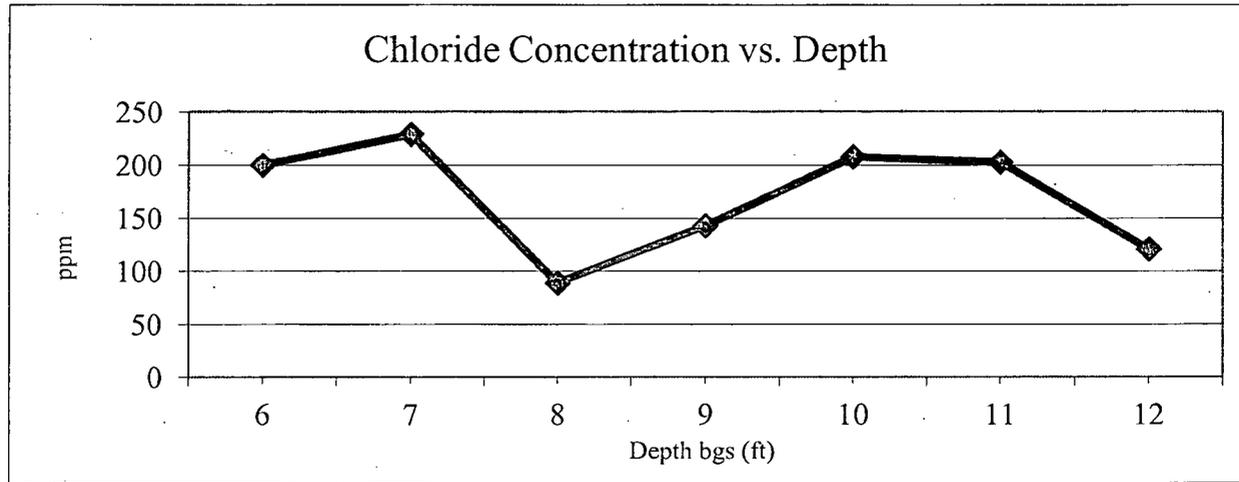
*Backhoe samples at junction (source)*

Depth, bgs (ft)	[Cl <sup>-</sup> ] ppm
6	200
7	229
8	89
9	143
10	208
11	203
12	121

Groundwater = 106 ft
