**CLOSURE**

RE: Termination Request  
EME I-17 EOL: UL/I, Sec. 17, T19S, R37E  
RICE Operating Company – Eunice Monument Eumont SWD System

**RICE OPERATING COMPANY  
JUNCTION BOX FINAL REPORT**

# EME I-17 EOL

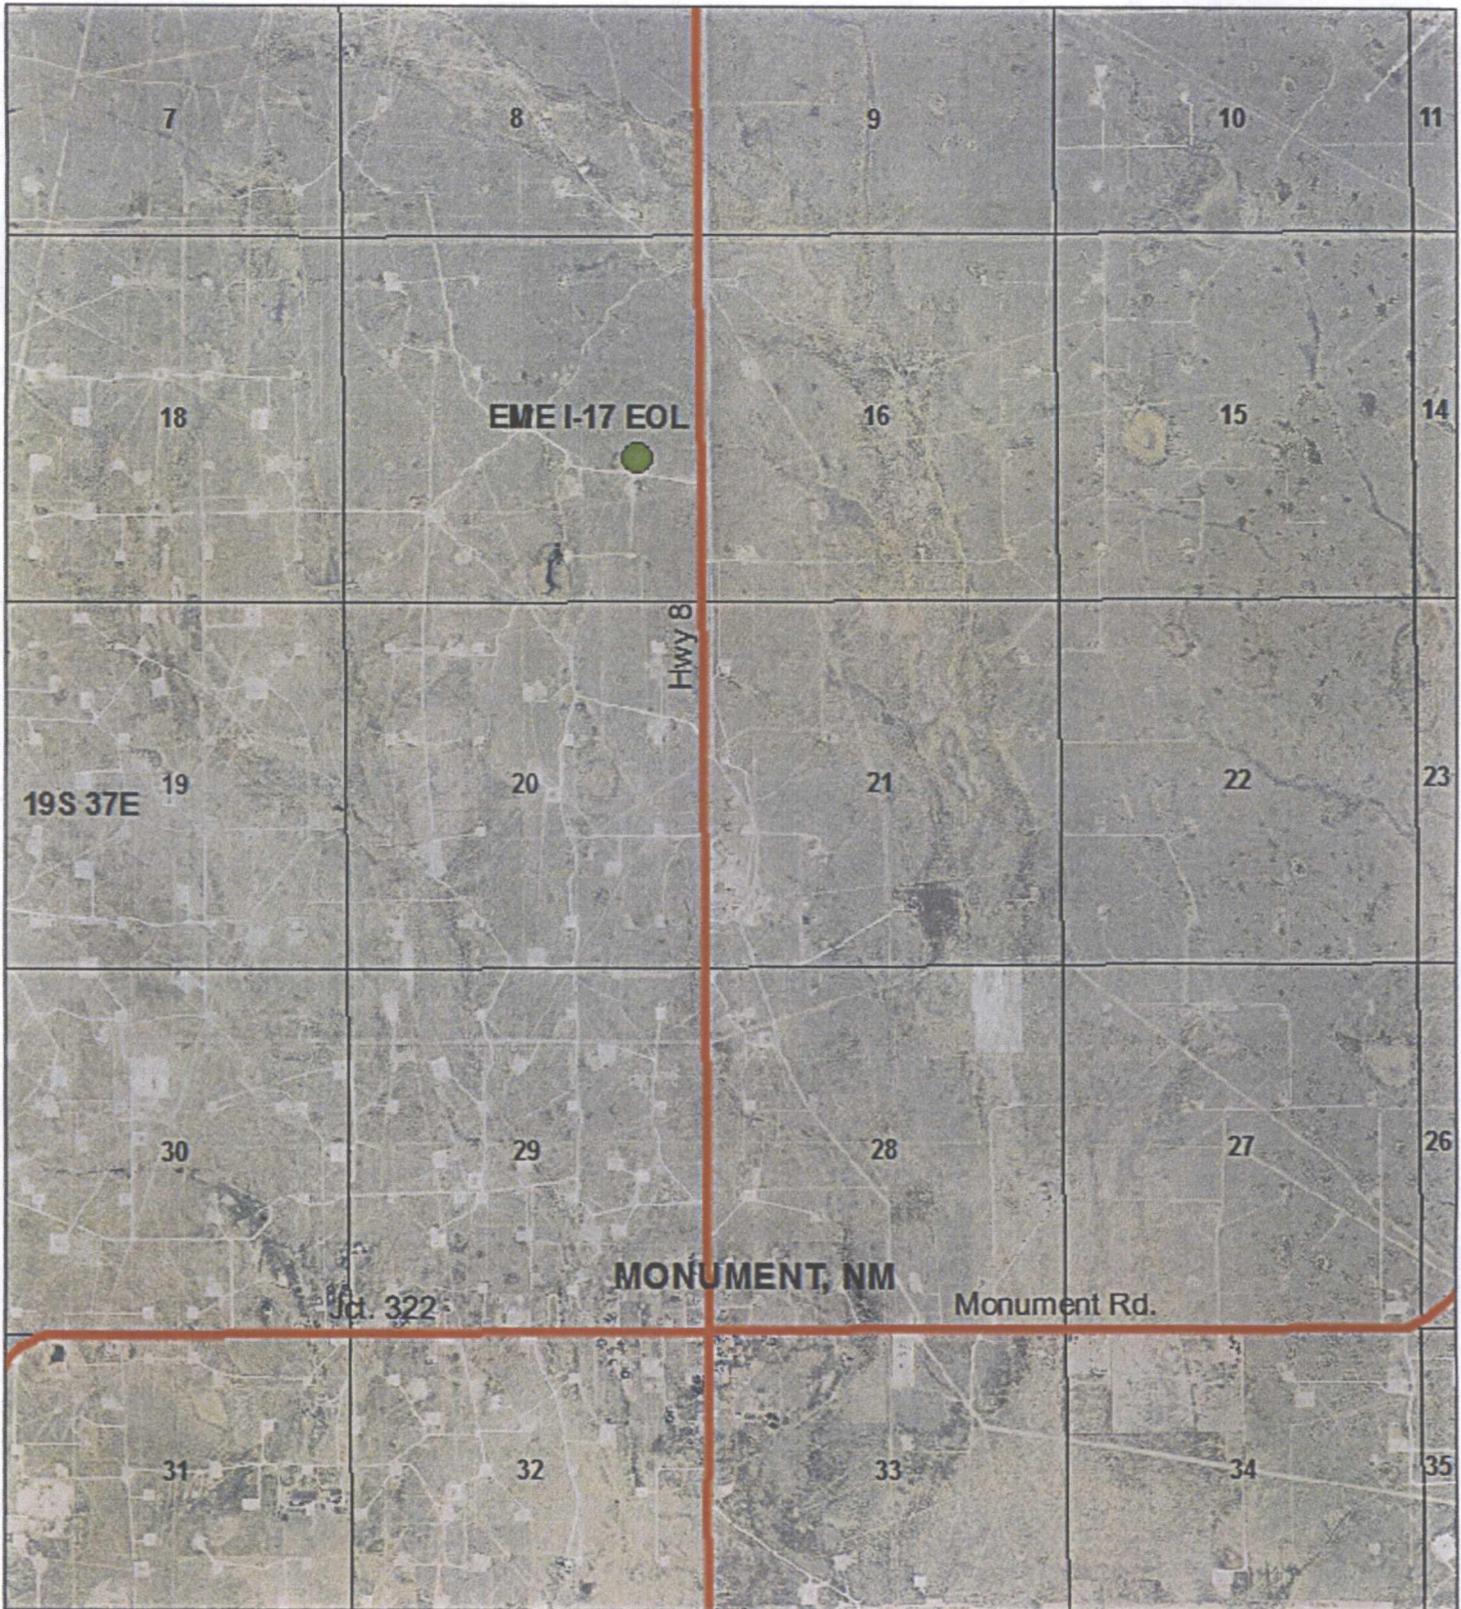
**EME I-17  
EOL**

**UL/I SECTION 17  
T-19-S R-37-E  
LEA COUNTY, NM**

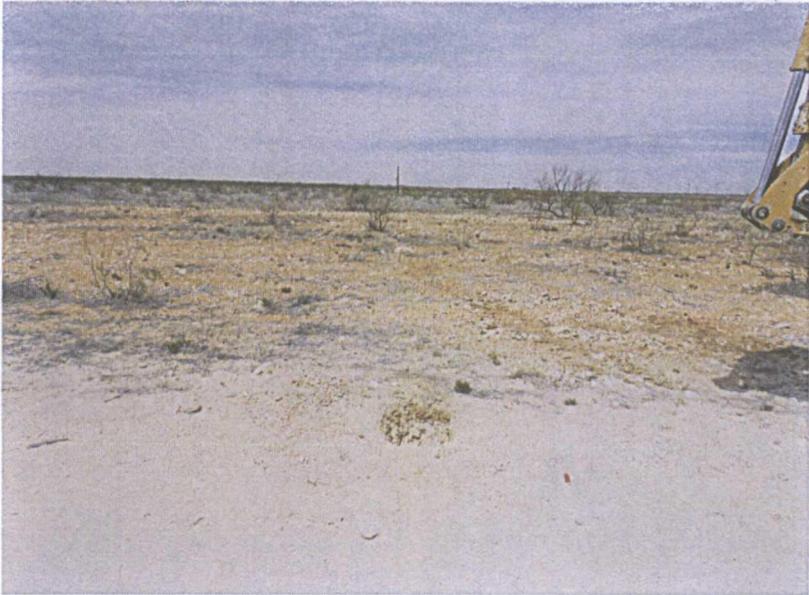
Site prior, facing north

4/5/2012

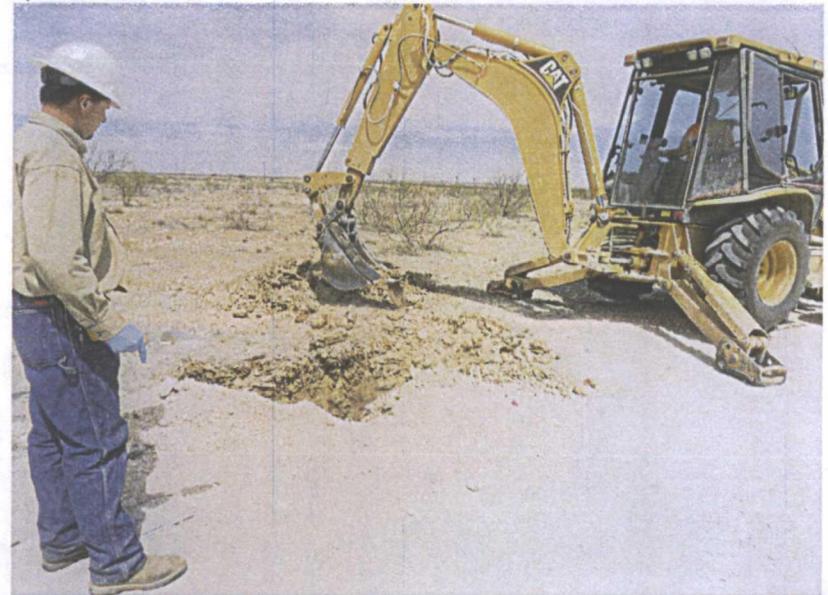
Excavating site, facing northeast

4/5/2012

**General Description of Remedial Action:** This junction and line were eliminated during the pipeline replacement/upgrade program. After the former junction box was removed, an investigation was conducted using a backhoe to collect soil samples at regular intervals creating a 3x7x7 ft. deep excavation. Chloride field tests performed on each sample yielded concentrations similar to that of the background sample. Organic vapors were measured using a PID which yielded low concentrations. The deepest sample, 7 ft. below ground surface (BGS), was sent to a commercial laboratory for analysis of chloride and TPH, which confirmed low concentrations of each. The excavation was backfilled with excavated soil to ground surface and contoured to the surrounding area. On 2/18/2013, the site was seeded with a blend of native vegetation and is expected to return to a productive capacity at a normal rate.

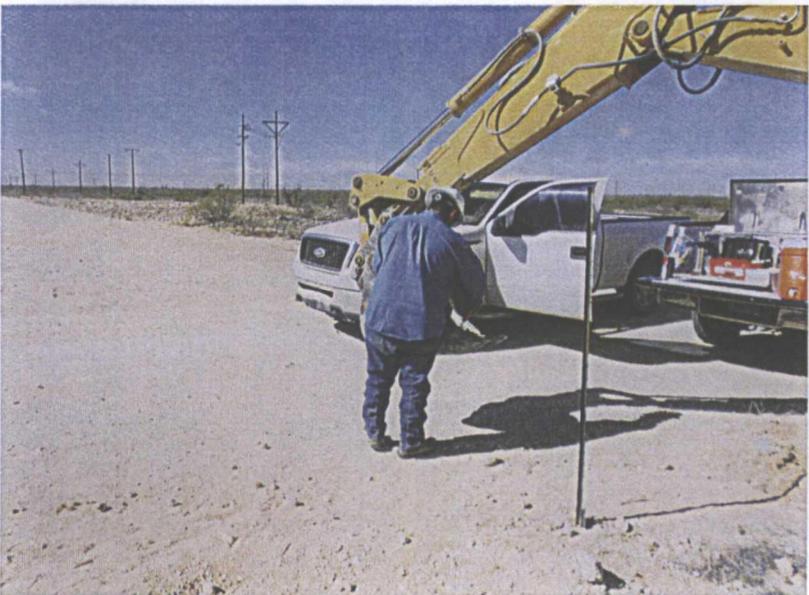
Collecting a sample, facing east

4/10/2012

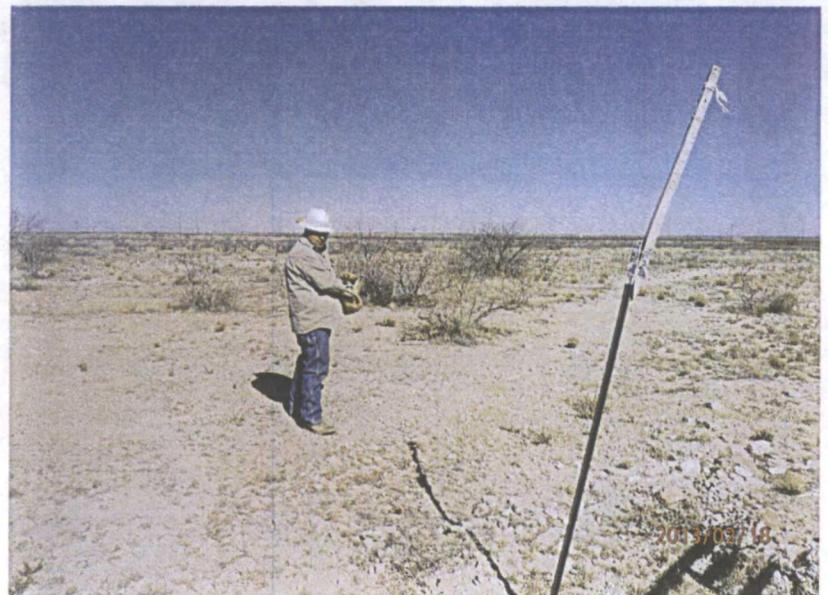
Seeding site

2/18/2013

Custom seed mix <input checked="" type="checkbox"/>	Prescribed mix <input type="checkbox"/>	Seed mix name: 1 lbs. Lea County/1 lbs. Winter Wheat/1 lbs. Blue Grama	Seeding date: 2/18/2013
Broadcast <input checked="" type="checkbox"/>			
Method: Hand Broadcast			
Soil conditions during seeding: Dry <input checked="" type="checkbox"/> Damp <input type="checkbox"/> Wet <input type="checkbox"/>			
Photos attached <input type="checkbox"/>	Observations:		
Number of photos:	The seed was raked into soil.

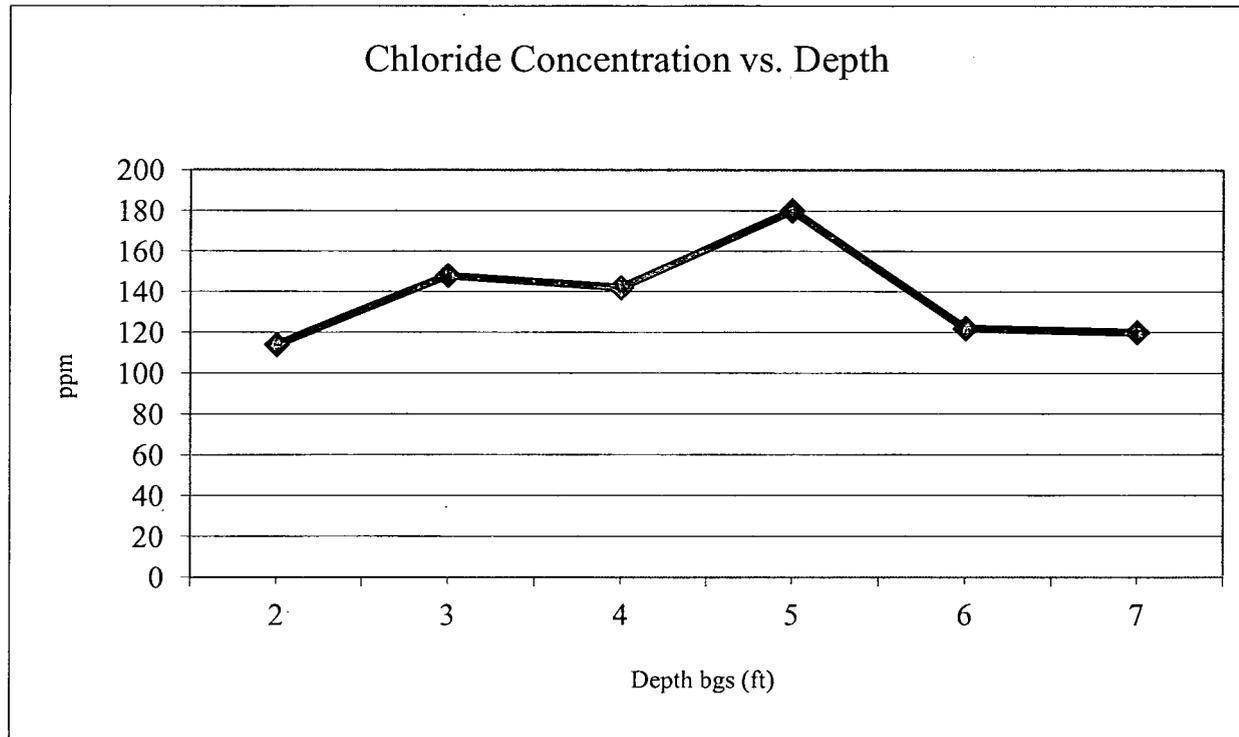
# EME I-17 EOL

*Backhoe samples at junction (source)*

Depth bgs (ft)	[Cl <sup>-</sup> ] ppm
2	114
3	148
4	142
5	180
6	122
7	120

Groundwater = 53 ft
