EME J-20 EOL

CLOSURE

RE: Termination Request
EME J-20 EOL: UL/J, Sec. 20, T19S, R37E
RICE Operating Company – Eunice Monument Eumont SWD System

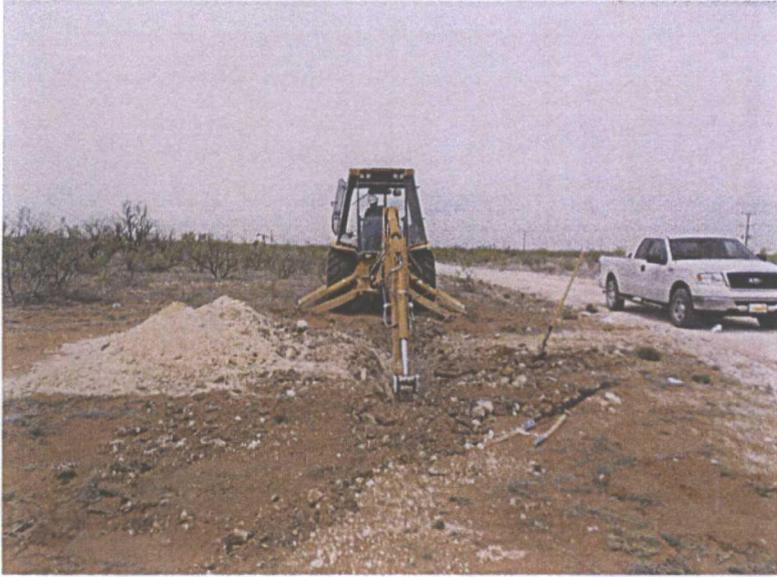
4/11/2012

Excavating site, facing north

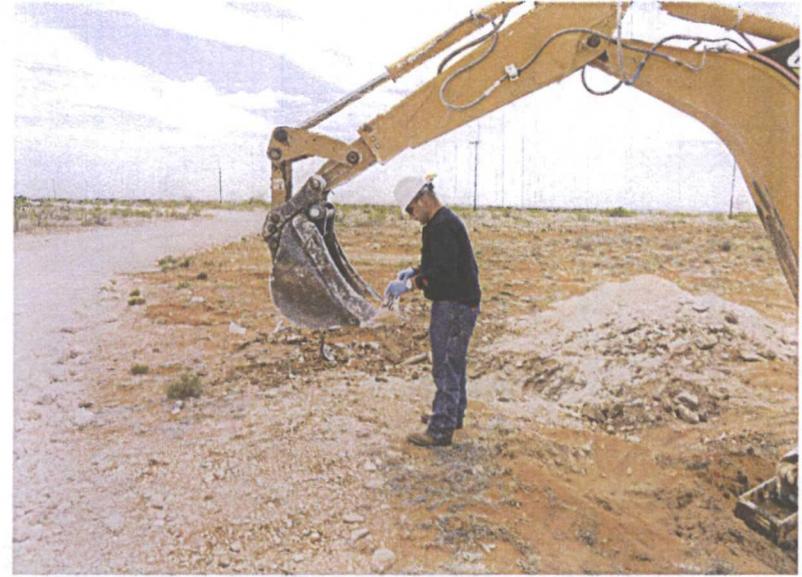
4/11/2012

Collecting sample, facing south

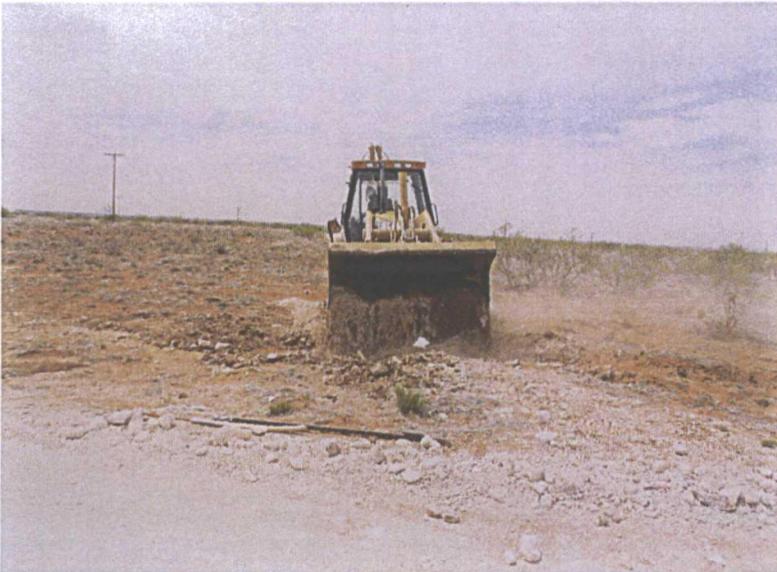
4/11/2012

Backfilling site, facing west

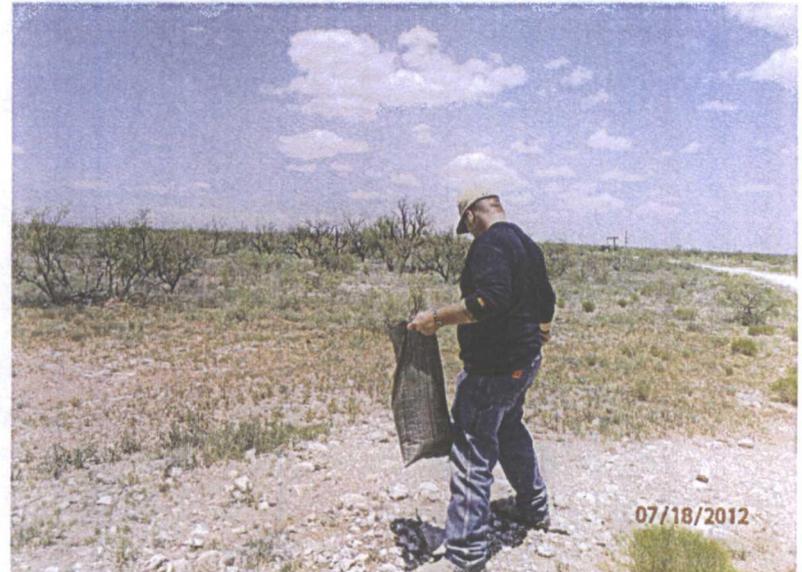
07/18/2012

Seeding site
