From: Hansen, Edward J., EMNRD
Sent: Thursday, May 02, 2013 4:42 PM
To: Hack Conder (hconder@riceswd.com)
Cc: Leking, Geoffrey R, EMNRD; Laura Pena (lpena@riceswd.com); Katie Jones <kjones@riceswd.com> (kjones@riceswd.com); Lara Weinheimer (lweinheimer@rice-ecs.com); Scott Curtis (scurtis@riceswd.com)
Subject: Remediation Plan (1R428-69) Termination - ROC Hobbs O-5 Vent Site

**RE: Termination Request
Rice Operating Company – Hobbs SWD System
Hobbs O-5 vent (1R428-69): UL/O sec. 5 T19S R38E**

Hobbs O-5 vent (1R428-69)

Unit Letter O, Section 5, T19S, R38E

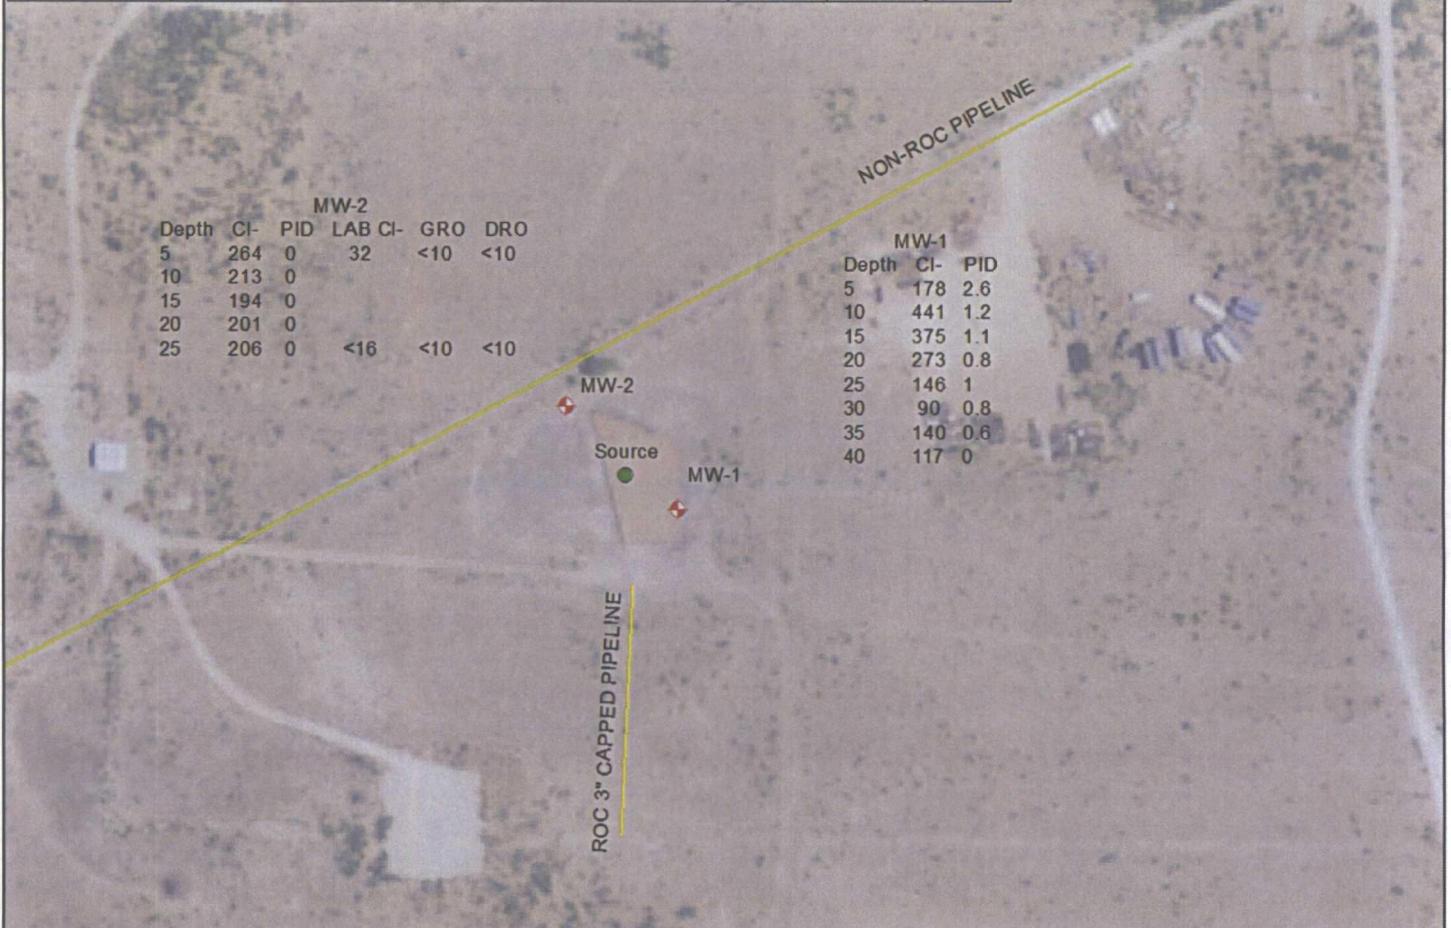
Figure 2

MW Soil Data and MW Sampling Data

MW-2

Depth	Cl-	PID	LAB Cl-	GRO	DRO
5	264	0	32	<10	<10
10	213	0			
15	194	0			
20	201	0			
25	206	0	<16	<10	<10

MW-1

Depth	Cl-	PID
5	178	2.6
10	441	1.2
15	375	1.1
20	273	0.8
25	146	1
30	90	0.8
35	140	0.6
40	117	0

MW	Depth to Water	Total Depth	Sample Date	Cl	TDS	Benzene	Toluene	Ethyl Benzene	Total Xylenes	Sulfate
1	33.89	44.14	3/24/2011	236	887	<0.001	<0.001	<0.001	<0.003	48.3
	34.05	44.14	6/21/2011	180	782	<0.001	<0.001	<0.001	<0.003	66
	34.37	44.14	9/20/2011	192	796	<0.001	<0.001	<0.001	<0.003	66.6
	34.59	44.14	12/15/2011	220	779	<0.001	<0.001	<0.001	<0.003	159
	34.82	44.14	3/15/2012	244	1010	<0.001	<0.001	<0.001	<0.003	53.7
	35.08	44.14	6/11/2012	248	974	<0.001	<0.001	<0.001	<0.003	54.5
	35.37	44.14	9/6/2012	184	827	<0.001	<0.001	<0.001	<0.003	58.9
	35.62	44.14	11/29/2012	188	878	<0.001	<0.001	<0.001	<0.003	58.1

DGW = 35 FT

The monitor wells have been sampled quarterly since they have been installed (Figure 2). Chloride concentrations in the near-source well (MW-1) have decreased since the maximum concentration was observed in 2009, and have remained below 250 mg/L for ten consecutive quarters. During the most recent quarterly monitor well sampling event collected on November 29th, 2012, MW-1 had a chloride value of 188 mg/L and MW-2 had a chloride value of 60 mg/L (Appendix A). It is evident from the monitor well data that the chlorides contributed to groundwater by the site are slight and have abated.

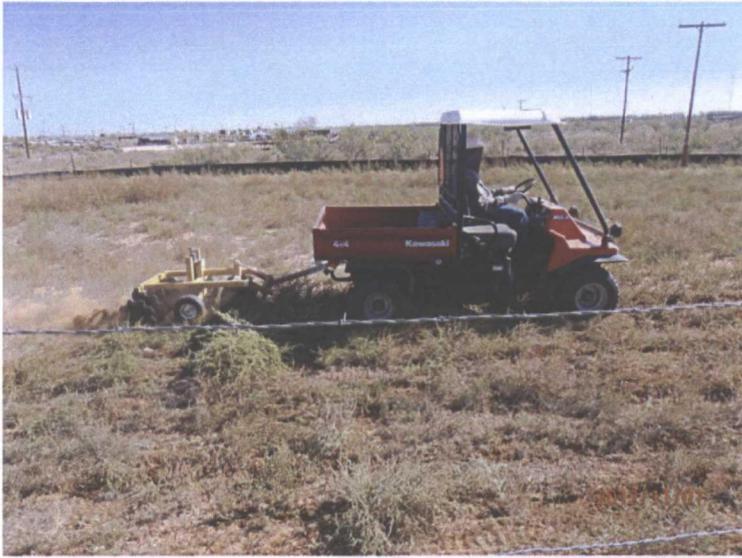
Tilling the location, facing east

On November 1st and 2nd, 2012, soil amendments were added to the site and then was seeded with a blend of native vegetation. Vegetation will provide an infiltration barrier for the site, since plants capture water through their roots thereby reducing the amount of water traveling through the vadose zone to groundwater. Documentation for this seeding event will be found in Appendix B.

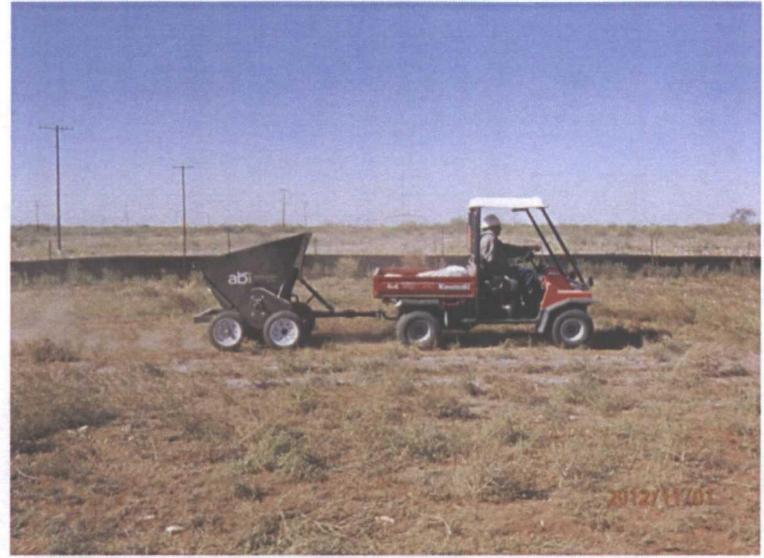
Adding soil amendments, facing west

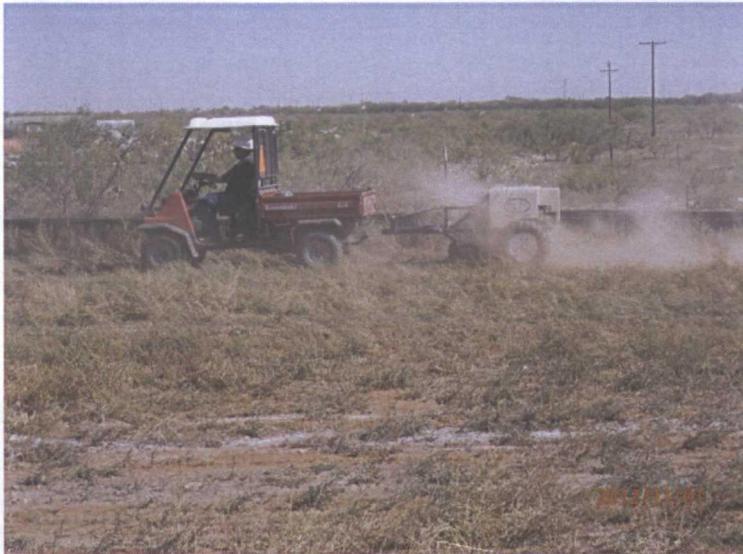
Seeding the site, facing east

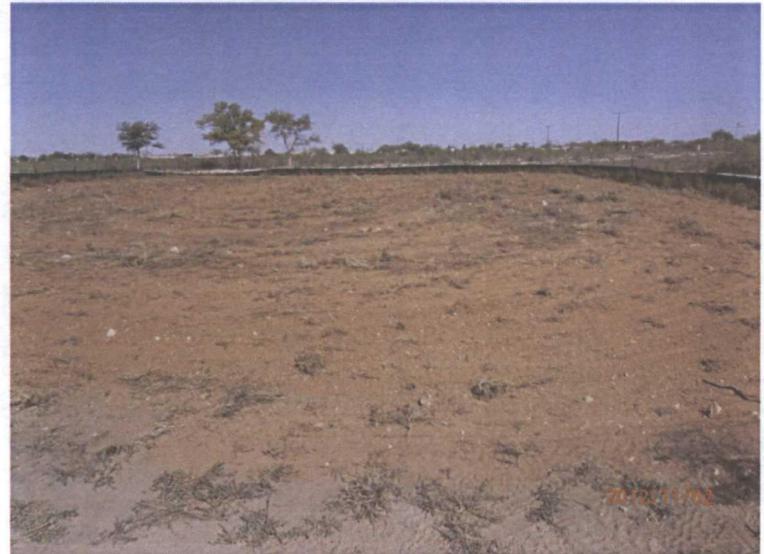
Site photo of completed work, facing west
