**RE: Termination Request  
for the Rice Operating Company's  
EME G-32 Site  
Unit Letter G, Section 32, T19S, R37E, NMPM, Lea County, New Mexico  
Remediation Plan (1R427-72) Termination**

RE: Termination Request  
EME G-32 (1R427-72): UL/G, Sec. 32, T19S, R37E  
RICE Operating Company – Eunice Monument Eumont SWD System

**RICE OPERATING COMPANY  
JUNCTION BOX FINAL REPORT**

# EME G-32 (1R427-72)

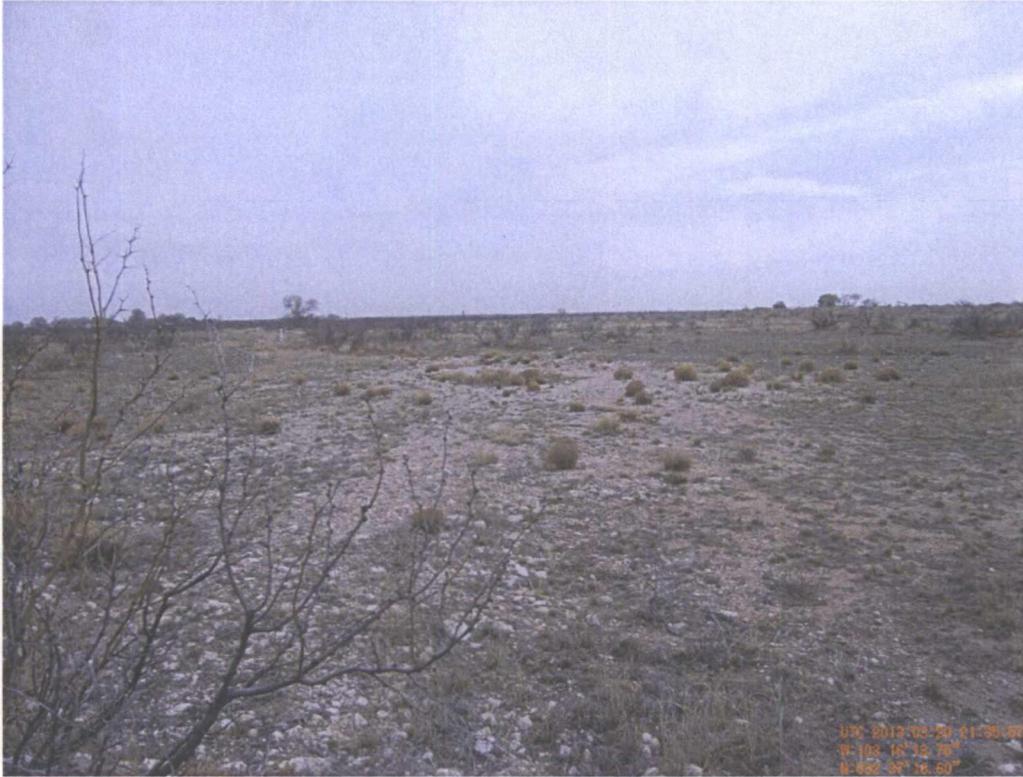
Facing south

In 2002, ROC initiated work on the former G-32 junction box. The site is located in UL/G, Sec. 32, T19S, R37E. NM OSE records indicate that groundwater would likely be encountered at a depth of approximately 28 +/- feet. The site was delineated using a backhoe to collect soil samples at regular intervals, creating a 20x20x7 ft deep excavation. Each sample was field titrated for chlorides, resulting in chloride concentrations that decreased with depth. The 11 ft samples was sent to a commercial laboratory for analysis of chloride, TPH and BTEX, resulting in a chloride concentration of 334 mg/kg and concentrations of gasoline range organics (GRO), diesel range organics (DRO) and BTEX below detectable limits. Representative samples were collected from the excavation sidewalls and bottom and sent to a commercial laboratory for analysis. The sidewalls sample resulted in a chloride concentration of 354 mg/kg, GRO concentration below detectable limits and a DRO concentration of 27.9 mg/kg. The bottom composite sample resulted in a chloride concentration of 149 mg/kg, a GRO concentration below detectable limits and a DRO concentration of 51.6 mg/kg. Both samples were analyzed for BTEX, resulting in below detectable limits throughout. A total for 84 cubic yards of excavated soil was properly disposed of at a NMOCD facility. Vegetation has rebounded at the site, so no re-vegetation efforts are needed. Vegetation

above the liner will act as an evapo-transpiration barrier that will also inhibit the downward migration of residual chlorides and hydrocarbons. Plants capture water through their roots and so reduce the amount of water infiltrating below the root zone. A junction box is no longer needed at the site.
