RE: Termination Request
EME K-1 (1R427-107): UL/K Sec. 1, T20S, R36E
RICE Operating Company – Eunice Monument Eumont SWD System

EME K-1 (1R427-107)

**RICE OPERATING COMPANY
JUNCTION BOX FINAL REPORT**

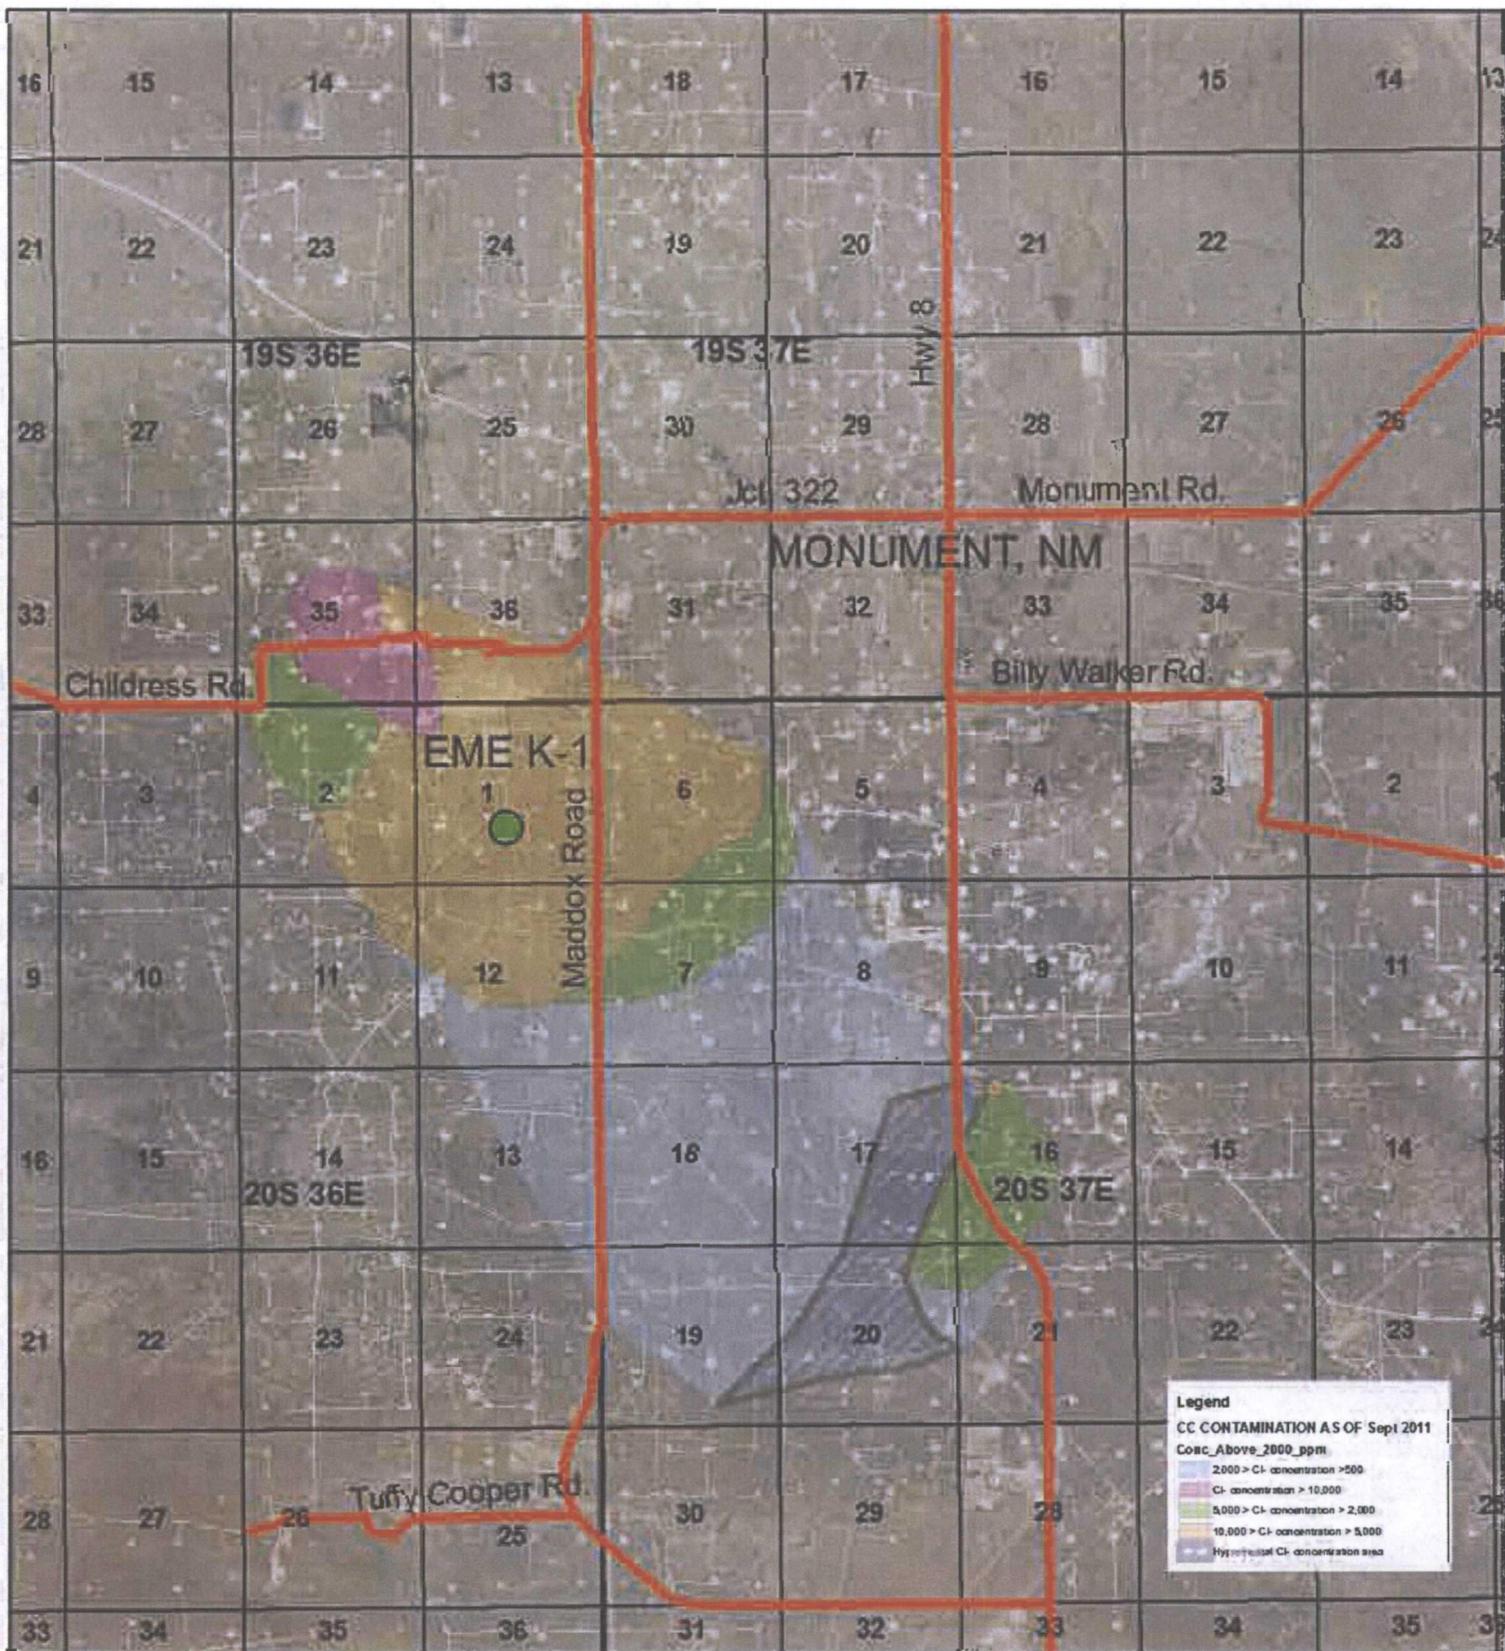
Site Location Map

This site is located within the regionally impacted groundwater plume in an area with groundwater chloride concentrations between 5,000 – 10,000 mg/l (see Site Location Map).

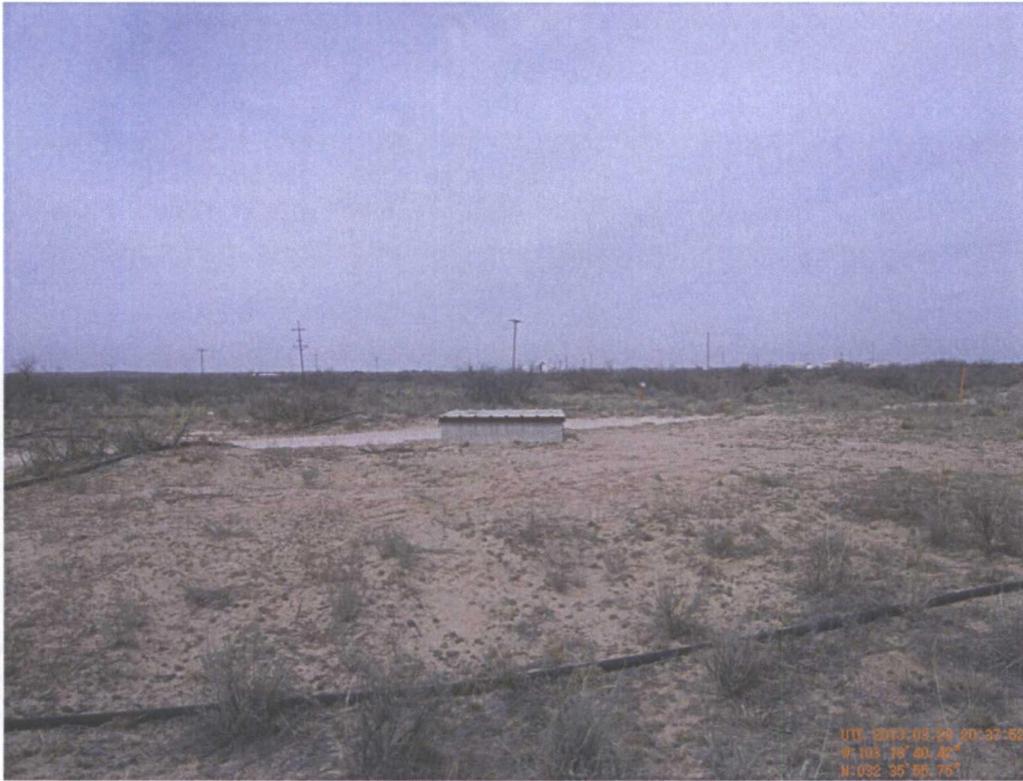
Facing north

3/20/2013

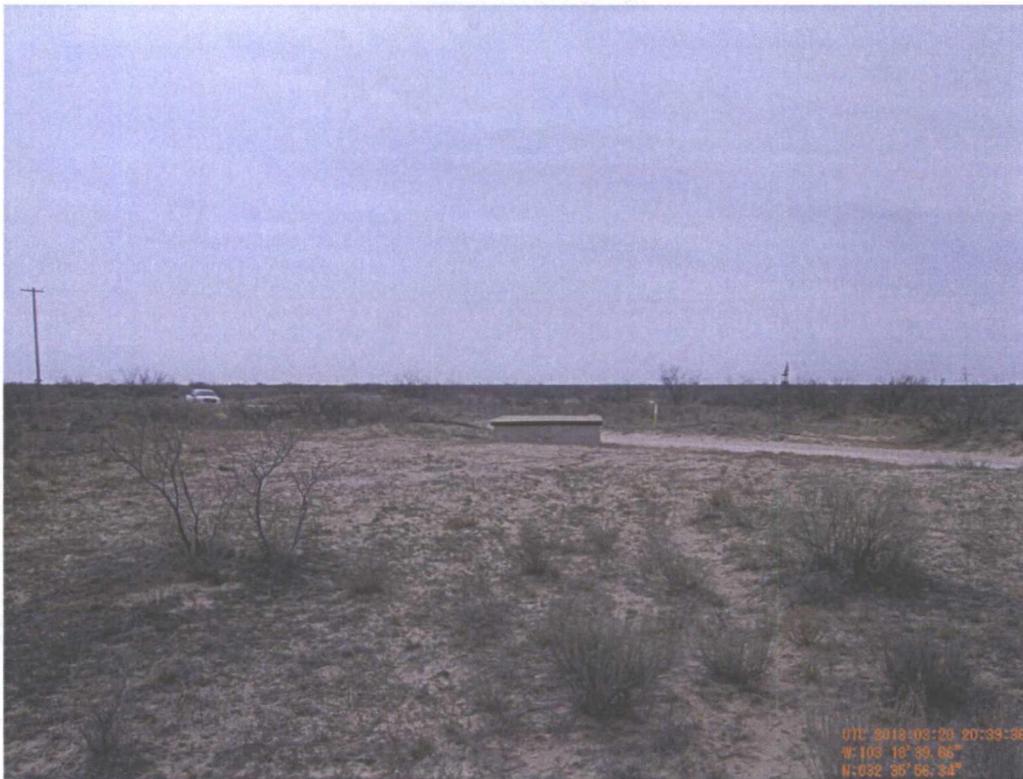
Facing west

3/20/2013
