**From:** Hansen, Edward J., EMNRD  
**Sent:** Tuesday, June 04, 2013 2:42 PM  
**To:** Hack Conder (hconder@riceswd.com)  
**Cc:** Leking, Geoffrey R, EMNRD; Laura Pena (lpena@riceswd.com); Katie Jones <kjones@riceswd.com> (kjones@riceswd.com); Scott Curtis (scurtis@riceswd.com)  
**Subject:** Remediation Plan (1R427-79) Termination - ROC EME M-9-3 Site

**RE: Termination Request  
for the Rice Operating Company's  
EME M-9-3 Site  
Unit Letter M, Section 9, T20S, R37E, NMPM, Lea County, New Mexico  
Remediation Plan (1R427-79) Termination**

RE: Termination Request  
EME M-9-3 (1R427-79): UL/M, Sec. 9, T20S, R37E  
RICE Operating Company – Eunice Monument Eumont SWD System

**RICE OPERATING COMPANY  
JUNCTION BOX FINAL REPORT**

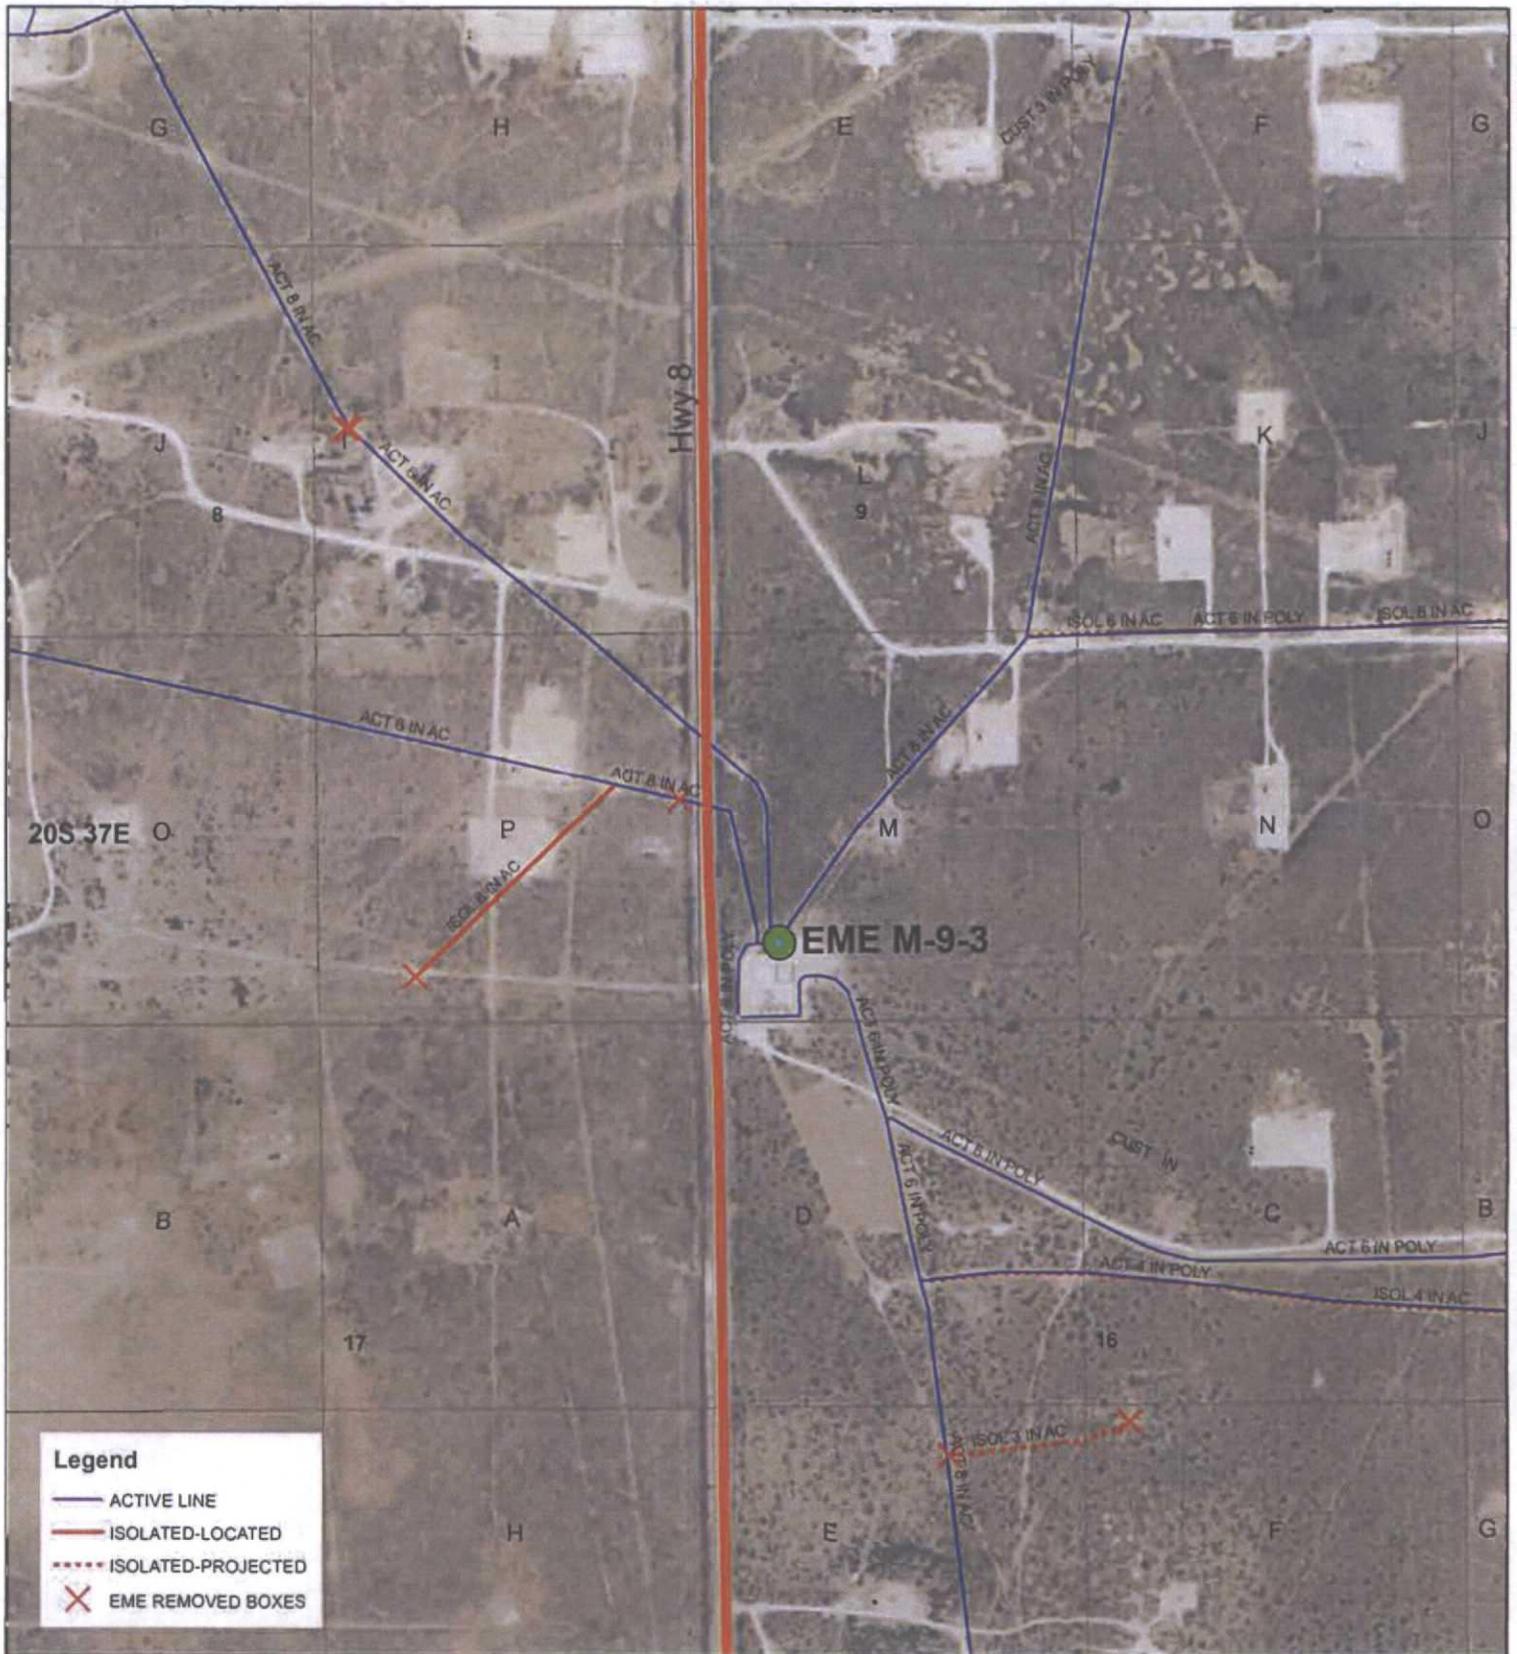
# Area Map

- ACTIVE LINE
- ISOLATED-LOCATED
- ..... ISOLATED-PROJECTED
- X EME REMOVED BOXES

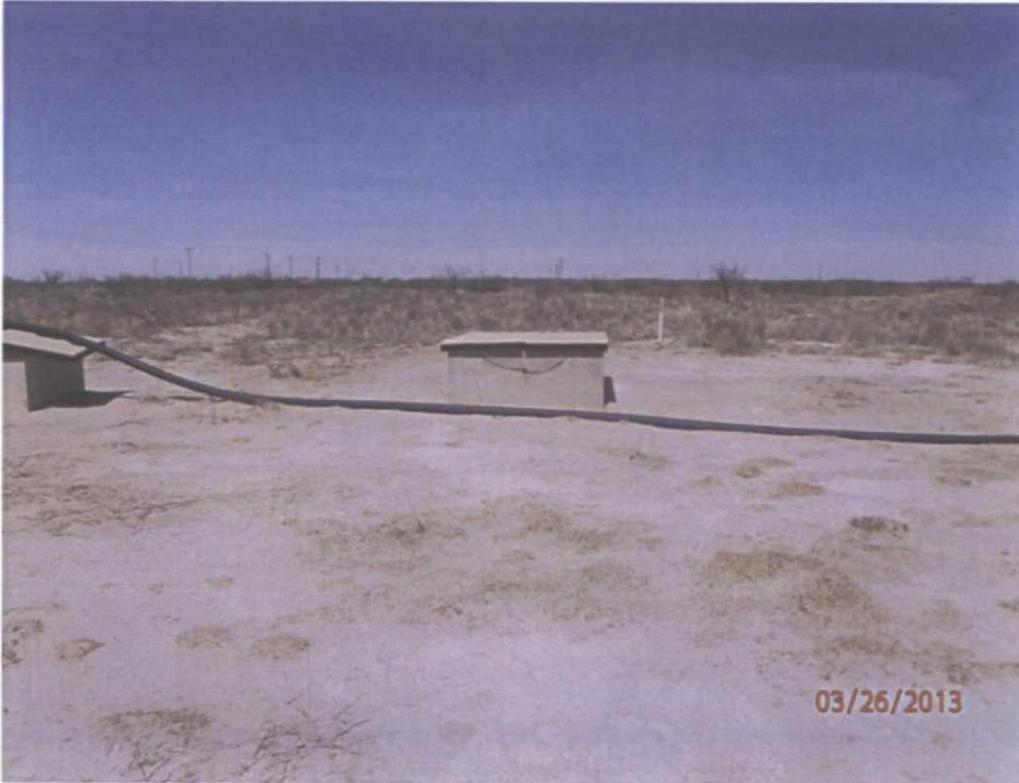
Facing north

ground surface (BGS) where a compacted red-bed clay layer was installed and density tested. The clay layer will provide a barrier that will inhibit the downward migration of chlorides to groundwater. The excavation was backfilled with remediated soil to ground surface and contoured to the surrounding area. The remediated soil was tested in 3 ft lifts, resulting in low concentrations of chloride. A new, water-tight junction box was built over the same location within an active facility; therefore, seeding is not necessary.
