1R - 427-70

RE: Termination Request
EME J-2 (1R427-70): UL/J, Sec. 2, T20S, R37E
RICE Operating Company – Eunice Monument Eumont SWD System

**RICE OPERATING COMPANY
JUNCTION BOX FINAL REPORT**

EME J-2 (1R427-70)
UL/J, Section 2, T20S, R37E

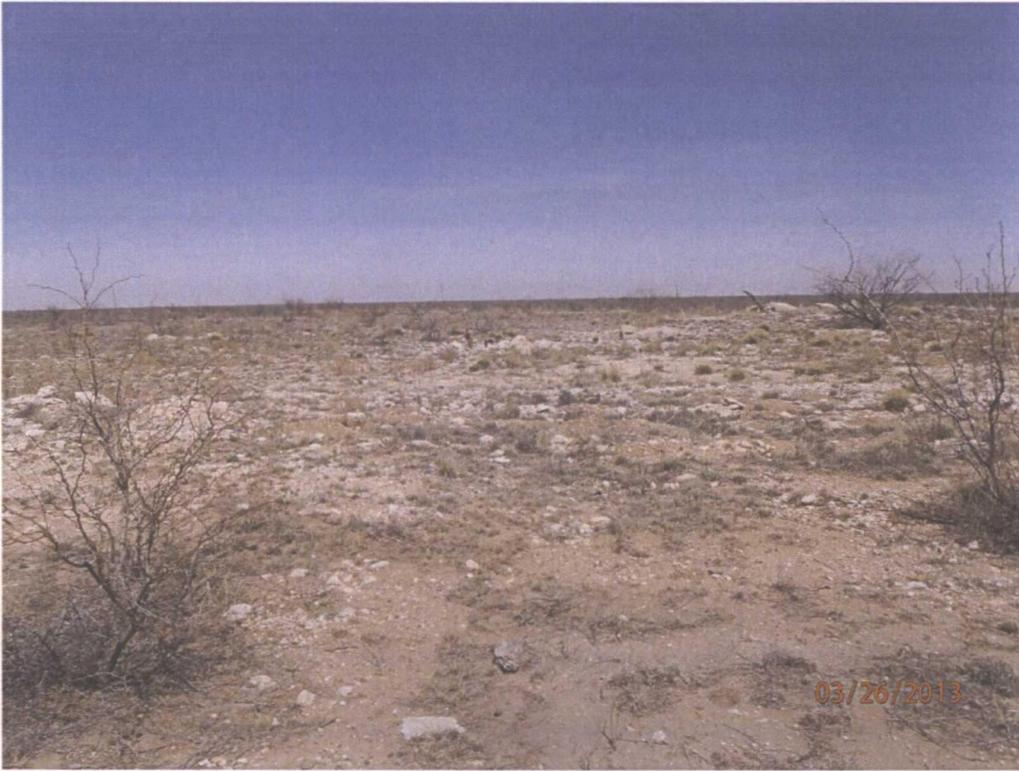
Facing north

In 2002, ROC initiated work on the former J-2 junction box. The site is located in UL/J, Sec. 2, T20S, R37E. An updated groundwater survey indicates that there are no water sources within a mile radius and there is no groundwater in the area. The site was delineated using a backhoe to collect soil samples at regular intervals, creating a 20x15x5 ft deep excavation. Each sample was field titrated for chlorides, resulting in chloride concentrations that decreased with depth. Representative samples of the sidewalls and bottom were collected and sent to a commercial laboratory for analysis of chloride and TPH, resulting in a sidewall chloride concentration of 598 mg/kg and a gasoline range organics (GRO) and a diesel range organics (DRO) concentration below detectable limits. The bottom sample resulted in a chloride concentration of 421 mg/kg and concentrations of GRO and DRO below detectable limits. A compacted clay layer was installed and a new water proof junction box was installed. The clay layer will provide a barrier that will inhibit the downward migration of chlorides to groundwater. Vegetation has rebounded at the site so no re-vegetation efforts are needed. The water proof junction box has since been eliminated.
