Rice Environmental Consulting & Safety

**RE: CAP Report and Termination Request
Rice Operating Company – BD SWD System
BD M-26-1 (1R426-04): UL/M sec. 26 T21S R37E**

CAP Report on the Vadose Zone Remediation

BD M-26-1 (1R426-04)
Unit Letter M, Section 26, T21S, R37E

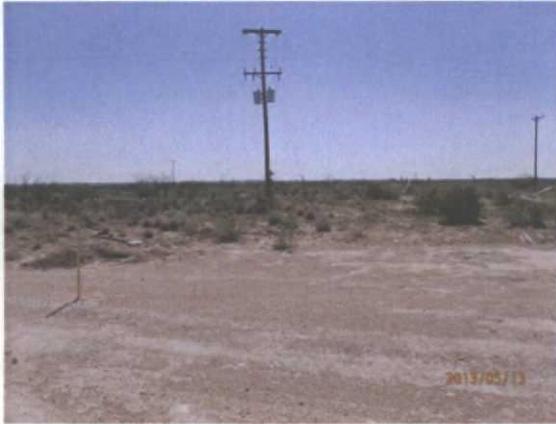
site prior, facing east 5/13/2013

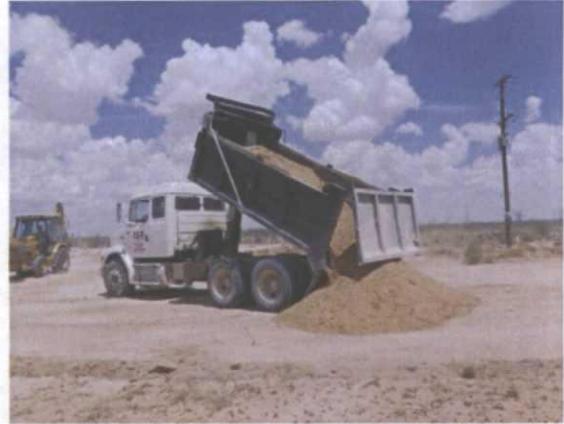
importing blow sand, facing north 5/14/2013

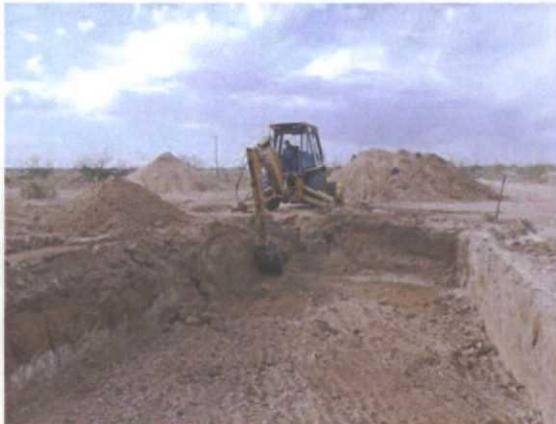
excavating the site, facing west 5/15/2013

RECS personnel were on site beginning on May 8th, 2013, to begin excavating for liner installation. The site was excavated as shown on Figure 2 to a depth of 5.5 ft. A total of 372 yards of excavated soil was disposed of at a NMOCD approved facility. The remaining excavated soil was blended on site and an 8 point composite sample was taken and field tested for hydrocarbons returning a result of 9 ppm. The sample was then taken to a commercial laboratory for analysis and returned a chloride result of 176 mg/kg. A total of 312 yards of blow sand was imported to the site and an 8 point composite sample was field tested for hydrocarbons returning a result of 16.1 ppm. The sample was then taken to a commercial laboratory, which returned a chloride result of non-detect.

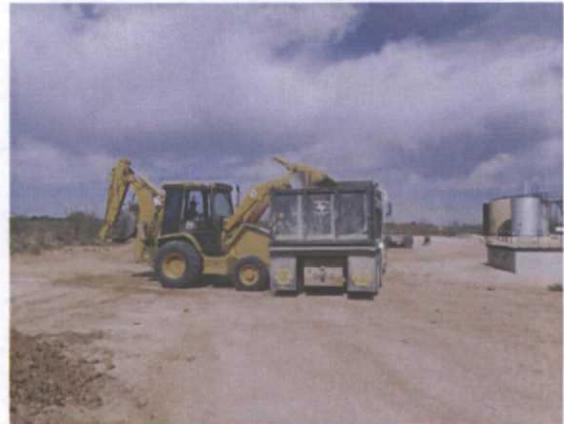
exporting excavated soil to Sundance for disposal, facing west 5/15/2013

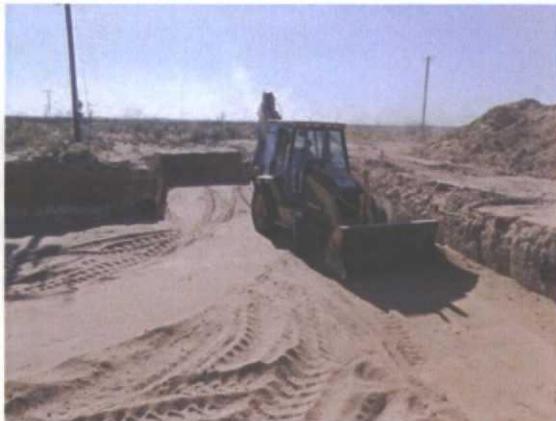
padding the completed excavation with 6 inches of blow sand, facing east 5/17/2013

The bottom of the excavation was padded with 6 inches of imported blow sand and a 20-mil reinforced poly liner was installed and properly seated into the excavation. The top of the liner was also padded with blow sand. The remainder of the excavation was backfilled with the blow sand and blended excavated soil. The surface of the excavation was contoured to the surrounding location.

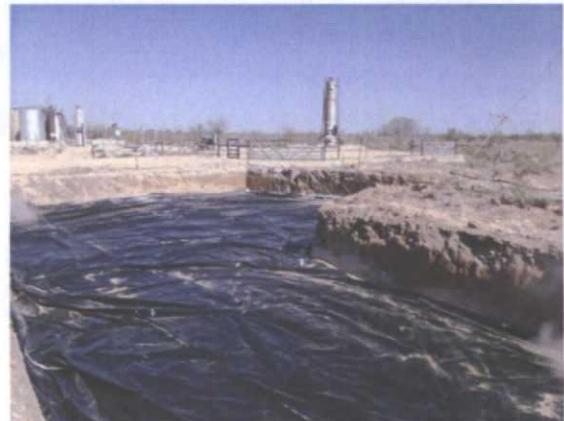
20-mil, reinforced liner installed at approximately 5 ft bgs, facing northwest 5/17/2013

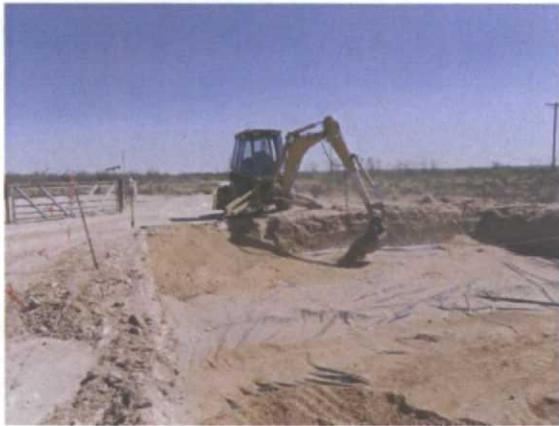
padding the liner with blow sand,
facing north 5/17/2013

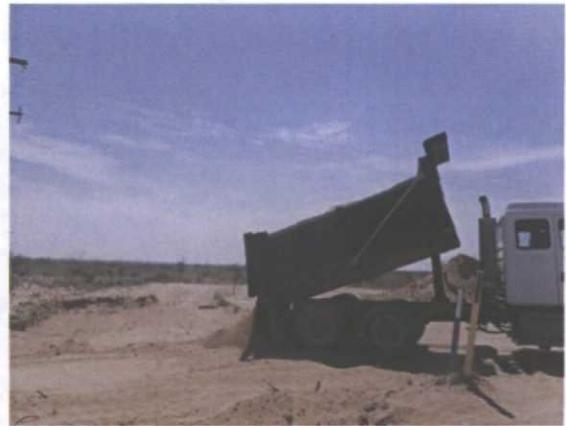
importing blow sand to contour the site to the
surrounding area, facing east 5/23/2013

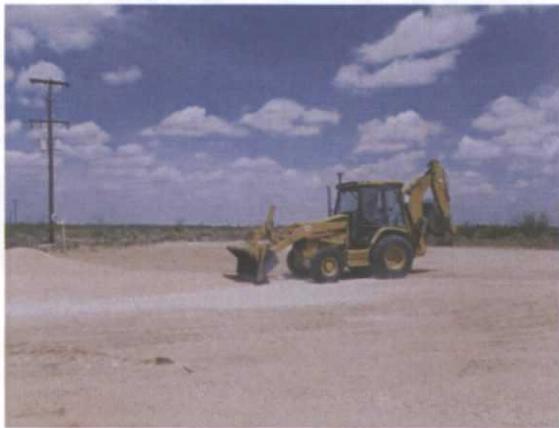
repairing the lease road, facing east
5/24/2013

A total of 36 yards of base coarse was imported to the site to repair the lease road. A sample of the base coarse was field tested for hydrocarbons and returned a result of 0 ppm. The sample was then taken to a commercial laboratory for analysis and returned a chloride result of 80 mg/kg.

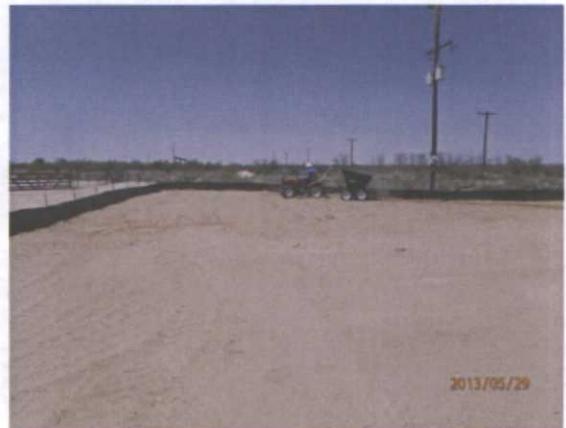
spreading amendments, facing north
5/29/2013

Silt net fencing was placed around the excavation to prevent erosion and maintain seed integrity. Soil amendments were added to the soil and the site was seeded with a blend of native vegetation.

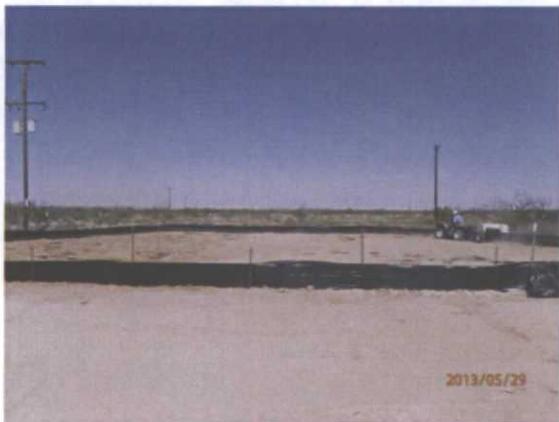
seeding the backfilled site, facing east
5/29/2013

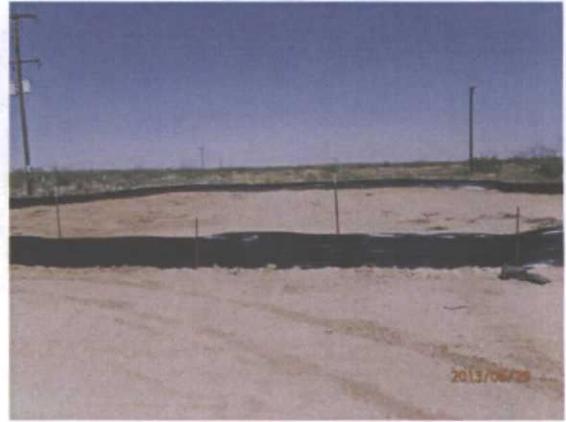
site complete, facing east 5/29/2013
