**RE: CAP Report for Groundwater  
Apache Corporation  
NMGSAU 1631 (1R-2627): UL/J sec. 32 T19S R37E**

# Site Location Map

## APACHE NMGSAU 1631

# Monitor Well Sampling Data

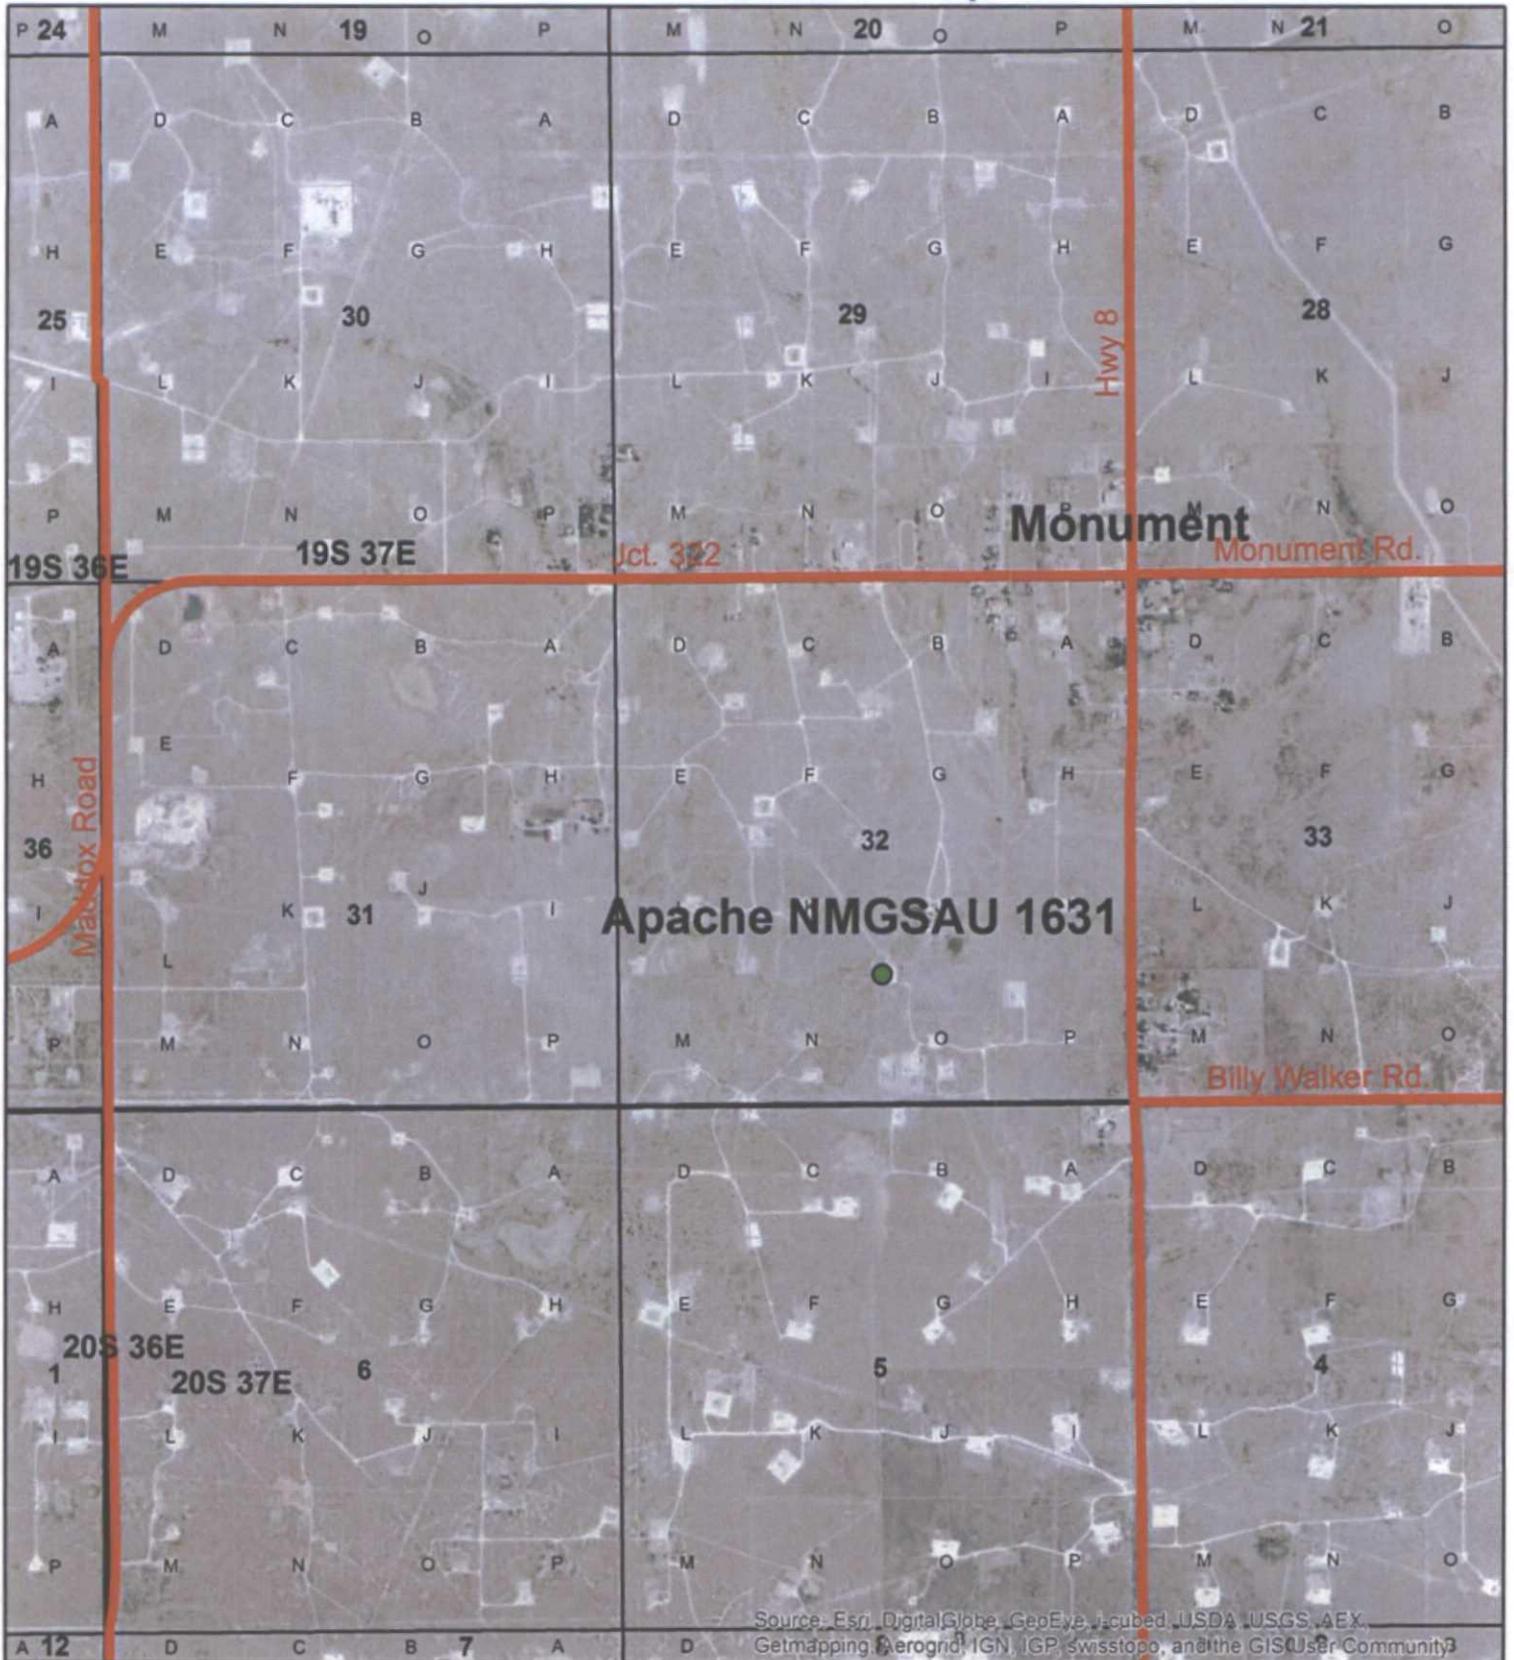
Figure 1

The site is located approximately 1 mile southwest of Monument at UL/J, Sec. 32, T19S, R37E in Lea County, NM (Figure 1). A leak was discovered at the site on September 28<sup>th</sup>, 2010. An unknown amount of produced water was released from the injection line collar. According to monitor well sampling data at the site, groundwater is located at approximately 14 ft below ground surface (bgs).

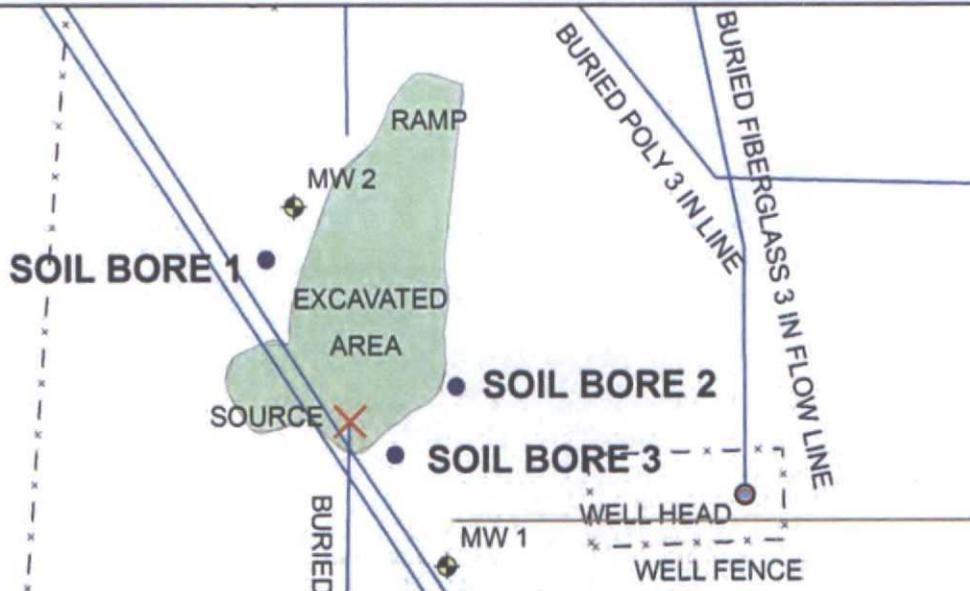
**Figure 2**

On October 25<sup>th</sup>, 2010, MW-1 was installed 45 ft southeast of the line break. On December 21<sup>st</sup>, 2010, MW-2 was installed 56 ft NNW of the line break, and on April 13<sup>th</sup>, 2011, MW-3 was installed 199 ft SE of the line break (Figure 2). The monitor wells have been sampled quarterly since their installation (Appendix A).

MW	Depth to Water	Total Depth	Sample Date	Cl	TDS	Benzene	Toluene	Ethyl Benzene	Total Xylenes	Sulfate
1	13.84	50.35	11/3/2010	6400	12700	0.015	0.001	0.004	0.01	1120
	13.83	50.35	1/6/2011	3250	6600	0.007	<0.001	0.002	0.006	697
	13.86	50.36	5/19/2011	2420	4770	<0.001	<0.001	<0.001	<0.003	531
	13.81	50.35	9/1/2011	860	2060	<0.001	<0.001	<0.001	<0.003	232
	13.99	50.35	11/18/2011	1480	3150	<0.001	<0.001	<0.001	<0.003	344
	13.87	50.35	3/6/2012	1280	2730	<0.001	<0.001	<0.001	<0.003	363
	XXX	50.35	6/20/2012	540	1420	<0.001	<0.001	<0.001	<0.003	116
	XXX	50.35	9/25/2012	970	2190	<0.001	<0.001	<0.001	<0.003	190
	XXX	50.35	12/13/2012	1040	1970	<0.001	<0.001	<0.001	<0.003	223
	XXX	50.35	3/27/2013	480	1040	<0.001	<0.001	<0.001	<0.003	84
XXX	50.35	6/26/2013	352	1010	<0.001	<0.001	<0.001	<0.003	81

XXX: Not gauged due to pump in well.

MW	Depth to Water	Total Depth	Sample Date	Cl	TDS	Benzene	Toluene	Ethyl Benzene	Total Xylenes	Sulfate
2	13.47	61.15	1/6/2011	320	878	<0.001	<0.001	<0.001	<0.003	81.1
	13.52	61.15	5/19/2011	296	907	<0.001	<0.001	<0.001	<0.003	67.1
	13.68	61.15	9/1/2011	284	785	<0.001	<0.001	<0.001	<0.003	75.7
	13.69	61.15	11/18/2011	308	860	<0.001	<0.001	<0.001	<0.003	64.1
	13.58	61.15	3/6/2012	280	907	<0.001	<0.001	<0.001	<0.003	68.8
	13.78	61.15	6/20/2012	280	920	<0.001	<0.001	<0.001	<0.003	64
	13.81	61.15	9/25/2012	268	853	<0.001	<0.001	<0.001	<0.003	63.8
	13.64	61.15	12/13/2012	280	847	<0.001	<0.001	<0.001	<0.003	57.7
	13.72	61.15	3/27/2013	264	854	<0.001	<0.001	<0.001	<0.003	67.8
	13.88	61.15	6/26/2013	268	868	<0.001	<0.001	<0.001	<0.003	69.7

MW	Depth to Water	Total Depth	Sample Date	Cl	TDS	Benzene	Toluene	Ethyl Benzene	Total Xylenes	Sulfate
3	18.69	30.05	5/19/2011	300	903	<0.001	<0.001	<0.001	<0.003	69.6
	18.7	30.05	9/1/2011	308	845	<0.001	<0.001	<0.001	<0.003	84.8
	17.93	30.05	11/18/2011	380	954	<0.001	<0.001	<0.001	<0.003	78.6
	18.06	30.05	3/6/2012	324	989	<0.001	<0.001	<0.001	<0.003	77.3
	18.43	30.05	6/20/2012	296	922	<0.001	<0.001	<0.001	<0.003	70
	18.58	30.05	9/25/2012	288	938	<0.001	<0.001	<0.001	<0.003	70.5
	18.26	30.05	12/13/2012	288	818	<0.001	<0.001	<0.001	<0.003	77
	18.26	30.05	3/27/2013	292	881	<0.001	<0.001	<0.001	<0.003	77.3
	18.57	30.05	6/26/2013	280	915	<0.001	<0.001	<0.001	<0.003	75.4

Since the groundwater source removal and pumping program began on April 10<sup>th</sup>, 2012, a total of 3,965 barrels of groundwater have been removed from the site. Given the most recent laboratory chloride readings 352 mg/L in MW-1, the volume of groundwater removal indicates that 221 kg of chloride have been removed. The pumping program will remain in operation until the winter months arrived. In order to maintain integrity of the system and avoid possible utility and/or environmental damages, the pumping system at the site will be shut in throughout the winter months and will resume in the spring of 2014. As stated in the CAP for Groundwater, approved in August 2012, Apache will continue the pumping program until the chloride concentrations decrease to near-background levels.
