Pit, Below-Grade Tank, or
Proposed Alternative Method Permit or Closure Plan Application

1.
Operator: Regency Field Services, LLC OGRID #: _____
Address: 801 South Loop 464 Monahans, Texas 79756
Facility or well name: Drip Tank #111 RP-1820
API Number: _____ OCD Permit Number: _____
U/L or Qtr/Qtr ^E _____ Section 27 Township 22S Range 36E County: Lea Co, NM
Center of Proposed Design: Latitude 32 21.904 Longitude -103 15.517 NAD: 1927 1983
Surface Owner: Federal State Private Tribal Trust or Indian Allotment

Figure 1
Site Location Map
 Southern Union Gas Services
 Drip Tank #111 Historical
 Lea County, New Mexico
 NMOCD Reference #: 1RP-1820

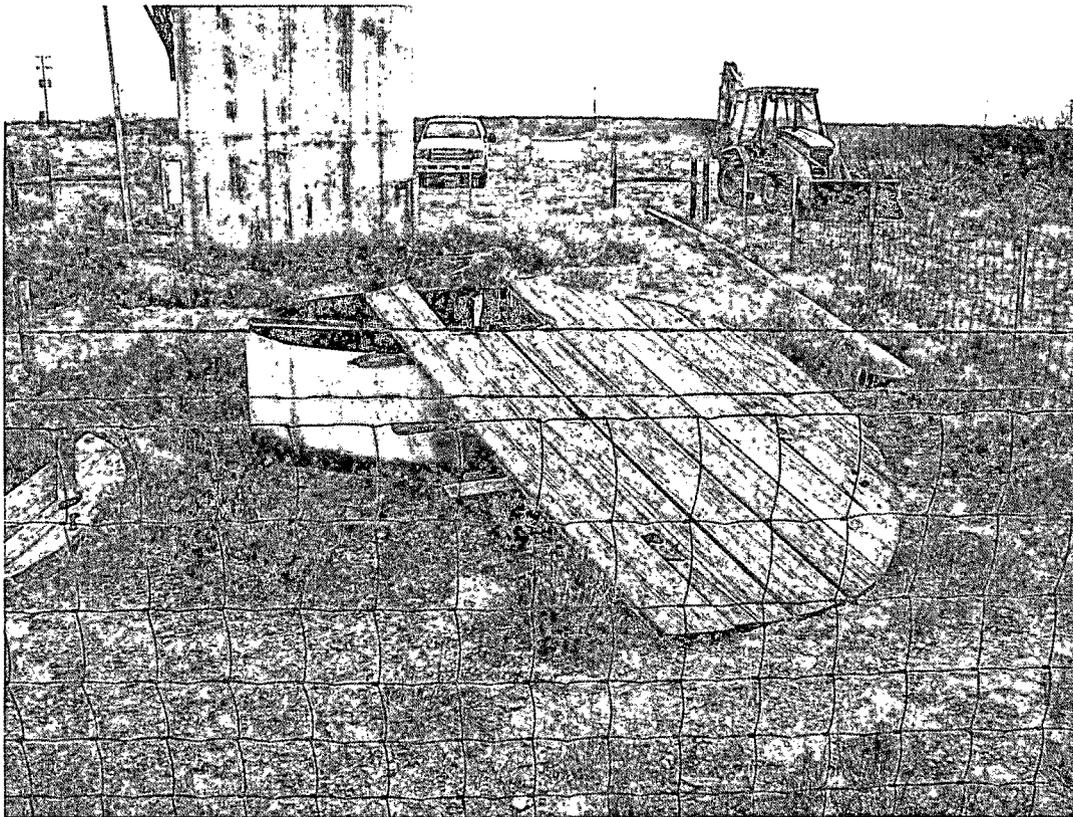
Photograph of BGT at the Drip Tank #111 prior to being removed.

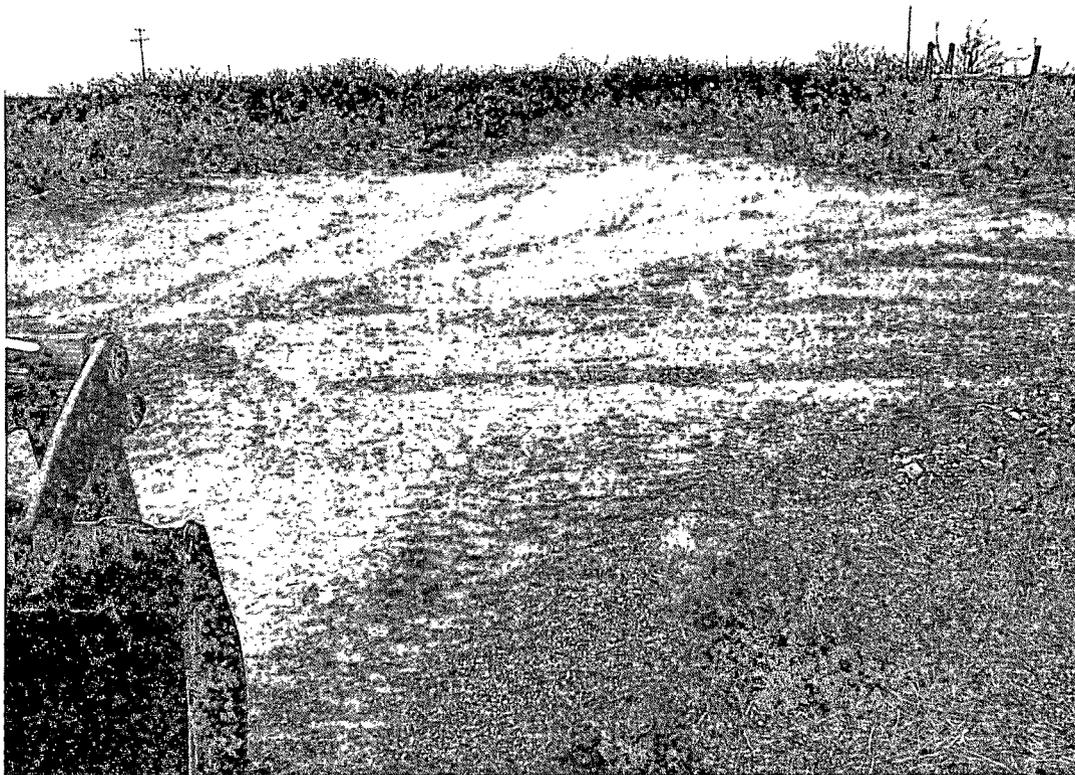
Photograph of the former BGT location at the Drip Tank #111.

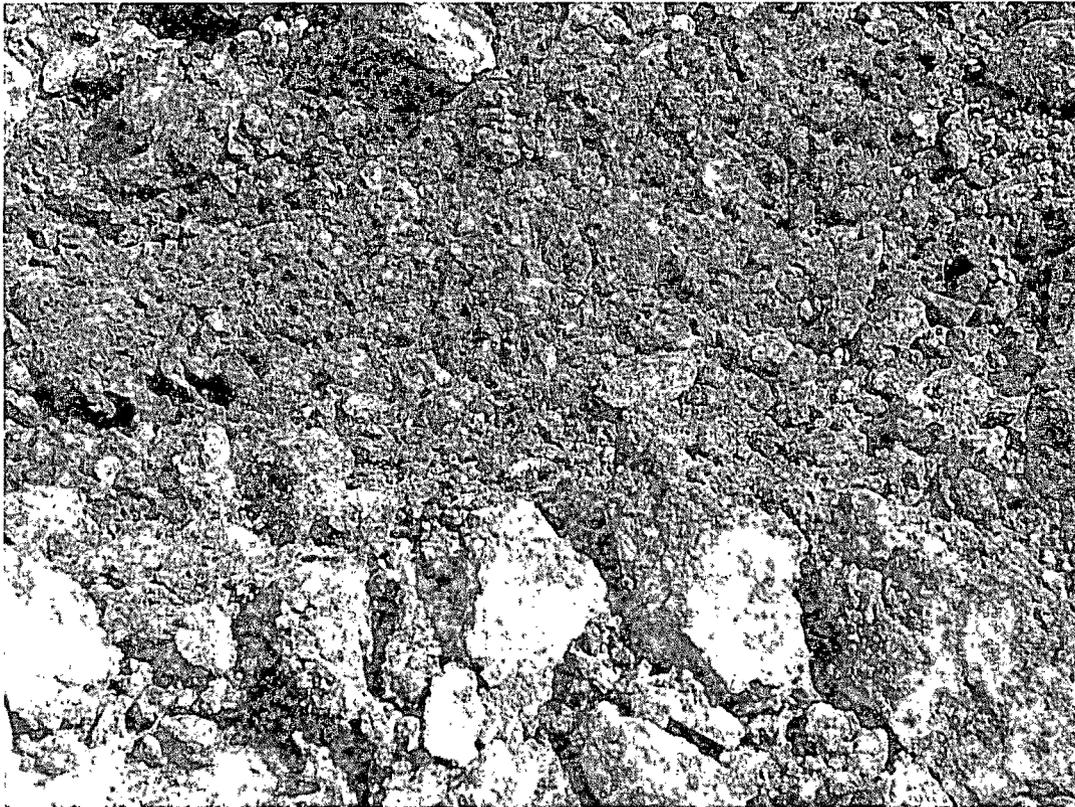
Photograph of the area inferred to be a historical "Pit" at the Drip Tank #111.

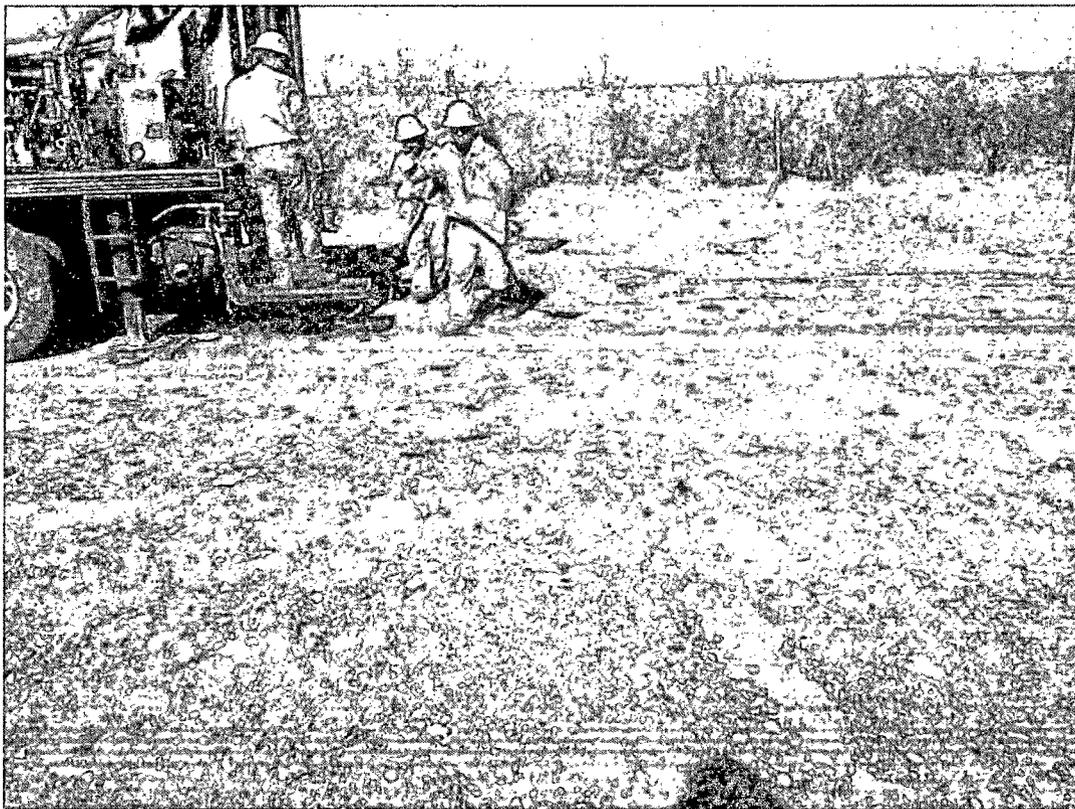
Photograph of soil boring activities at the Drip Tank #111.

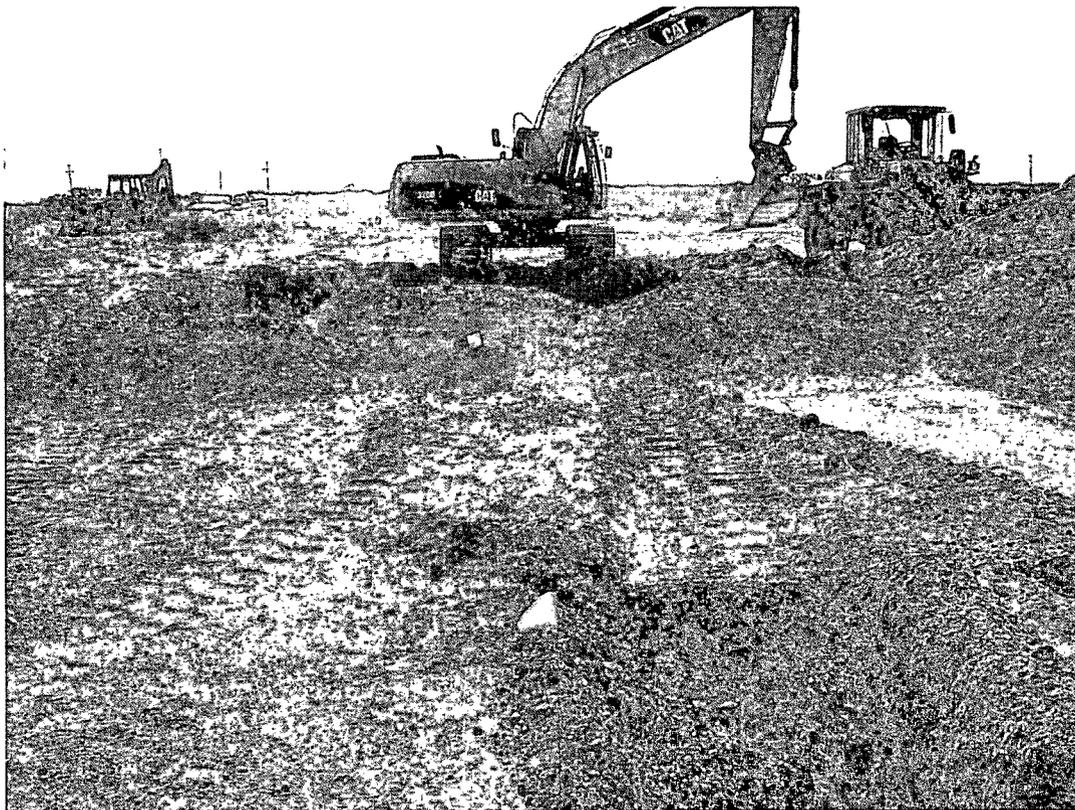
Photograph of soil boring location and excavation activities at the Drip Tank #111.

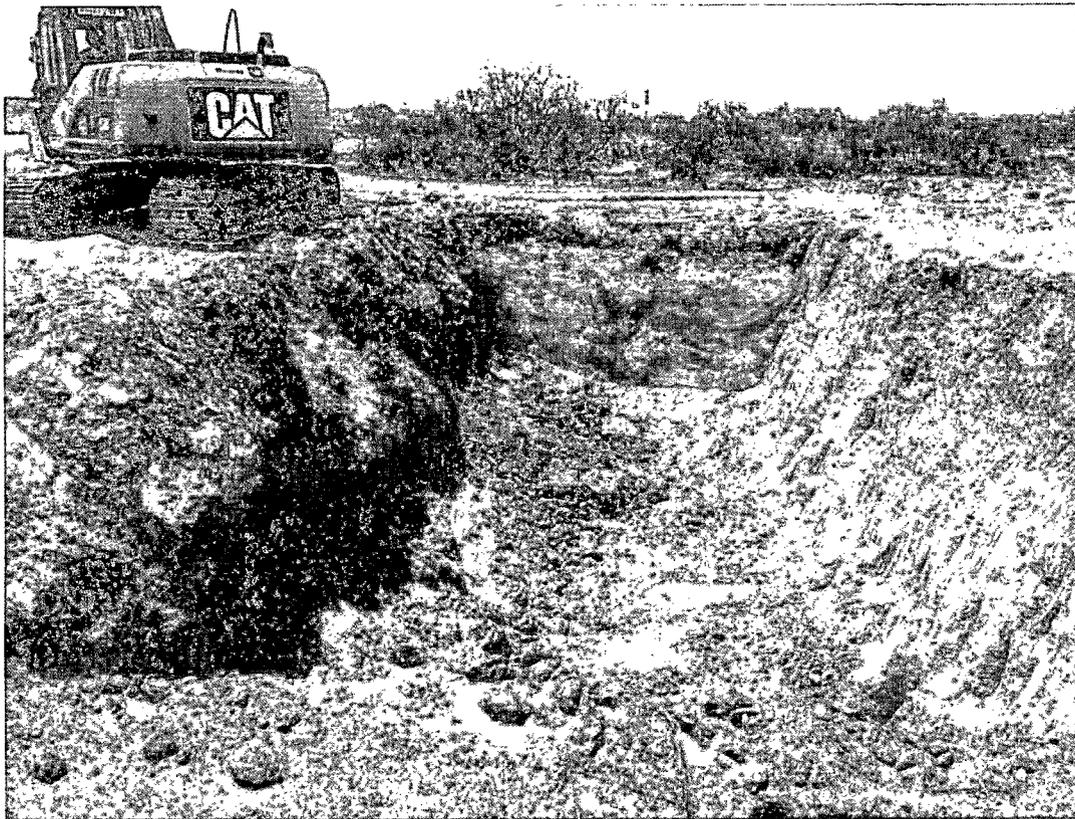
Photograph of excavation activities at the Drip Tank #111.

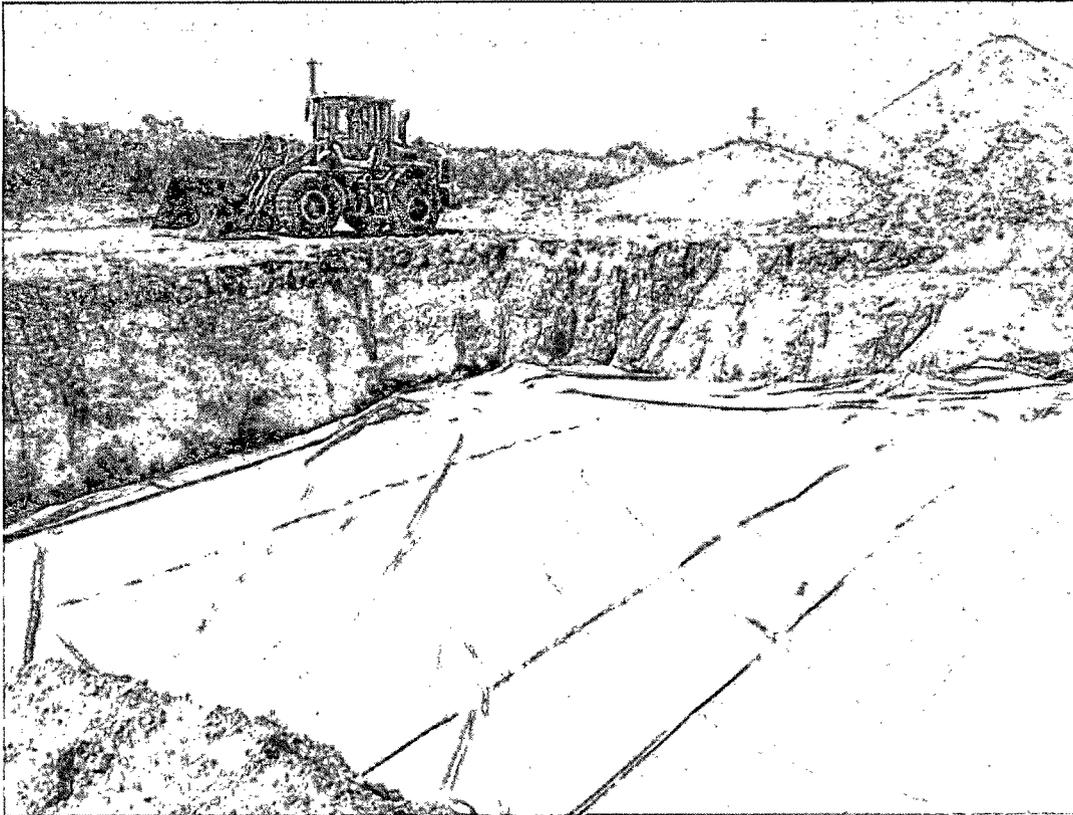
Photograph of the installation of a 20-Mil poly liner at the Drip Tank #111.

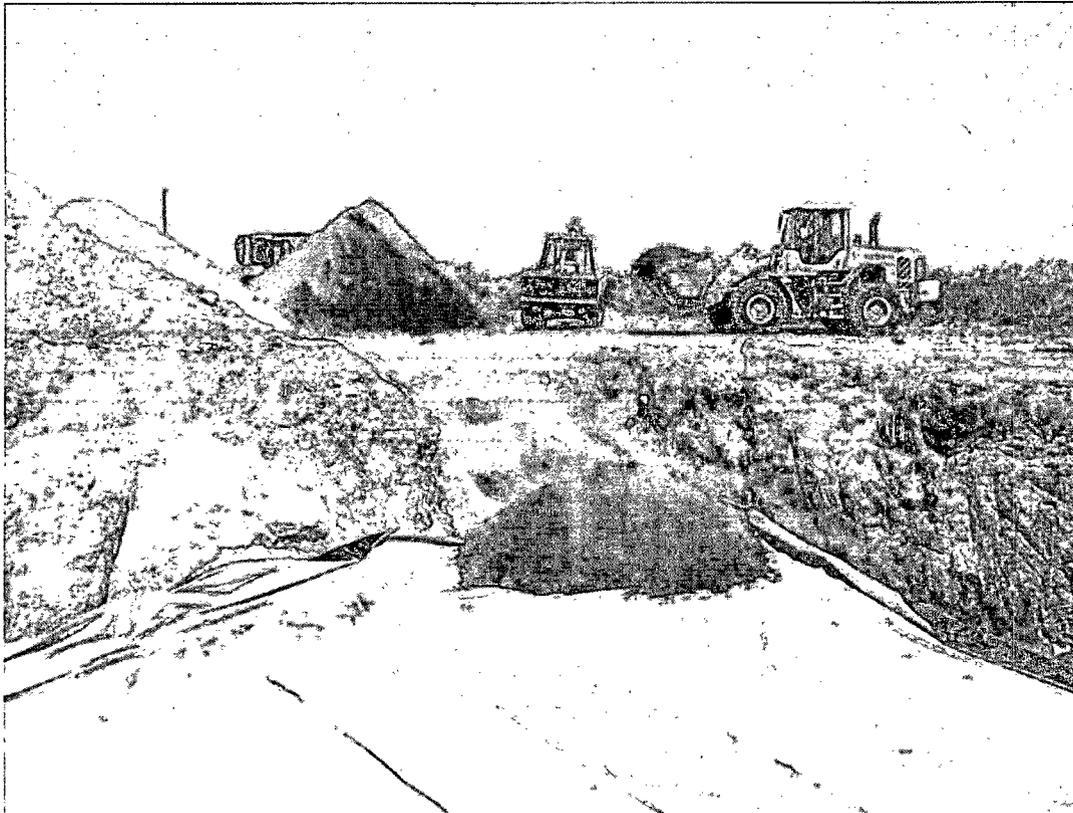
Photograph of the installation of pad sand at the Drip Tank #111.

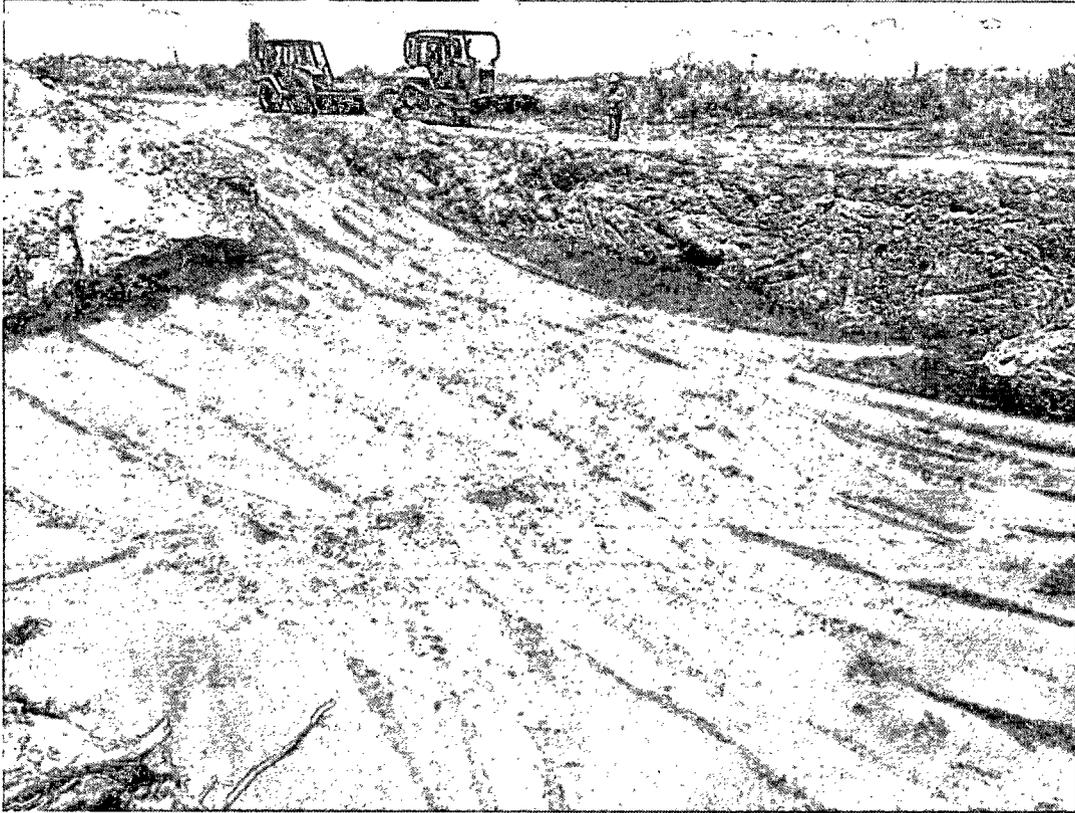
Photograph of backfilling activities at the Drip Tank #111.

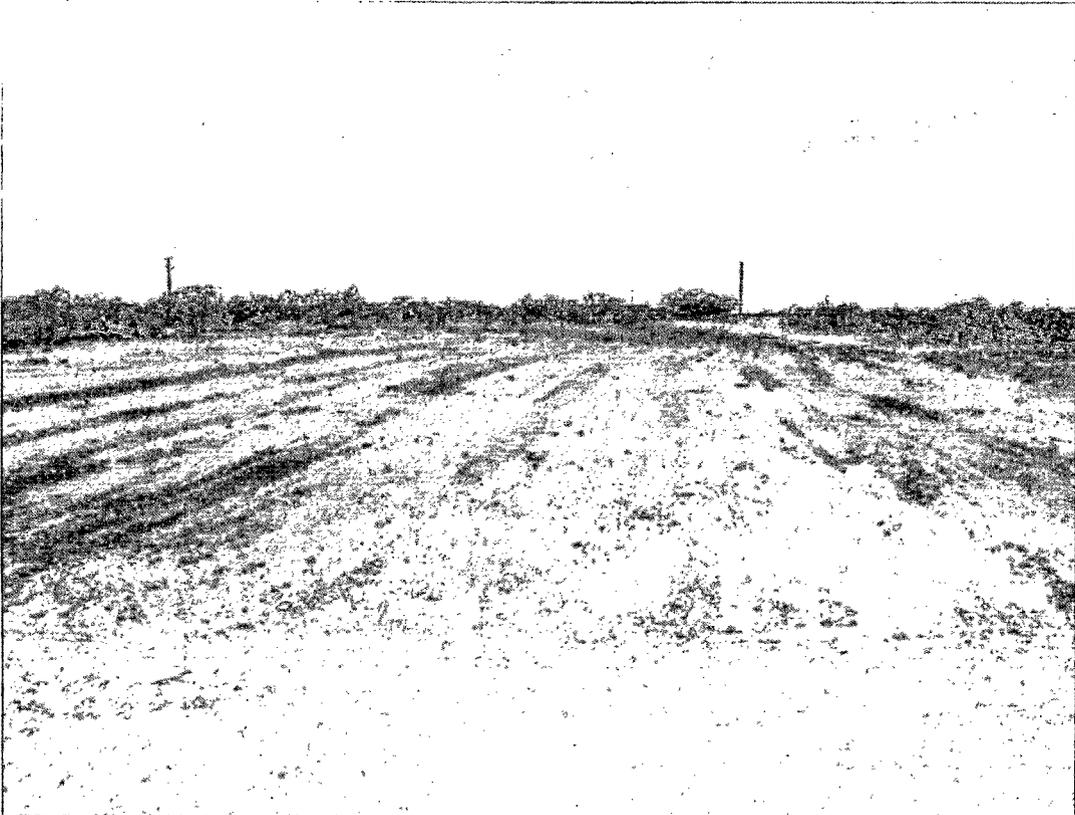
Photograph of the Drip Tank #111 upon completion of remediation activities.

Laboratory analytical results from confirmation soil samples collected from the sidewalls of the Drip Tank #111 excavation indicated concentrations of benzene, BTEX, TPH and chloride were less than NMOCD regulatory standards. An approved twenty-millimeter (20mm) polyurethane was installed in the floor of the excavation at approximately twelve feet (12') bgs. This engineering control is designed to inhibit the vertical migration of contaminants left in-situ. Based on these laboratory analytical results and the installation of an approved engineering control, Basin recommends Regency provide the NMOCD Hobbs District Office a copy of this *Remediation Summary & Risk-Based Site Closure Request* and request the NMOCD grant site closure to the Drip Tank #111 Historical Release Site.
