RE: Nash Draw #29 modular impoundment final spill report. API No: 30-015-29434
2RP-1674

R.T. Hicks Consultants is pleased to submit the enclosed Form C-141 "Release Notification and Correction Action" final report on the behalf of XTO Energy.

On September 23 - 27th, 2013; we performed reclamation activities in accordance with our remediation plan outline in the March 15 report. The remediation plan states:

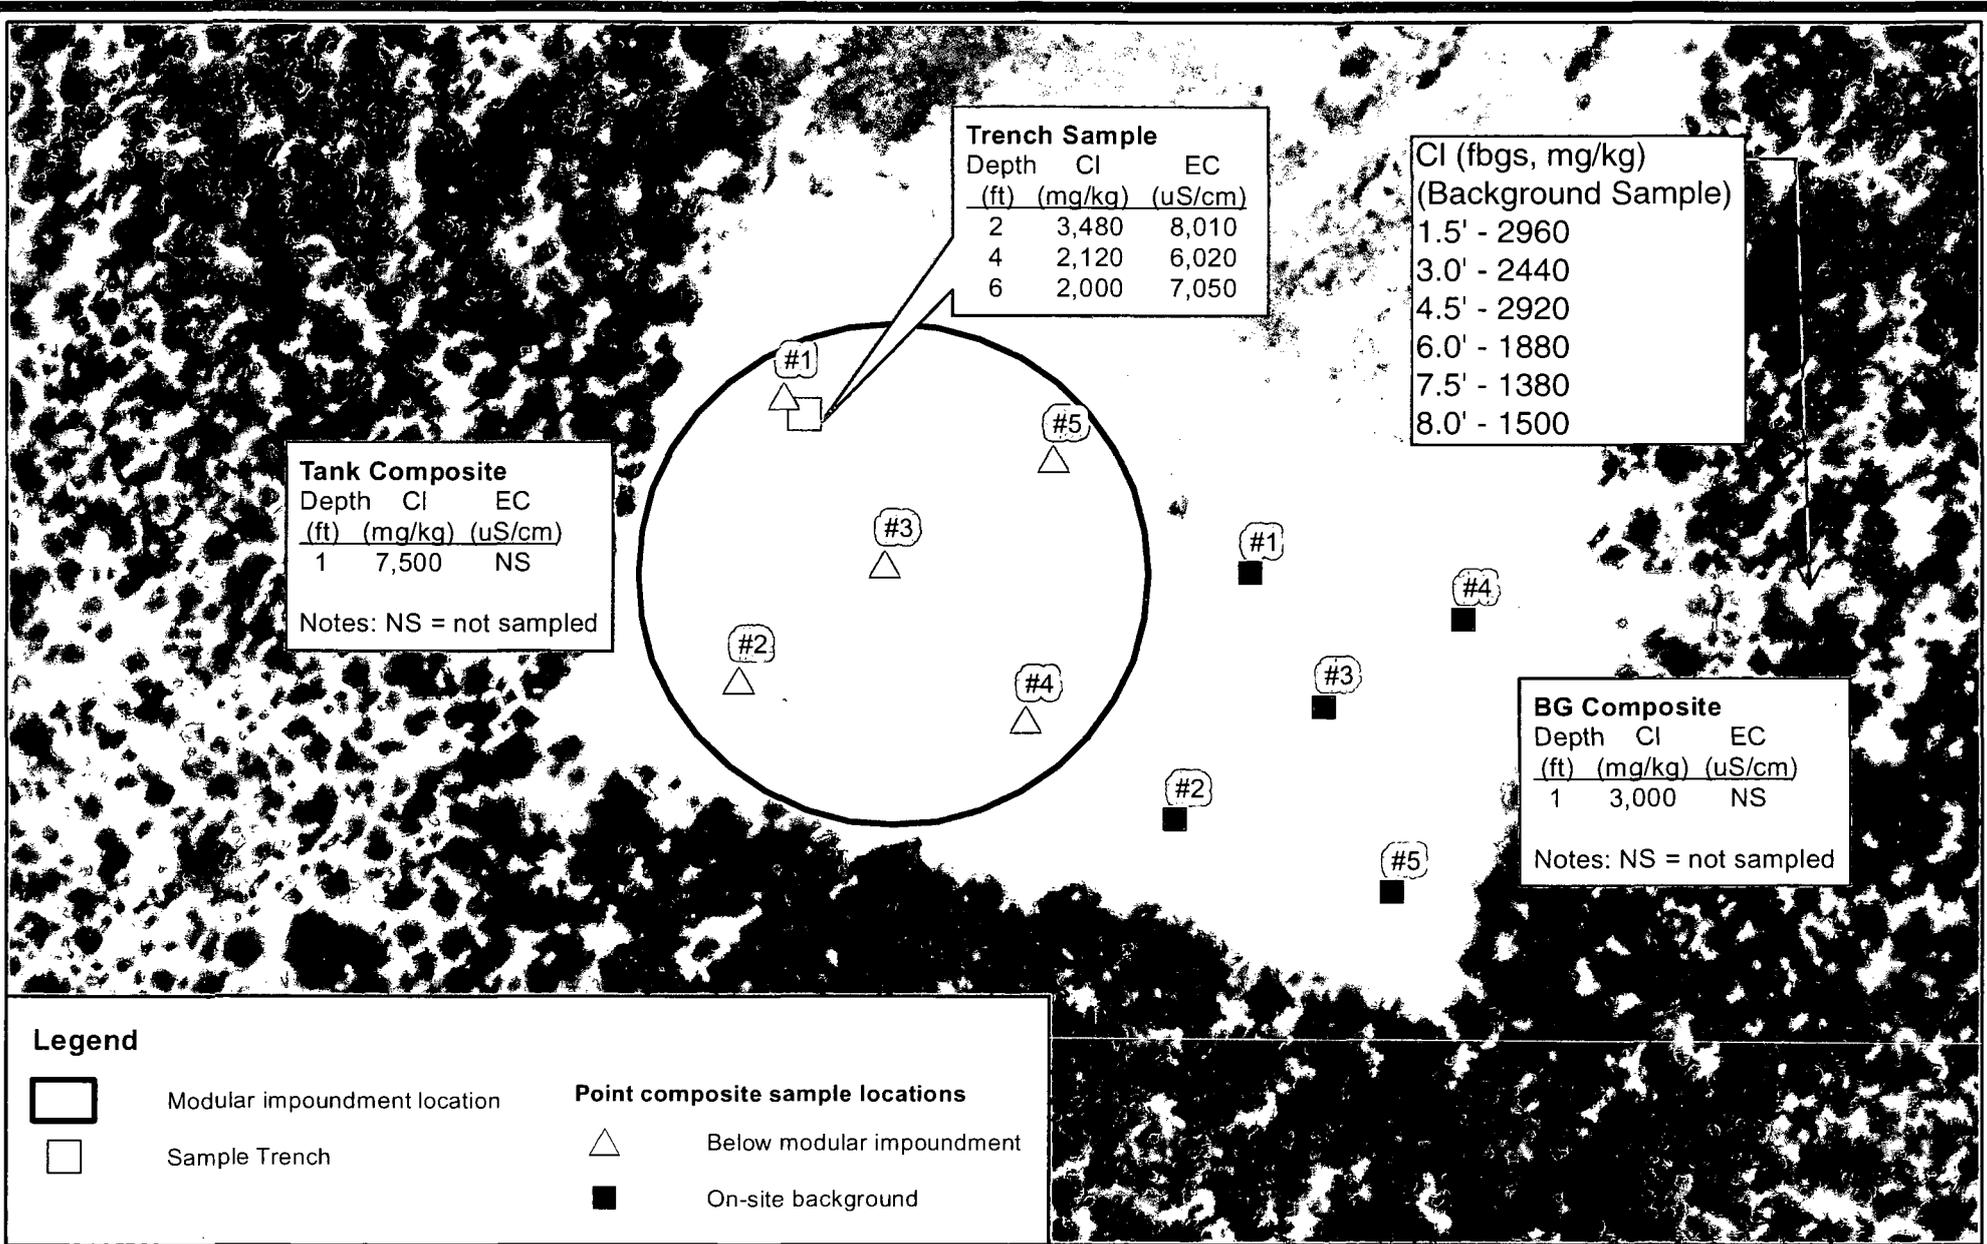
Trench Sample

Depth (ft)	Cl (mg/kg)	EC (uS/cm)
2	3,480	8,010
4	2,120	6,020
6	2,000	7,050

**Cl (fbgs, mg/kg)
(Background Sample)**

1.5'	2960
3.0'	2440
4.5'	2920
6.0'	1880
7.5'	1380
8.0'	1500

Tank Composite

Depth (ft)	Cl (mg/kg)	EC (uS/cm)
1	7,500	NS

BG Composite

Depth (ft)	Cl (mg/kg)	EC (uS/cm)
1	3,000	NS

Chloride Concentrations in Soil

The location and chloride chemistry of the samples are presented on Plate 1. The chemistry is summarized in Table 1, below. Table 2 shows the lithology of the "Trench Sample". The laboratory certificate of analysis is attached.

Between November 13, 2012 and June 24, 2013, soil samples were obtained to determine the magnitude, extent, and background hydrocarbon and chloride concentrations associated with the reported release. Table 1 summarizes the results of soil sampling. Plate 1 shows the locations of the soil samples.

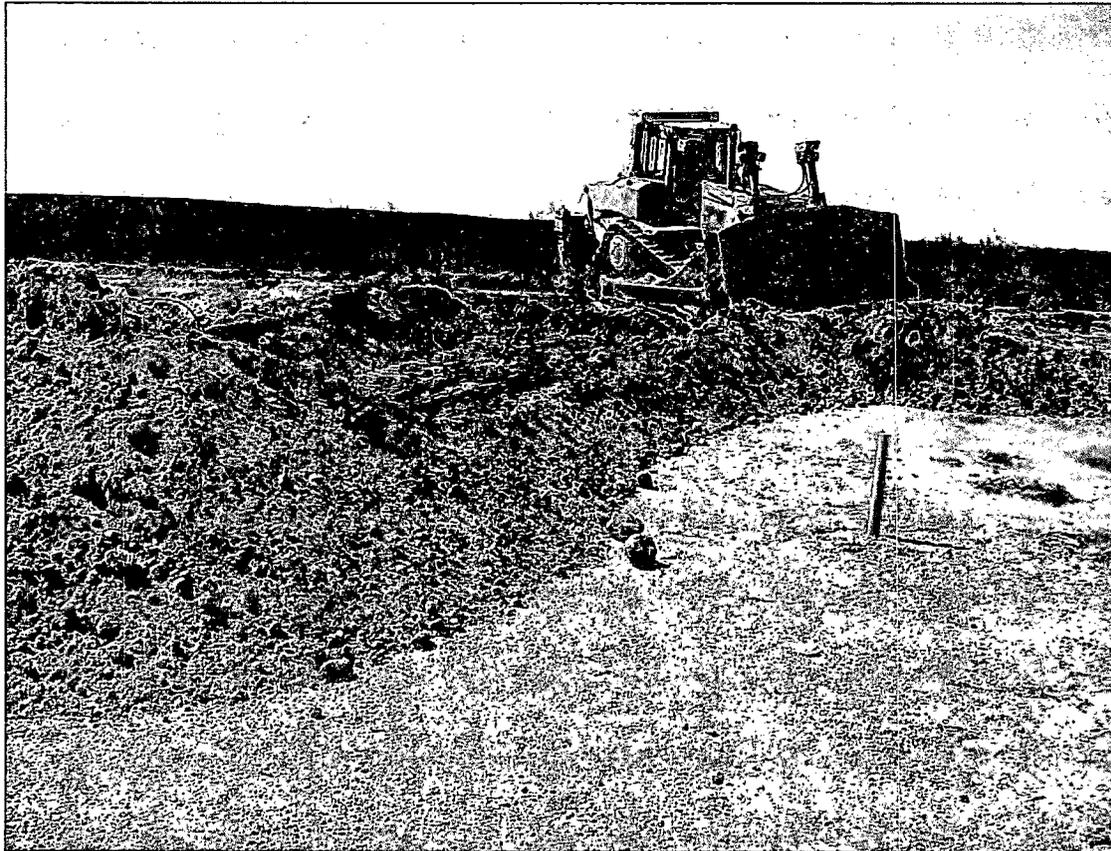
Figure 1: Stockpiling chloride impacted caliche near western 1/3 of location pad.

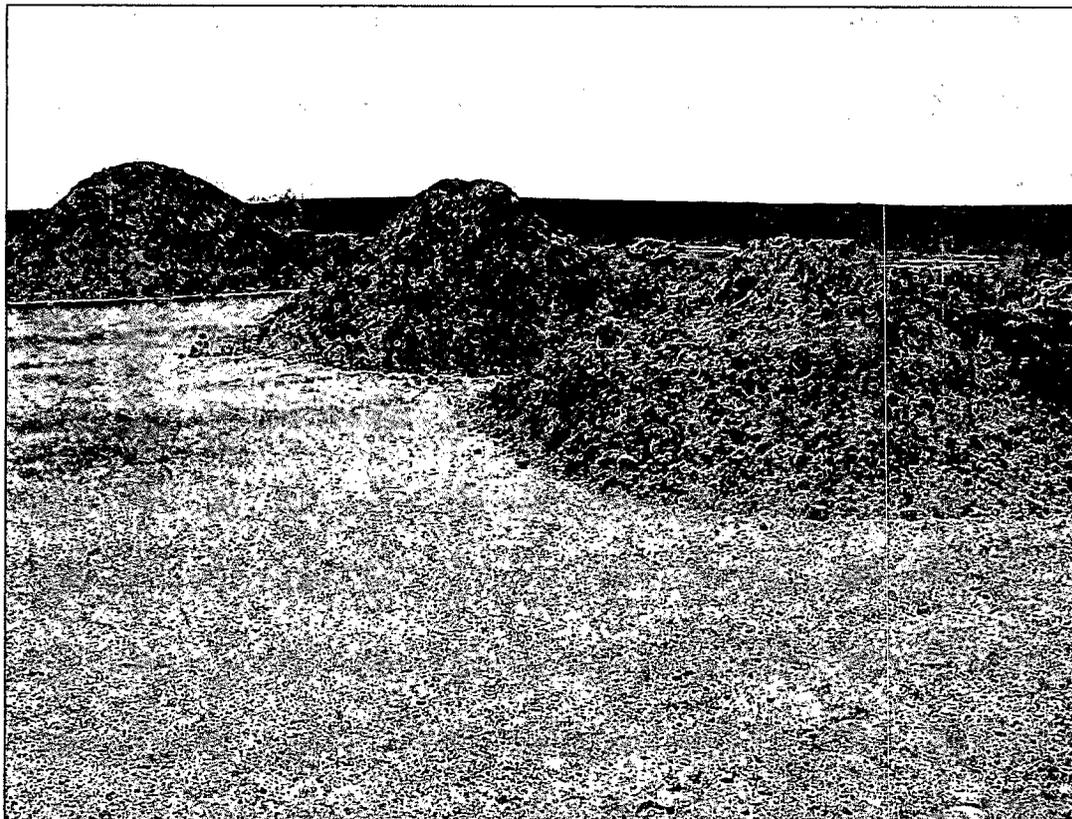
Figure 2: Stockpiled impacted caliche (two right soil piles) waiting transport to R360. The far left soil pile (background) is clean soil to be used for BLM interim reclamation activities.

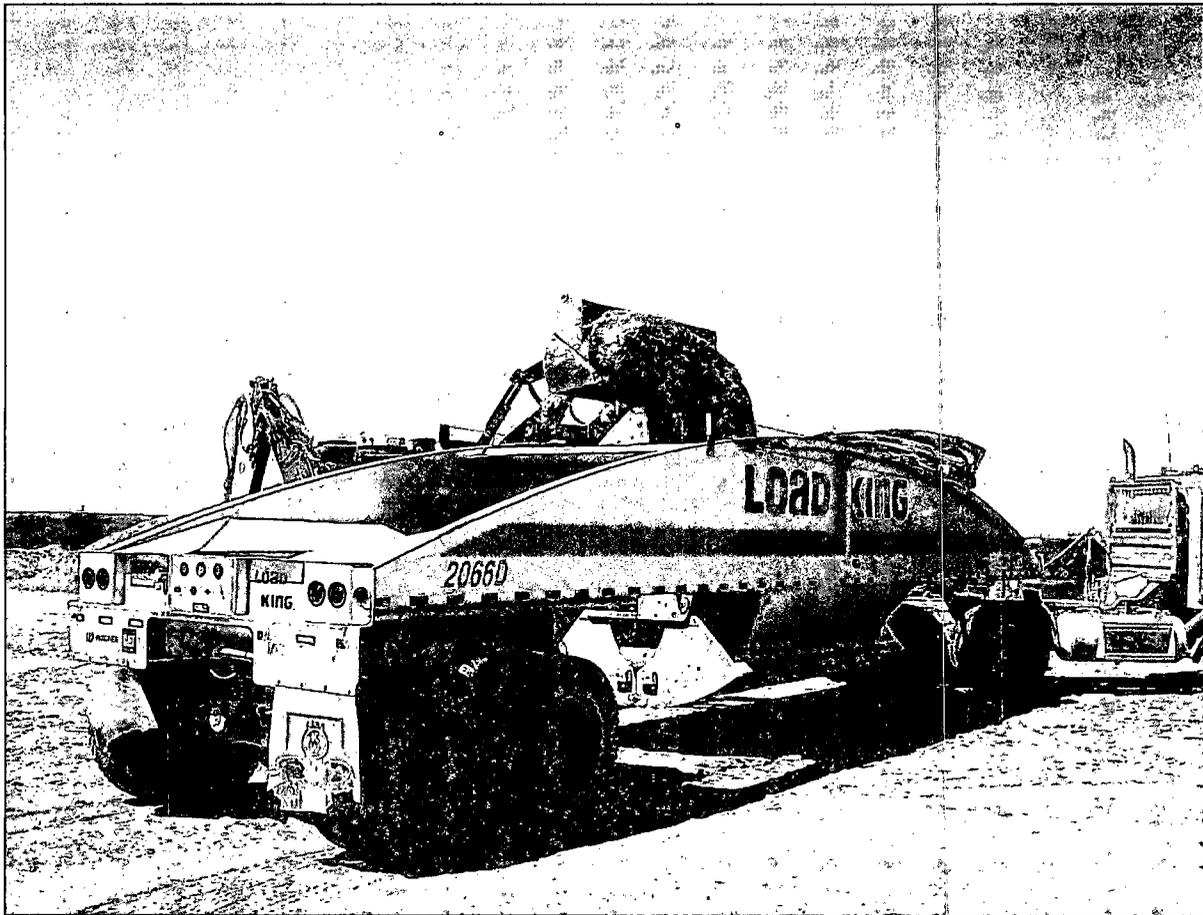
Figure 3: Stockpiled chloride impacted caliche being loaded for transport to R360.

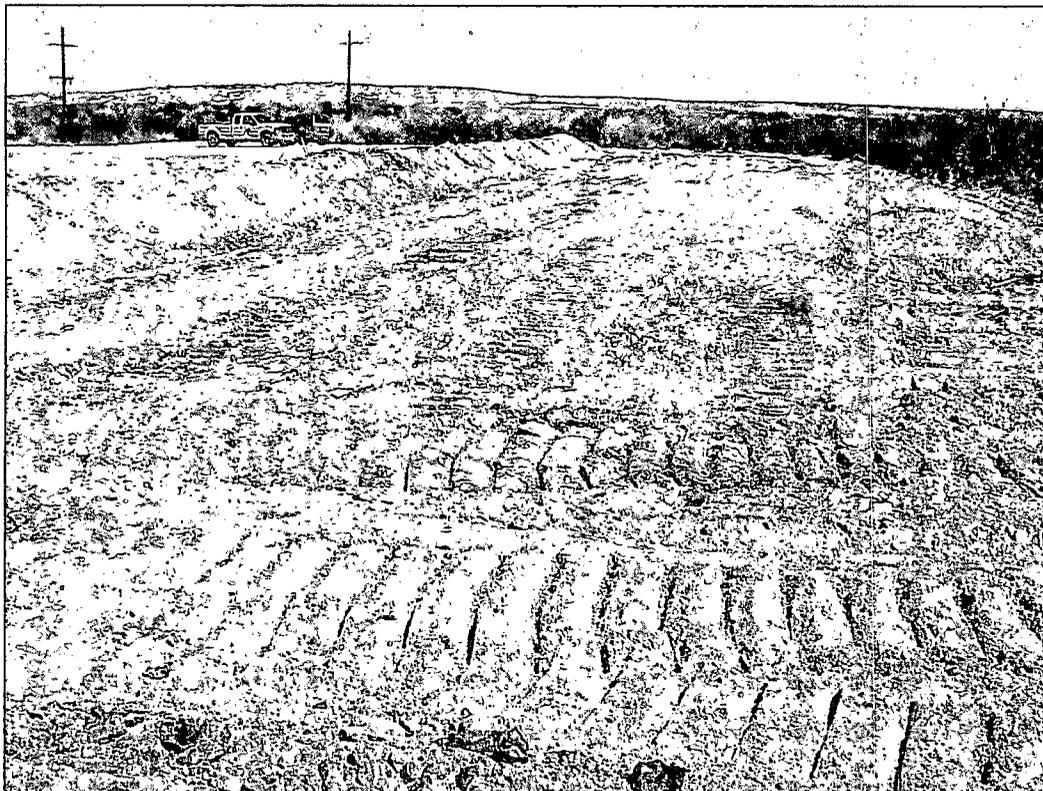
Figure 4: Western 1/3 of caliche pad removed and ready for ripping and seeding. Portions of the caliche pad were included in BLM interim reclamation activities.
