## **REMEDIATION SUMMARY AND SITE CLOSURE REQUEST**

**BOPCO, LP  
POKER LAKE UNIT #145 FLOW LINE  
Eddy County, New Mexico  
Unit Letter "E" (SW/NW), Section 32, Township 23 South, Range 30 East  
Latitude 32.261914° North, Longitude 103.912095° West  
NMOCD Reference #2RP-832**

**November 2013**

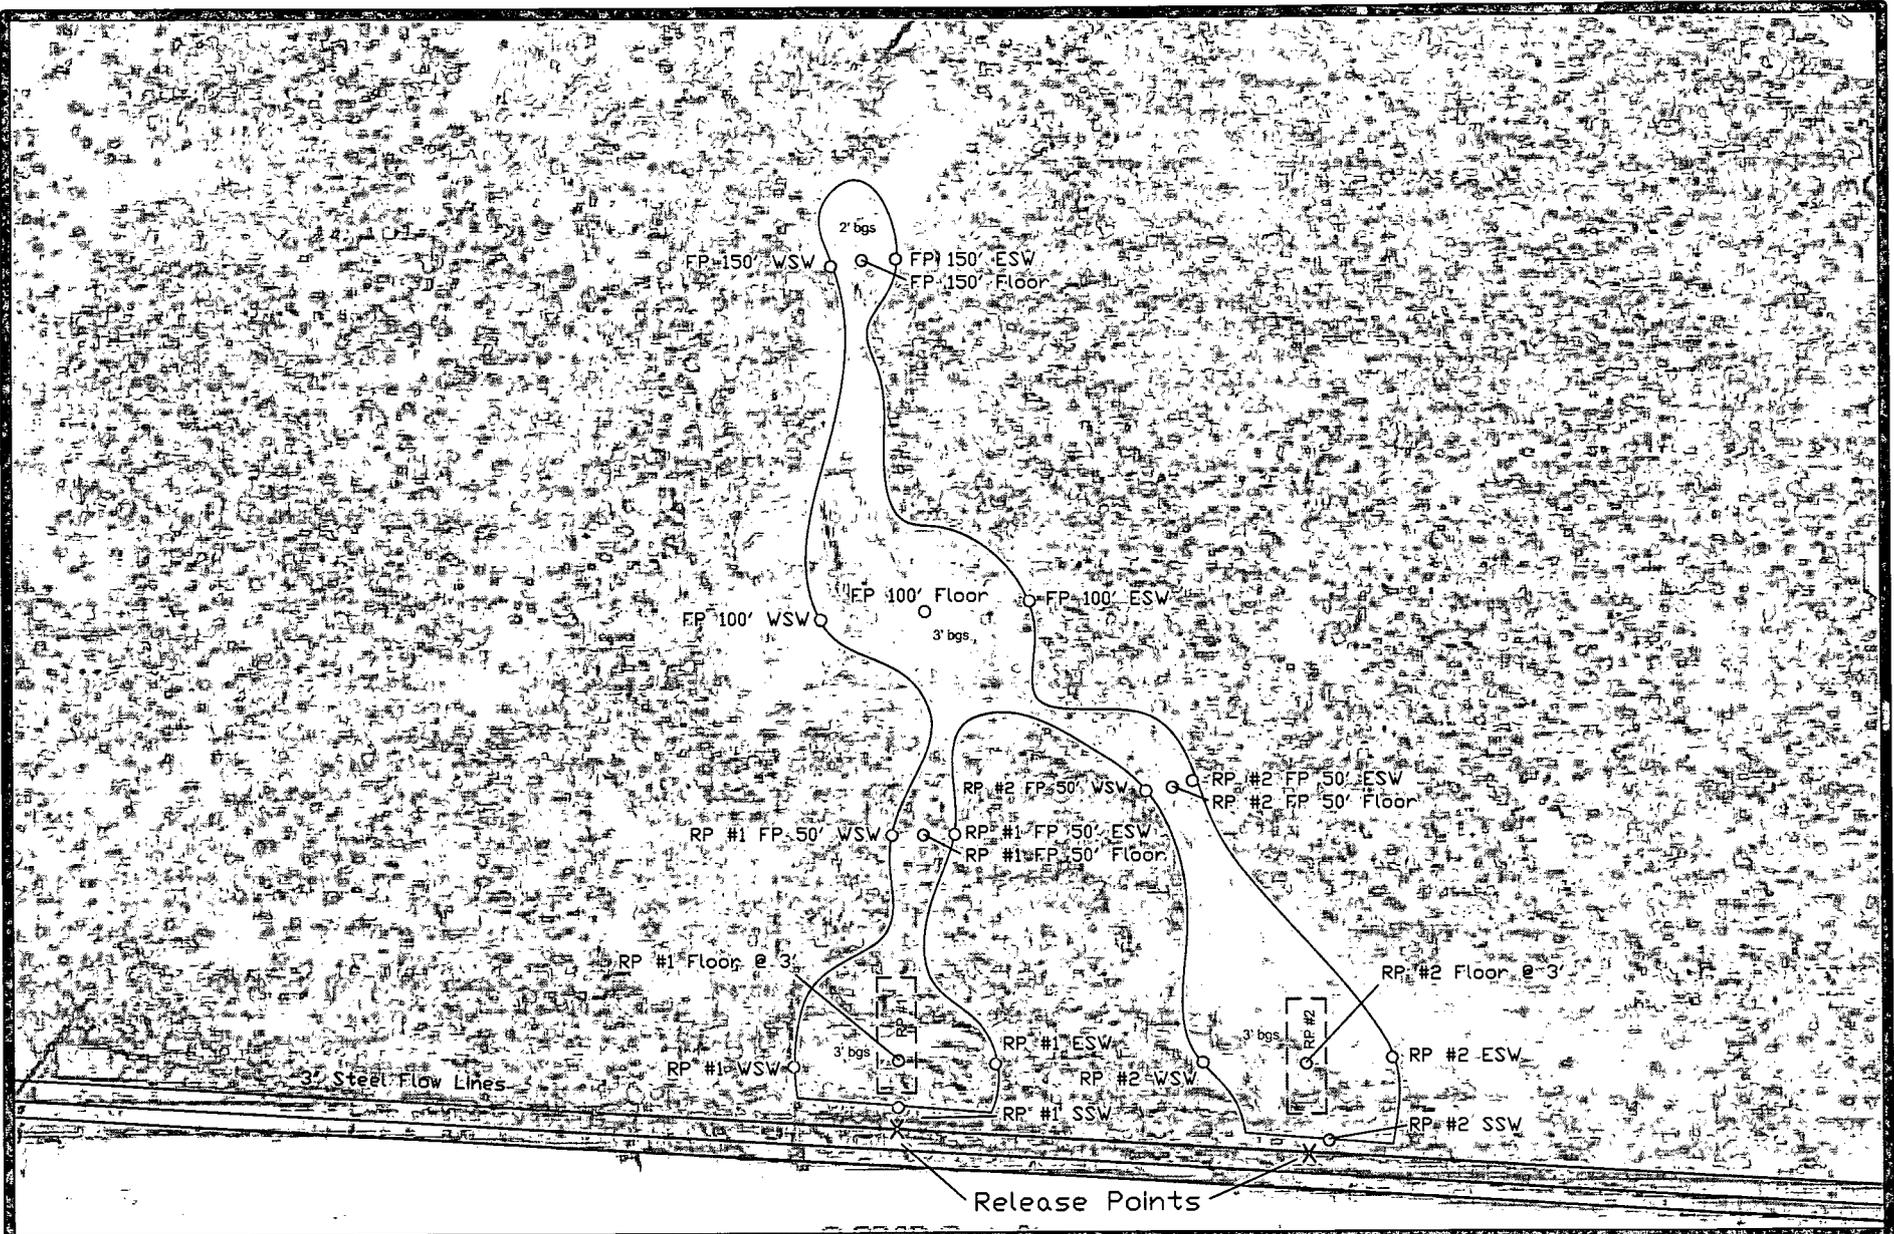
**Figure 2**  
 Site and Sample Location Map  
 BOPCO, LP  
 Poker Lake Unit #145 Flow Line  
 Eddy County, New Mexico

Delineation trench RP #2 Floor was advanced adjacent to the eastern-most release point. During the advancement of the delineation trench, two (2) soil samples (RP #2 Floor @ 3' and RP #2 Floor @ 5') were collected and submitted to the laboratory for analysis of chloride concentrations. Laboratory analytical results indicate chloride concentrations ranged from 944 ppm for soil sample RP #2 Floor @ 3' to 912 ppm for soil sample RP #2 Floor @ 5'. Soil sample RP #2 Floor @ 5' was also analyzed for concentrations of BTEX and TPH. Laboratory analytical results indicated BTEX and TPH concentrations were less than the appropriate laboratory MDL. A "Site and Sample Location Map" is provided as Figure 2.

○	Sample Location	—	Pipeline
---	Excavation Extent	- - -	3' bgs Grade
□	Test Trench

On November 7, 2013, excavation of impacted soil commenced at the release site. The floor of the excavation was advanced to approximately threefeet (3') bgs, and sidewalls of the excavation were advanced until field tests suggested concentrations of BTEX, TPH and chloride were less than NMOCD Regulatory Standards. Excavated soil was stockpiled on-site atop an impermeable liner, pending final disposition.

On November 8, 2013, six (6) soil samples (RP#1 SSW, RP#1 ESW, RP#1 WSW, RP#2 SSW, RP#2 ESW and RP#2 WSW) were collected from the sidewalls of the excavation and submitted to the laboratory for analysis of chloride concentrations. Laboratory analytical results indicated chloride concentrations ranged from 640 ppm for soil sample RP #1 ESW to 64.0 ppm for soil sample RP #1 WSW. Chloride concentrations were below NMOCD Regulatory Standards in each of the submitted soil samples. The excavation was advanced to the north.

On November 11, 2013, ten (10) soil samples (RP #1 FP 50' WSW, RP #1 FP 50' ESW, RP #1 FP 50' Floor, RP #2 FP 50' WSW, RP #2 FP 50' ESW, RP #2 FP 50' Floor, FP 150' WSW, FP 150' ESW, FP 150' Floor and FP 100' ESW) were collected from the floor and sidewalls of the excavation and submitted to the laboratory for analysis of chloride concentrations. Laboratory analytical results indicated chloride concentrations ranged from 512 ppm for soil sample RP #1 FP 50' ESW to <16.0 ppm for soil sample RP #1 FP 50' WSW. Soil samples RP #1 FP 50' Floor, RP #2 FP 50' Floor and FP 150' Floor were also analyzed for concentrations of BTEX and TPH, which were determined to be less than the appropriate laboratory MDL in each of the submitted soil samples. BTEX, TPH and chloride concentrations were below NMOCD Regulatory Standards in each of the submitted soil samples.

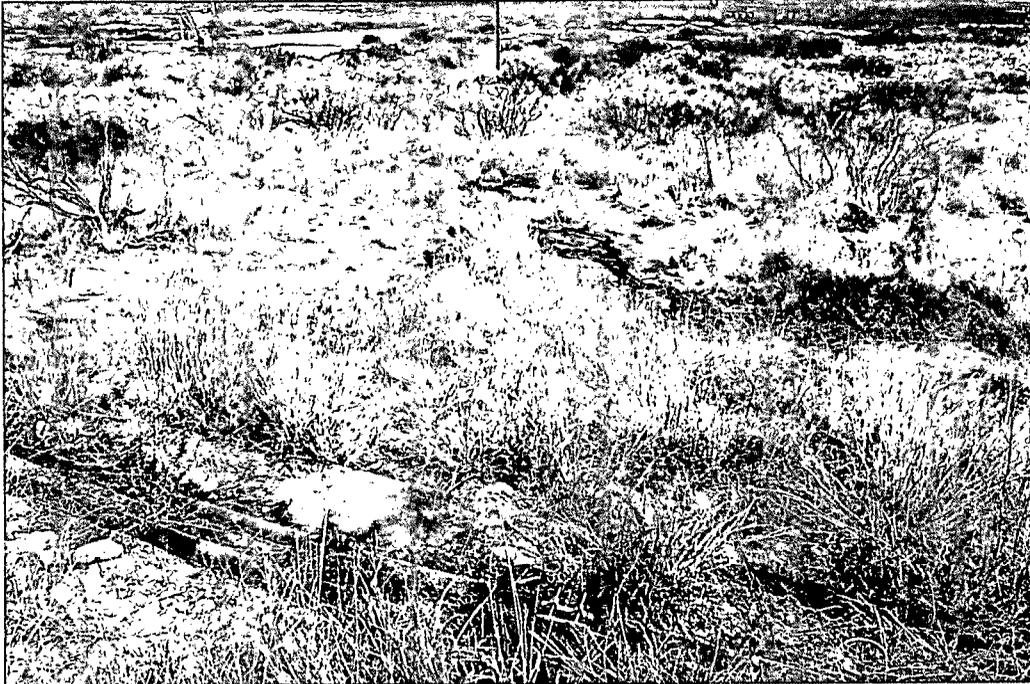
On June 7, 2011, BOPCO discovered a release had occurred on the Poker Lake Unit #145 Flow Line. Failure of a two and seven-eighths-inch (2 7/8") flow line resulted in a release of produced water and crude oil. The failure was attributed to external corrosion. During initial response activities, a repair clamp was placed on the affected area of the pipe to mitigate the release. The release was reported to the New Mexico Oil Conservation Division (NMOCD) Artesia District Office on June 7, 2011. The "Release Notification and Corrective Action" (Form C-141) indicated approximately ten barrels (10 bbls) of produced water and less than one barrel (1 bbl) of crude oil were released, with no recovery. The Form C-141 is provided as Appendix A.

The release occurred adjacent to a lease road on land owned by the NMSLO and impacted an area of pasture land measuring approximately two hundred feet (200') in length and two feet (2') in width. The flow path of the release terminated in an area of land owned by the BLM that had been impacted by several historic produced water releases. Since the area affected by the June 7, 2011, release is indistinguishable from that affected by the historic releases, the releases were remediated simultaneously. The total impacted area measures approximately twelve hundred square feet (1,200 ft<sup>2</sup>). General photographs of the release site are provided as Appendix B.

Photograph of the initial release at the PLU #145 Release Site. (Looking Northwest)

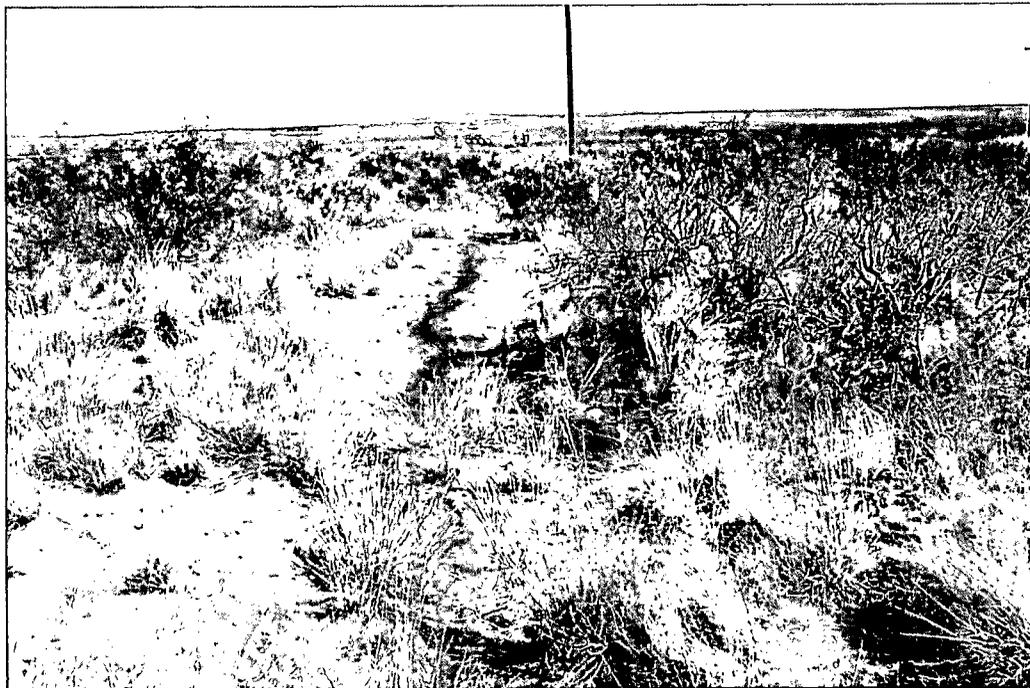
Photograph of the initial release and narrow flowpath at the PLU #145 Release Site. (Looking Northwest)

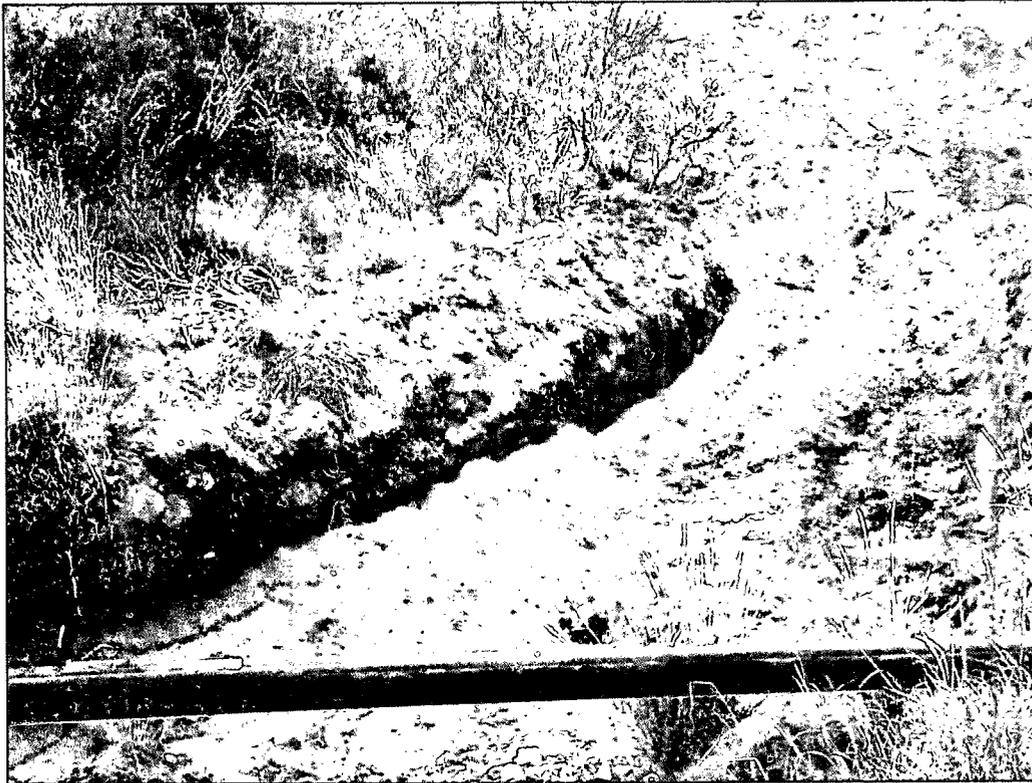
Photograph of excavation and sample locations at release point RP #1. (Looking Northwest)

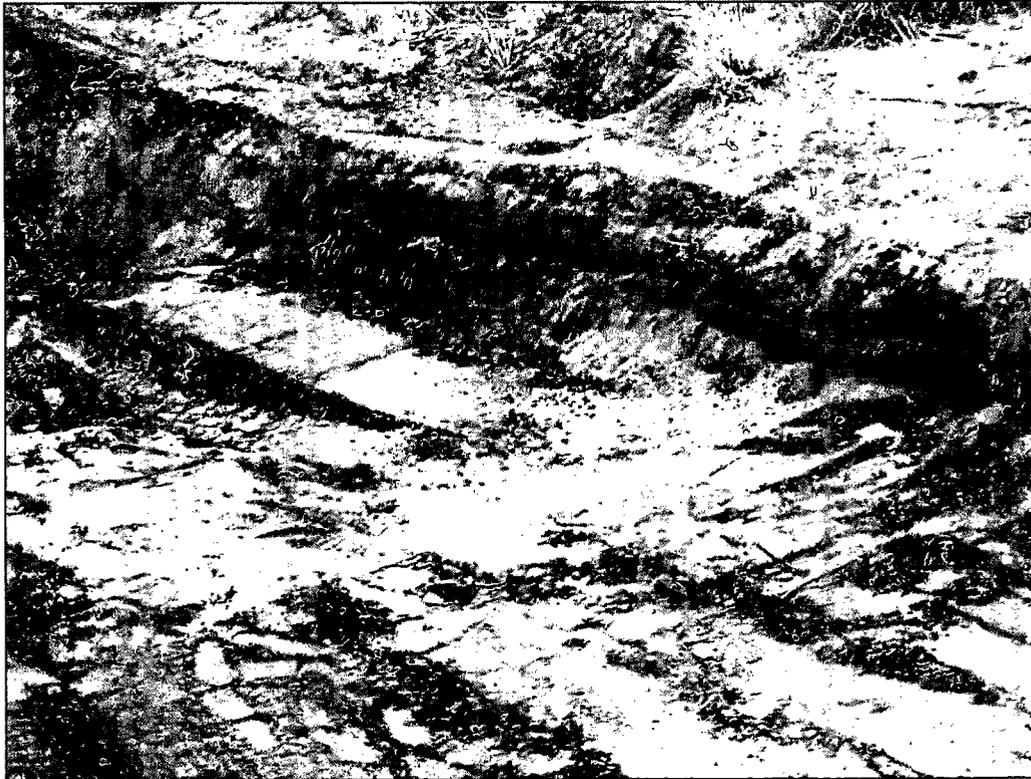
Photograph of excavation and sample at Release Point RP #2. (Looking Northeast)

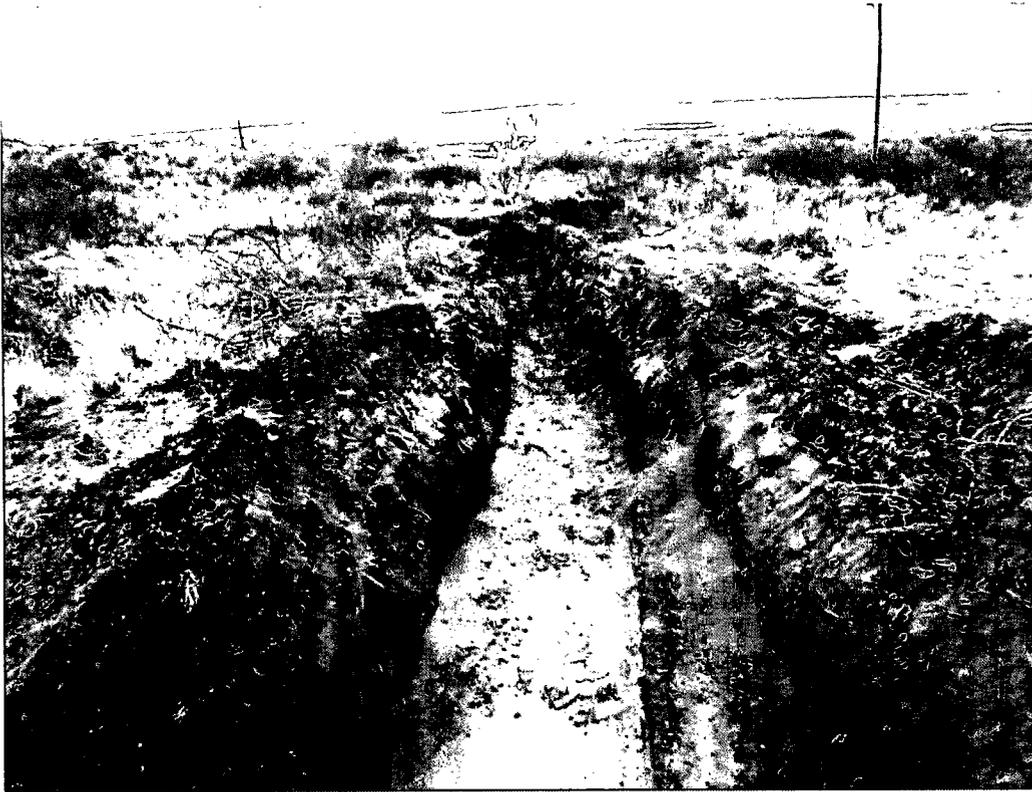
Photograph of sample locations and excavated RP#2 Flowpath area. (Looking North)

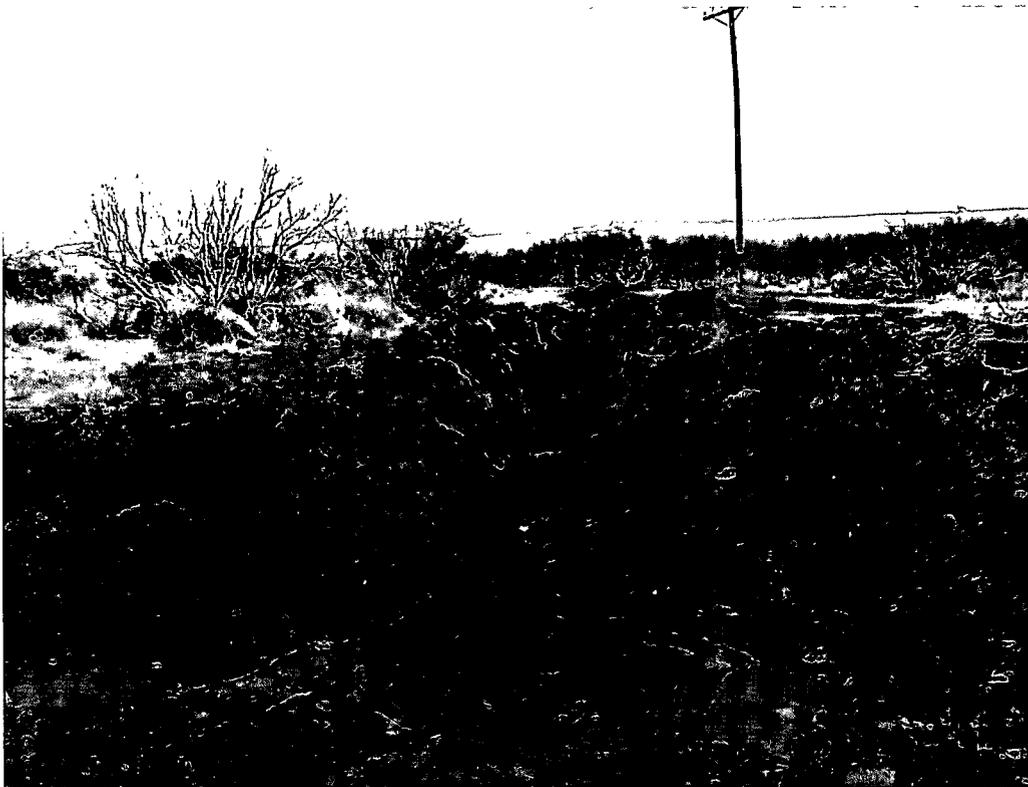
Photograph of excavation and sample locations at convergence of RP#1 and RP#2 Flow Paths.

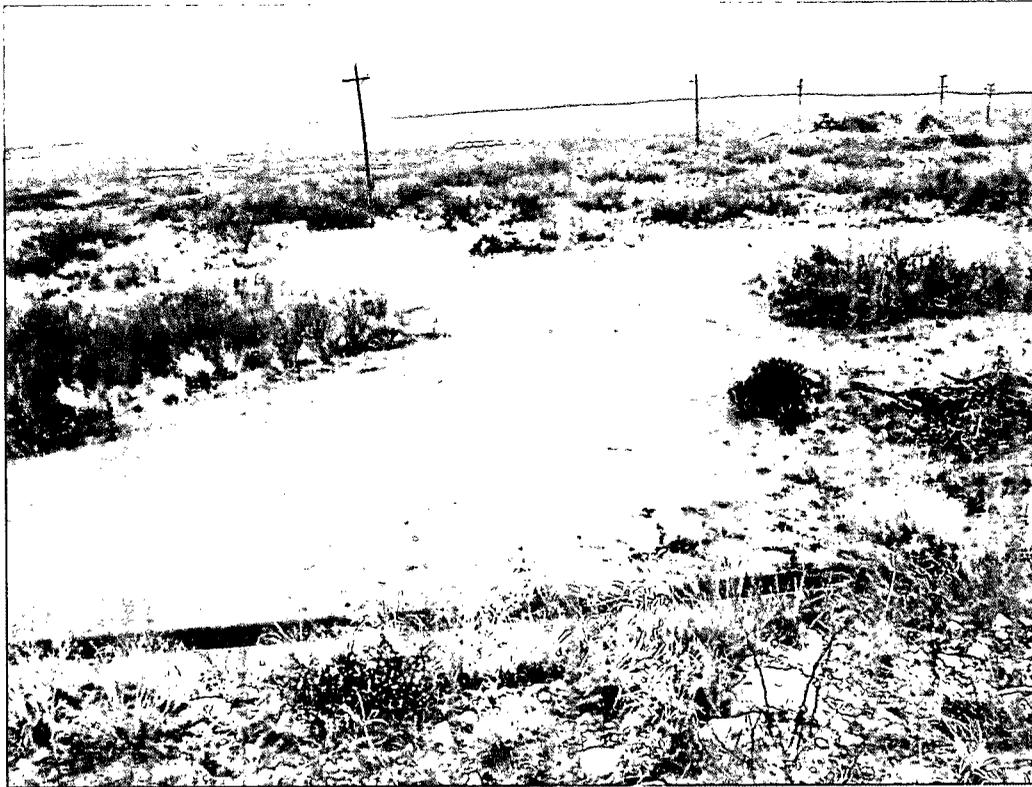
Photograph of western portion of the release site after remediation activities.

Between November 11 and 14, 2013, approximately two hundred and sixty cubic yards (260 yd<sup>3</sup>) of impacted material was transported to Lea Land, LLC (NMOCD Permit #WM-01-035) for disposal. The final dimensions of the excavation were approximately three (3) to fifteen feet (15') in width, one hundred and fifty feet (150') in length and two (2) to three feet (3') in depth. Upon receiving laboratory analytical data from confirmation soil samples, the excavated area was backfilled with a mixture of river rock and sand in an effort to mitigate erosion. Following backfilling, areas affected by the remediation activities were contoured to fit the surrounding topography. The site will be reseeded at a time conducive to germination.

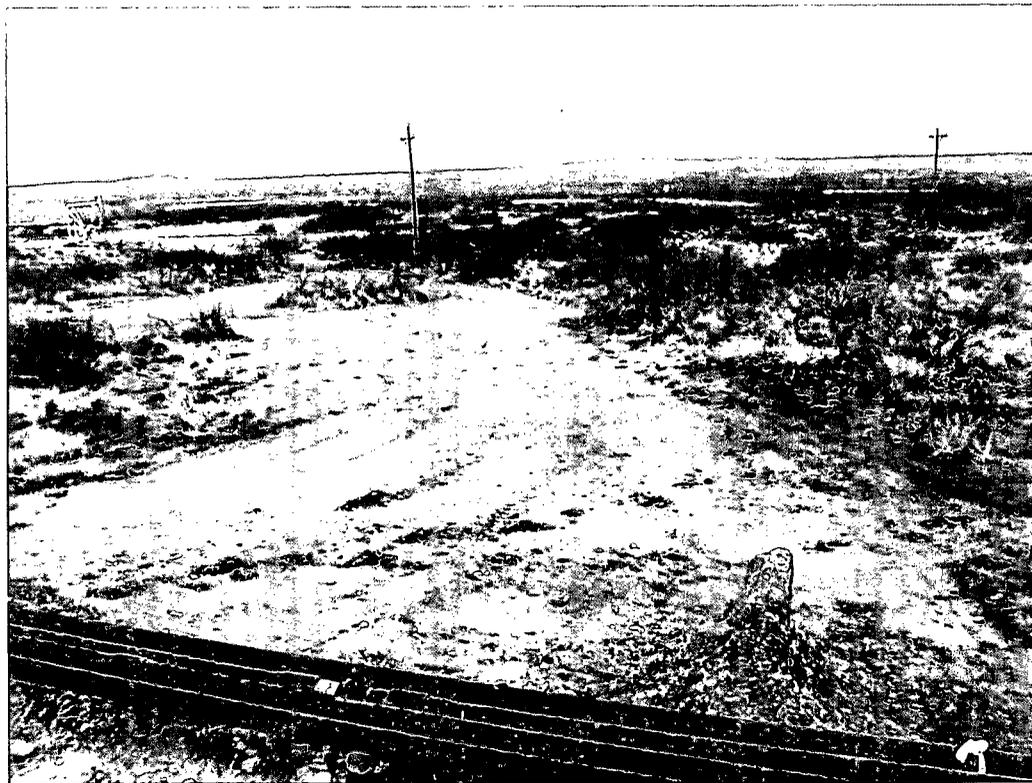
Photograph of eastern portion of the release site after remediation activities.
