REMEDIATION SUMMARY AND RISK-BASED SITE CLOSURE REQUEST

BOPCO, LP
POKER LAKE UNIT #261/78 10" Mainline 10-29-13
Eddy County, New Mexico
Unit Letter "H" (SE/NE), Section 19, Township 24 South, Range 30 East
Latitude 32.205853° North, Longitude 103.913044° West
NMOCD Reference #2RP- 2041

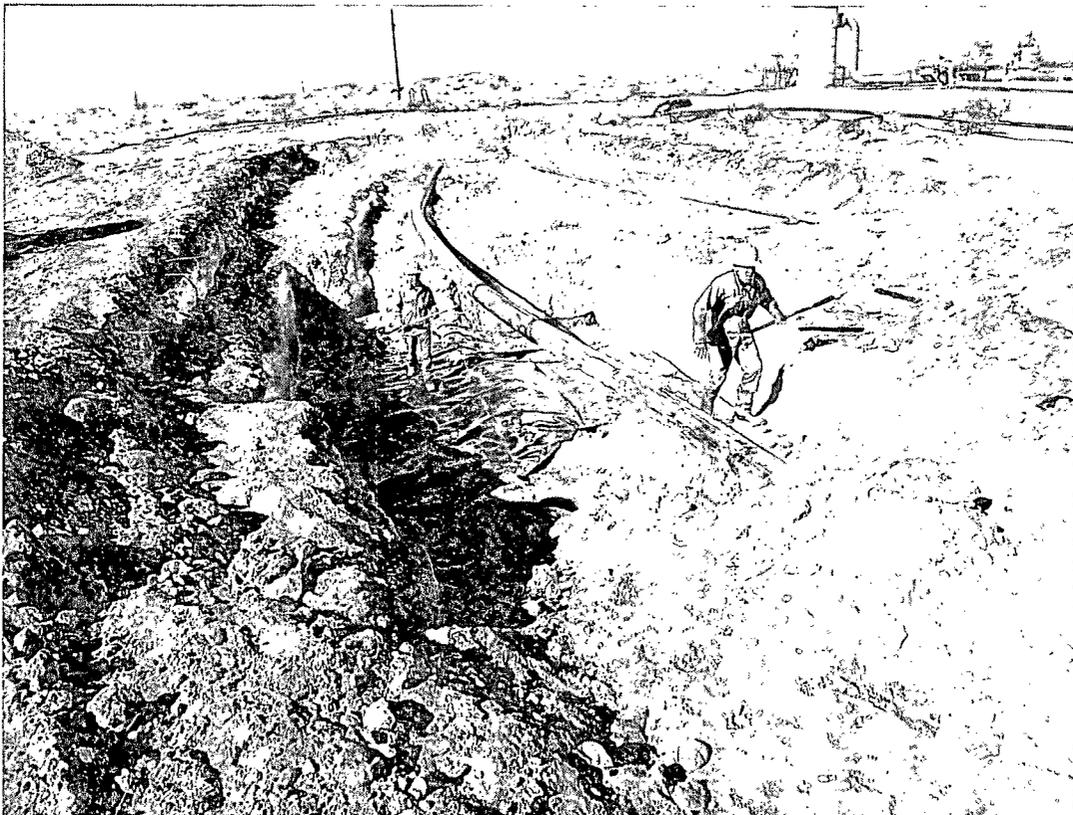
Photograph of the liner installation at the PLU #261/78 10" Mainline Release Site.

On November 21, 2013, upon receiving NMOCD and BLM approval, a 20-mil polyurethane liner was installed in the floor of the excavation at approximately seven feet (7') bgs in the area

defined by RP Trench. A one-foot (1') layer of non-impacted pad sand was installed both above and below the liner to maintain its integrity during installation and backfilling activities. This engineering control is designed to inhibit the vertical migration of contaminants left in-situ.

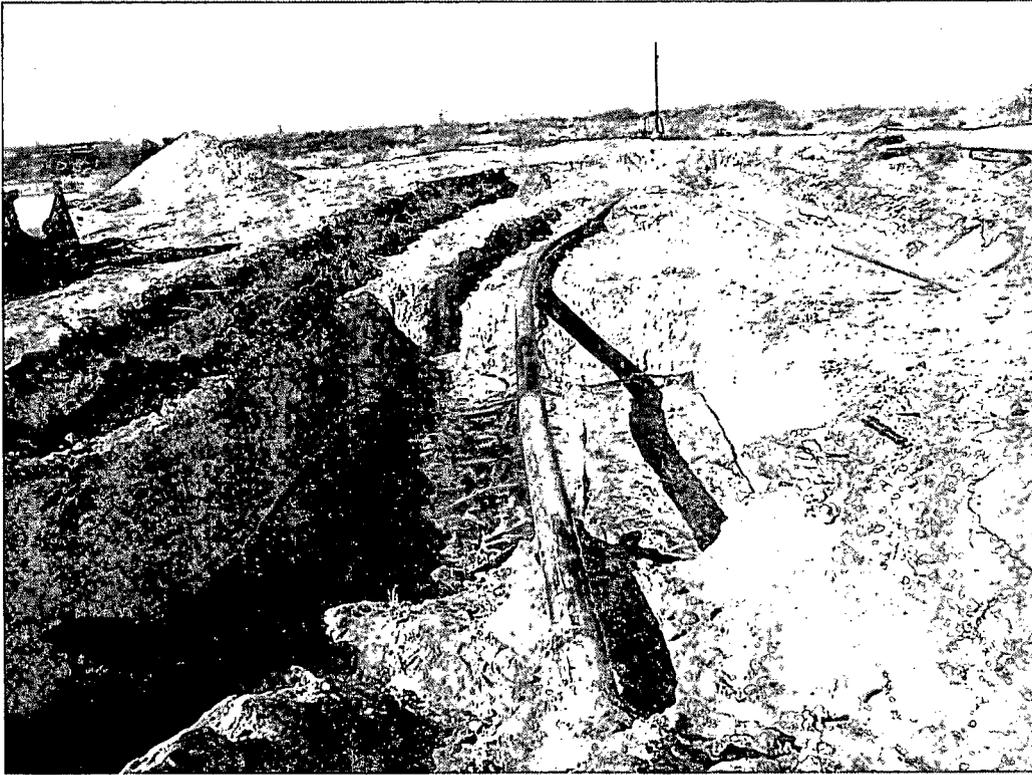
Photograph of the liner installation in the eastern portion of the excavation at the PLU #261/78 10" Mainline Release Site.
