Report Type: Closure Report

Site:	Resposado 2 State #2H				
Company:	COG Operating				
Section, Township and Range	Unit A	Section 2	T26S	R29E	
Lease Number:	API-30-015-39455				
County:	Eddy County				
GPS:	32.07818° N			103.95021° W	
Surface Owner:	State				
Mineral Owner:					
Directions:	South of Malaga, at the intersection of Hwy 285 and CR 725 (Longhorn Rd). Travel east on CR 725 (Longhorn Rd) for 4.3 miles, turn left and travel 2.7 miles, turn left and travel 1.1 miles to the site on right side of road.

Re: Closure Report for the COG Operating LLC., Resposado 2 State #2H, Well Site, Unit A, Section 2, Township 26 South, Range 29 East, Eddy County, New Mexico.

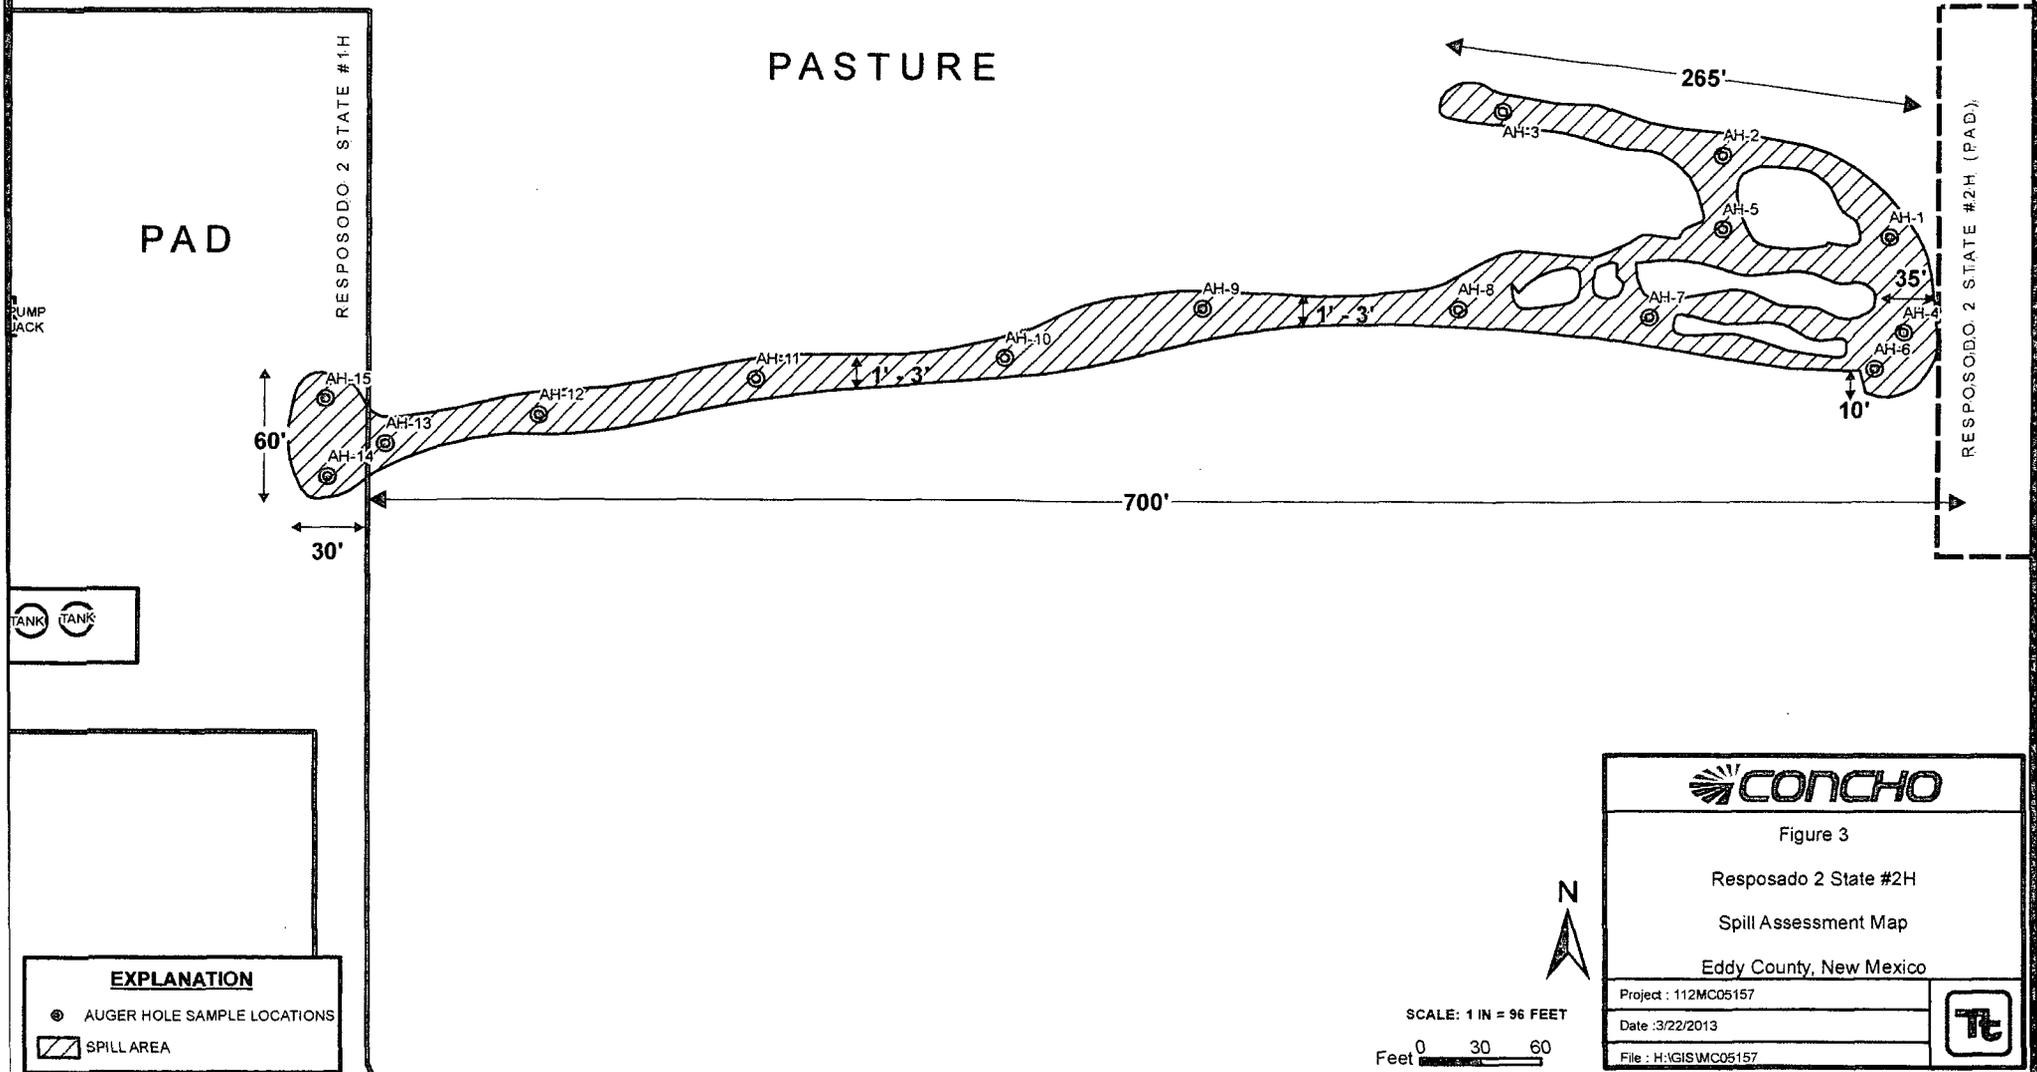
Figure 3

On March 13, 2013, Tetra Tech personnel inspected and sampled the spill area. A total of fifteen (15) auger holes (AH-1 through AH-15) were installed using a stainless steel hand auger to assess the impacted soils. Selected samples were analyzed for TPH analysis by EPA method 8015 modified, BTEX by EPA Method 8021B and chloride by EPA method 300.0. Copies of laboratory analysis and chain-of-custody documentation are included in Appendix C. The sampling results are summarized in Table 1. The auger hole locations are shown on Figure 3.

Referring to Table 1, none of the samples exceeded the RRAL for TPH and BTEX. The areas of auger holes (AH-7, AH-9, AH-10, AH-11, AH-12, AH-14 and AH-15), the chlorides concentrations did not show a significant impact to the subsurface soil and do not appear to an environmental concern. The remaining areas showed a shallow chloride impact to the soils. Auger holes (AH-1, AH-2, AH-3, AH-6 and AH-8) showed chloride concentrations ranging from 1,060 to 1,900 mg/kg at 0-1' and significantly declined with depth at 1-1.5' below surface. In the areas of AH-4, AH-5 and AH-13, the chloride impacted soils were not vertically defined, with concentrations of 1,220 mg/kg, 1,490 mg/kg and 1,690 mg/kg, respectively.

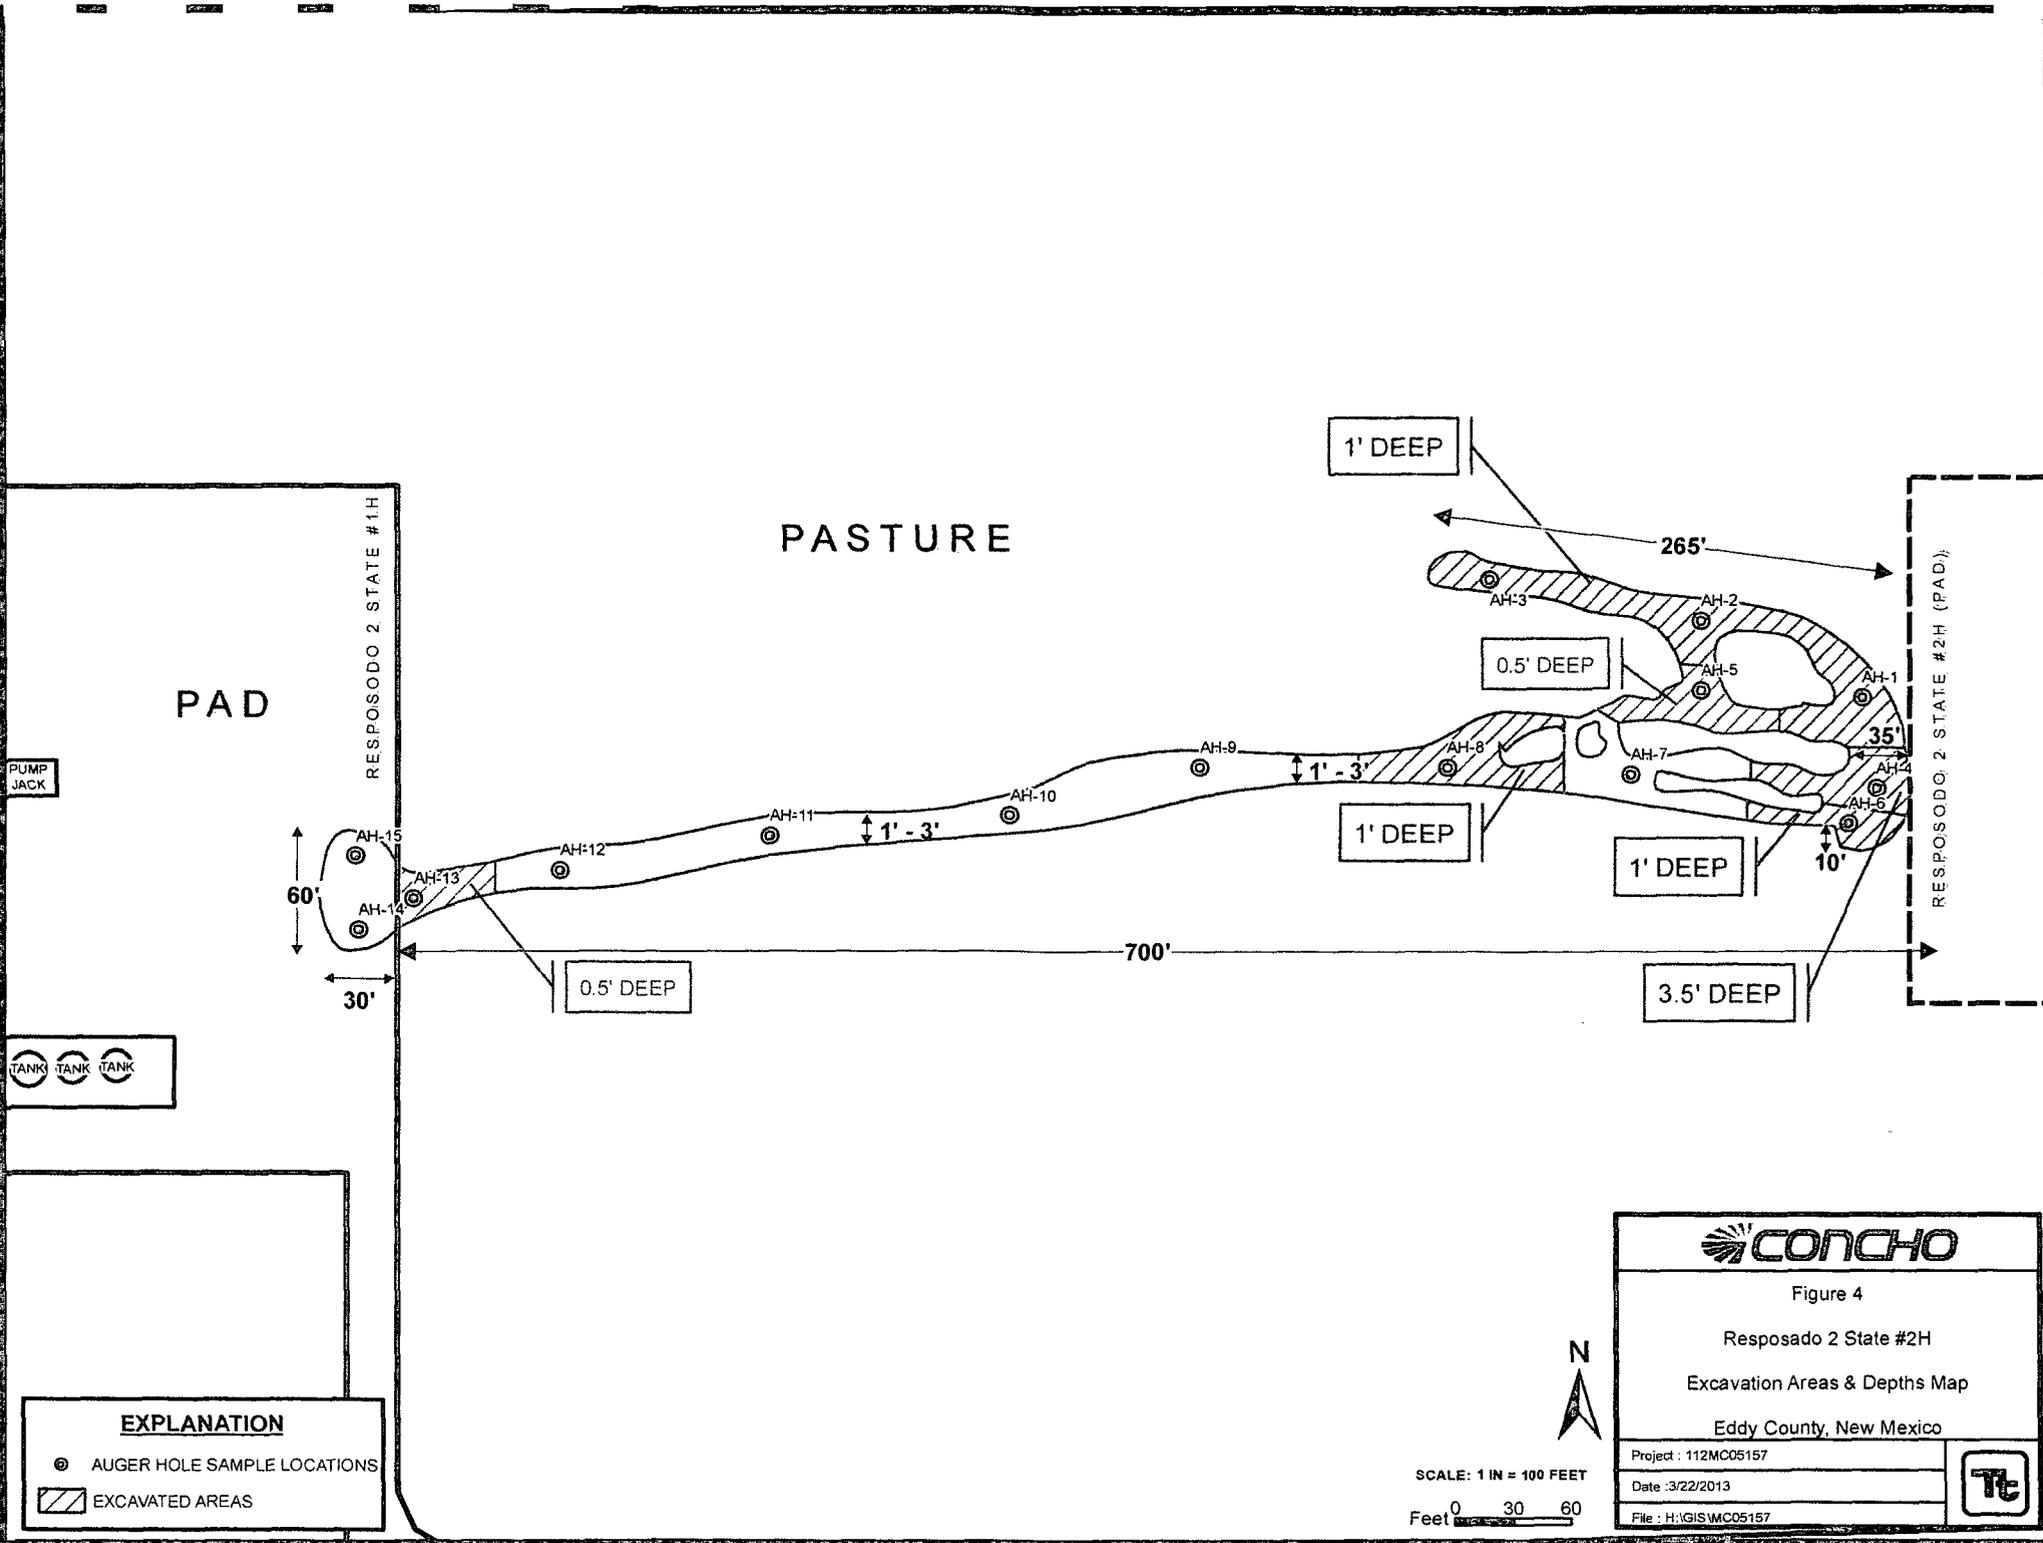
Figure 4

Tetra Tech supervised the removal of the impacted material as highlighted (green) in Table 1 and shown on Figure 4. The areas of AH-1, AH-2, AH-3, AH-6 and AH-8 were excavated to a depth of approximately 1.0' below surface. Tetra Tech installed backhoe trenches in the areas of AH-4, AH-5 and AH-13 in order to attempt to vertically define the chloride impact. Based on the field data, these areas were excavated to the appropriate depths. The area of AH-4 showed chloride concentrations of 2,070 mg/kg and was not vertically defined due to the dense caliche formation. Due to the size and limited spill path, this does not appear to be an environmental concern.

Once the areas were excavated to the appropriate depths, the excavation was backfilled with clean soil. Approximately 440 cubic yards were removed and transported to a proper disposal.

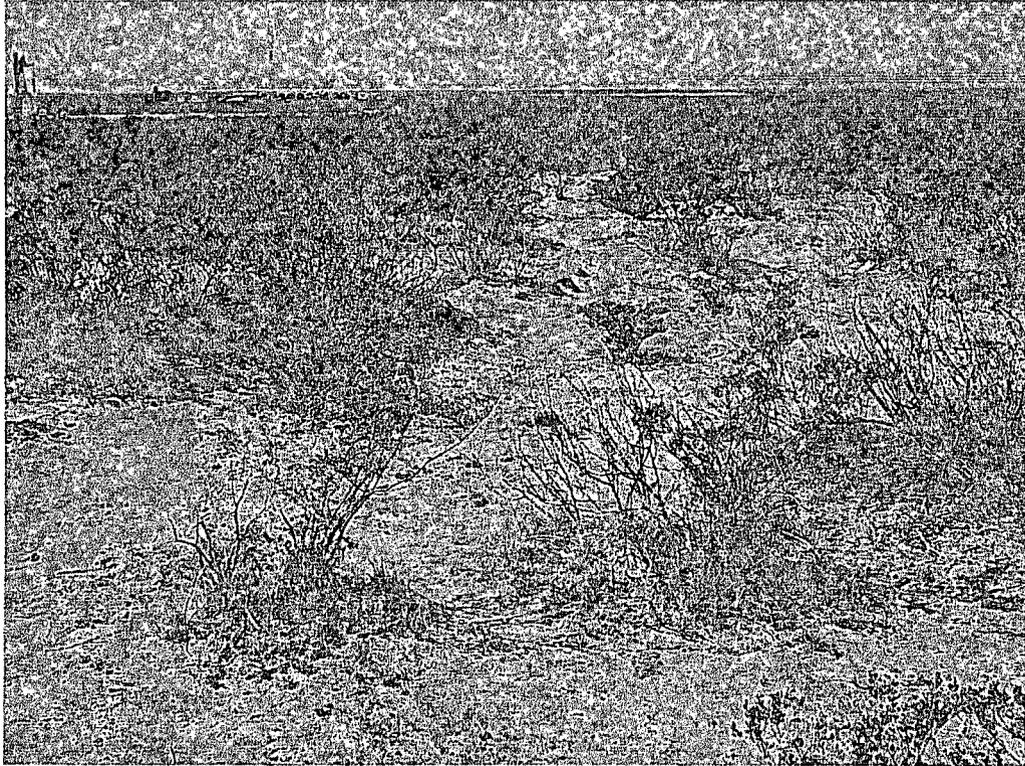
View West – Area of AH-3

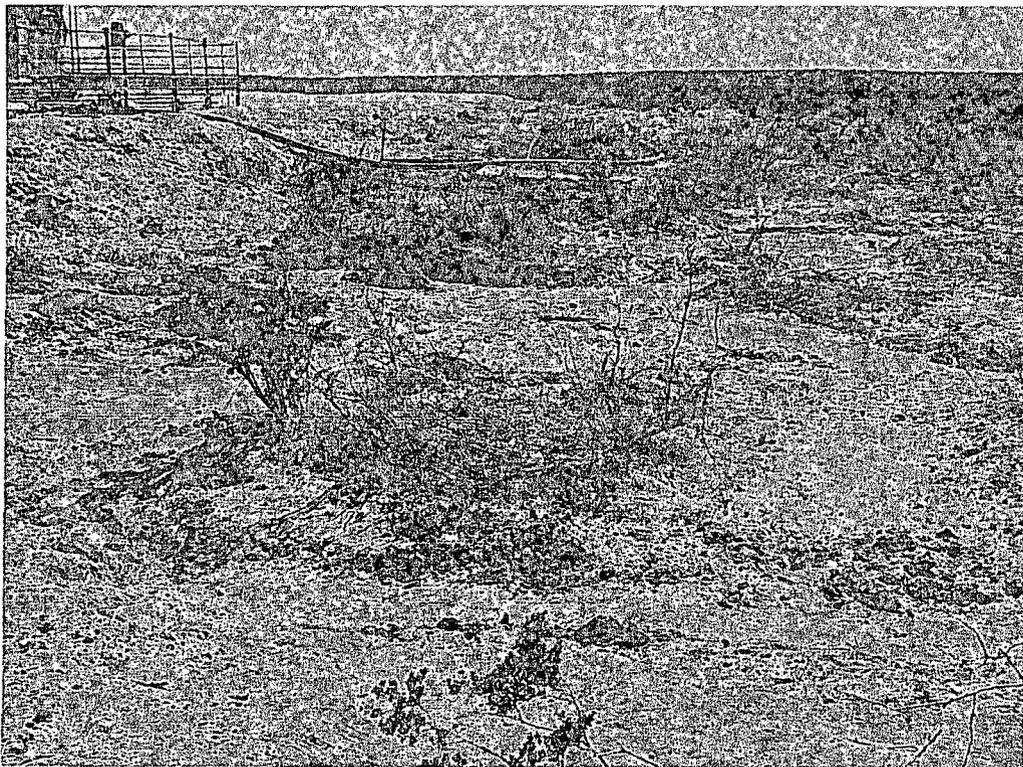
View South – Area of AH-4 and AH-6

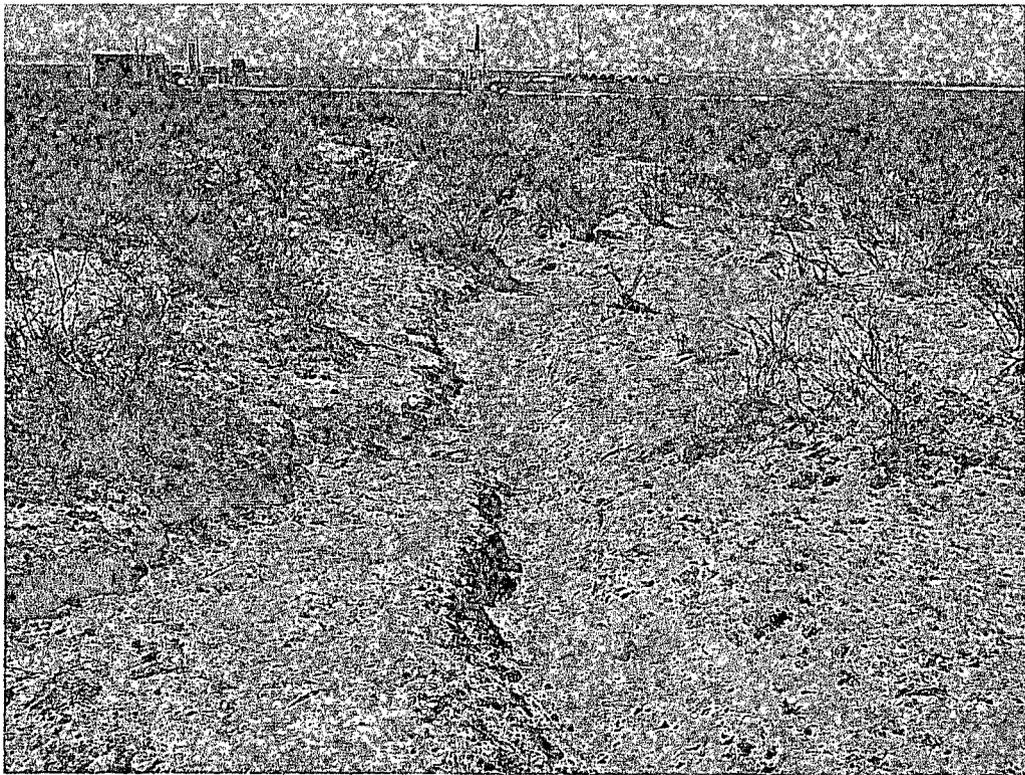
View West – Area of AH-7

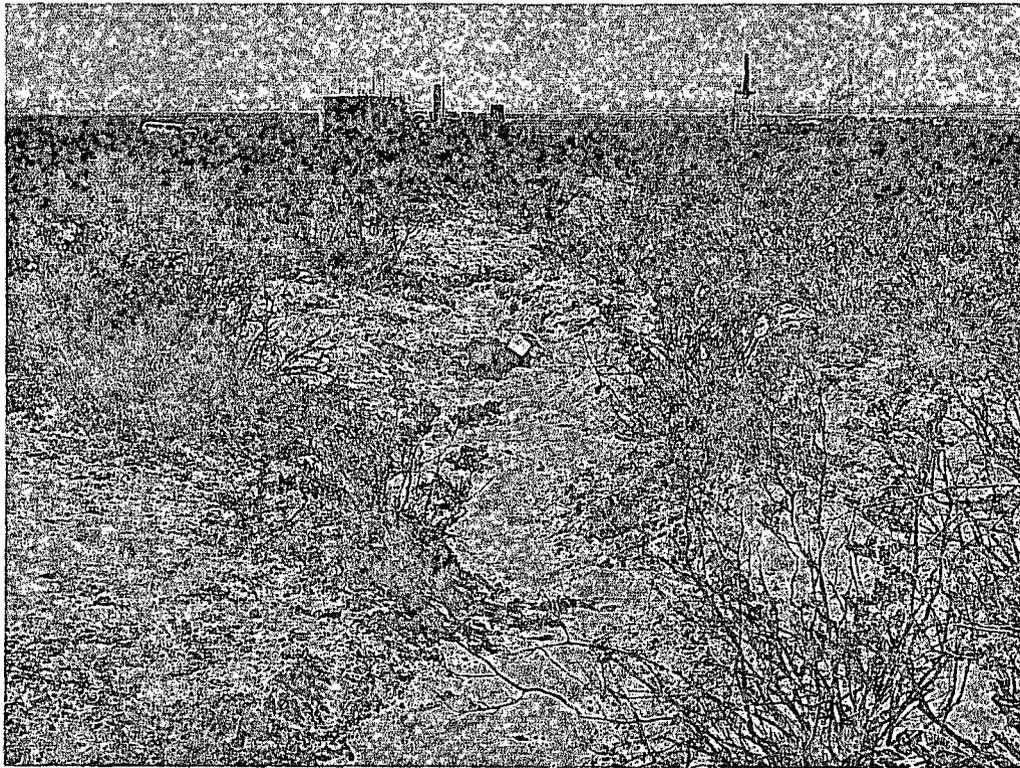
View West – Area of AH-8

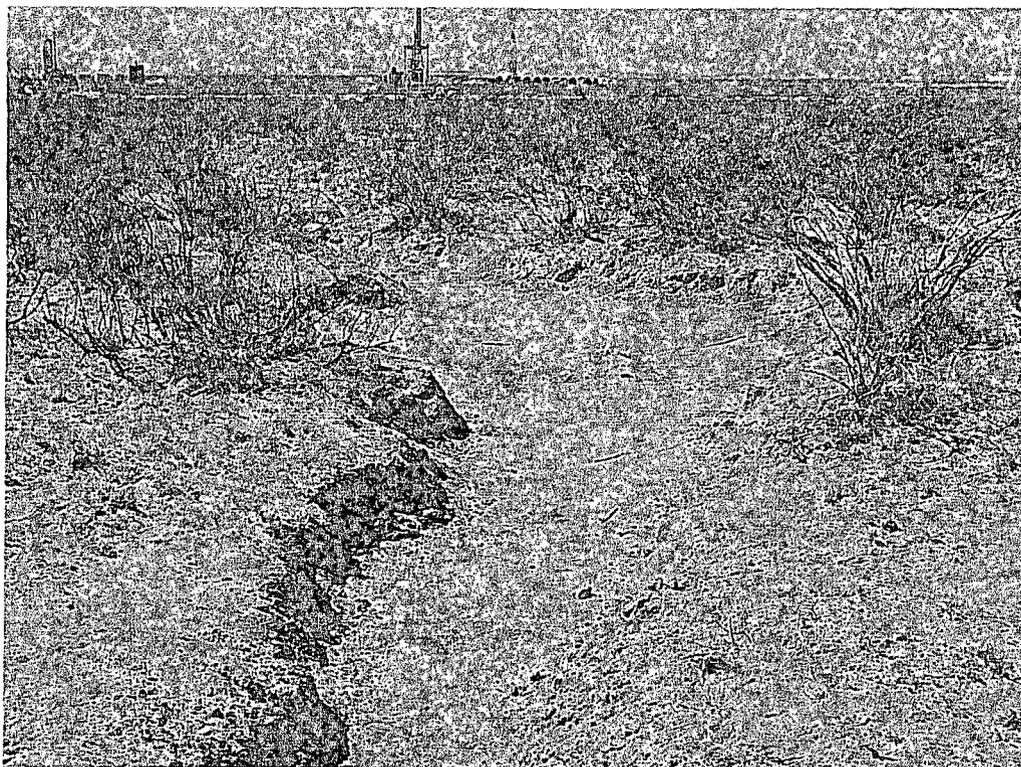
View West – Area of AH-9

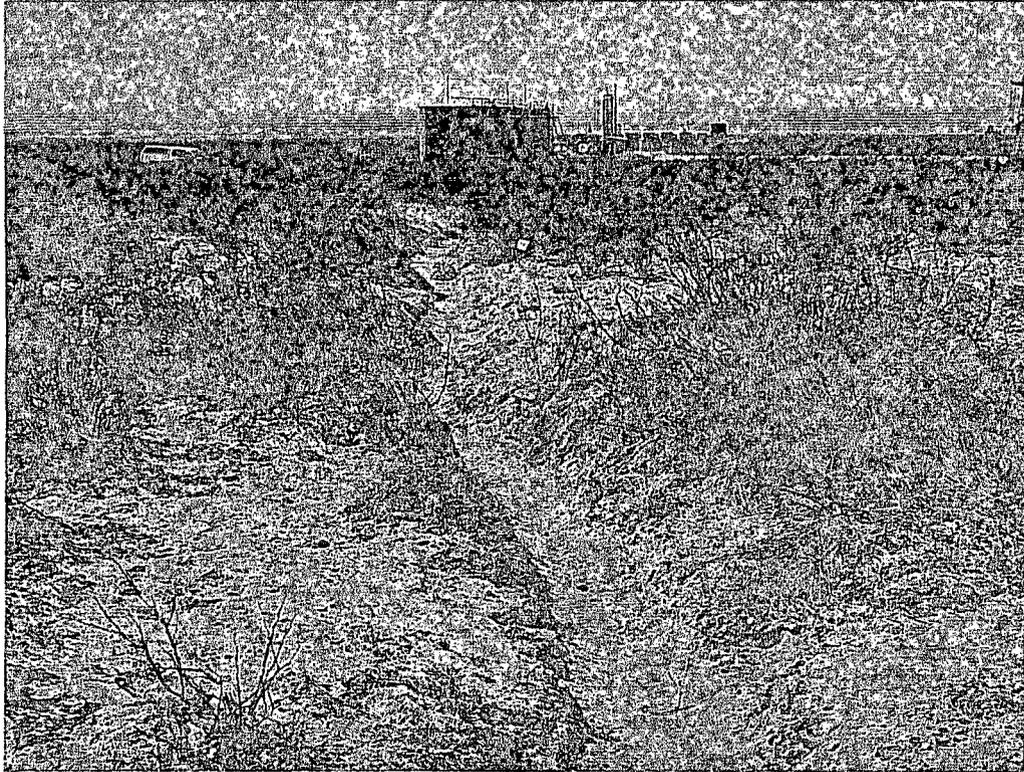
View West – Area of AH-10

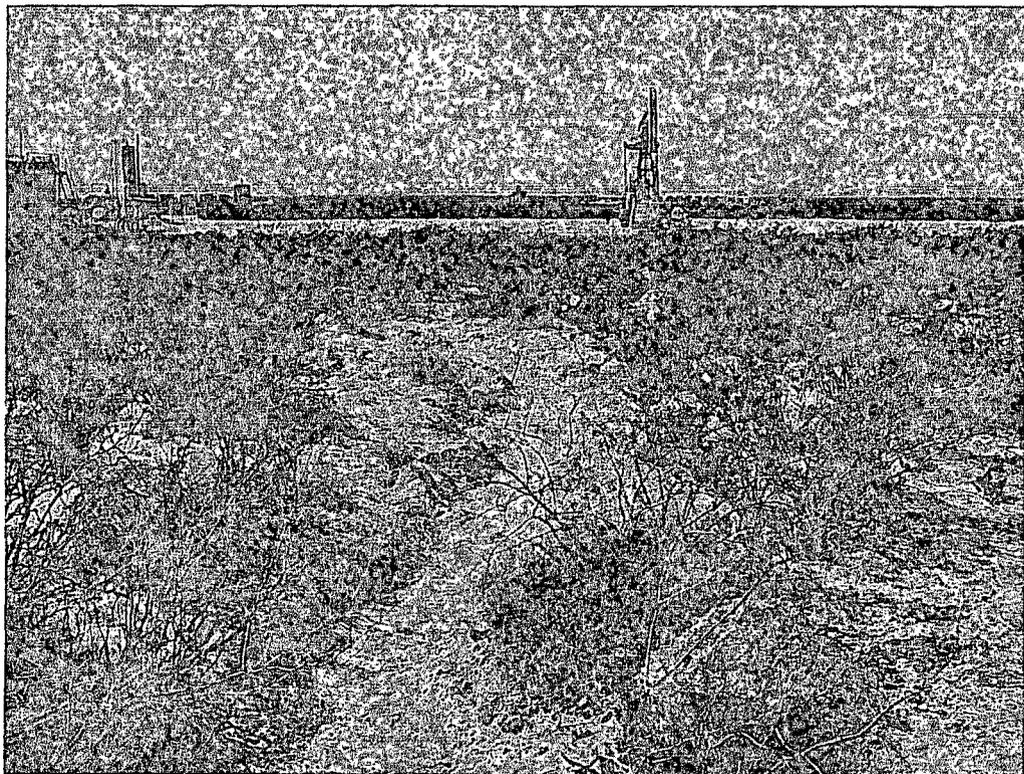
View West – Area of AH-11

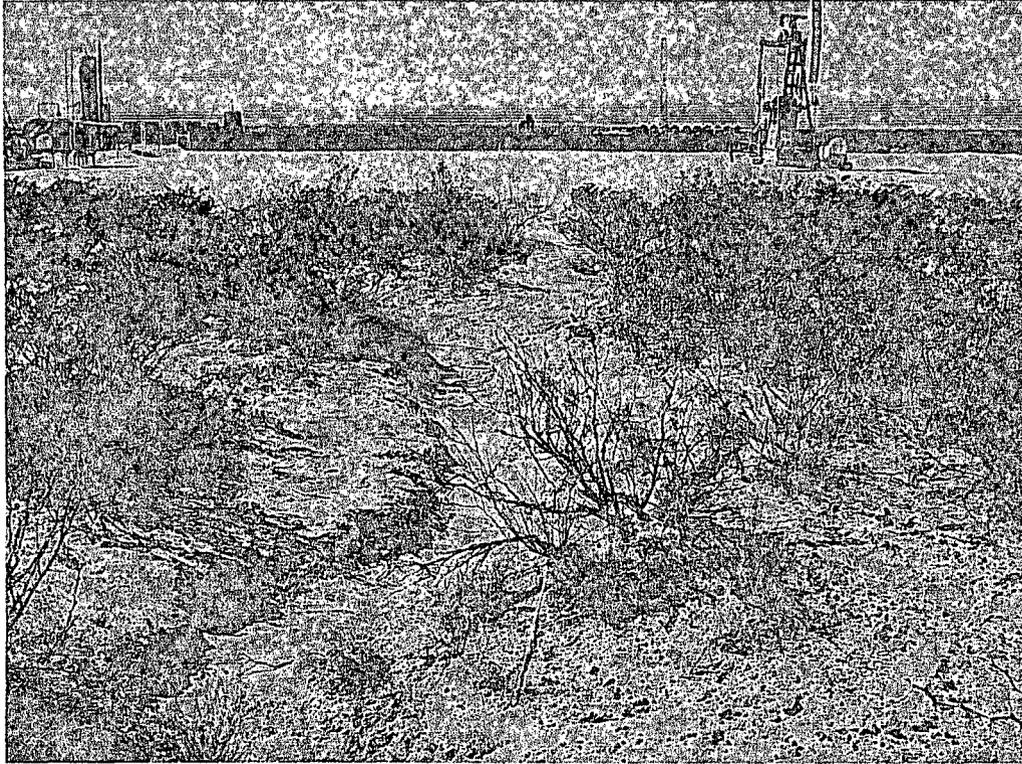
View West – Area of AH-12

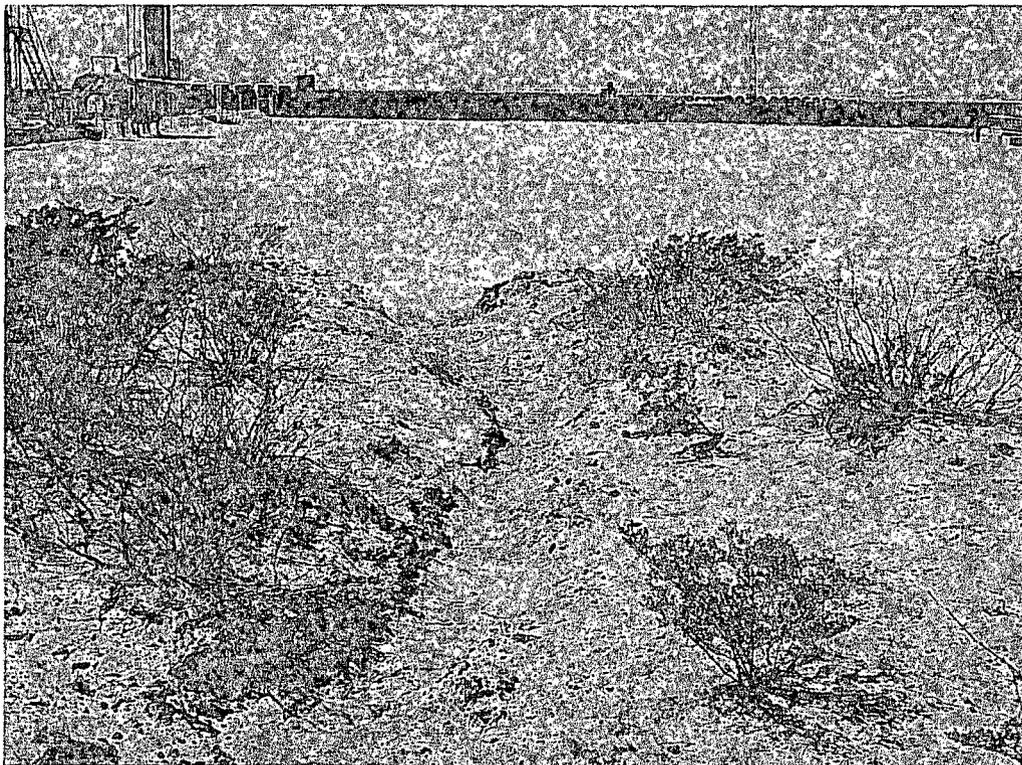
View West – Area of AH-13
