REMEDIATION SUMMARY AND SITE CLOSURE REQUEST

**BOPCO, LP
POKER LAKE UNIT #140 TANK BATTERY
Eddy County, New Mexico
Unit Letter "E" (SW/NW), Section 32, Township 23 South, Range 30 East
Latitude 32.263302° North, Longitude 103.910493° West
NMOCD Reference #s 2RP-1907 & 2RP-2072**

December 2013

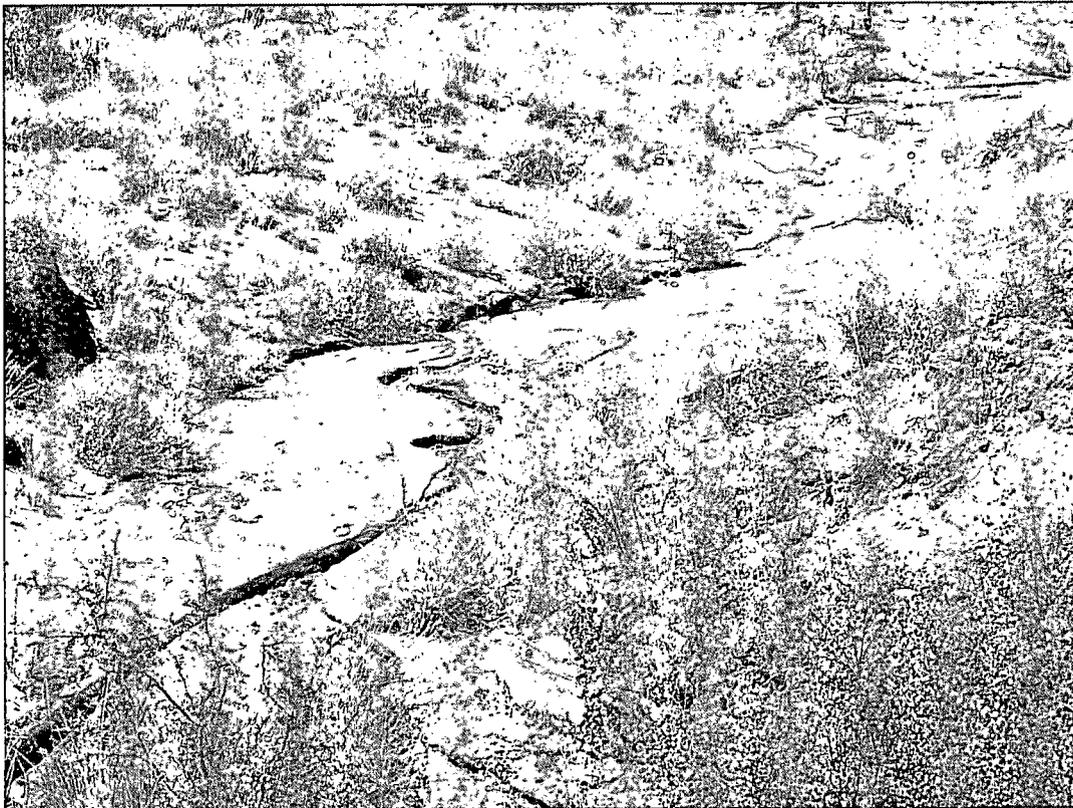
Photograph the initial release and flowpath at the PLU #140 Tank Battery Release Site.

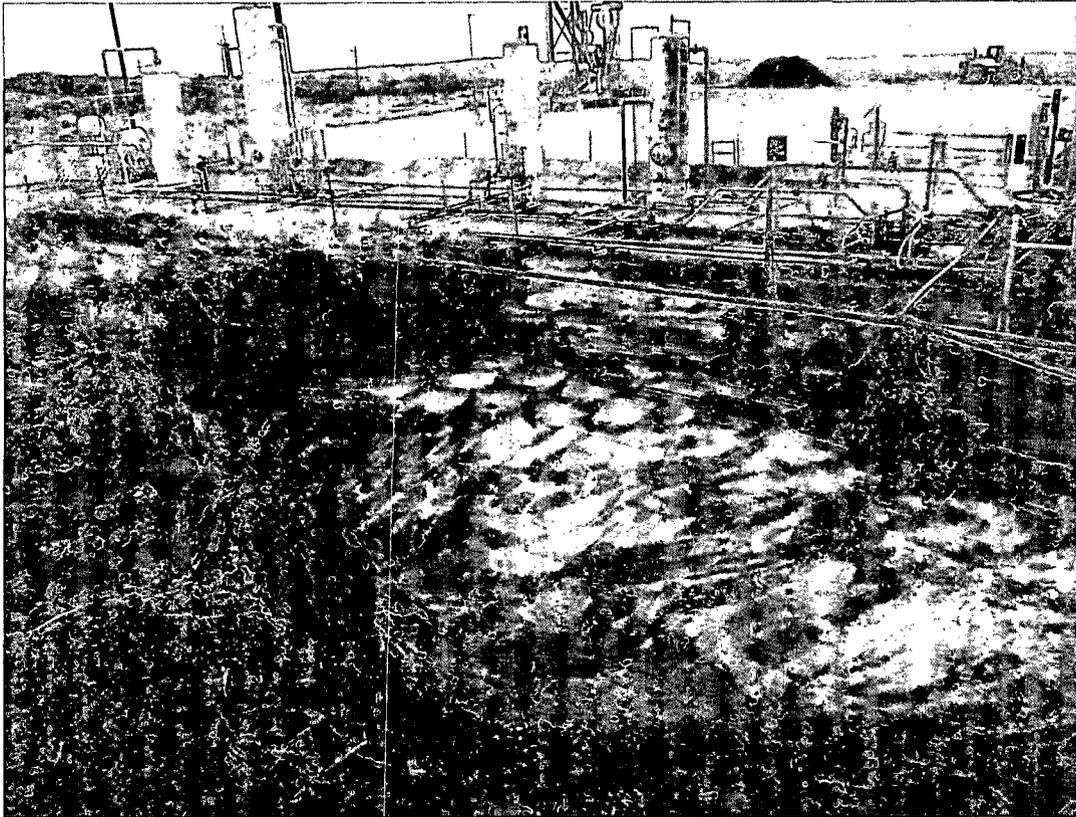
Photograph of the primary excavation southeast of the containment area at the PLU #140 Tank Battery. (Looking West)

On November 15, 2013, Basin began excavation activities at the release site. The floor and sidewalls of the excavation were advanced until field tests suggested concentrations of BTEX, TPH and chloride were less than NMOCD Regulatory Standards. Excavated material was stockpiled on-site, pending final disposition.

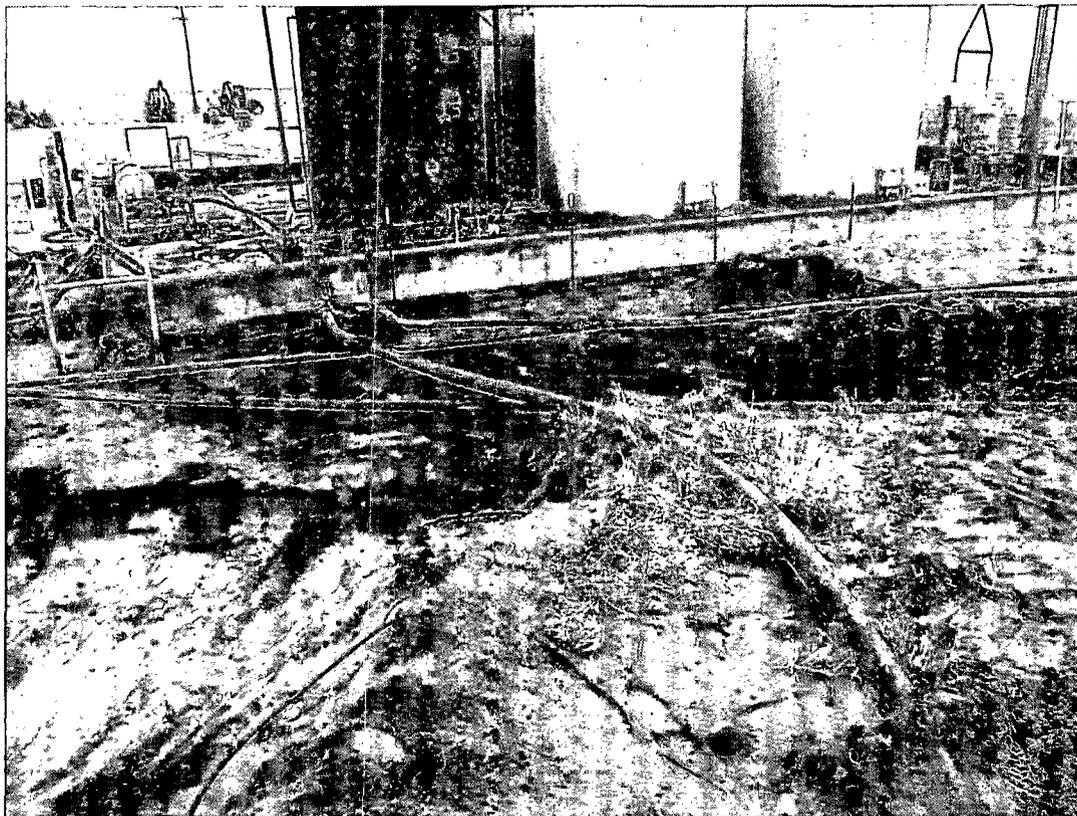
Photograph of a portion of the excavation at the PLU #140 Tank Battery. (Looking West)
