### Report Type: Closure Report

<b>General Site Information:</b>			
<b>Site:</b>	Southwest Central Tank Battery		
<b>Company:</b>	COG Operating LLC		
<b>Section, Township and Range</b>	Unit O	Sec 20	T17S R30E
<b>Lease Number:</b>	NMNM-0467932		
<b>County:</b>	Eddy County		
<b>GPS:</b>	32.8154	103.99518	
<b>Surface Owner:</b>	Federal		
<b>Mineral Owner:</b>			
<b>Directions:</b>	From Loco Hills, New Mexico, intersection of Highway 82 and Hagerman Cutoff Road, go west on Highway 82 for 0.6 miles and turn south into lease road. Go 0.1 miles and lease road will veer to the east, turn south through a well location and go 0.1 miles to location

**Re: Closure Report for the COG Operating LLC., Southwest Central Tank Battery, Unit 0, Section 20, Township 17 South, Range 30 East, Eddy County, New Mexico.**

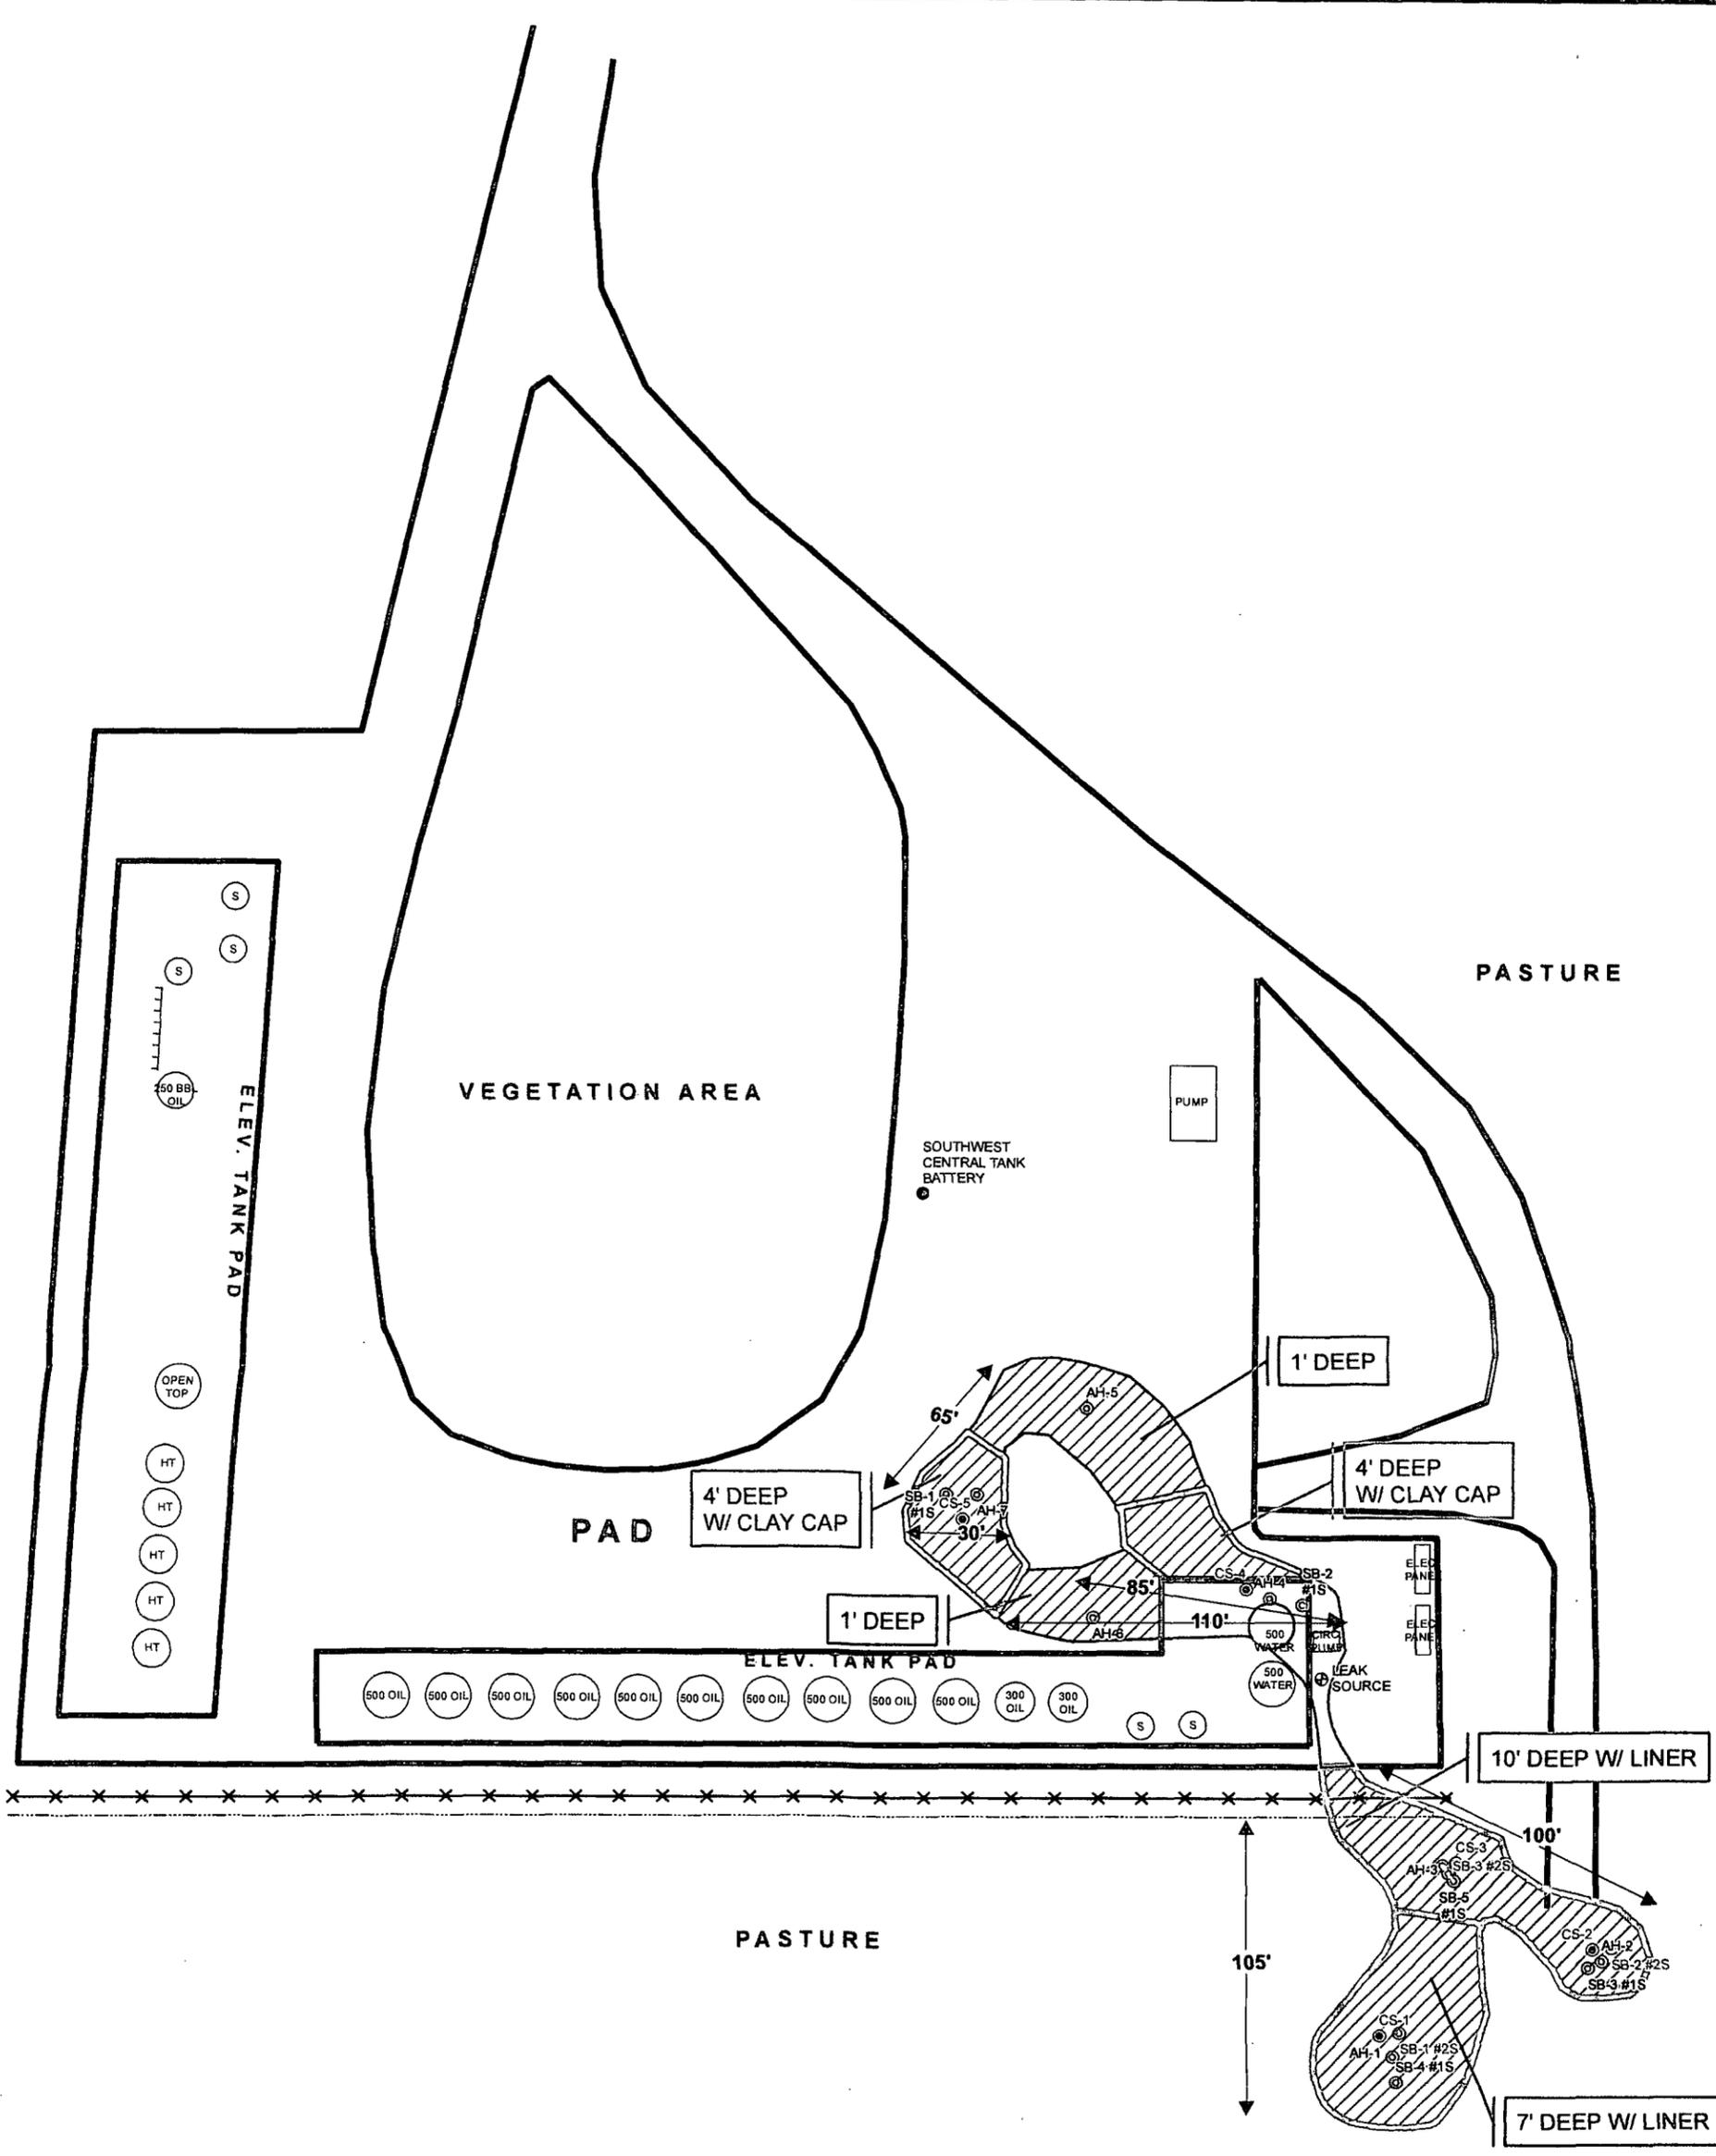
Figure 4  
Southwest Central Tank Battery  
Excavation Areas & Depths Map  
Eddy County, New Mexico

The final excavation depths of the soil remediation were met as stated in the approved work plan. The excavation depths are highlighted in Table 1 and shown on Figure 4. Once excavated to the appropriate depths, Tetra Tech collected confirmation samples from the pad and in the pasture area.

Based on the approved work plan, Tetra Tech personnel supervised the excavation of the site. For safety concerns, COG had moved two of the water tanks located along the east edge of the pad. The tanks were installed on the east side of the pad, which encompassed a portion of the spill area.

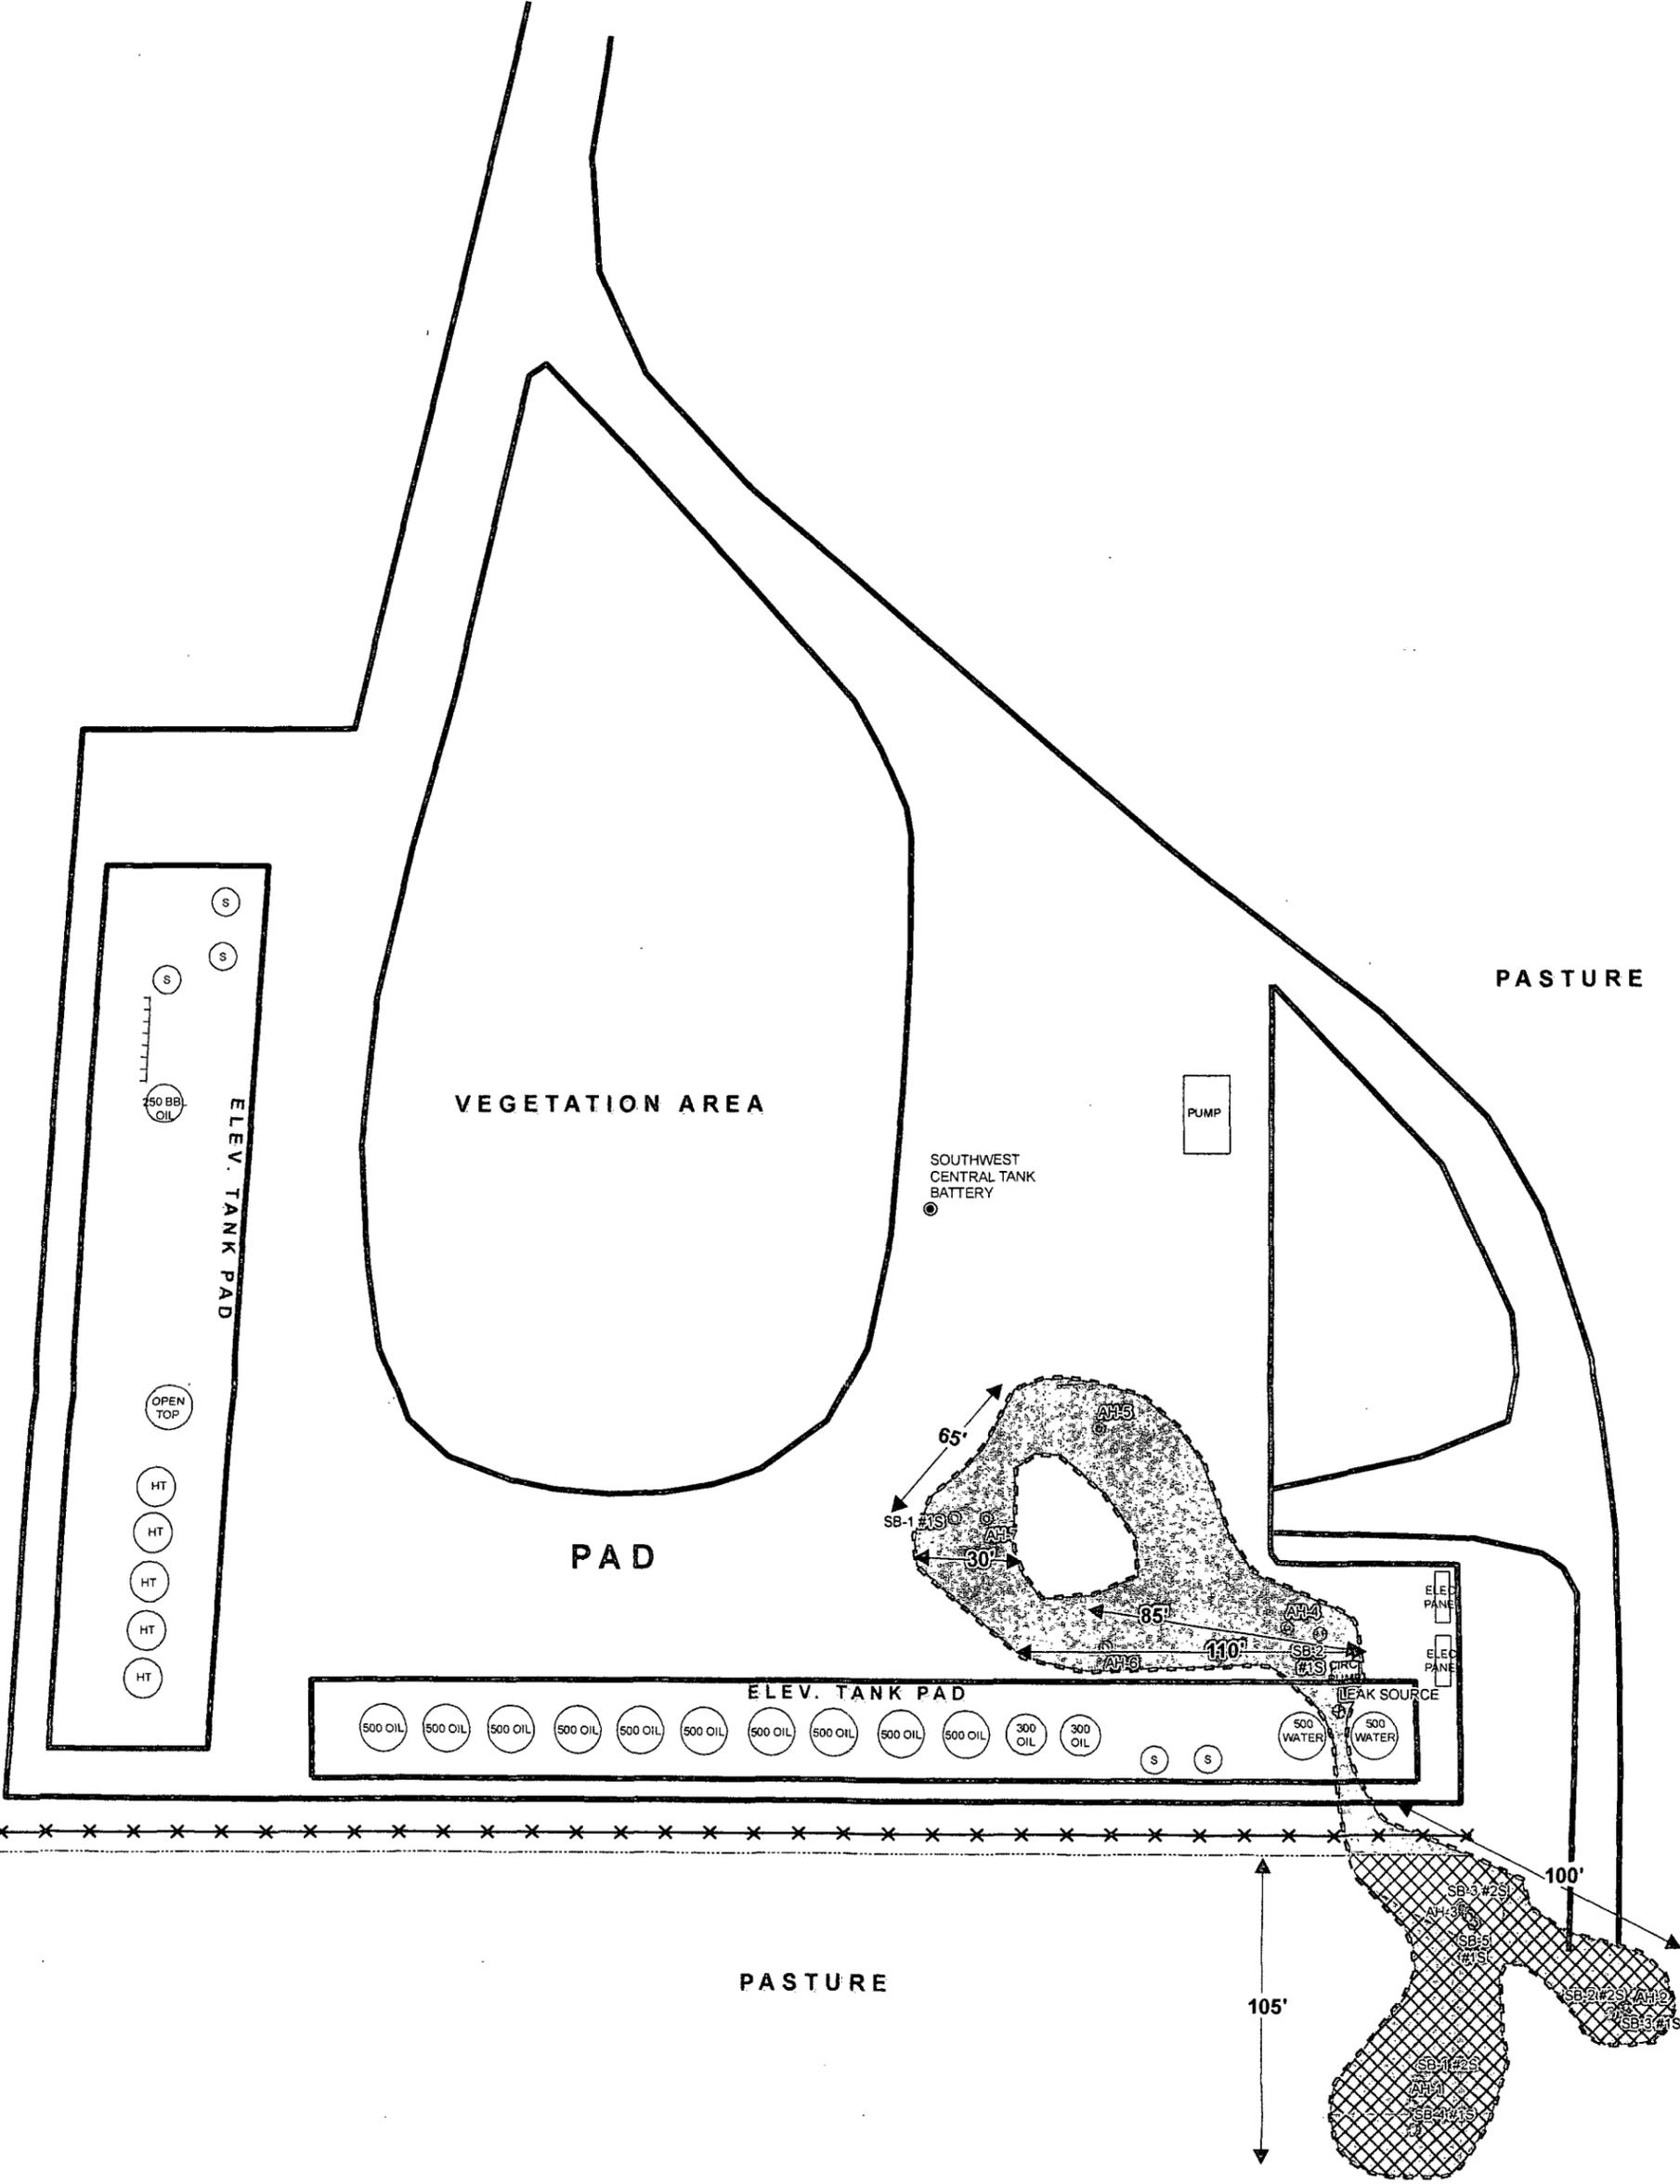
Figure 3

COG Operating has reported three spills at the facility and submitted the initial C-141 forms for each spill to the NMOCD. For this work plan, the spills will be referenced as Spill #1, #2 and #3. The approximate spill footprint areas are shown on Figure 3.

stainless steel hand auger to assess the impacted soils. Selected samples were analyzed for TPH analysis by EPA method 8015 modified, BTEX by EPA Method 8021B and chloride by EPA method 300.0. Copies of laboratory analysis and chain-of-custody documentation are included in Appendix B. The sampling results are summarized in Table 1. The auger hole locations are shown on Figure 3.

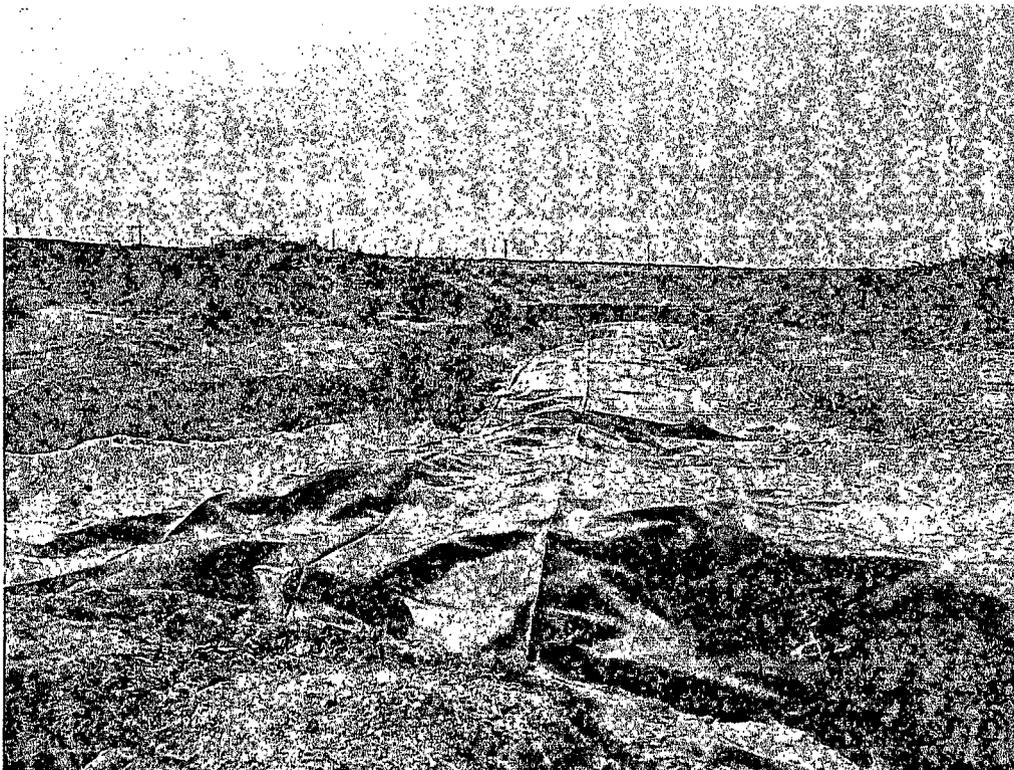
View South – Liner installation in area of AH-1 thru AH-3.

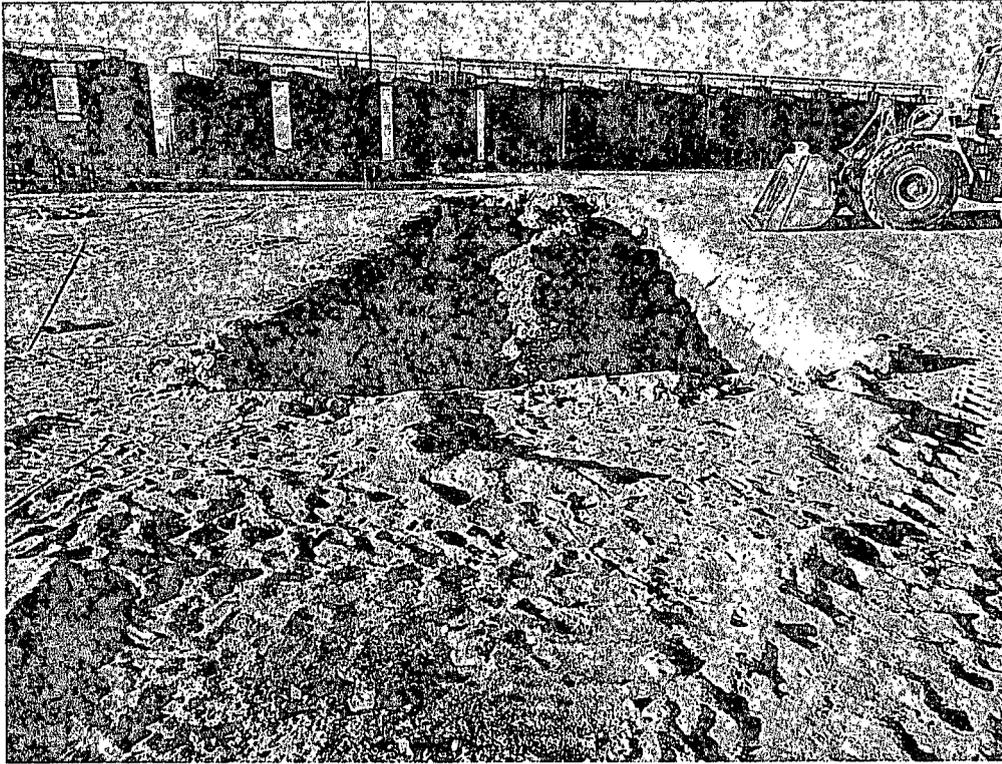
View Southwest – Excavation and clay cap installation in area of AH-7.

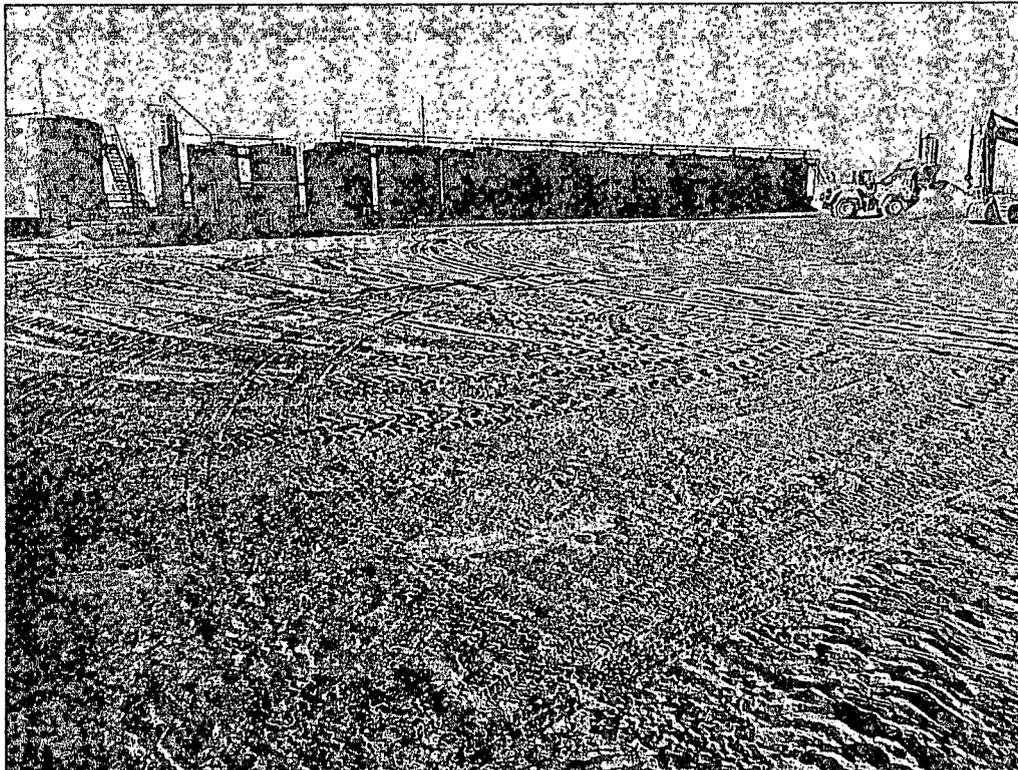
View South – Backfill of areas on pad.
