# Linn Energy Turner B #81

## CLOSURE REPORT

BLM Event NU12001TG

April 28, 2014

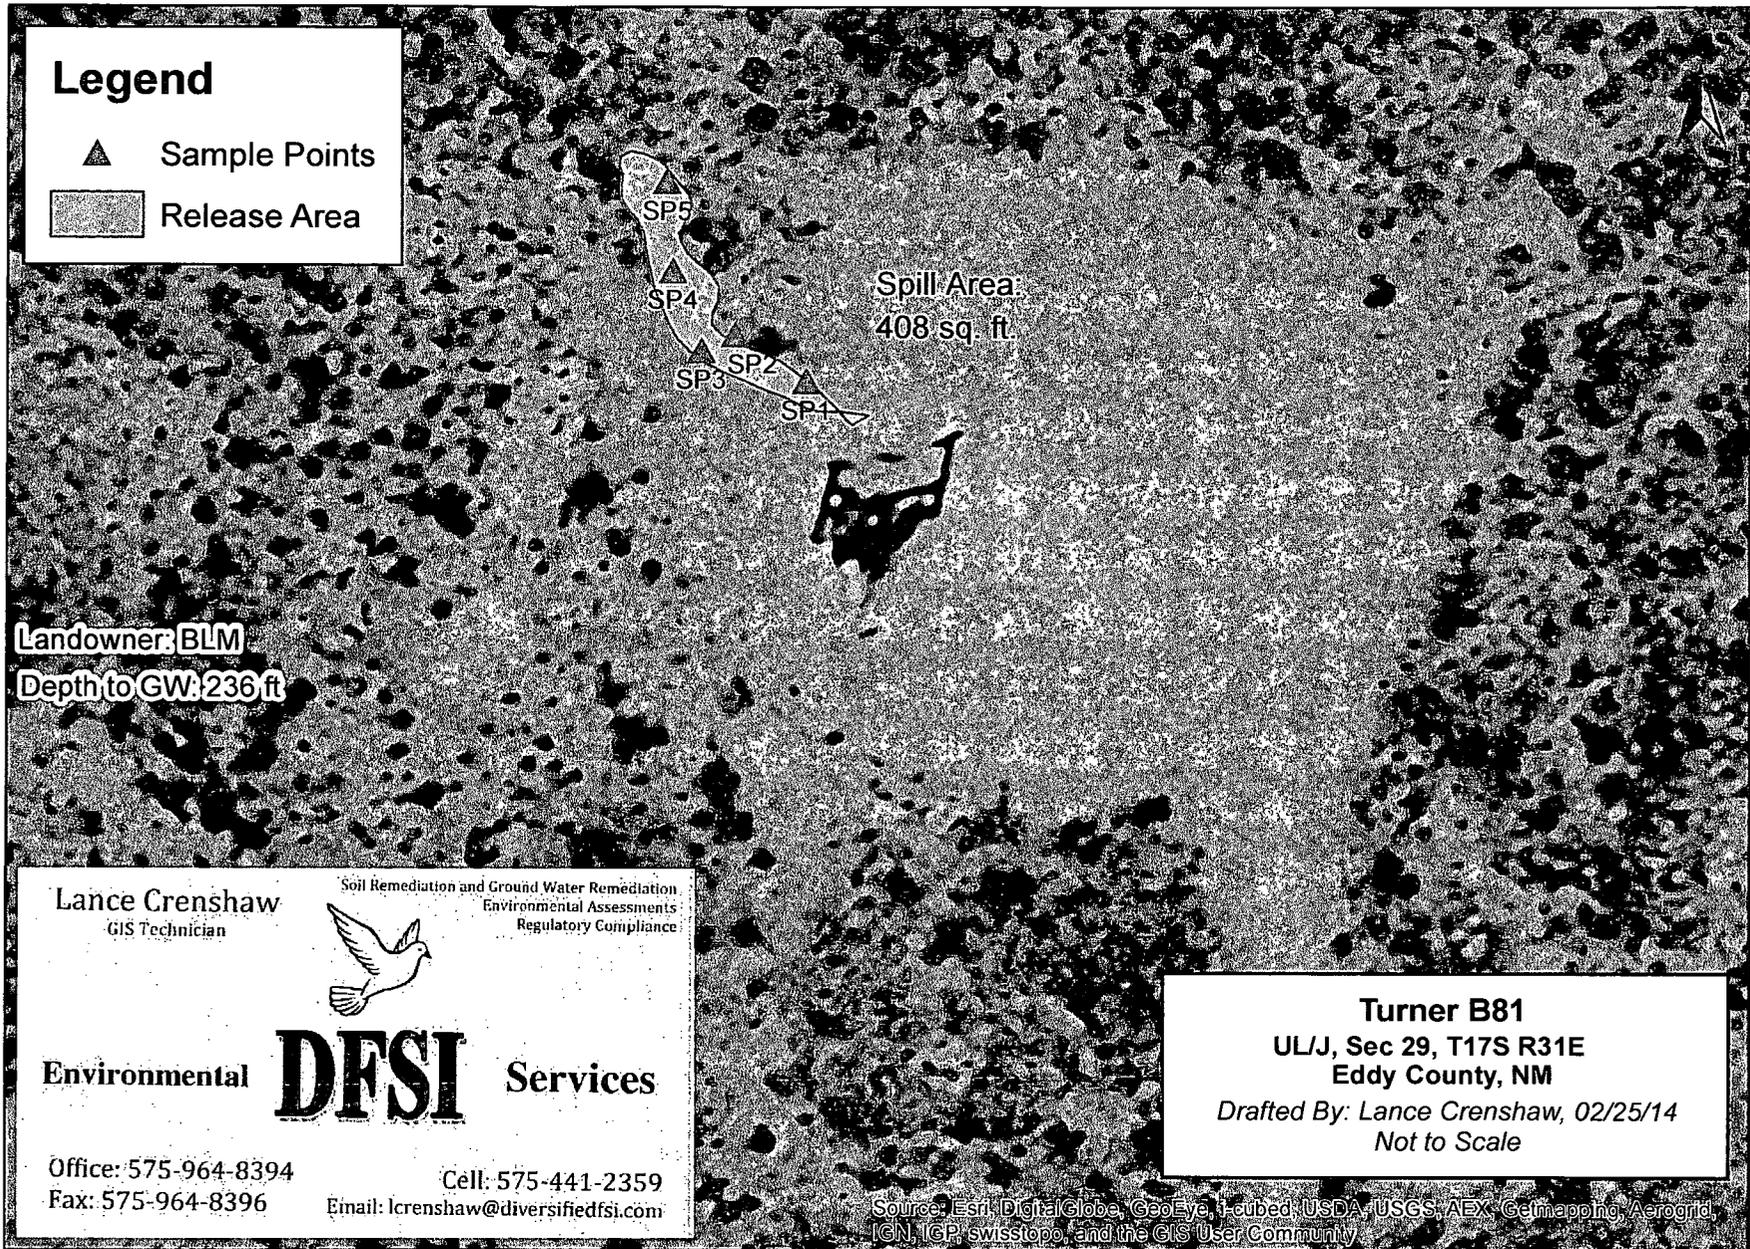
# Excavation Plat

On August 20, 2013 DFSI personnel collected surface soil samples from the site (Figure). The samples were field screened for chloride and showed elevated levels one of the sample points. The samples were submitted to a commercial laboratory for chloride, TPH, and BTEX analyses (Appendix IV).

Visually impacted soils were excavated throughout the entire leak area and removed to a NMOCD approved disposal facility. Simultaneous soil field testing revealed low chloride and hydrocarbon levels at 1 to 2 ft. below ground surface (bgs) (Figure). However, chloride remained elevated at 1699 mg/kg at 4 ft. bgs near the well head on the pad. Due to SP1 being at the wellhead it was proposed and accepted by the BLM that this area would be excavated to 4ft. bgs., and backfilled with imported caliche. Soil samples were collected from the excavation floor and submitted to a laboratory for confirmation (Appendix IV). The second sample on the northwest of the well head on the pad indicated significant reduction in chloride at 1 ft. bgs. The lab returned analysis at 32 mg/kg. SP3 thru SP5 were located in the pasture. The commercial lab returned analysis for SP3 at 1ft bgs chloride of 48 mg/kg. SP4 and SP5 returned analyses of acceptable chloride levels at surface level. TPH totaled less than 10.0 mg/kg GRO and less than 21.0 mg/kg DRO in all confirmation samples. Photographs of site activities can be viewed in Appendix II.

On March 27, 2014 DFSI submitted a remediation request to NMOCD and the BLM. Henceforth, DFSI excavated SP1 to 4ft. bgs., and backfilled. Due to the location of SP1 at the well head no liner was installed. SP2, and SP3 were excavated from 1 to 1.5 ft. bgs. respectively, and backfilled with fresh caliche. SP4 and SP5 were located in the pasture. On April 10, 2014, this area was scraped, blended and re-seeded with Lesser Prairie Chicken seed mixture. Thereby restoring the pasture area to its natural state per BLM requirements.

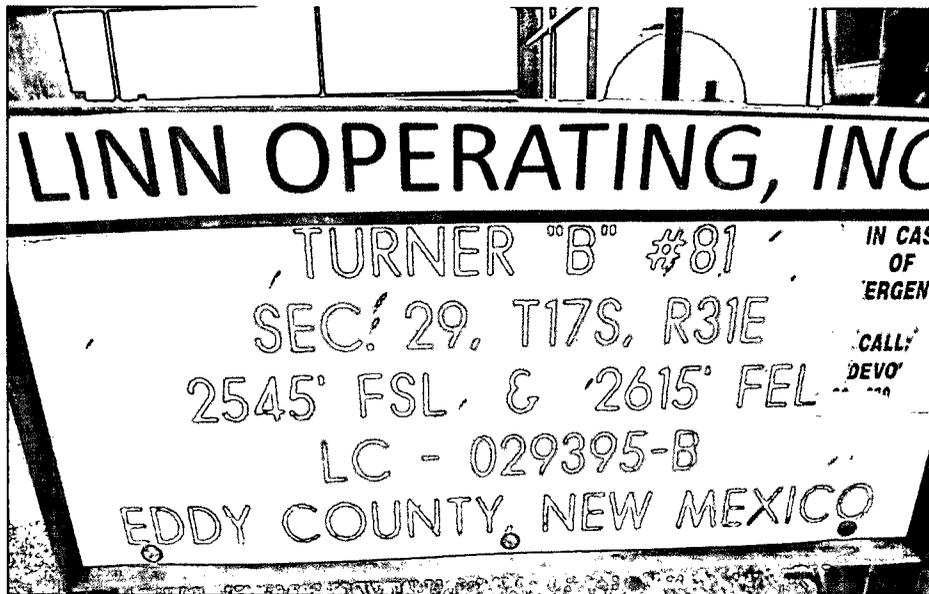
Sign marking location 8/16/13

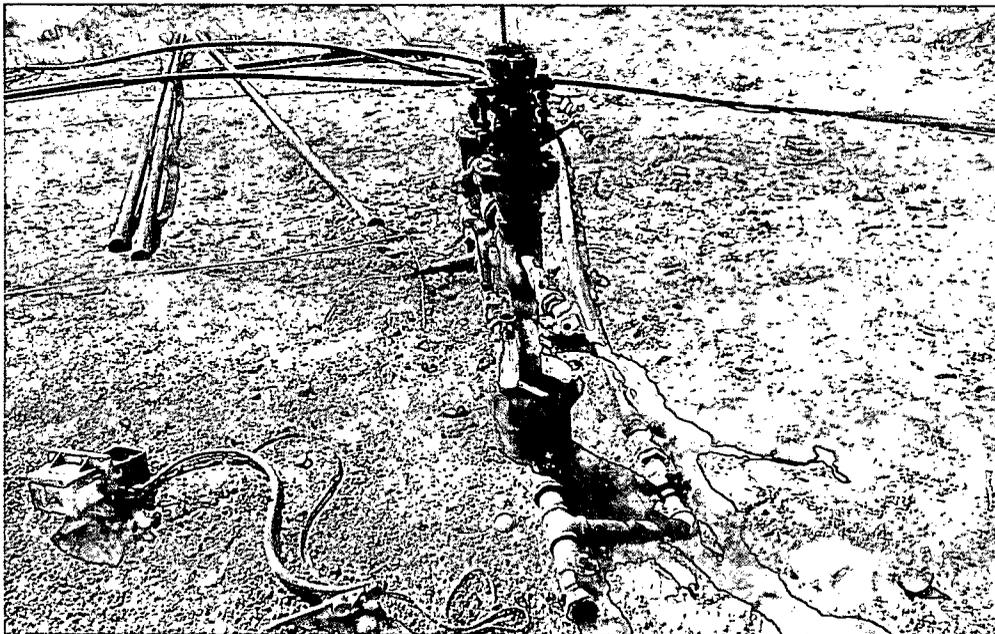
Valve leak location NW of lease road 08/16/13

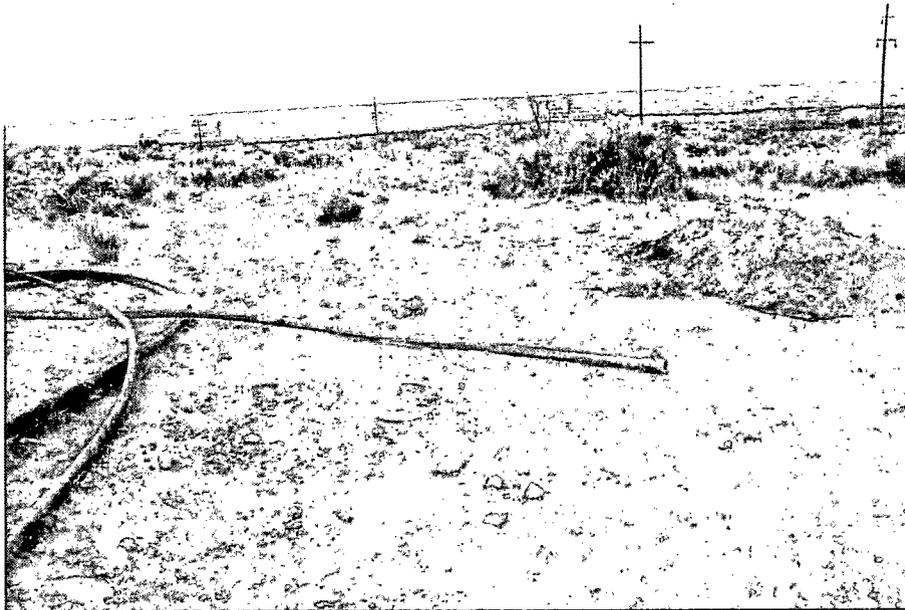
Impacted soil 8/16/12

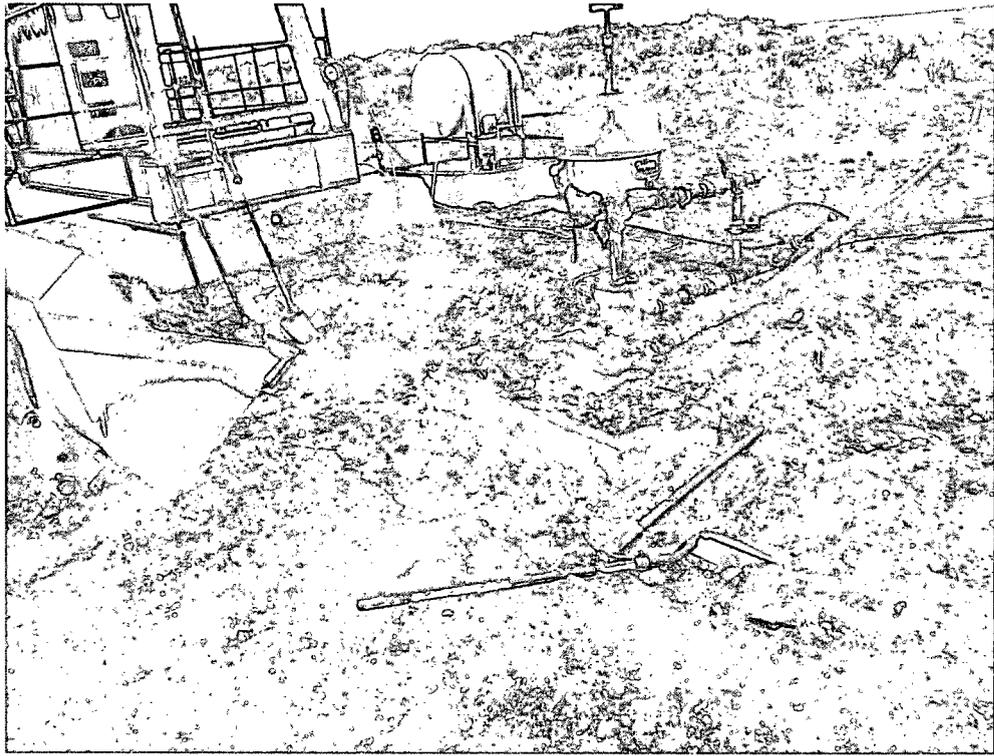
Excavation of impacted area 4/7/14

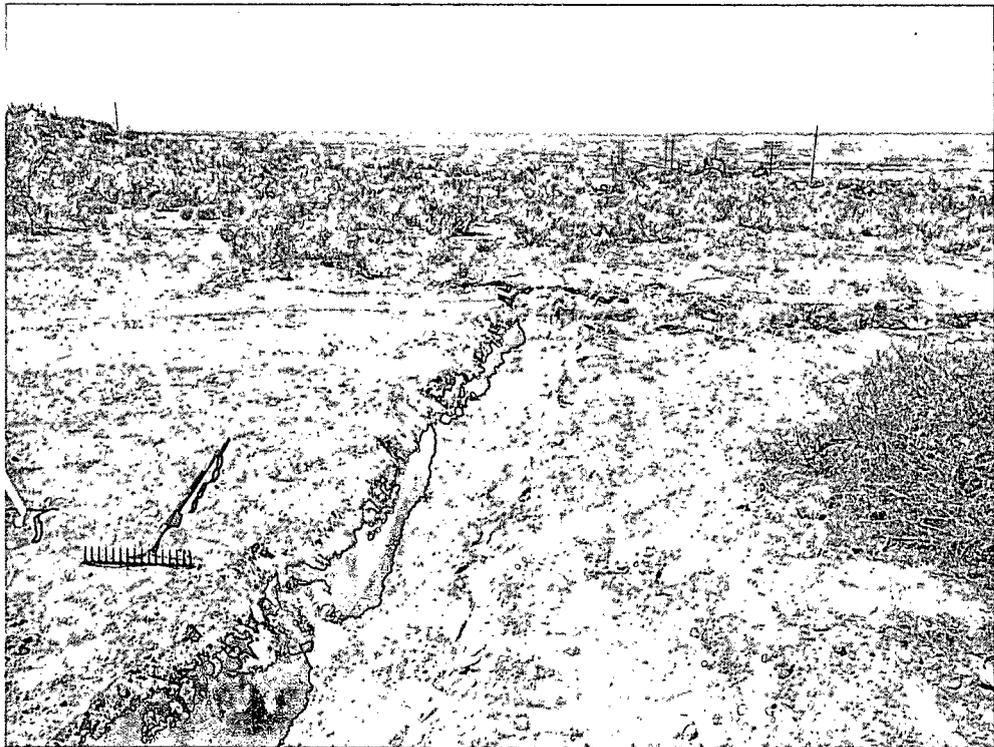
Excavation of impacted run off area 4/8/14

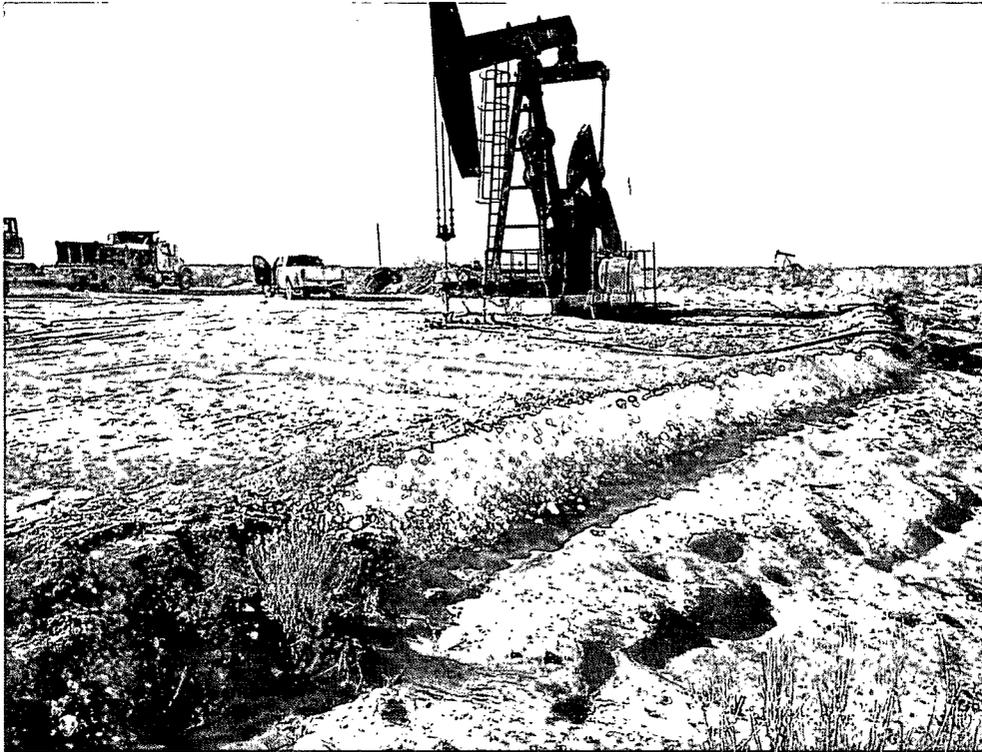
Site at completion 4/11/14

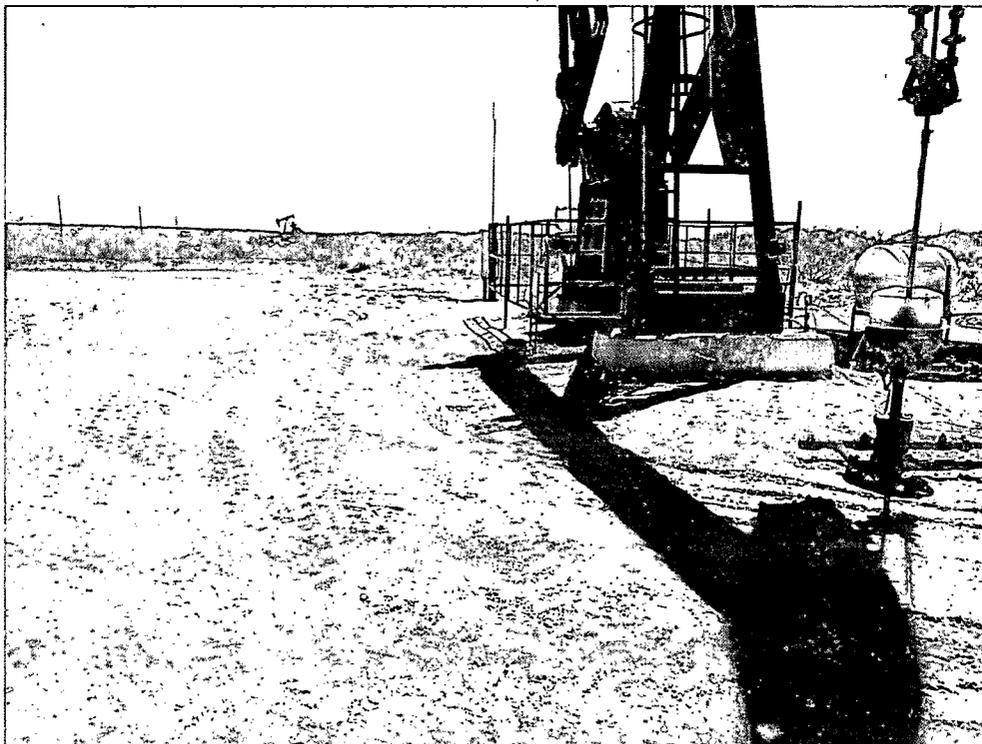
Site at completion of well head area 04/15/14

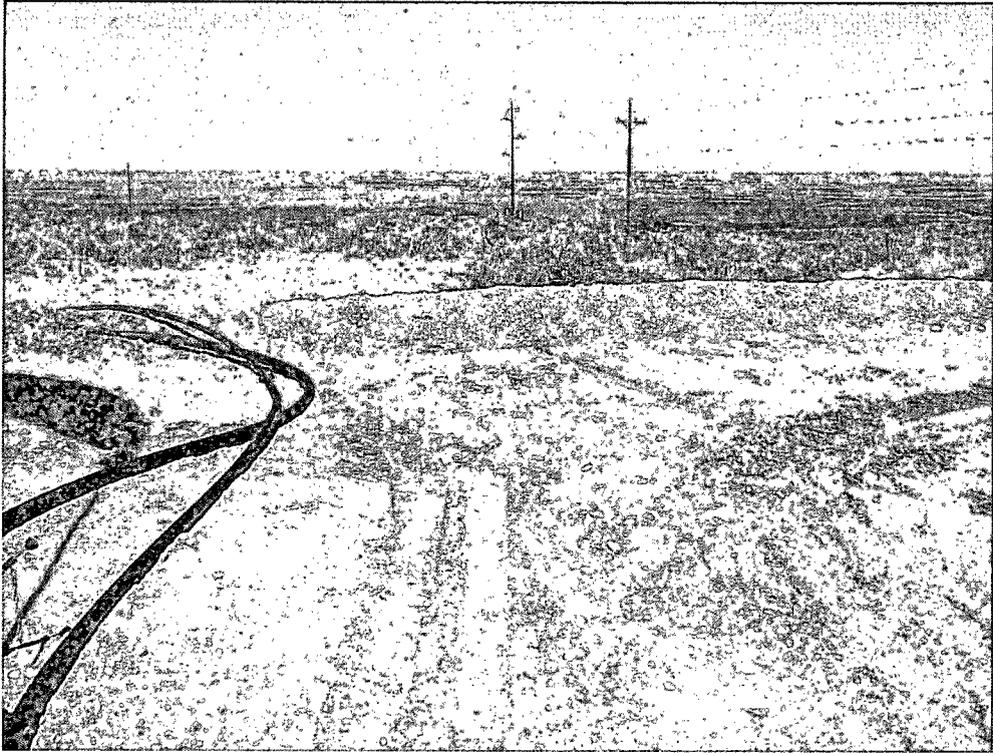
Pasture area after tilled and seeded 4/22/14
