Linn Energy Turner B #103

CLOSURE REPORT

API No. 30-015-26665

Unit Letter B, Section 20, Township 17 South, Range 31 East

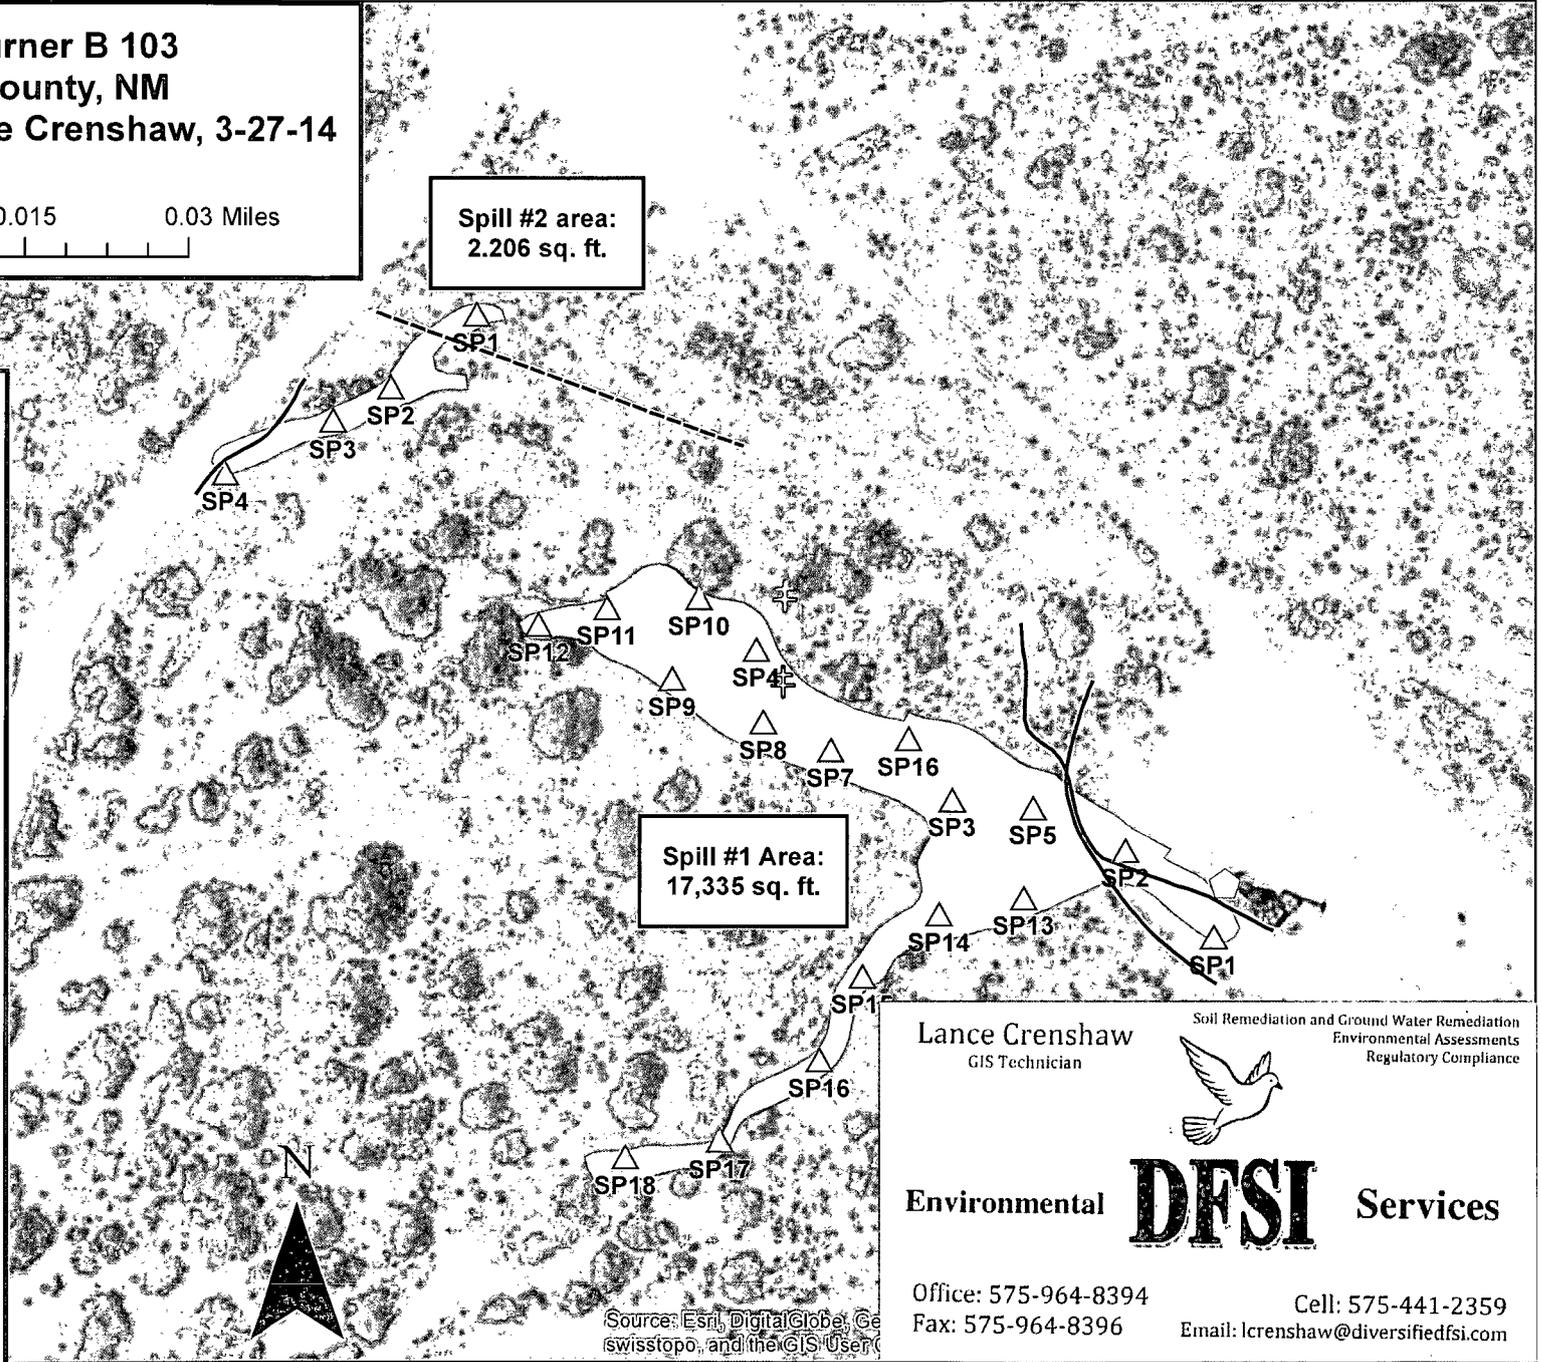
Site Diagram

On March 10, 2014 DFSI personnel collected surface soil samples from the initial spill site which encompassed a 17,335 sq. ft. area (Figure). There was a total of 18 sample points established. The samples were submitted to a commercial laboratory for chloride, TPH, and BTEX analyses (Appendix IV).

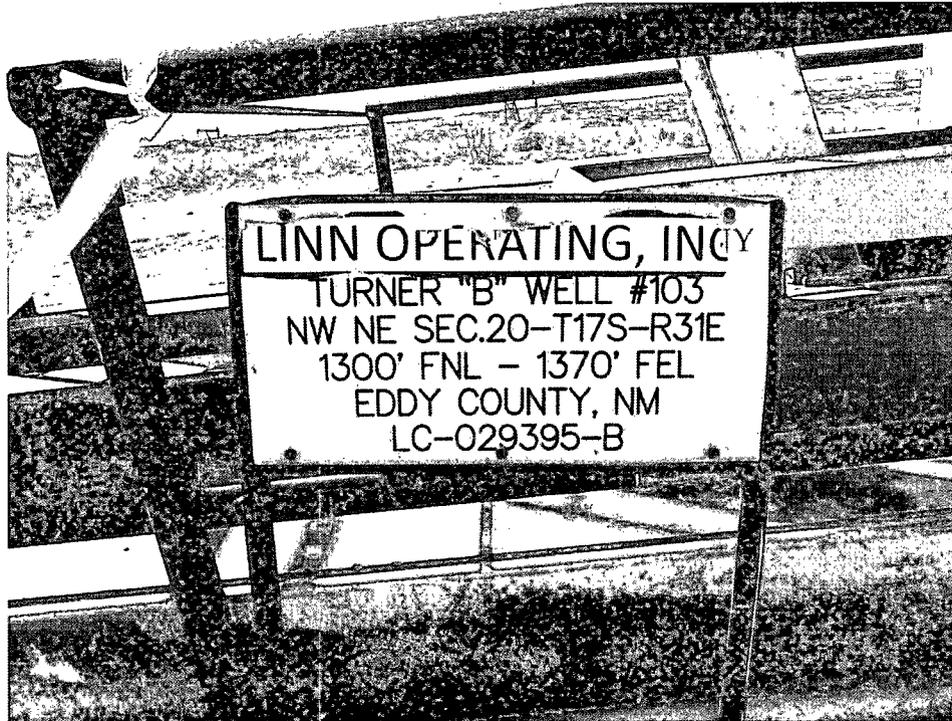
Sign Marking Location 03/07/14

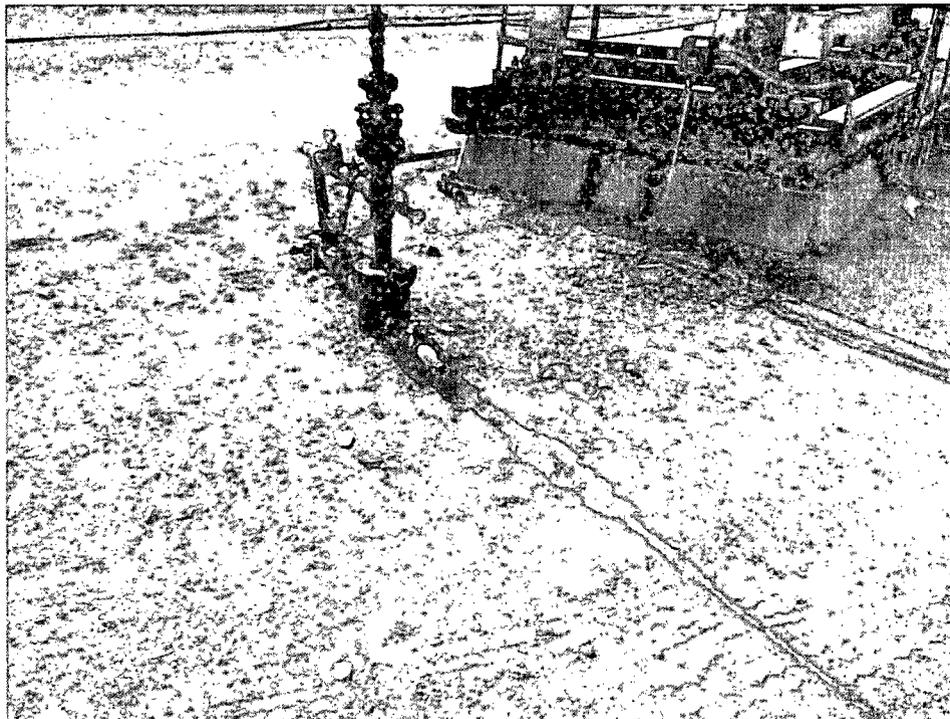
Initial spill area 03/07/14

The flow line at the Turner B #103 froze and plugged off, the flow line ruptured near the pumping unit. The well was shut-in and the flow line was repaired. A vacuum truck was brought to the location and free fluids were recovered.

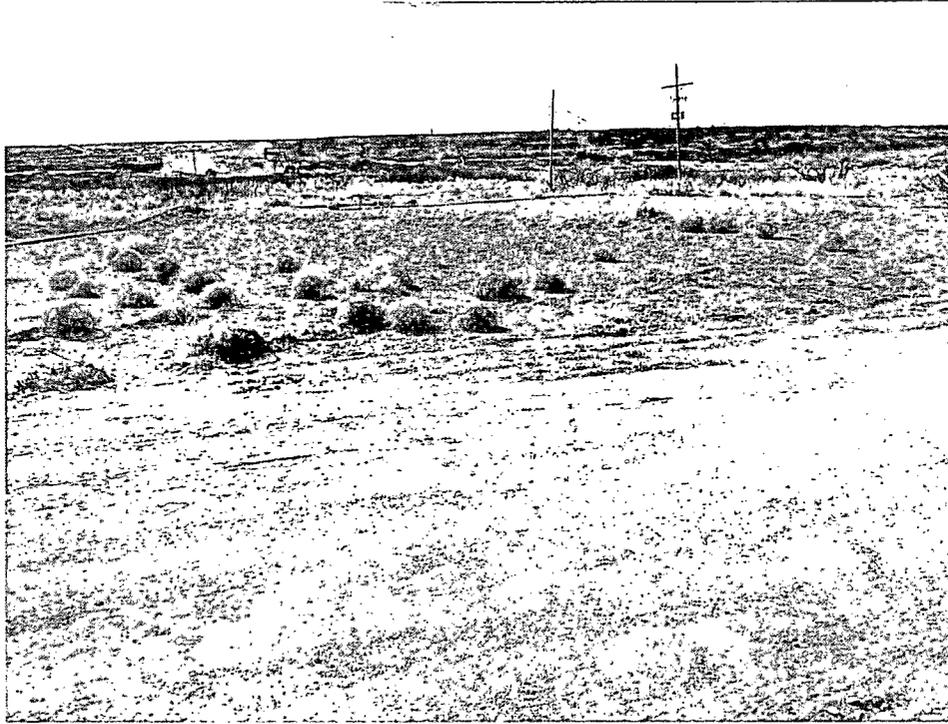
Impacted pad and pasture area 03/07/14

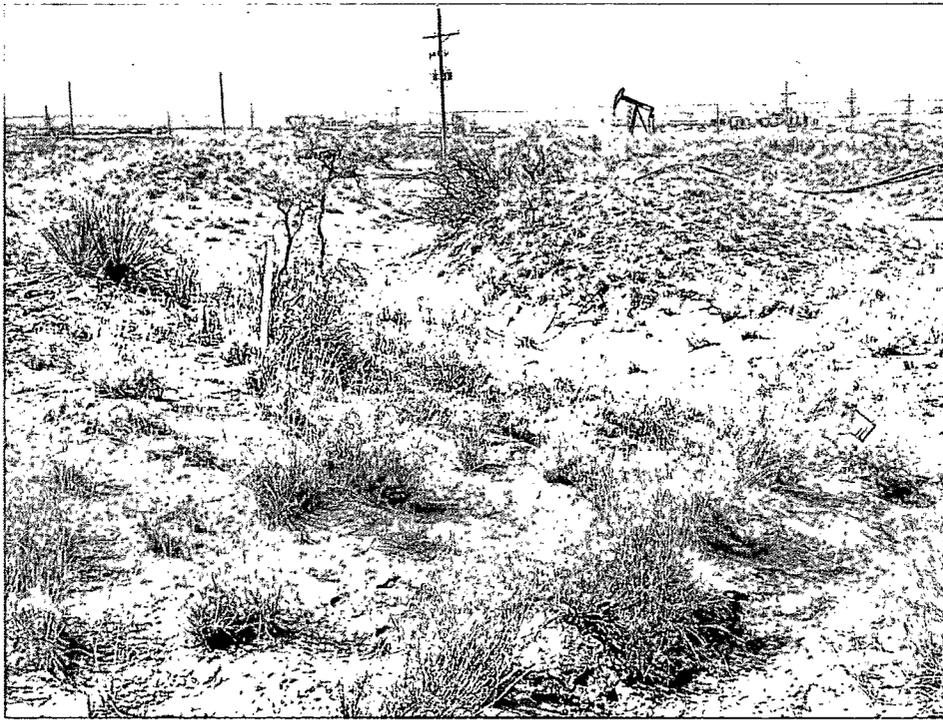
Impacted pasture with sample points 03/21/14

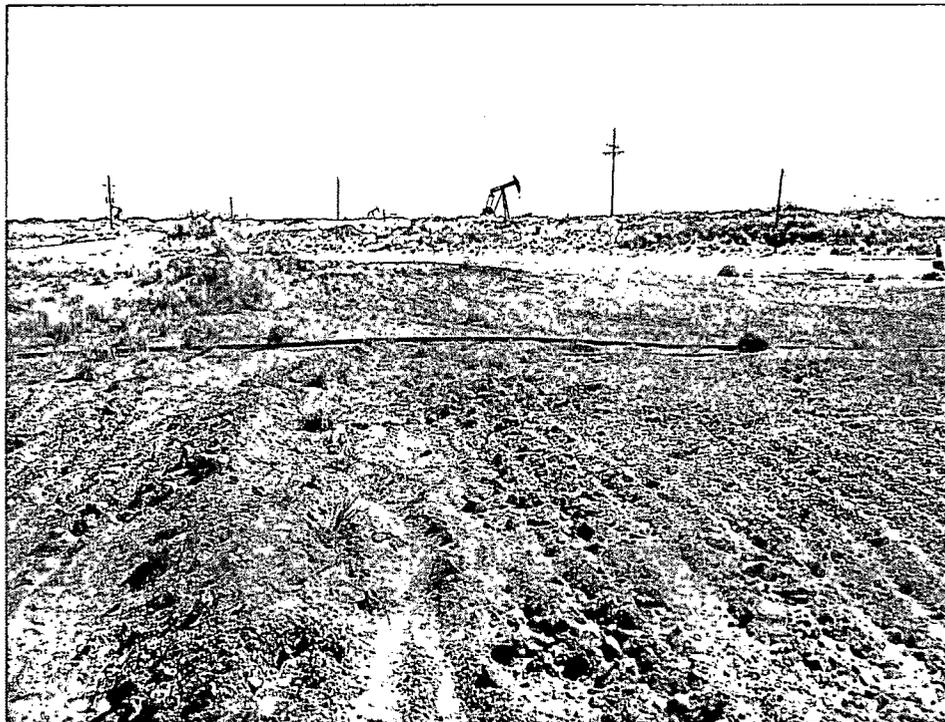
2nd spill site pasture area at completion of seeding 04/28/14

Describe Area Affected and Cleanup Action Taken.*
The flow line was immediately shut in and repaired. There was an impact of 15 gal. of produced water. DFSI removed the impacted soil to an NMOCD approved facility. On April 10, 2001 the site was seeded and restored to its natural state per BLM guidelines.
