BOPCO

Poker Lake Unit #139

CLOSURE REPORT

2RP-901

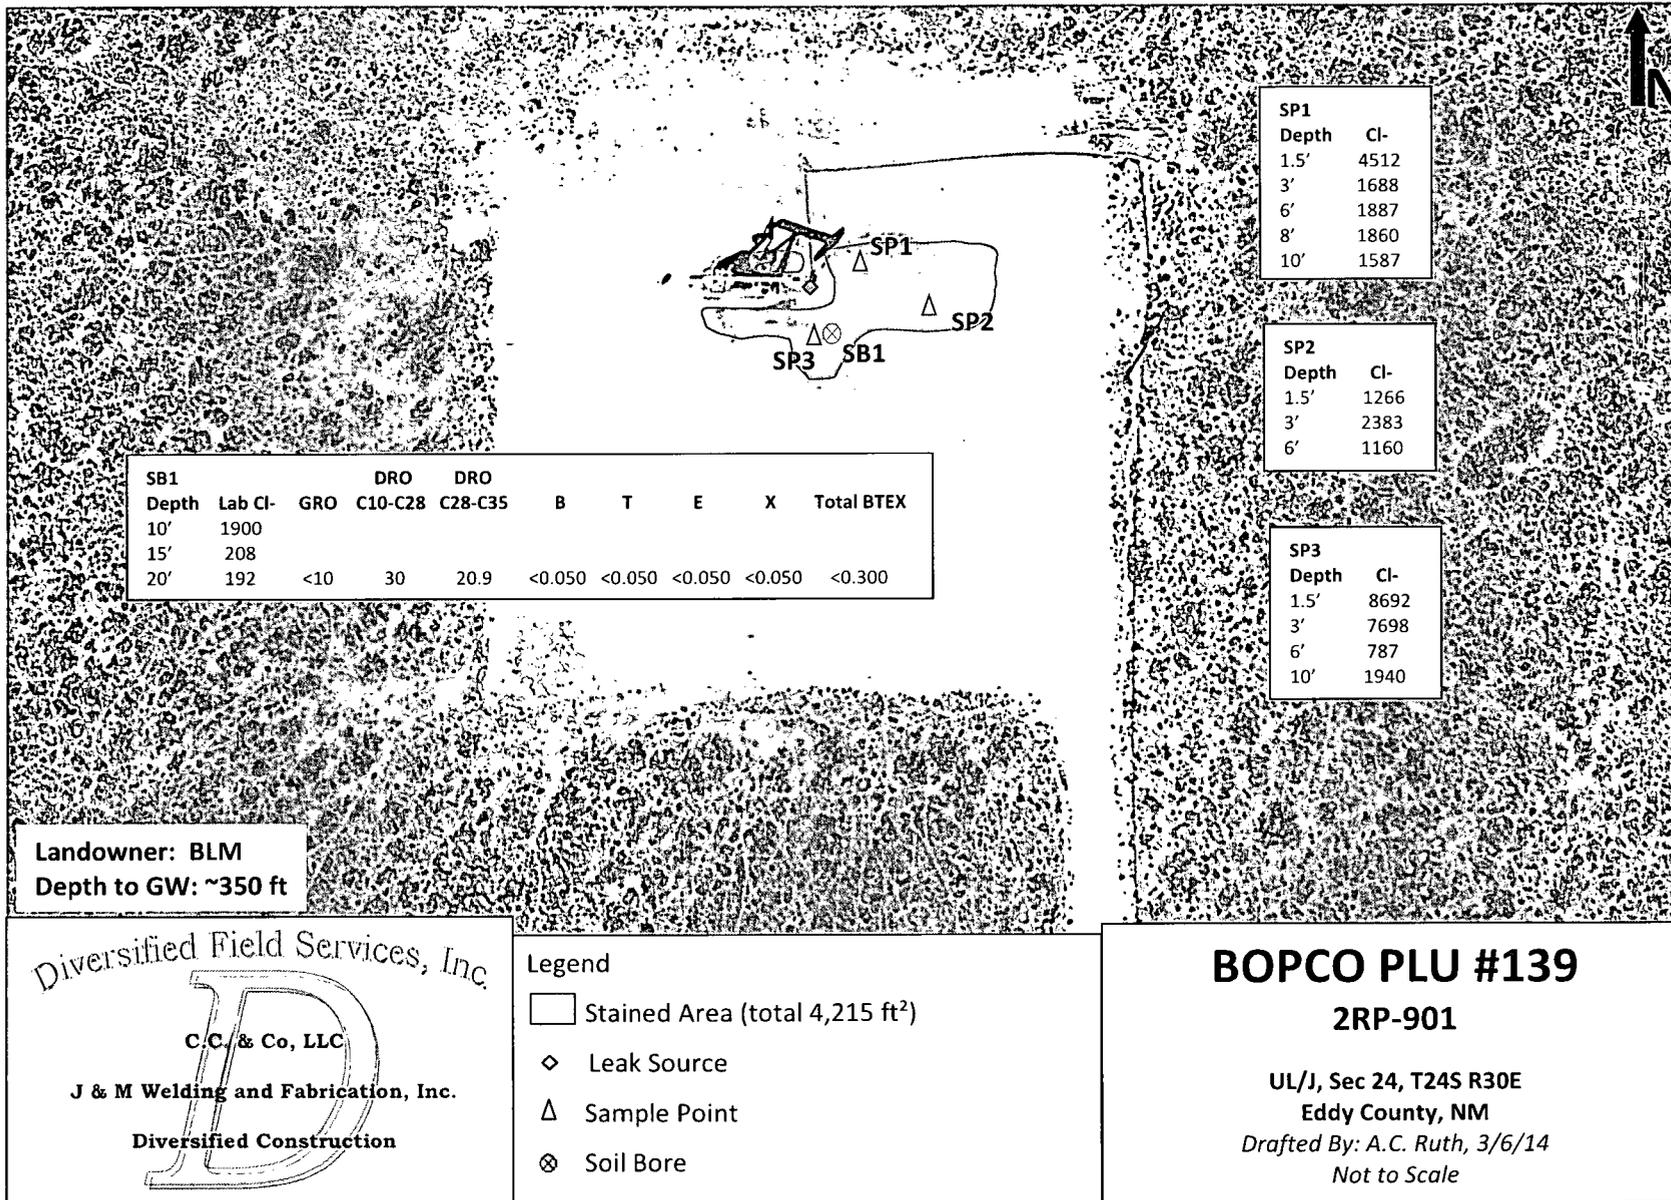
FIGURE: Site Diagram with Sample Data

On September 30, 2013, DFSI personnel collected soil samples from the site with a hand auger and backhoe. The samples were field screened for chloride. Samples were taken to 10 ft. below ground surface (bgs), at which point, soils were compacted such that the backhoe was refused (Figure).

On October 7, 2013, DFSI personnel excavated the site to 3 ft. bgs and installed a 20 mil plastic liner in the excavation floor. A poly pipe was installed in the most highly impacted area of the site (SP3) through the liner in order to later delineate the depth of impact at the site via drilling. The excavation was backfilled with imported caliche and leveled. Photographs of site activities can be viewed in Appendix II. Soil samples were inadvertently not submitted to a commercial laboratory for analyses. The NMOCD was notified on October 11, 2013 of the lack of laboratory analyses and conditions at the site, whereby an allowance was made for the submittal of the proposed soil bore samples to represent site delineation (Appendix V).

On December 11, 2013, SB1 was drilled at the former SP3 and samples were collected to 20 ft. bgs. The 10 ft., 15 ft., and 20 ft. samples were sent to an NMOCD approved commercial laboratory for chloride, TPH (Total Petroleum Hydrocarbons – GRO/DRO), and BTEX (benzene, toluene, ethyl benzene, xylene) analyses. At 20 ft. bgs, chloride reduced to 192 mg/kg. GRO was less than 10 mg/kg, DRO (C10-C28) was 30 mg/kg, DRO (C28-C35) was 20.9 mg/kg, and Total BTEX was less than 0.300 mg/kg (Appendix IV).

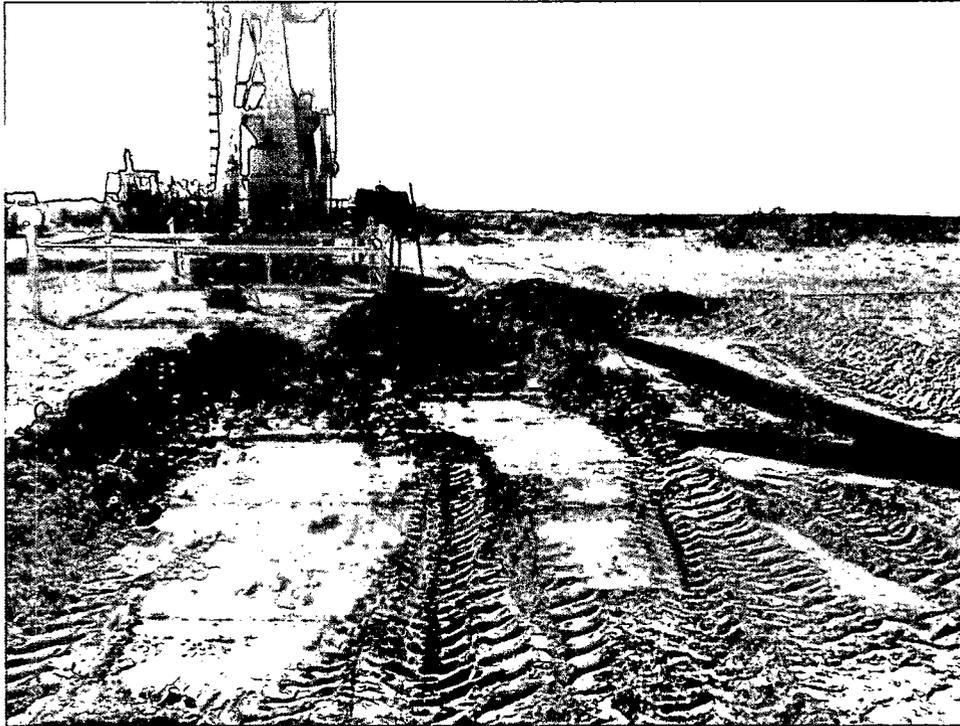
Beginning excavation of impacted soils 9/25/13

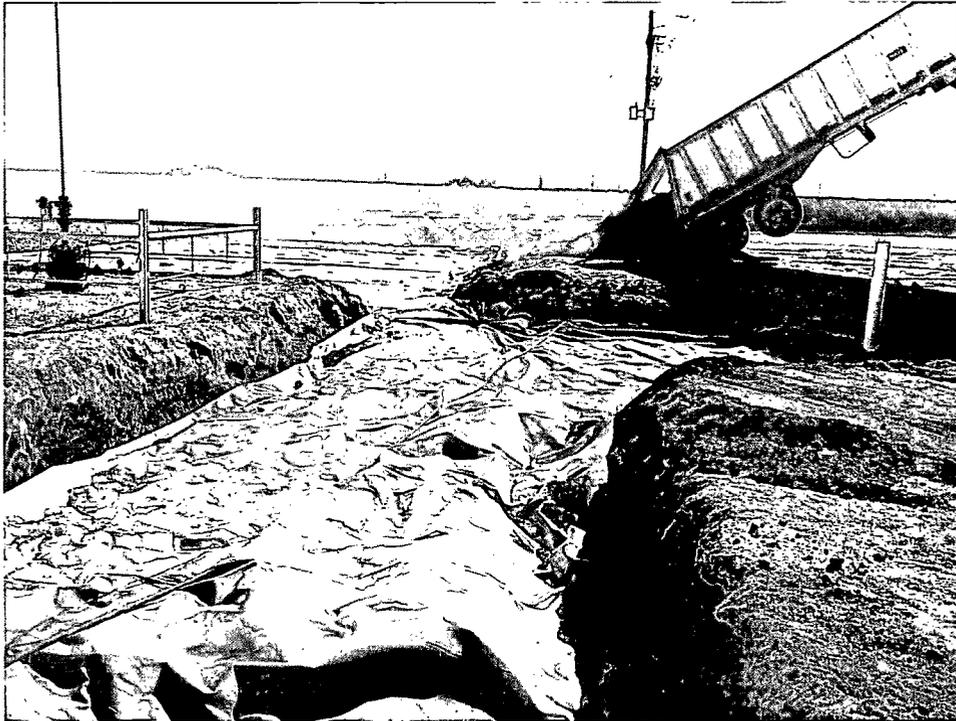
Liner installed in completed excavation, beginning backfill 10/7/13

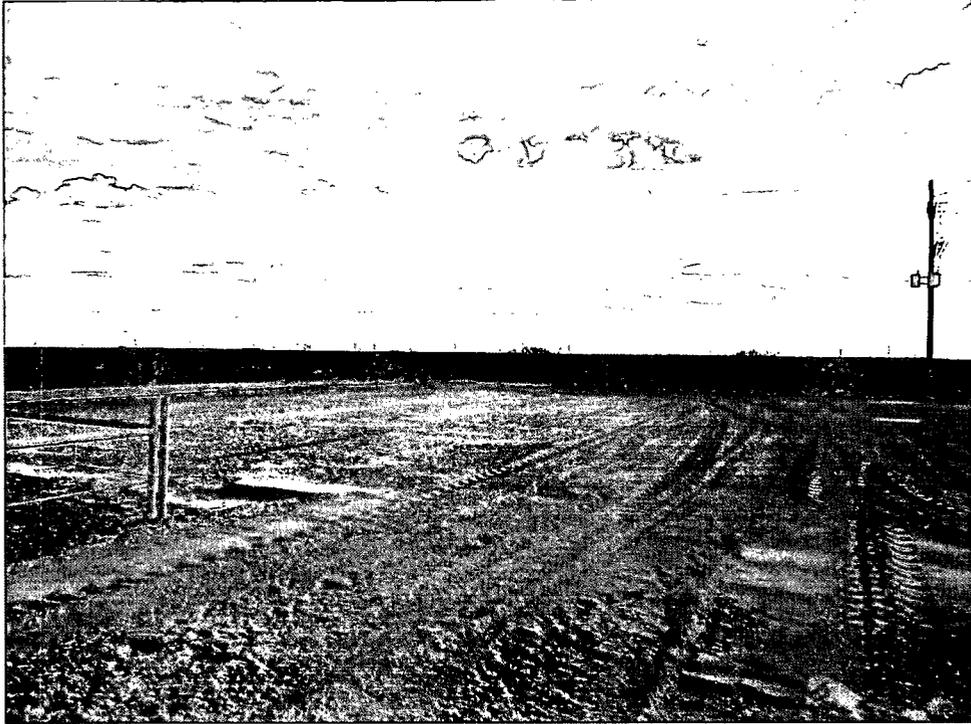
Site backfilled 10/8/13

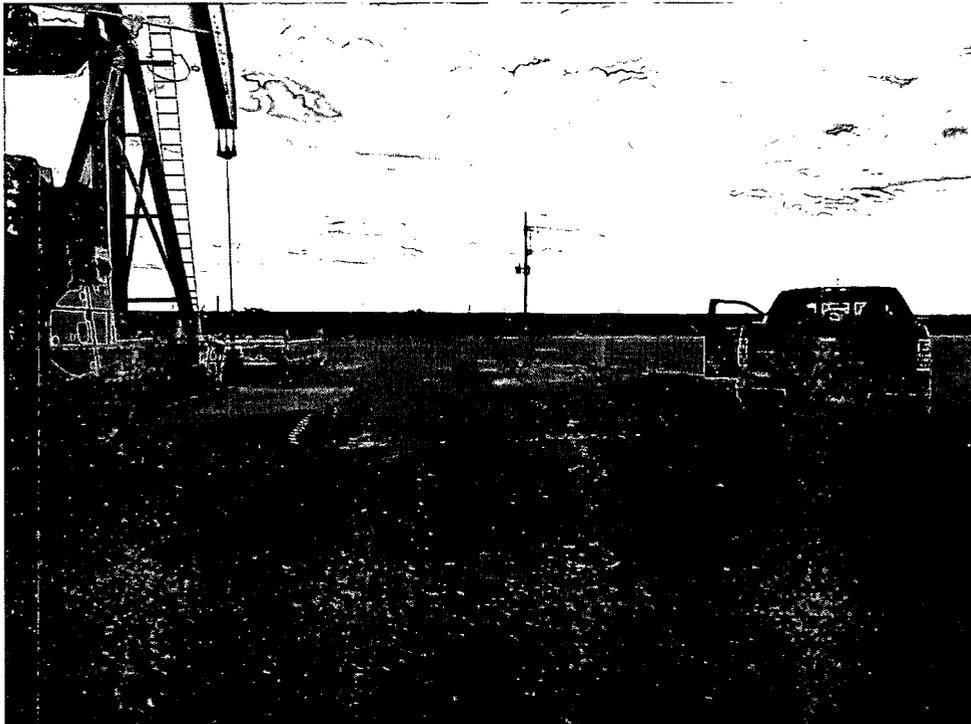
Site backfilled and leveled 10/8/13
