State E 1288 Battery

Termination Request

Unit Letter F, Section 27, Township 18S, Range 28E

Quantum Resources – State E 1288 Battery

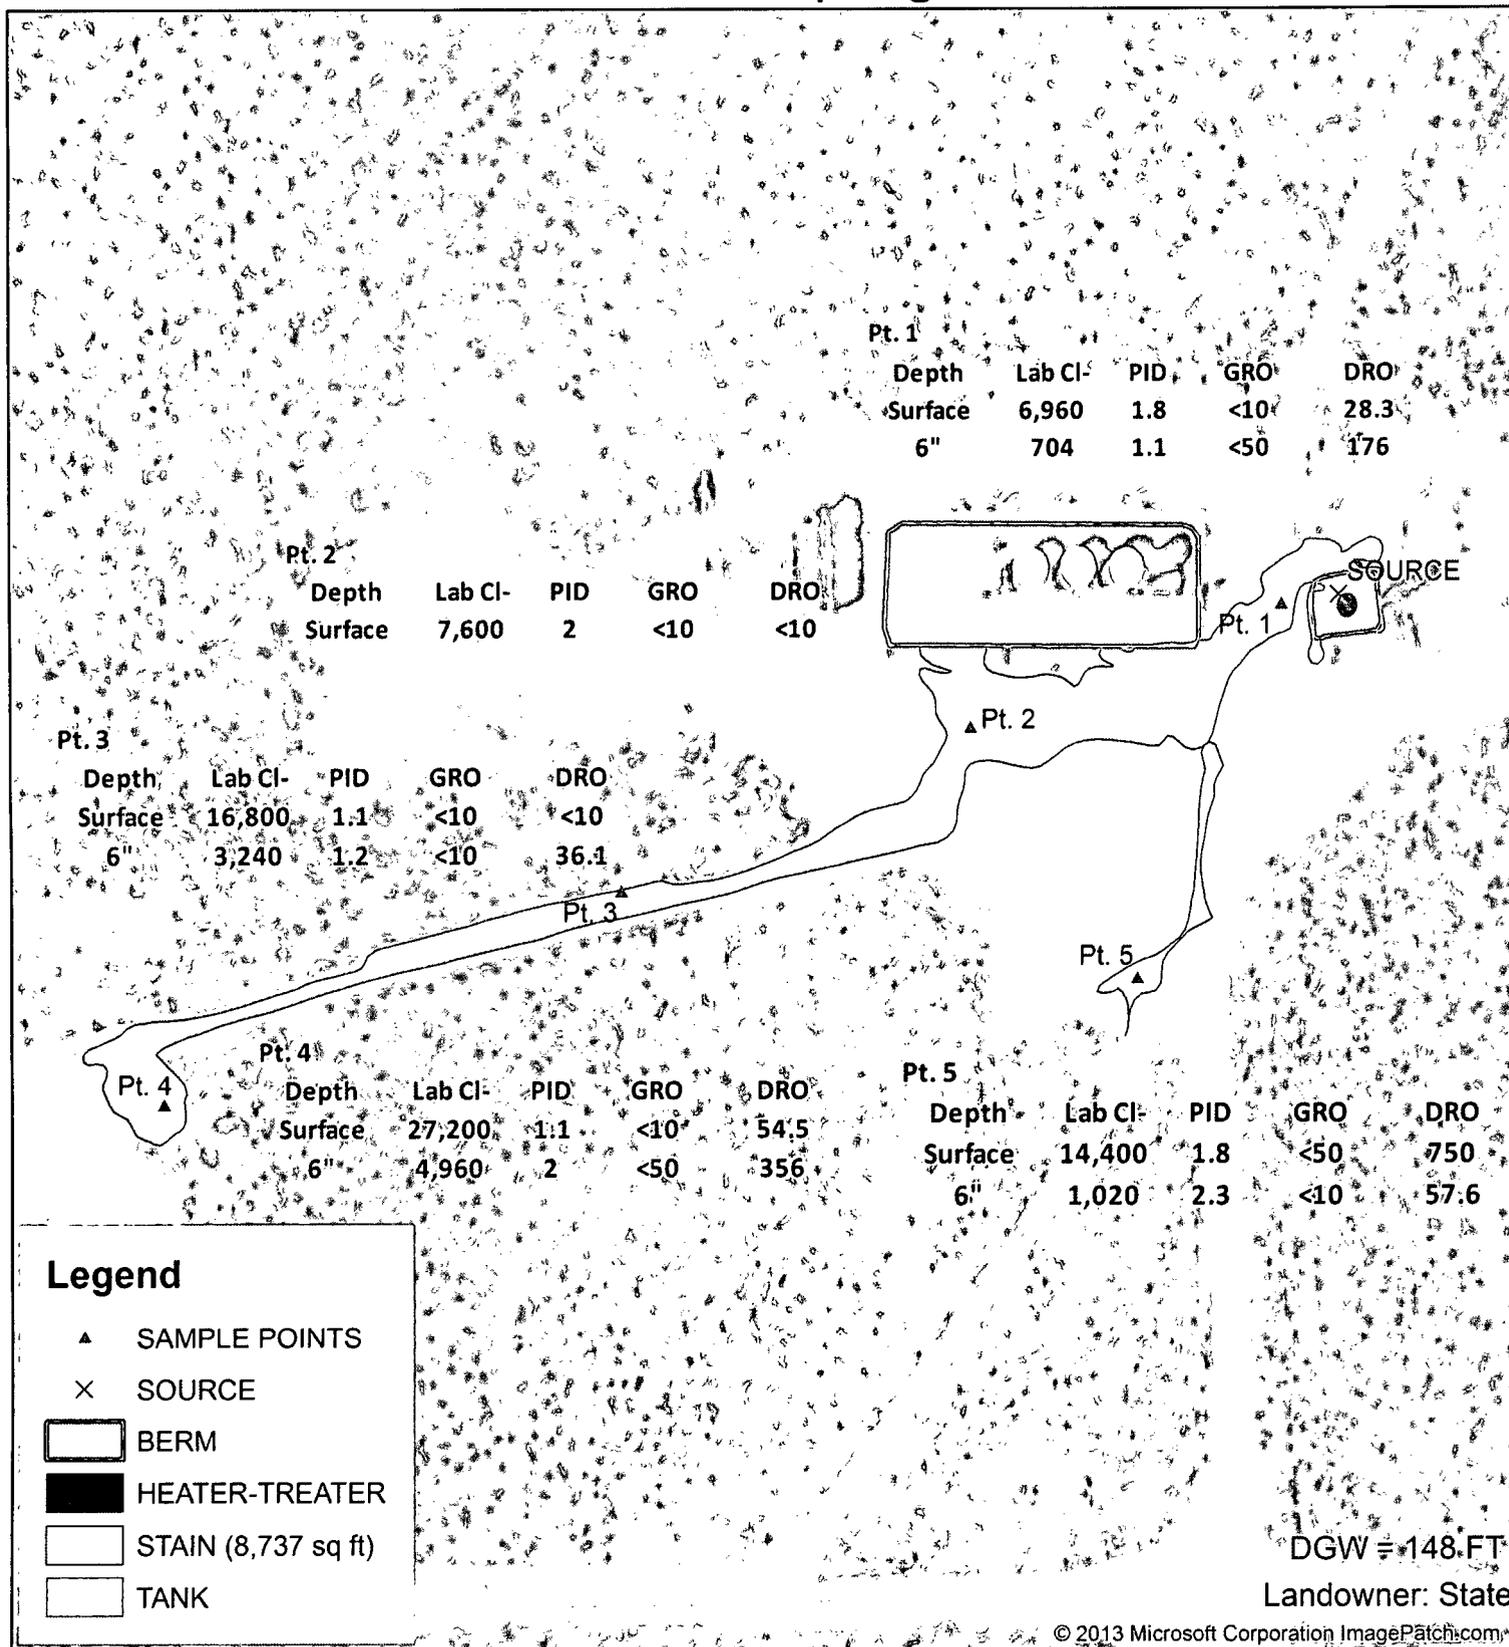
Figure 1

RECS personnel were on site beginning on October 31st, 2012 to take initial samples of the release. Samples were taken at the surface and at depth and field tested for chlorides and hydrocarbons (Figure 1). The samples were taken to a commercial laboratory for confirmation of field numbers. Laboratory readings showed elevated chlorides results which decreased with depth. GRO readings at all points and at all depth were non-detect. DRO readings were slightly elevated, especially with depth. The exception to this was at Pt. 5 where the DRO readings decreased with depth (Appendix A).

Initial Lab Sampling Data

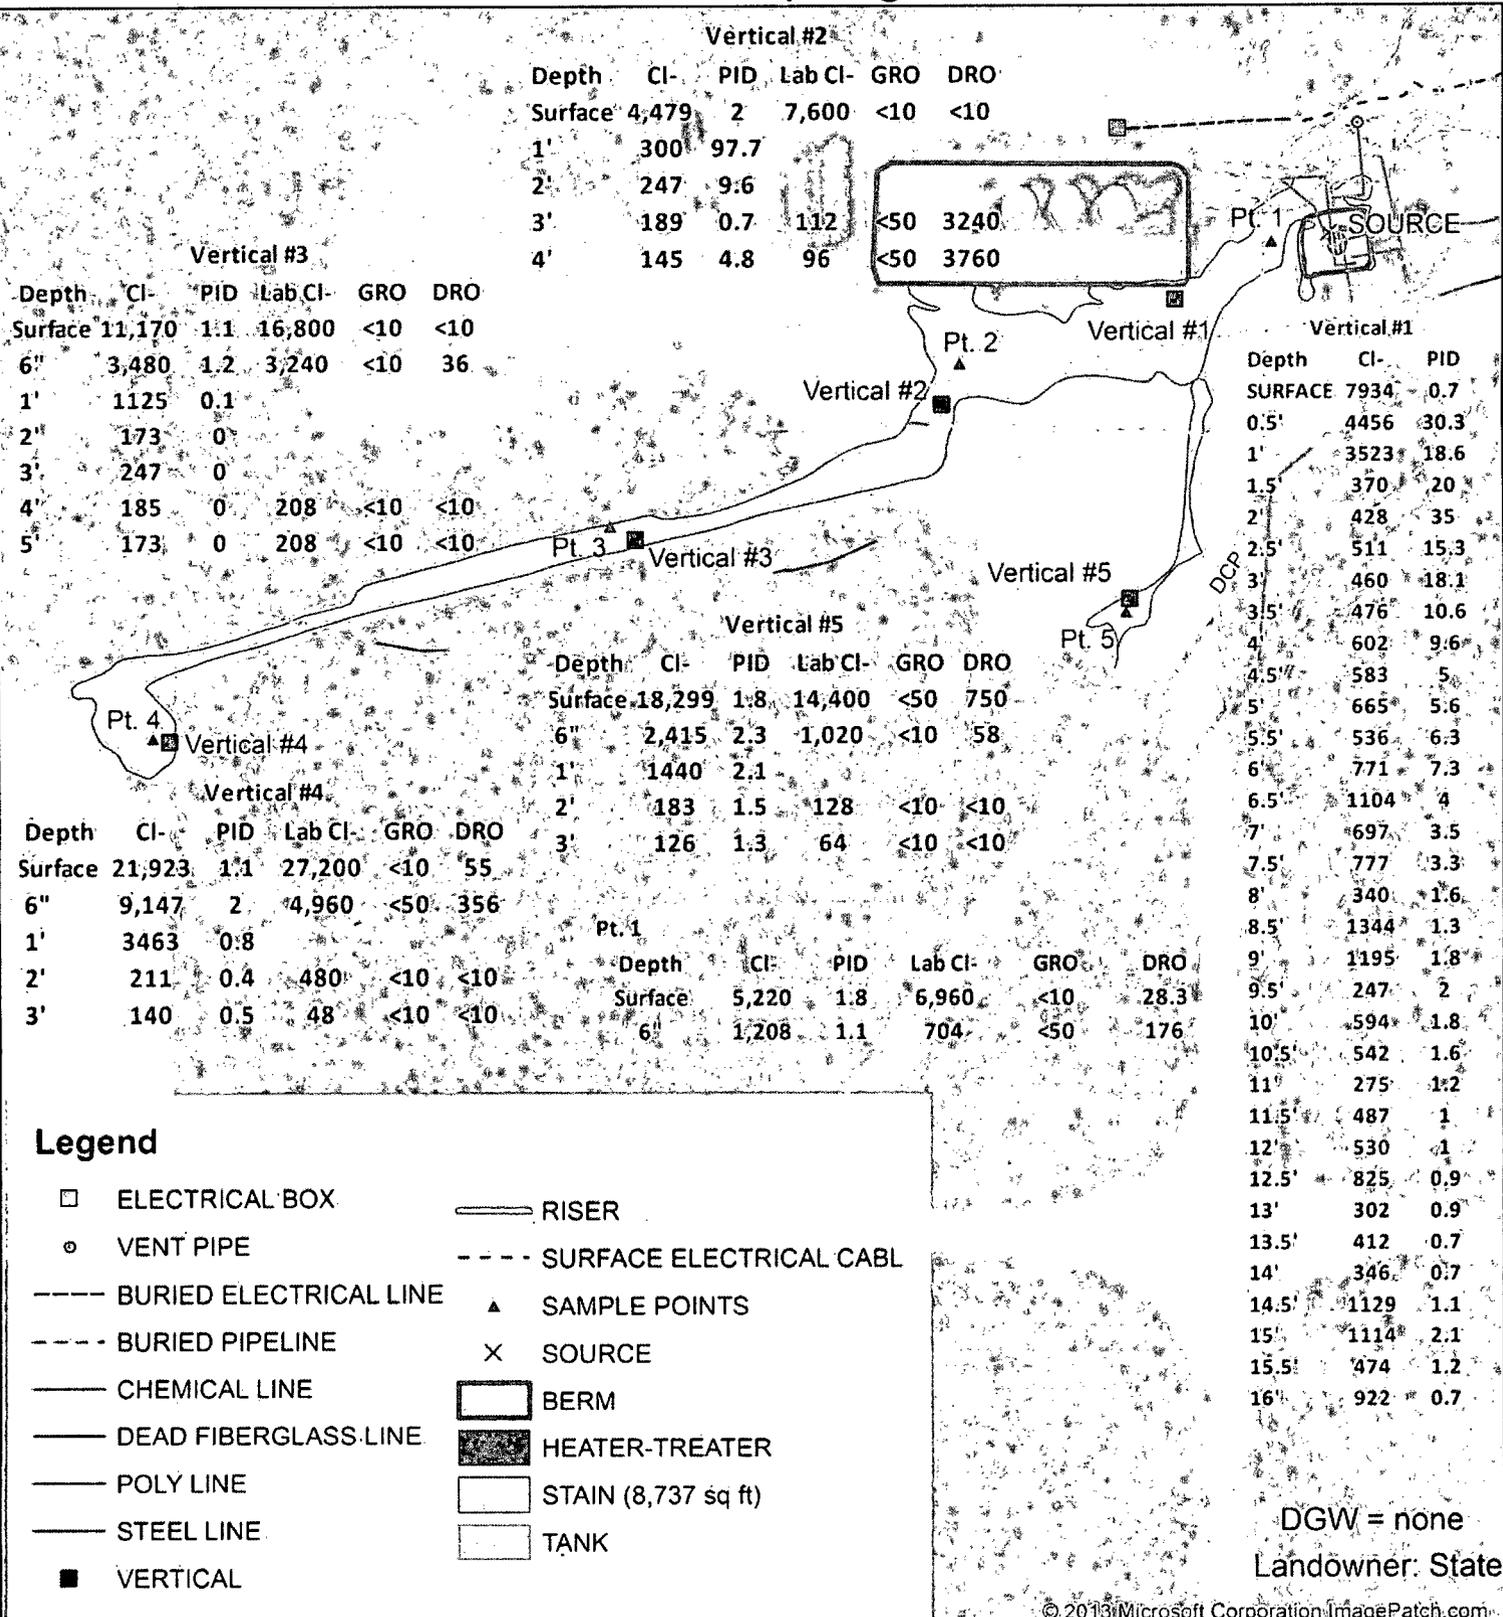
Figure 2

Five verticals were installed at the site to determine the extent of contamination in the vadose zone (Figure 2). Vertical #1 was excavated to a depth of 16 ft bgs where the field chloride reading was 922 mg/kg. Vertical #2 was excavated to a depth of 4 ft bgs. The 3 ft and 4 ft samples were taken to a commercial laboratory for analysis of chlorides and hydrocarbons. The samples returned laboratory chloride readings below 250 mg/kg and GRO readings of non-detect. The 3 ft sample returned a DRO reading of 3,240 mg/kg and the 4 ft sample returned a DRO reading of 3,760 mg/kg. Vertical #3 was excavated to a depth of 5 ft bgs. The 4 ft and 5 ft samples were taken to a commercial laboratory for analysis of chlorides and hydrocarbons. The samples returned laboratory chloride readings below 250 mg/kg and GRO and DRO readings of non-detect. Vertical #4 was excavated to a depth of 3 ft bgs. The 2 ft and 3 ft samples were taken to a commercial laboratory for analysis of chlorides and hydrocarbons. The 2 ft sample returned a laboratory chloride reading of 480 mg/kg and the 3 ft reading returned a laboratory

chloride reading of 48 mg/kg. Both samples returned GRO and DRO readings of non-detect. Vertical #5 was excavated to a depth of 3 ft bgs. The 2 ft and 3 ft samples were taken to a commercial laboratory for analysis of chlorides and hydrocarbons. The samples returned laboratory chloride readings below 250 mg/kg and GRO and DRO readings of non-detect (Appendix B).

Vertical Sampling Data

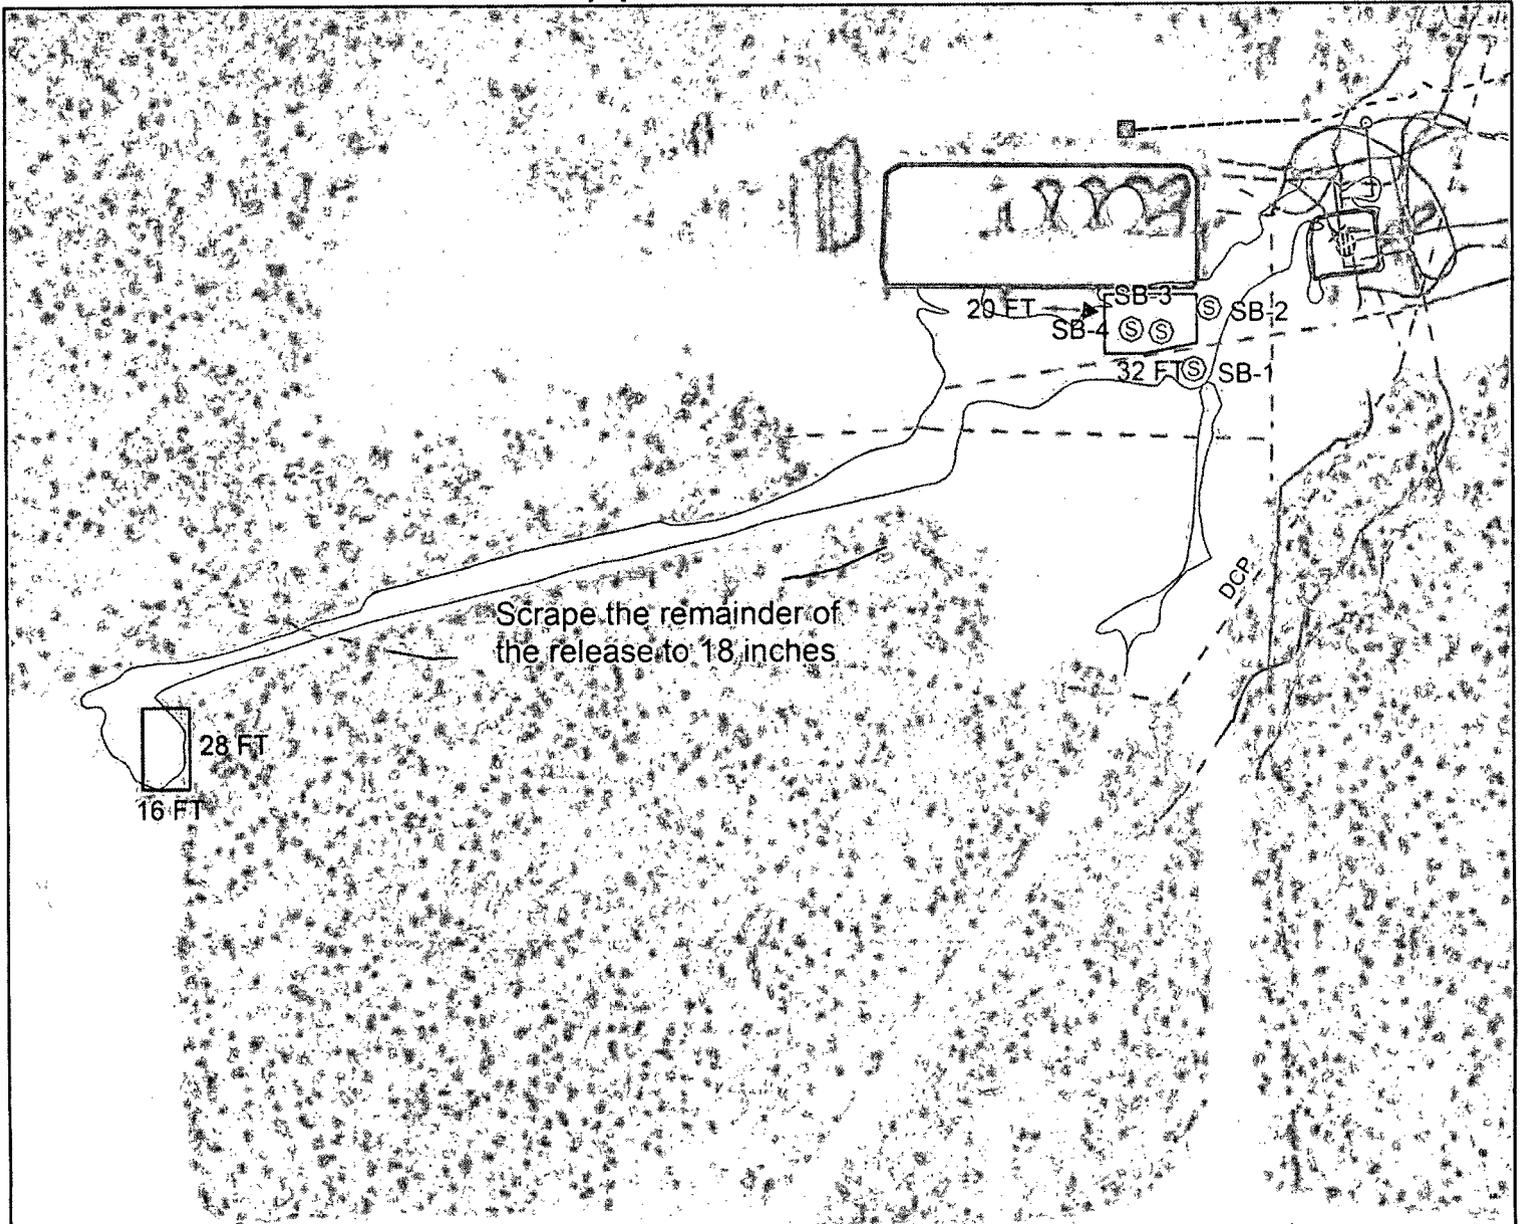
Figure 4

RECS personnel met with NMOCD – District 2 on May 21st, 2013. NMOCD required that the entire release area be scraped down 18 inches. At SB-3, the area was to be scraped down to 1 ft bgs and the soil exported to a NMOCD approved facility. Then the area was to be excavated down another 2 ft bgs and that soil be stockpiled on the site. At 3 ft bgs, a 1 ft thick clay layer was to be installed and then backfilled with the stockpiled soil. In the pasture, to the southwest, the area was to be scraped down 2 ft bgs (Figure 4).

NMOCD Approved Corrective Actions

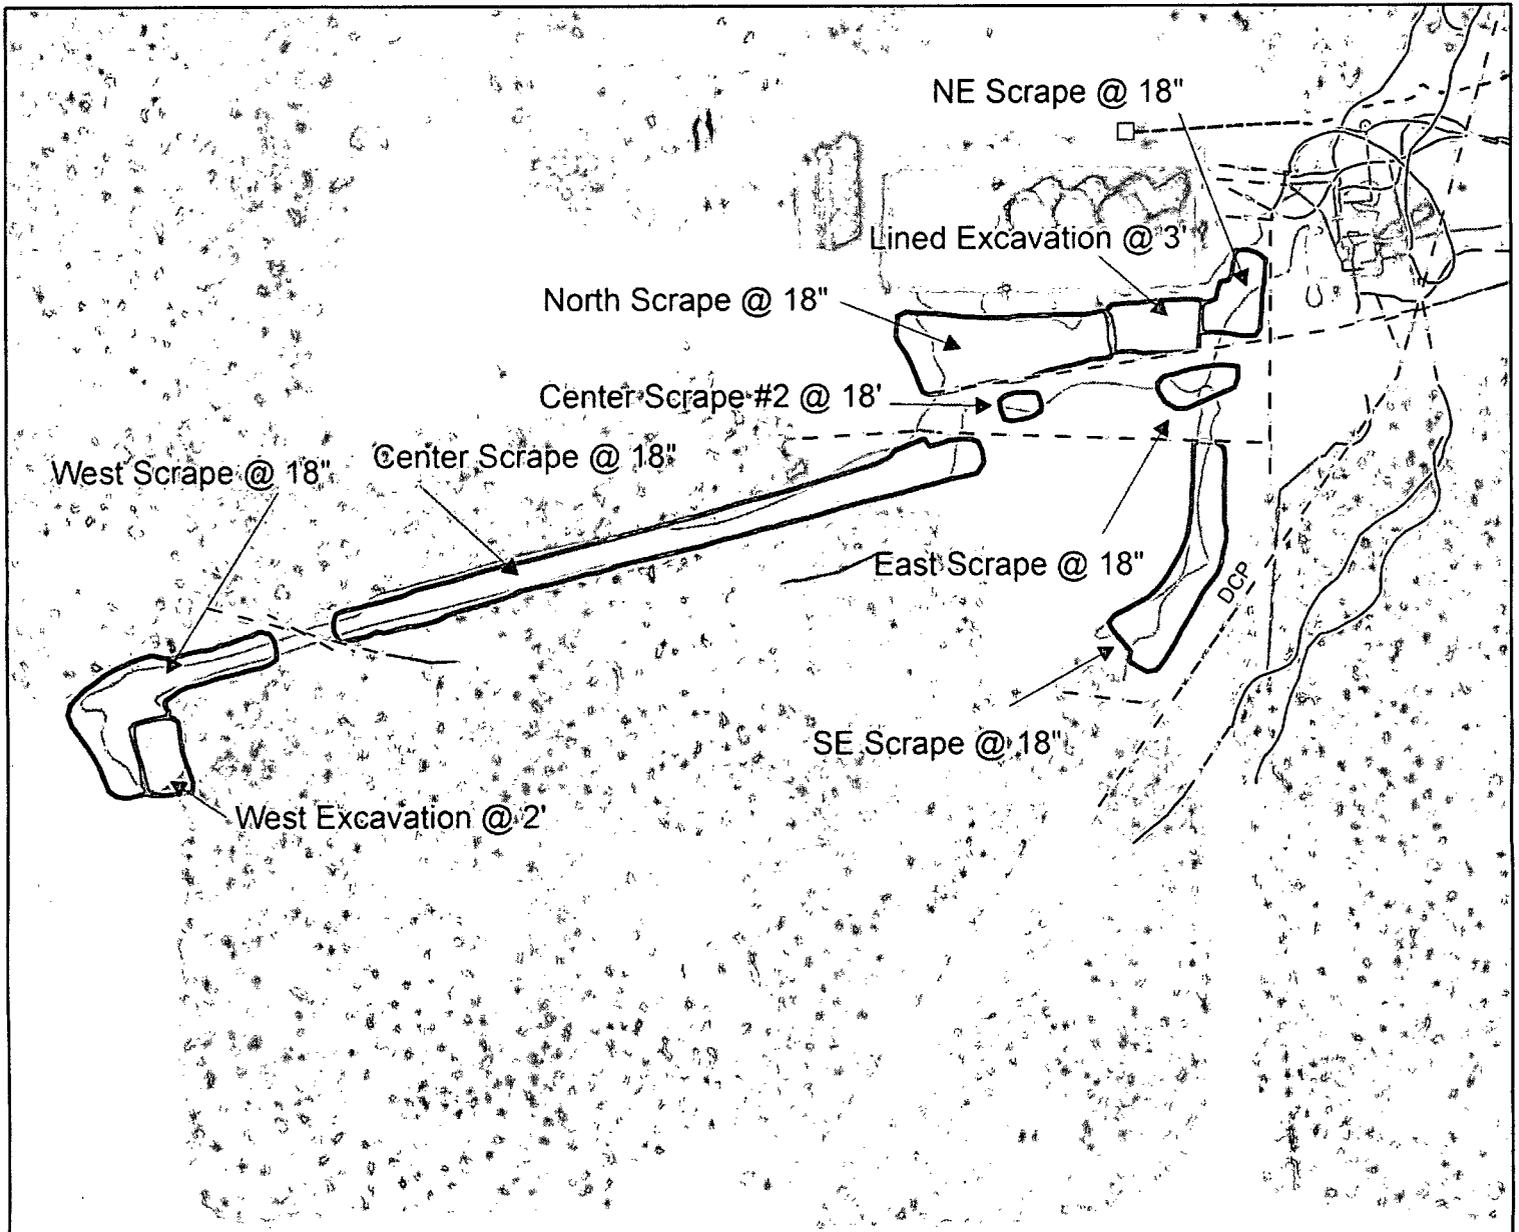
Figure 5

On June 20th, 2013, RECS personnel were on site to begin the scraping and excavation actions (Figure 5). The areas were scraped down as required by NMOCD. A total of 420 yards of excavated soil was taken to NMOCD approved facility for disposal. A total of 440 yards of soil and 12 yards of red clay was imported to the site. The scraped areas were backfilled with the clean, imported soil. At SB-3 at a depth of 3 ft bgs, a 1 ft thick clay layer was installed and properly seated into the excavation. On June 28th, 2013, Pettigrew & Associates was on site to conduct a clay compaction test on the clay layer (Appendix D). The Dry Density Percent Max result was 95.9 and the Percent Moisture result was 11.3. The excavation was then backfilled with the stockpiled soil to bring the excavation back to surface level.

Excavation Data

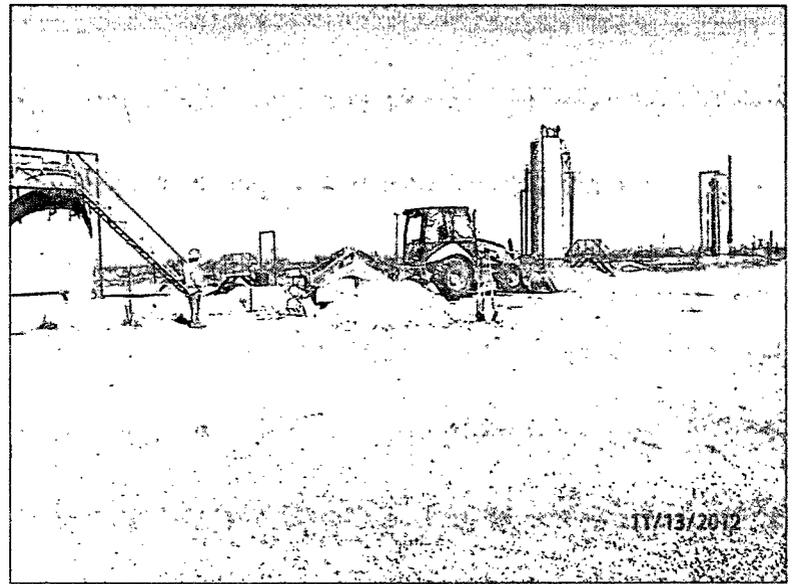
Digging Vertical #1, facing northeast

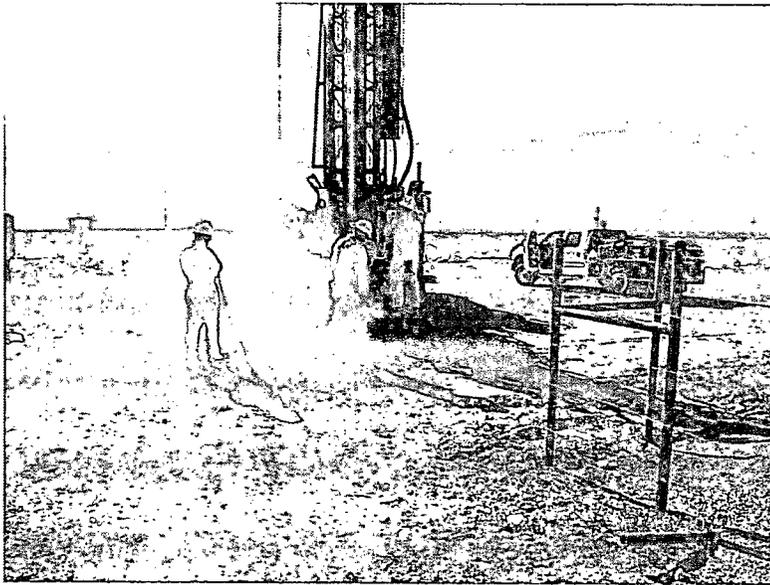
Drilling SB-1, facing south

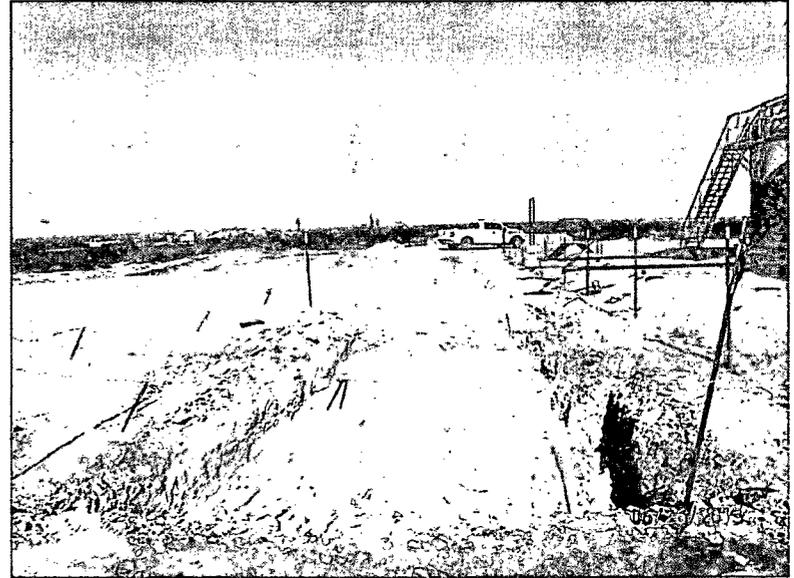
Lined excavation and north scrape completed, facing west 6/26/13

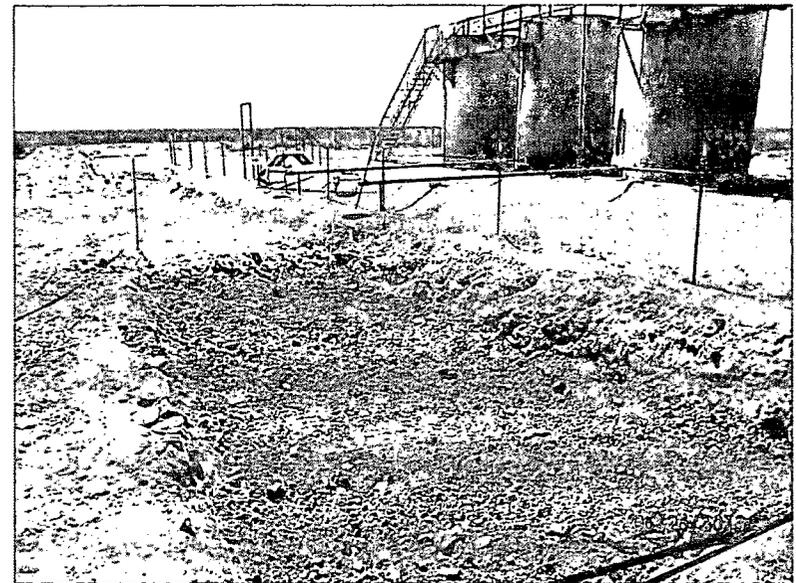
Clay layer installed, facing northwest 6/26/13

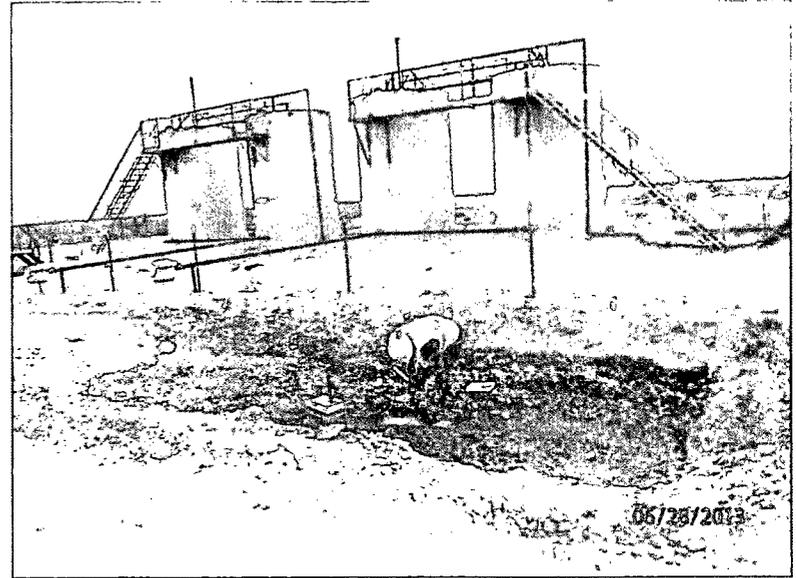
Clay compaction test, facing north
