## **REMEDIATION SUMMARY & SITE CLOSURE REQUEST**

**BOPCO, LP**  
**POKER LAKE UNIT CRUDE OIL GATHERING SYSTEM**  
**Eddy County, New Mexico**  
**Unit Letter "M" (SW/SW), Section 29, Township 24 South, Range 30 East**  
**Latitude 32.181606° North, Longitude 103.909504° West**  
**NMOCD Reference #: 2RP-2102**

February 2014

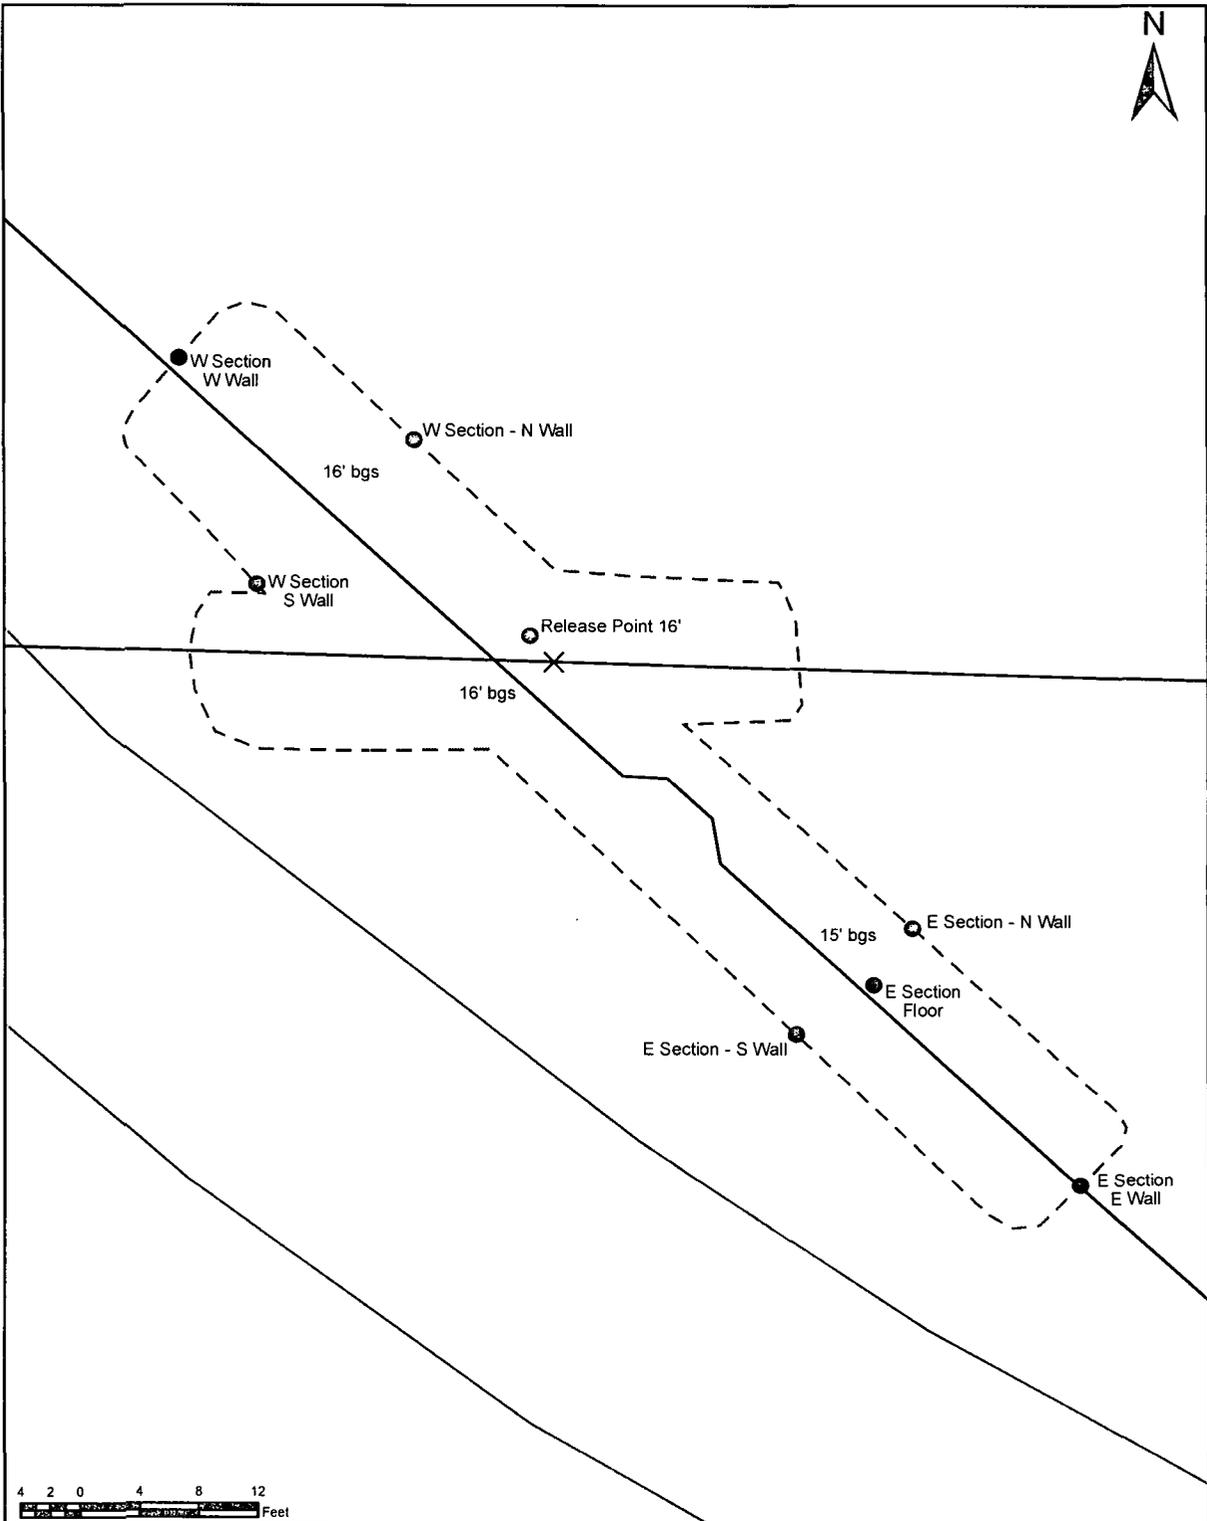
**Figure 2**  
**Site Location Map**  
**BOPCO, LP**  
**PLU Crude Oil Gathering System**  
**Eddy County, New Mexico**  
**NMOCD Reference #: 2RP-2102**

On December 18, 2013, seven (7) soil samples (E Section - N Wall, E Section - E Wall, E Section - S Wall, E Section - Floor, W Section - N Wall, W Section - W Wall, and W Section - S Wall) were collected from the floor and sidewalls of the excavation and submitted to the laboratory for analysis of TPH and chloride concentrations. Laboratory analytical results indicated TPH concentrations ranged from less than the laboratory MDL in soil samples E Section - N Wall, E Section - S Wall, W Section - N Wall, W Section - W Wall, and W Section - S Wall to 1,447 mg/kg in soil sample E Section - Floor. Chloride concentrations ranged from 80.0 mg/kg in soil samples W Section - N Wall and W Section - S Wall to 272 mg/kg in soil samples E Section - N Wall, E Section - E Wall, and E Section - S Wall.

From January 27 through January 28, 2014, the excavation was backfilled, compacted, and contoured to fit the surrounding topography. The final dimensions of the excavation were approximately ninety feet (90') in length, varying in width from approximately ten feet (10') to approximately twenty feet (20'), and varying in depth from approximately eight feet (8') to approximately sixteen feet (16') bgs.

On December 17, 2013, one (1) soil sample (Release Point 16') was collected from the floor of the excavation at the release point. The soil sample was submitted to Cardinal Laboratories in Hobbs, New Mexico, for analysis of BTEX, TPH, and chloride concentrations in accordance with Environmental Protection Agency (EPA) methods SW-846 8021b, SW-846 8015M, and 4500 Cl-B, respectively. Laboratory analytical results indicated BTEX constituent concentrations were less than the appropriate laboratory method detection limit (MDL), the TPH concentration was 49.5 mg/kg, and the chloride concentration was 192 mg/kg. Table 1 summarizes the "Concentrations of Benzene, BTEX, TPH & Chloride in Soil". A "Site & Sample Location Map" is provided as Figure 2. Laboratory analytical reports are provided as Appendix C.

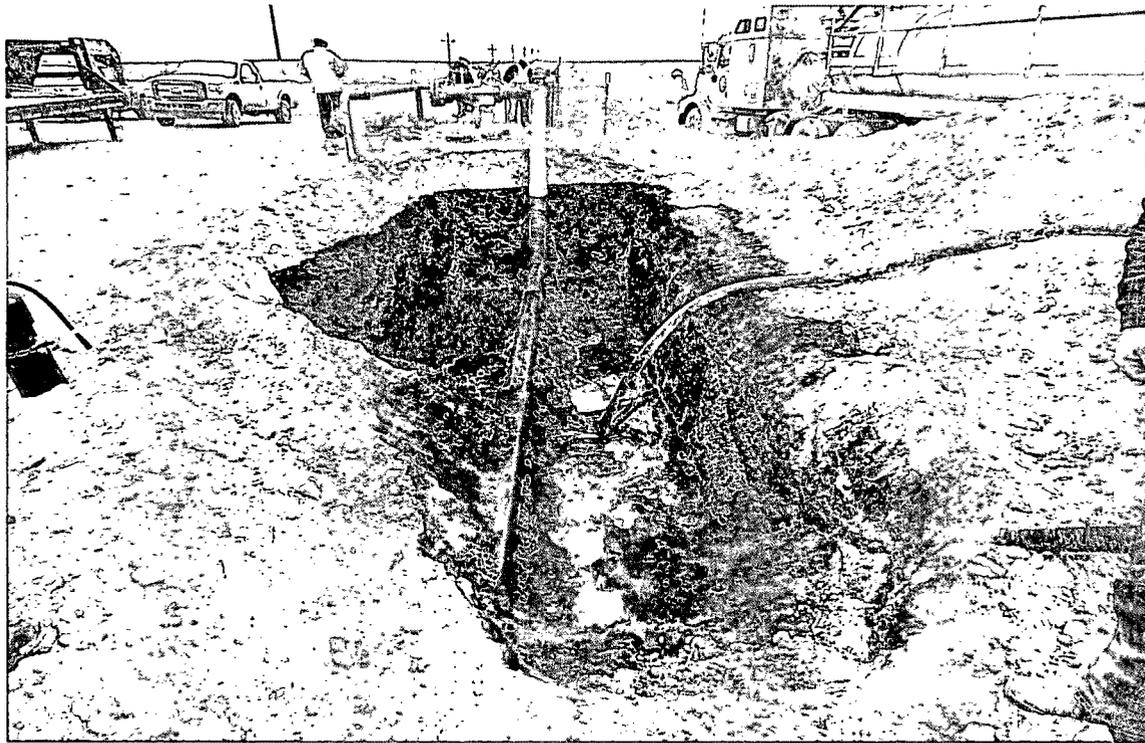
PLU Crude Oil Gathering System - Release Site

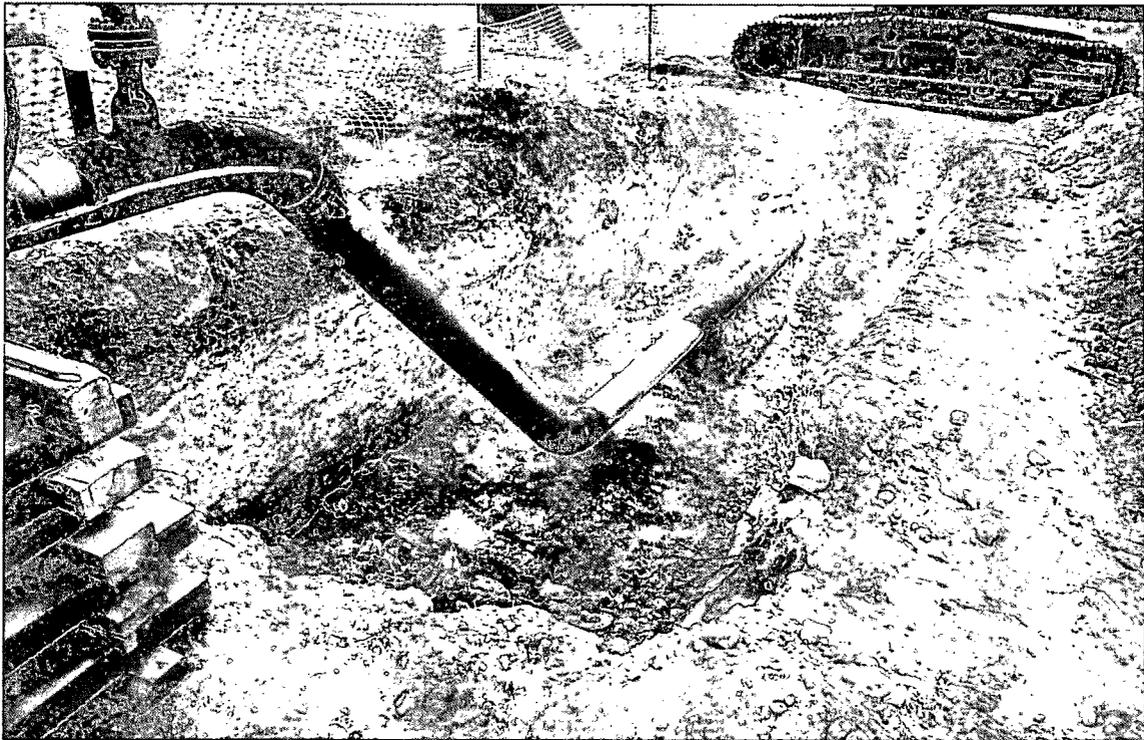
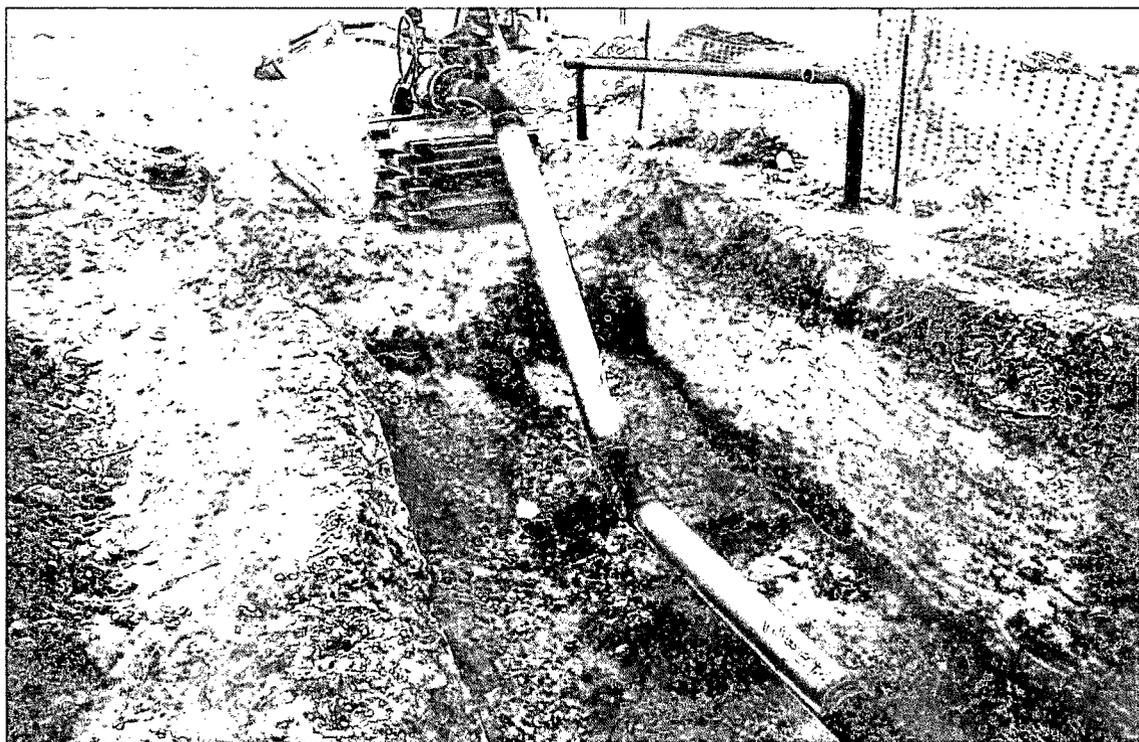
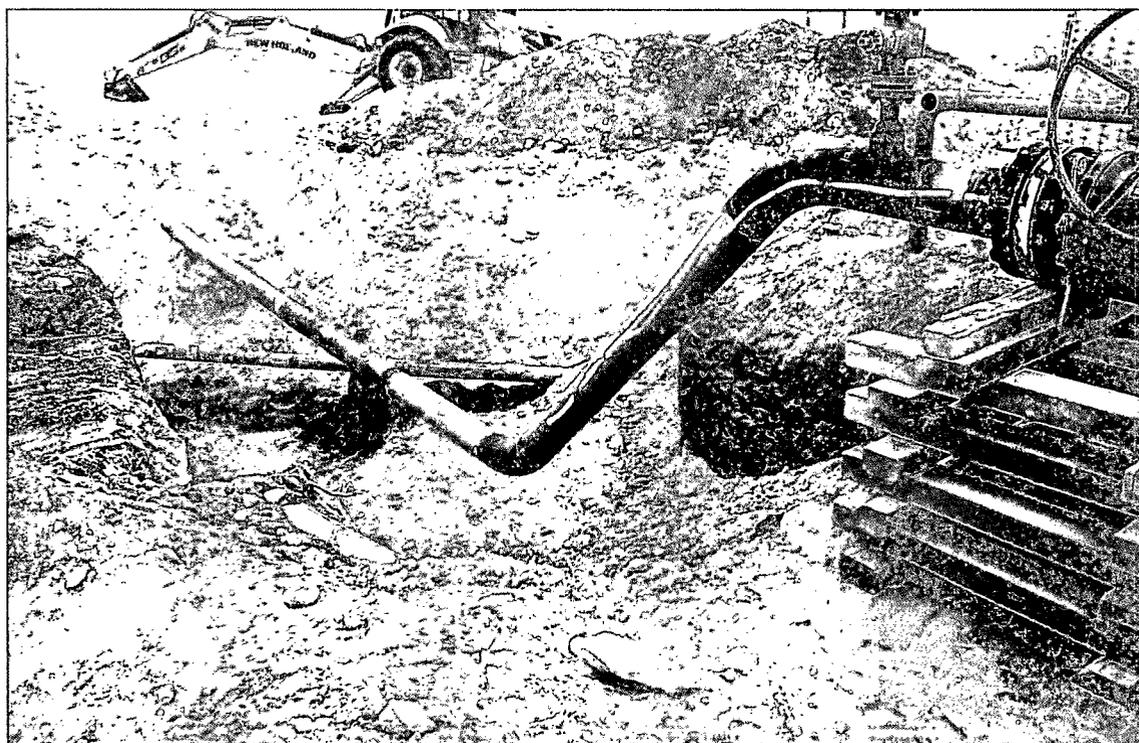
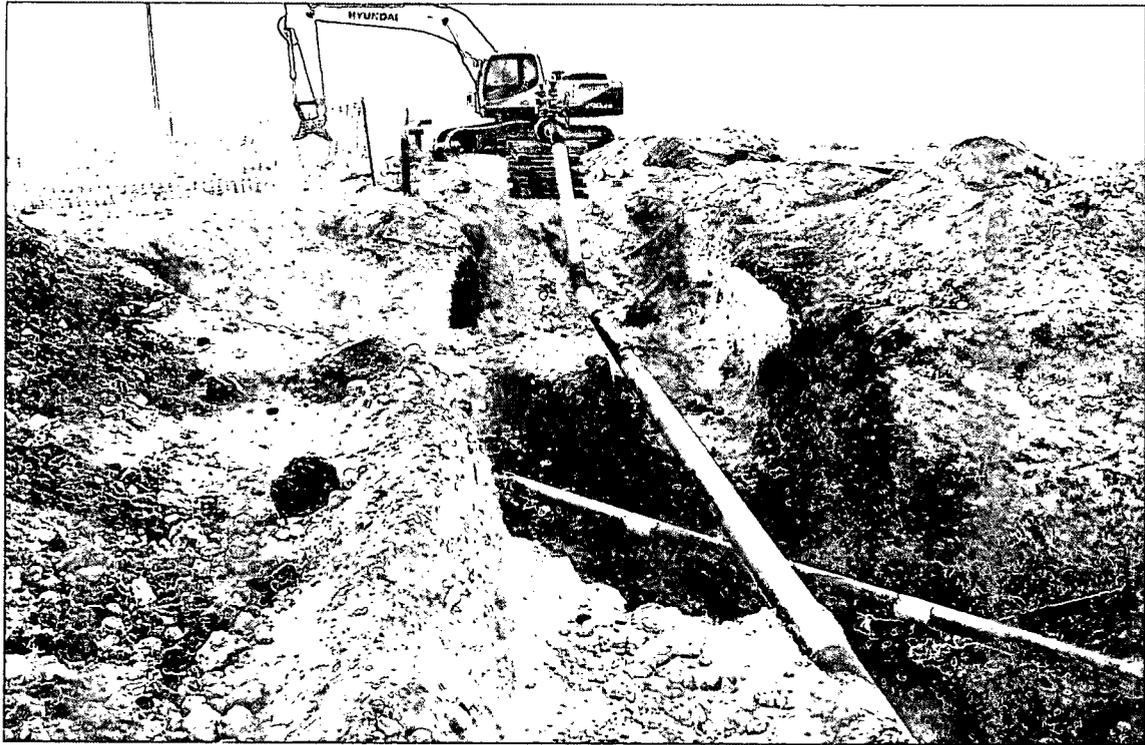
PLU Crude Oil Gathering System - Excavation

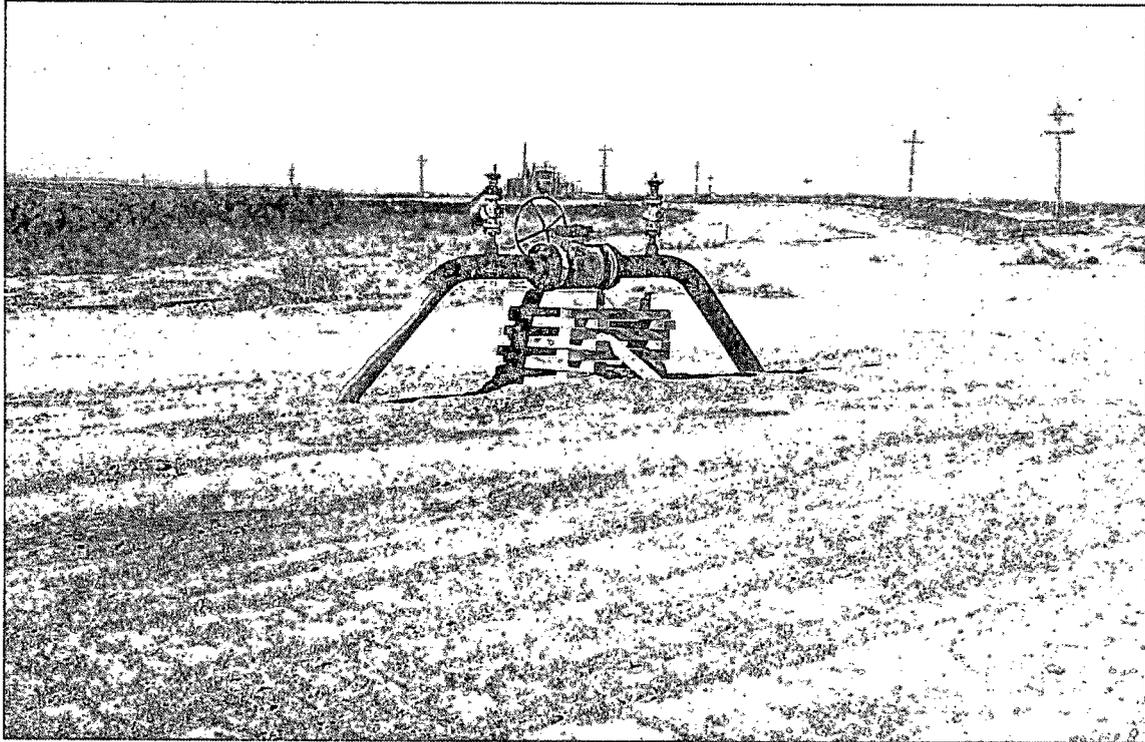
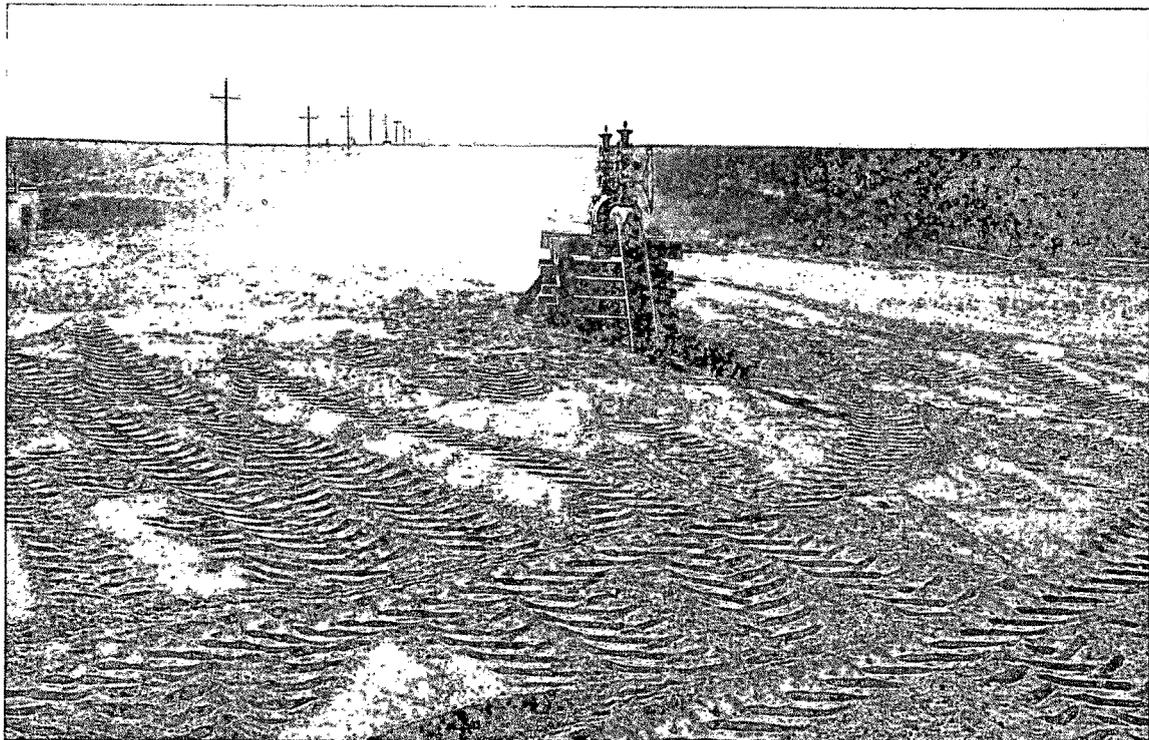
PLU Crude Oil Gathering System – Excavation (Following Backfill)
