RE: **Corrective Action Plan**

Linn Energy – H.E. West B #004 Battery – West B 38

2RP-1864

UL/F sec. 10 T17S R31E

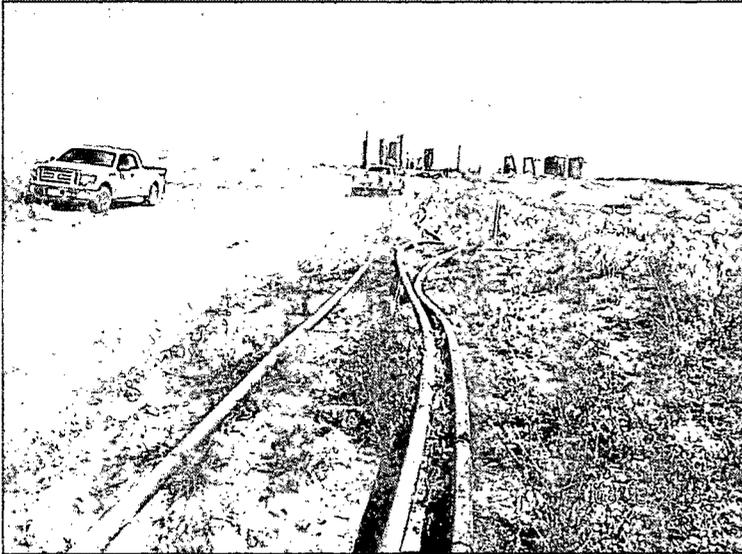
Initial release area, facing north

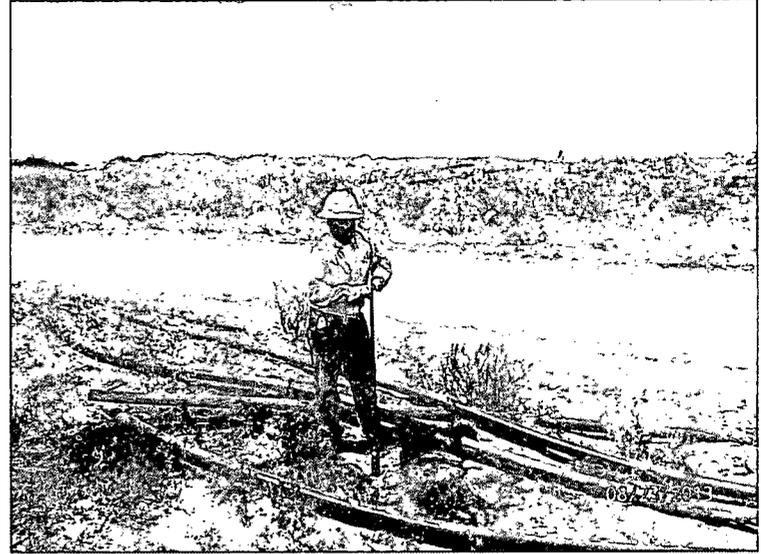
Hand auguring for depth, facing southwest
