# Remediation Summary Report Form

Site Name: JL Keel B 10

State Report No.: 2RP-1181

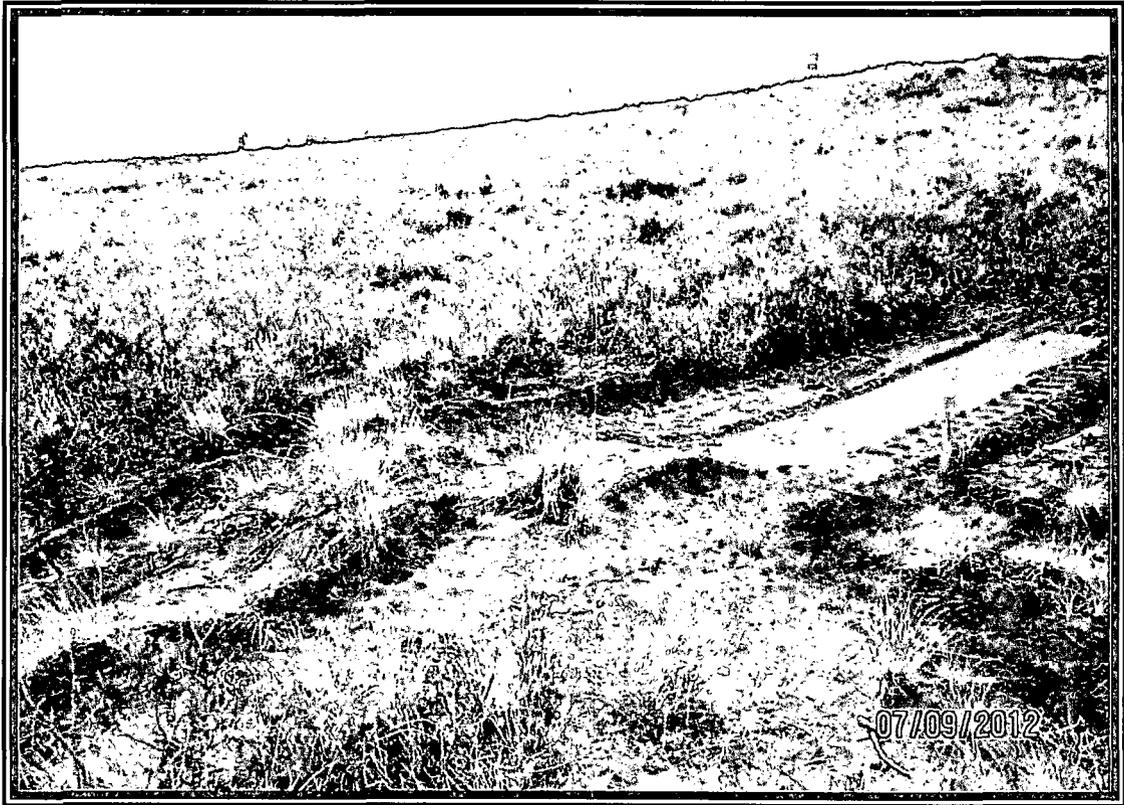
Spill area before excavation.

Impacted soils above regulatory threshold levels were manually and mechanically excavated from the spill area and transported off-site to Lea Land Landfill.

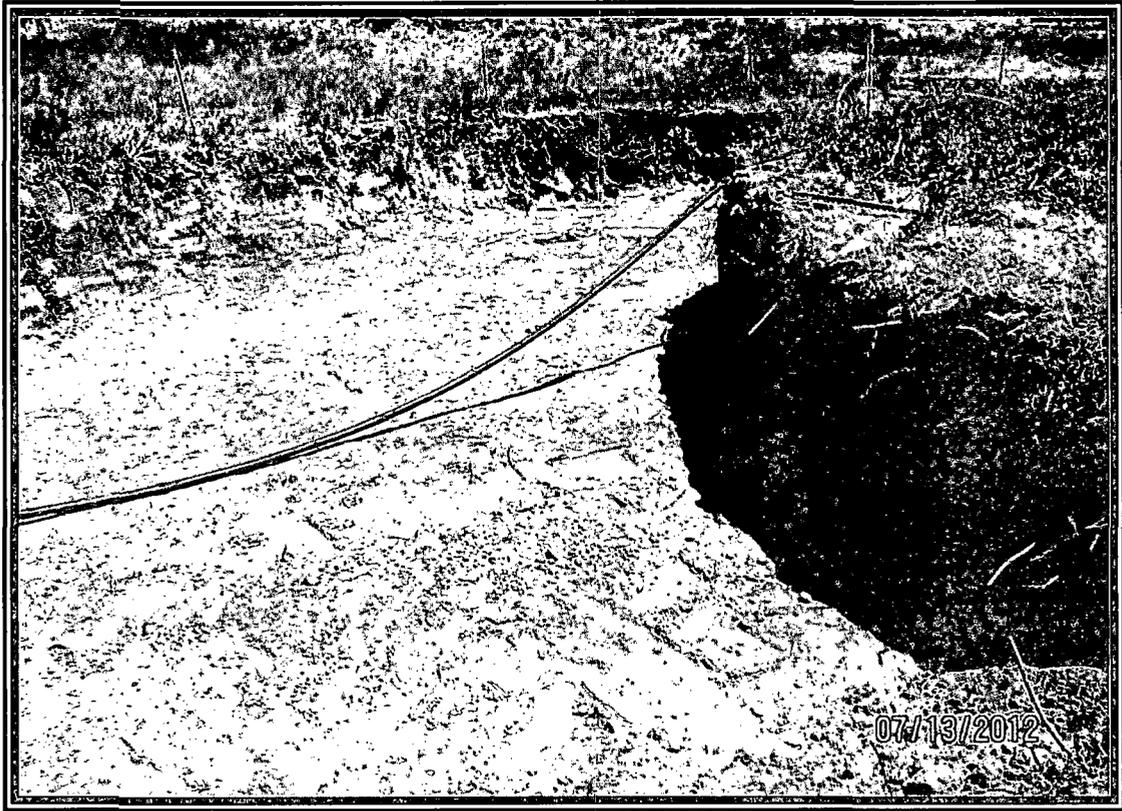
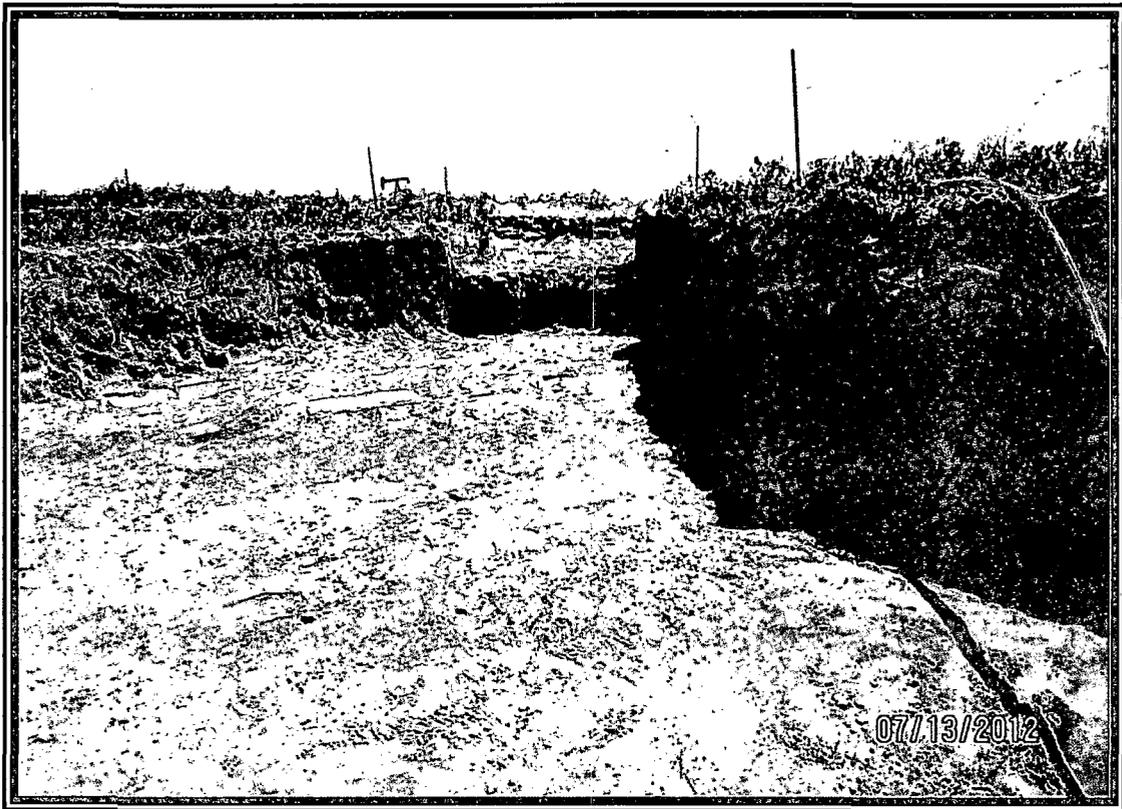
Spill area after excavation.

However, there is still impacted soil at SP1. A soil boring was performed at SP1 to a depth of 15-16 ft. The delineation determined the chloride levels to be 965mg at 16ft. Additional excavation is not practical at this point due to, numerous flow lines that traverse through all parts of the excavation, which restricts any further excavation due to safety concerns.

As discussed in section 5 of the Corrective Action Plan dated June 22, 2012, LINN is proposing to apply a calcium amendment to the bottom of the excavation (gypsum) then backfill with clean compacted fill material to within 1.5 – 2ft of surface then complete the backfill with compatible soil which is conducive to growing vegetation. Using gypsum will effectively assist in ensuring that any residual chlorides in the bottom of the excavation will not migrate further and cause any adverse impact to the reclamation of the site.
