Turner A #11

Closure Report

2RP-1239

**RE: TERMINATION REQUEST
Linn Energy – Turner A #11 AD
UL/P sec. 18 T17S R31E
API No. 30-015-05215
2RP-1239**

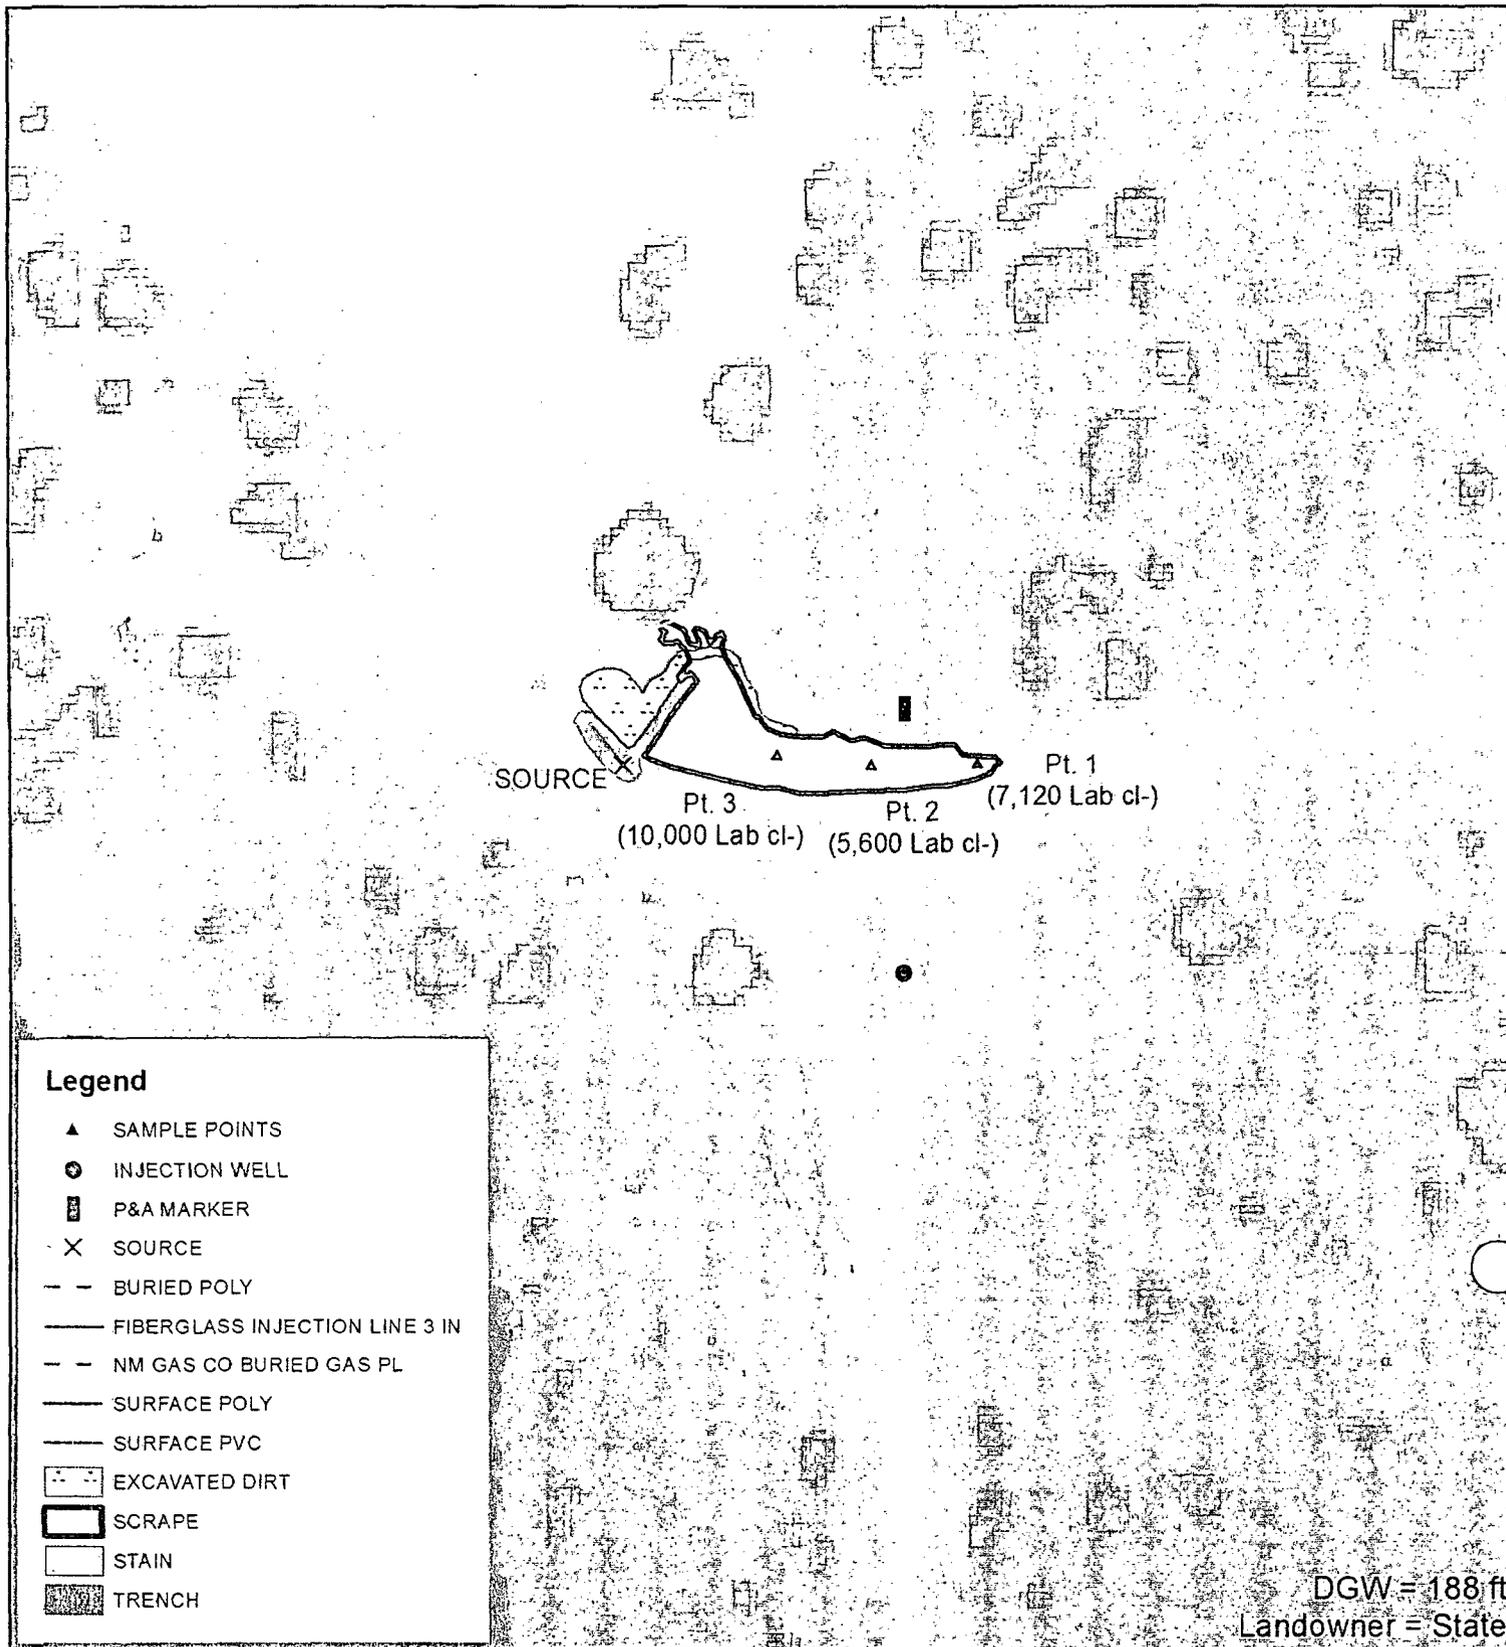
Figure 1

On July 19, 2012, RECS personnel initiated work on the Turner A #11. Soil samples were collected from ground surface and submitted to a commercial laboratory for chloride analysis (Figure 1). Chlorides ranged from 5,600 mg/kg to 10,000 mg/kg.

Site Plat

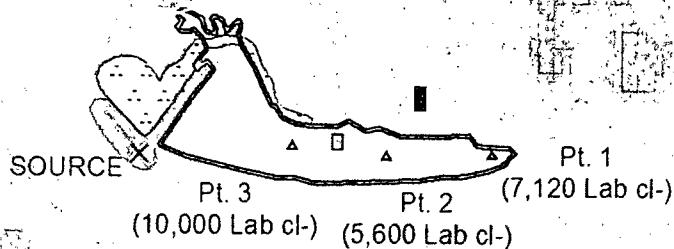
Figure 2

The leak area was scraped to less than 6" below ground surface (bgs). On August 9, 2012, soil samples were collected from Vertical #1 within the scraped area and field tested for chloride. Headspace measurements were also taken in the field using a Photo Ionization Detector (PID) (Figure 2). The samples from the scraped area surface, 1'6" bgs, and 2' bgs were submitted to a laboratory for chloride and TPH (GRO/DRO) analyses (Appendix C). The surface sample contained 2,360 mg/kg chloride and <10 mg/kg TPH. At 1'6" bgs, chloride was 112 mg/kg and TPH was <10 mg/kg. At 2' bgs, chloride was 64 mg/kg and TPH was <10 mg/kg.

Site Plat

VERTICAL #1					
Sample Description	Cl-	PID	LAB Cl-	GRO	DRO
Surface after scrape	2039	2.3	2360	<10	<10
6"	984	1.4			
1'	464	1.3			
1'6"	141	1.3	112	<10	<10
2'	119	1.3	64	<10	<10

Based on the results from laboratory analyses, the leak area was excavated to 1 ft. bgs. Impacted soils, totaling 40 yards, were removed to a NMOCD approved disposal facility. The excavation was backfilled with 48 yards of clean imported caliche (chloride 32 mg/kg – Appendix C), and the site was compacted and leveled. See Appendix B for photographs of field activities.

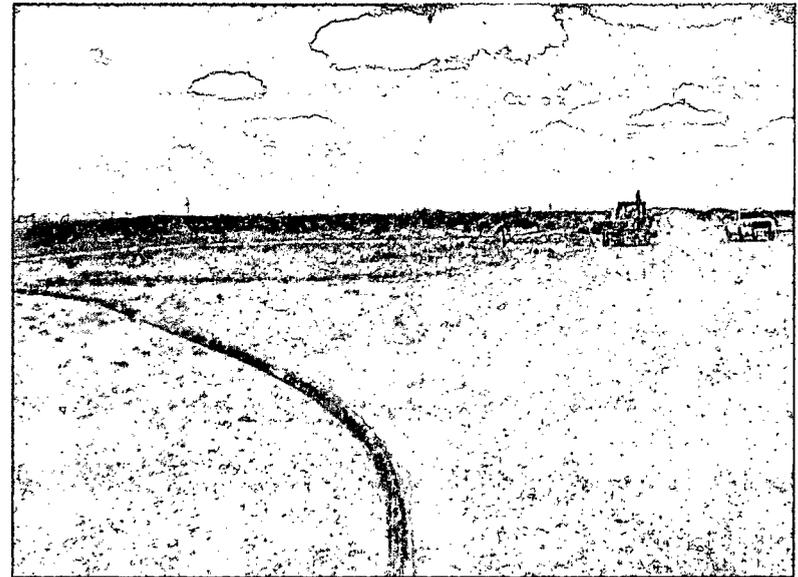
Initial release on road, facing northeast

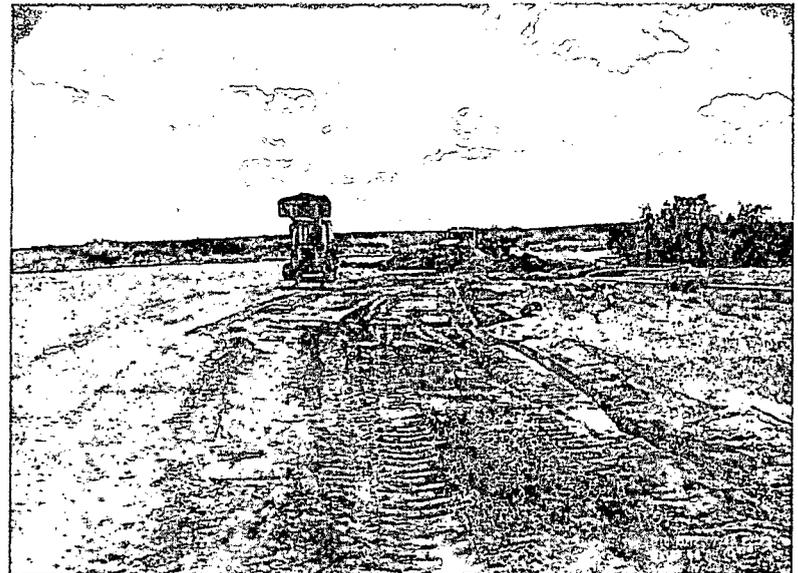
Scraping leak, facing west

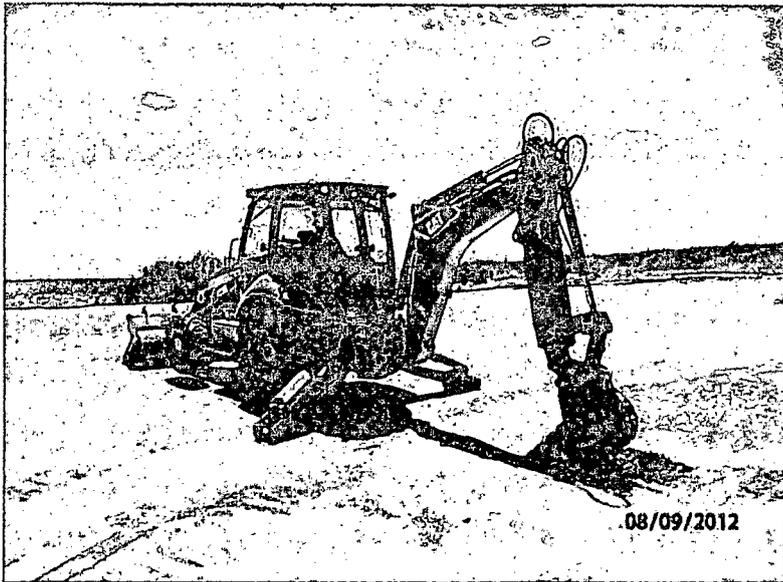
Digging vertical, facing south

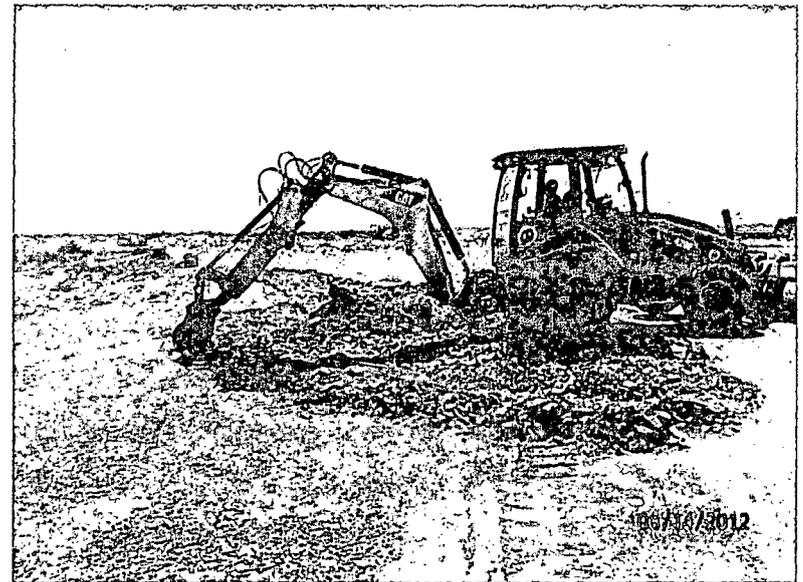
Excavating leak, facing east

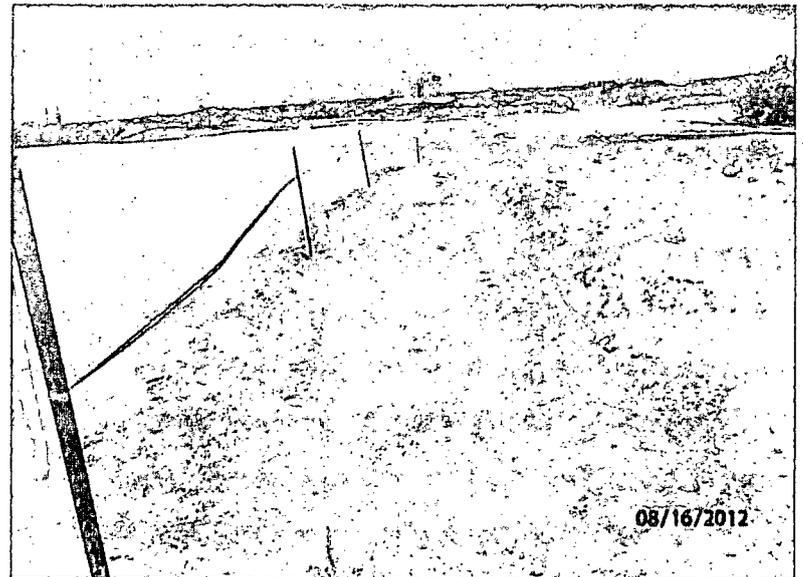
Final excavation, facing west

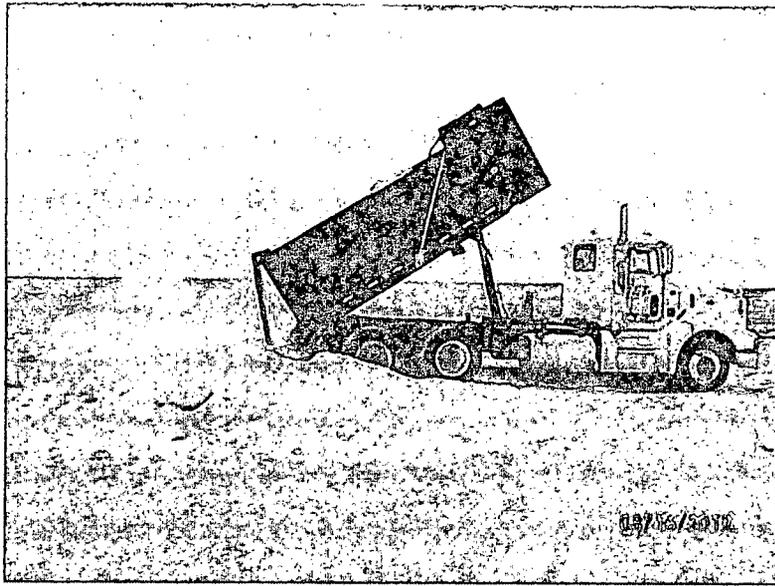
Importing caliche, facing south

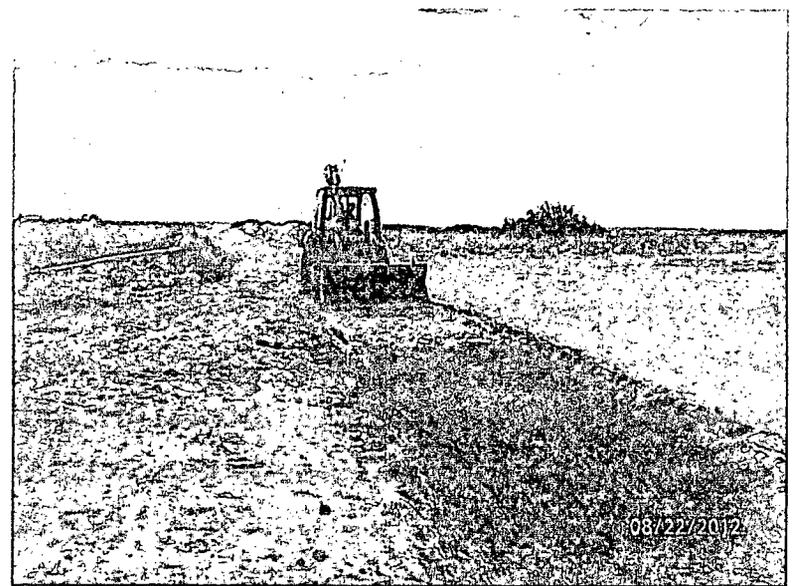
Backfilling, facing east
