Linn Energy Turner B #8

CLOSURE REPORT

2RP-1110

Unit Letter B, Section 20, Township 17 South, Range 31 East

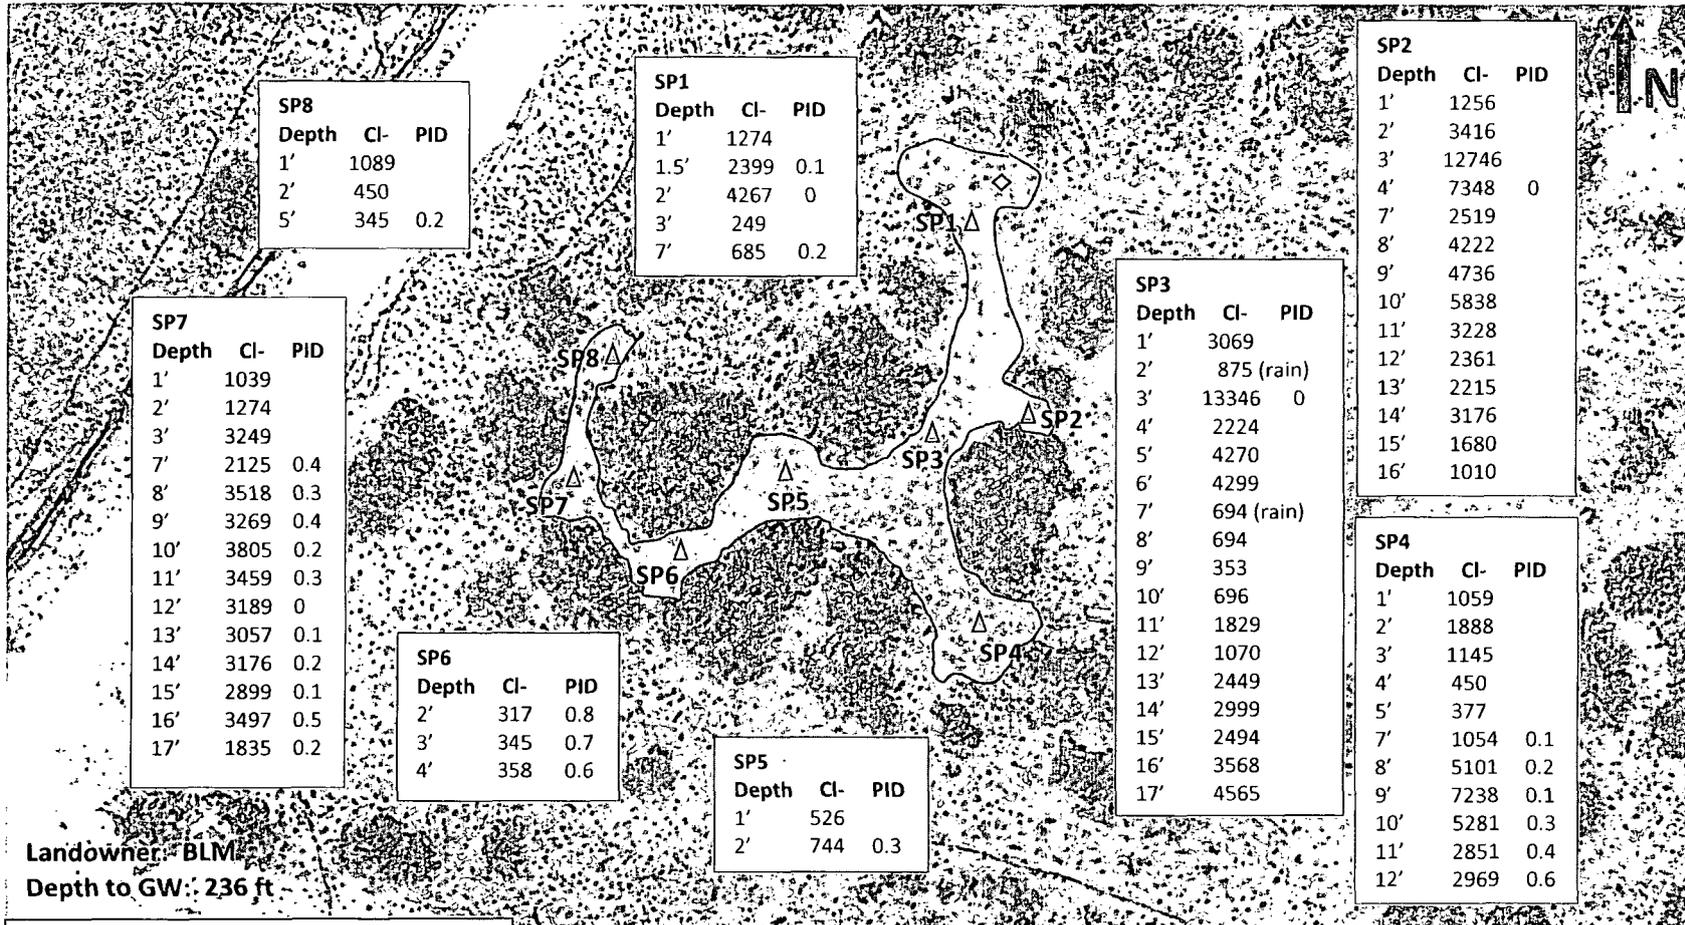
Leak Area and Sample Points

SP8		
Depth	CI-	PID
1'	1089	
2'	450	
5'	345	0.2

SP1		
Depth	CI-	PID
1'	1274	
1.5'	2399	0.1
2'	4267	0
3'	249	
7'	685	0.2

SP2		
Depth	CI-	PID
1'	1256	
2'	3416	
3'	12746	
4'	7348	0
7'	2519	
8'	4222	
9'	4736	
10'	5838	
11'	3228	
12'	2361	
13'	2215	
14'	3176	
15'	1680	
16'	1010

SP7		
Depth	CI-	PID
1'	1039	
2'	1274	
3'	3249	
7'	2125	0.4
8'	3518	0.3
9'	3269	0.4
10'	3805	0.2
11'	3459	0.3
12'	3189	0
13'	3057	0.1
14'	3176	0.2
15'	2899	0.1
16'	3497	0.5
17'	1835	0.2

SP6		
Depth	CI-	PID
2'	317	0.8
3'	345	0.7
4'	358	0.6

SP5		
Depth	CI-	PID
1'	526	
2'	744	0.3

SP3		
Depth	CI-	PID
1'	3069	
2'	875 (rain)	
3'	13346	0
4'	2224	
5'	4270	
6'	4299	
7'	694 (rain)	
8'	694	
9'	353	
10'	696	
11'	1829	
12'	1070	
13'	2449	
14'	2999	
15'	2494	
16'	3568	
17'	4565

- Stained Area (total 12,960 ft²)
- Leak Source
- Sample Point

The site is located southwest of Maljamar NM, Unit letter 'B', sec. 20, T17S R31E, in Eddy County. The impact to this site resulted from a compromise to the injection line at the collar due to corrosion around the threads. Linn Energy shut in the line at the header and repaired the line. Linn Energy took proactive measures by injecting fresh water combined with soap in order to force the fluids to surface. There was approximately 12,960 sq. ft. of impacted area. DFSI was retained to fully remediate the site. (Figure).

On February 27, 2014 DFSI submitted a proposed remediation plan for the above aforementioned site to the BLM, and NMOCD respectively, complete with a site excavation diagram (Figure). Whereby, it was noted that the site had been previously excavated to 6ft. bgs. DFSI proposed to backfill to 4ft. bgs., install a 20 mil liner, and backfilled with fresh topsoil. The plan was conditionally approved on February 27, 2014: liner key set on sides of excavation, and knocking sidewalls in on the liner in order to ensure enough ground cover to establish a sound root zone for vegetation (Appendix V).

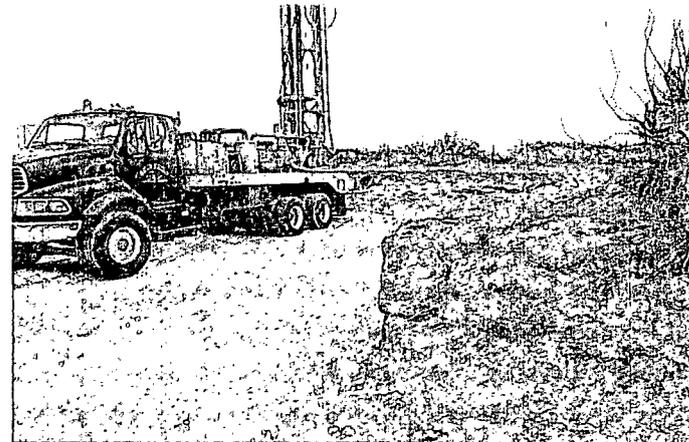
Drilling soil bore 2/18/14

DFSI personnel delineated SP2 by 1ft. intervals and field tested for chloride, however at 17ft. bgs., auger refusal was encountered. Therefore, on February 17, 2014 a drill point (hereinafter referred to as SB2), was established and bored to a depth of 70 ft. bgs. This soil bore sample was sent to a commercial laboratory for confirmation, whereby the results returned were as follows for SB2: chloride content was 176 mg/kg, BTEX, DRO and GRO were non-detect.

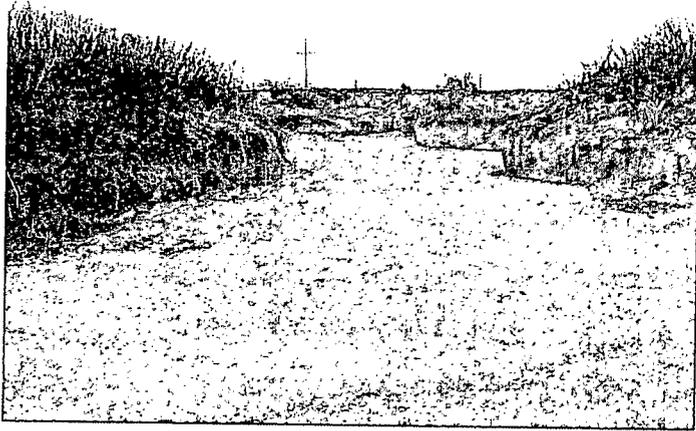
Backfill of excavation to 4 ft. 3/3/14

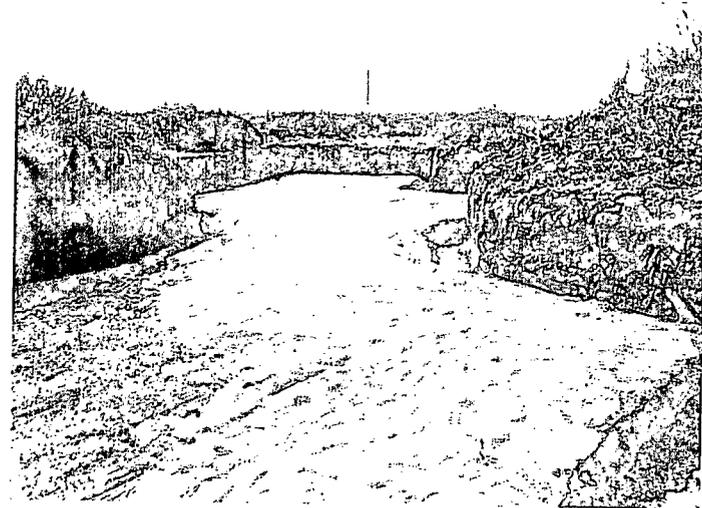
Backfill of excavation to 4 ft. 3/10/14
