RE: TORRO OPERATING HOBBS BATTERY

Torro Operating
Hobbs Battery

Attachment 4

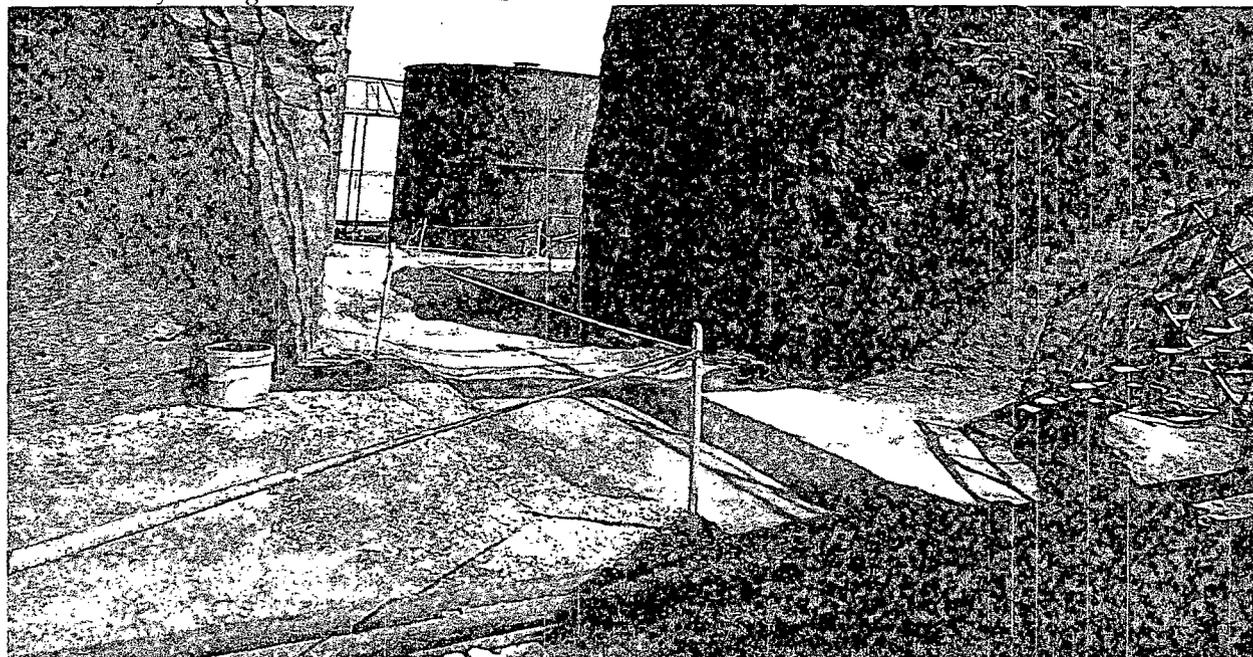
Main Battery Facing North Excavation @2'

Based upon the initial delineation results, the main battery in and around the tanks, was excavated by hand down to approximately 3' (BGS). At Approximately 3' (BGS) hard rock was encountered and further excavation using hand tool was not possible nor was it safe to continue digging due to the tanks. Soil samples were obtained and analyzed for CL, TPH and BTEX. Results were presented to OCD along with the explanation the further excavation was not possible. OCD recommendation was to conduct a soil boring inside the battery to determine the extent of the downward migration of contaminants.

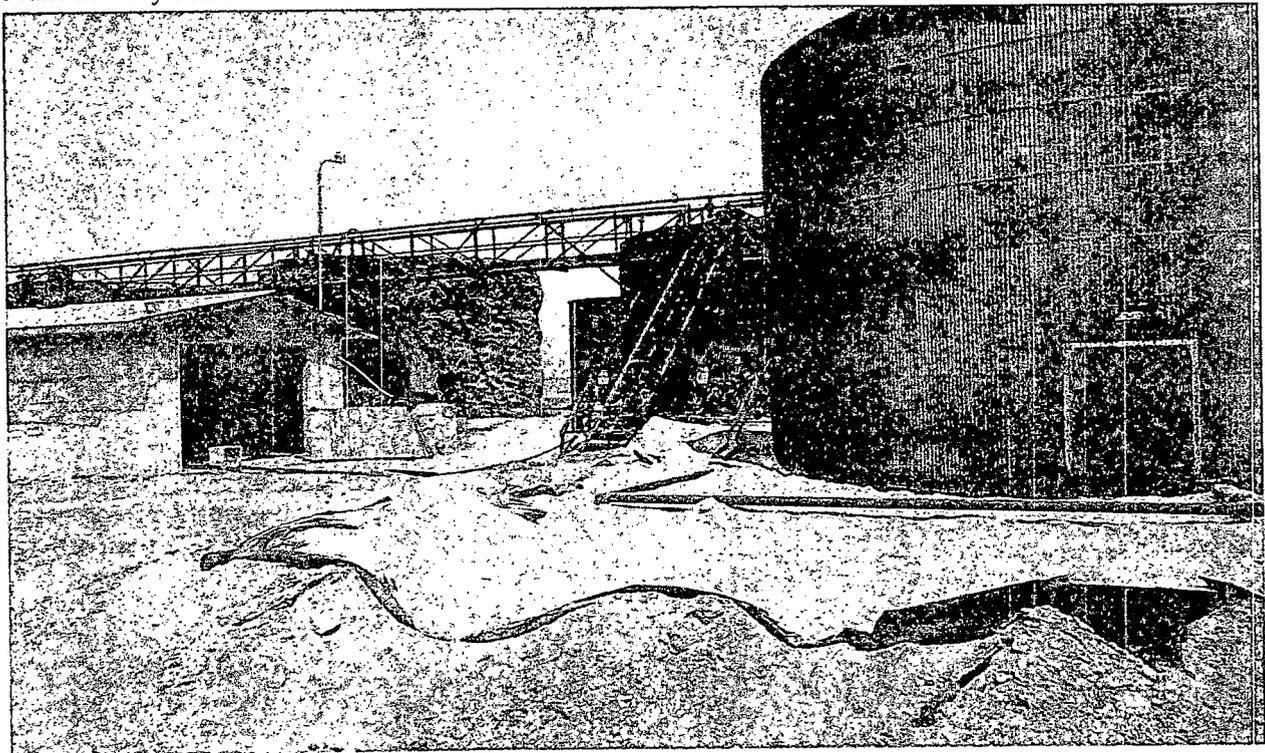
Main Battery Plastic Liner @3' BGS
