EBDU Satellite #2

Closure Report

API 30-025-06548

**RE: TERMINATION REQUEST
Apache – EBDU Satellite #2 AD
UL/C sec. 12 T21S R37E
API No. 30-025-06548**

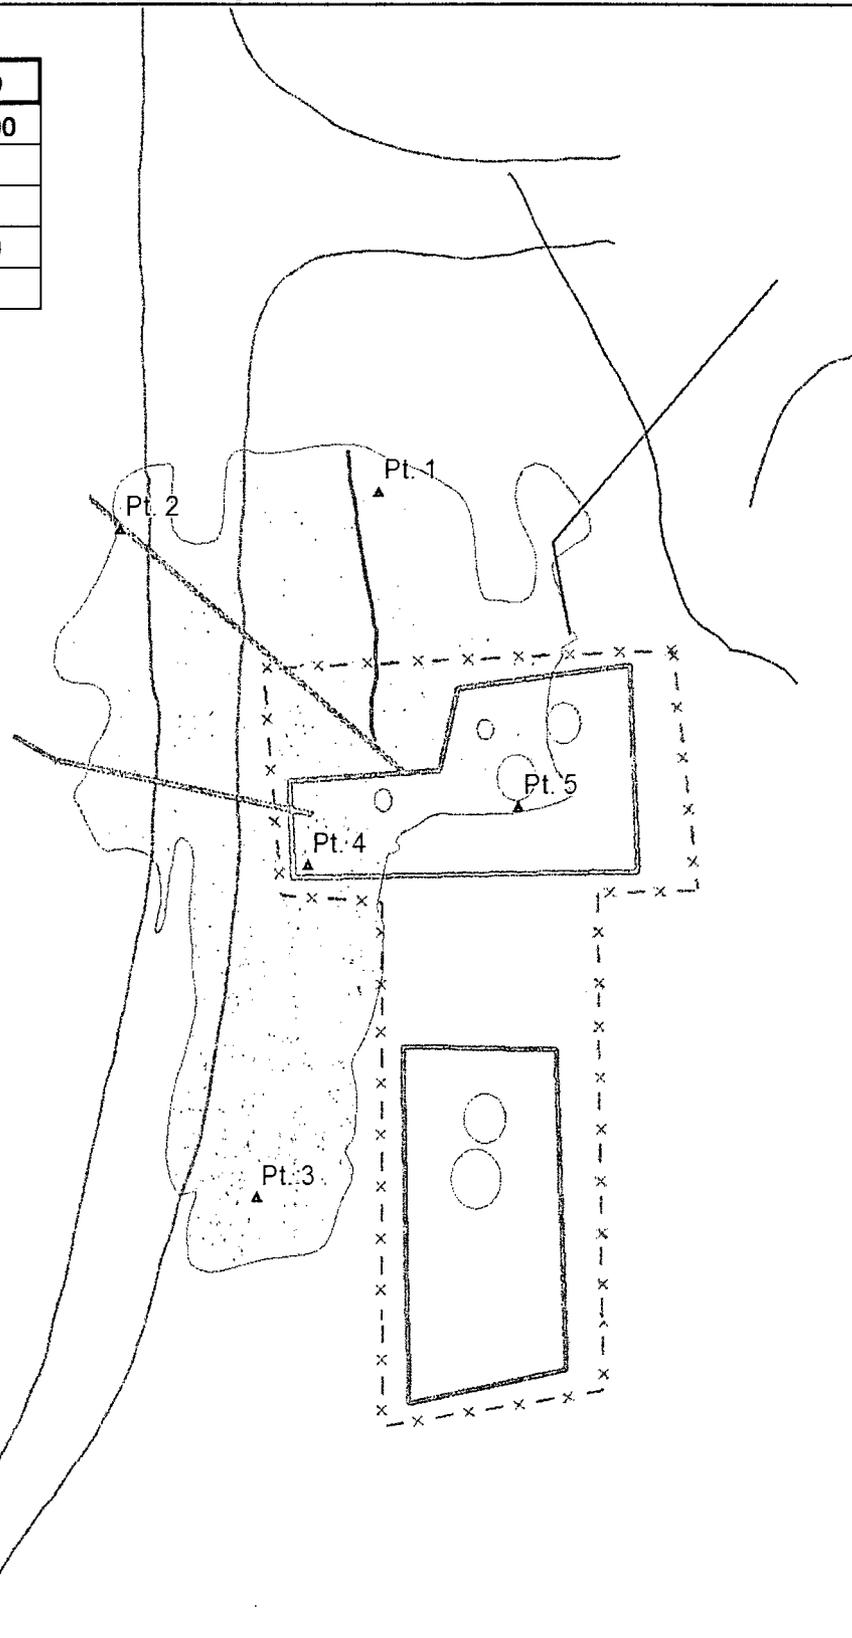
Figure 1

On November 10, 2011, RECS personnel initiated work on the EBDU Satellite #2. Surface soil samples were collected and field tested for chloride. Headspace measurements were also taken in the field using a Photo Ionization Detector (PID) (Figure 1). The samples were submitted to a commercial laboratory for chloride and TPH (GRO/DRO) analyses (Appendix C). Chloride was 480 ppm (parts per million or mg/kg) in the Pt.3 sample and 208 ppm or less in the remaining samples. TPH totaled 19,570 ppm in the Pt.1 sample and 282 ppm or less in the remaining samples.

Initial Sampling Data

INITIAL LAB DATA

Sample Description	Cl-	GRO	DRO
PT.1	208	7,870	11,700
PT.2	80	15.4	229
PT.3	480	<10	282
PT.4	<16	<10	73.9
PT.5	48	<10	<10

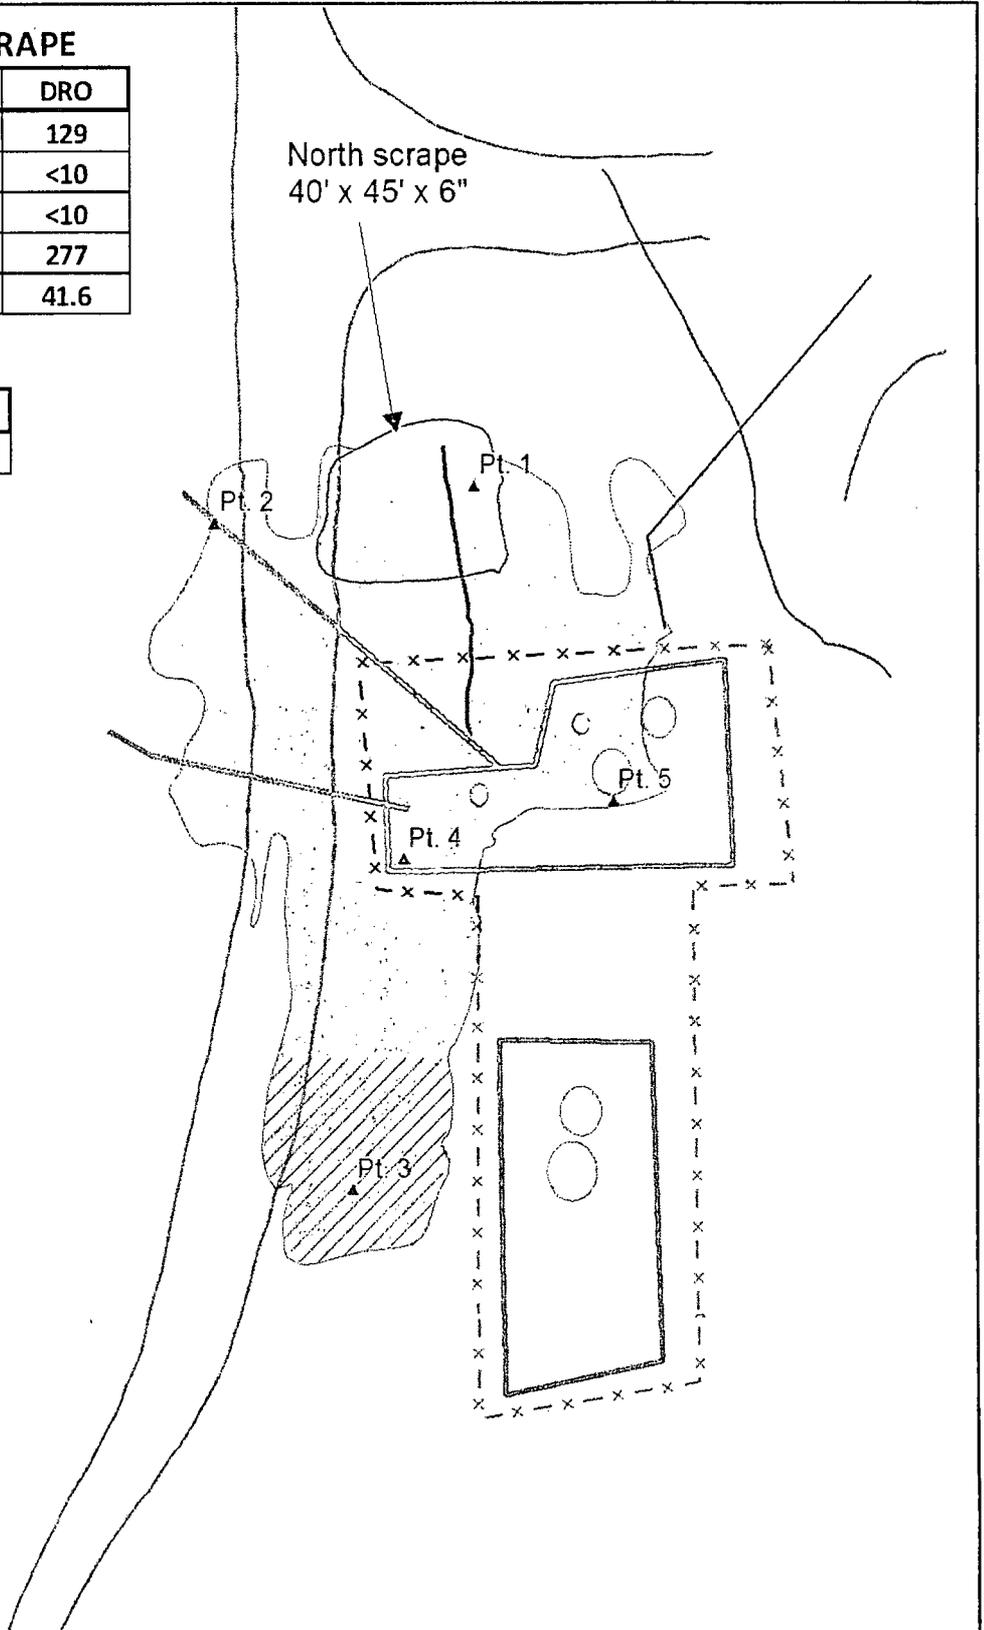
Figure 2

The areas in the vicinity of Pt.1 and Pt.3 were scraped to a depth of 6 inches (Figure 2). On November 14, 2011, RECS personnel collected representative grab samples from the walls and a composite sample from the floor of the excavation at Pt.1. The samples were field tested with a PID and chloride test. The samples were submitted to a commercial laboratory for chloride and TPH analyses (Appendix C). In all samples, chloride did not exceed 80.0 ppm, and TPH did not exceed 277 ppm. RECS personnel also collected a sample from the excavation floor at Pt.3, and

Final Sampling Data

FINAL LAB DATA - NORTH SCRAPE

Sample Description	Cl-	GRO	DRO
North wall	80	<10	129
South wall	<16	<10	<10
East wall	<16	<10	<10
West wall	<16	<10	277
5 pt. bottom comp.	<16	<10	41.6

Pt. 3 FIELD DATA

Sample Description	Cl-	PID
Pt. 3 @ 6"	145	2

tested the sample using the field-adapted Standard Method 4500 Cl- B which showed chloride reduced to 145 ppm.

Impacted soils were removed from the excavation and transported to a NMOCD approved disposal facility. The excavation was backfilled with clean caliche and contoured to the surrounding area. See Appendix B for photographs of field activities.

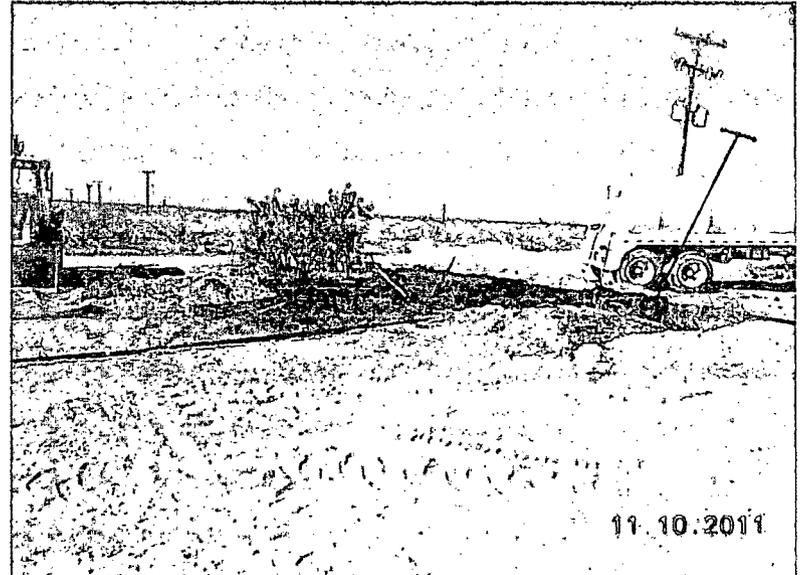
Stained area, facing northwest

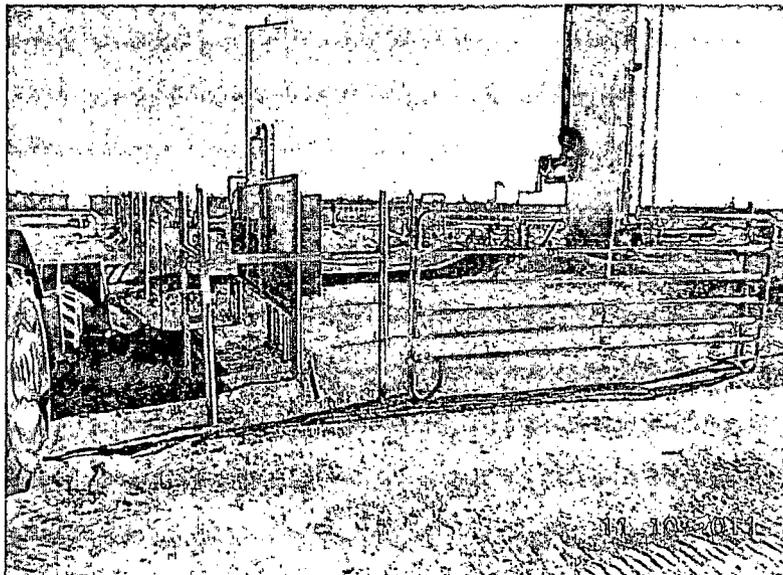
Stained area, facing southwest

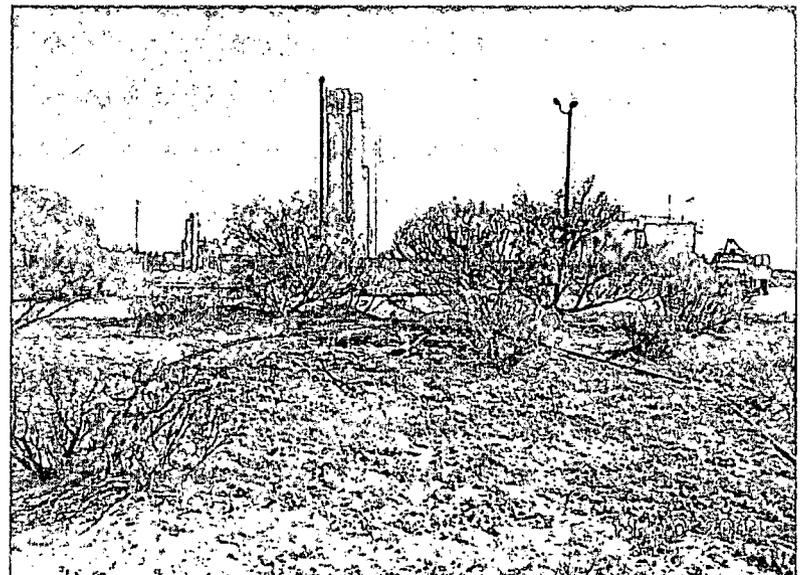
Stained area, facing west

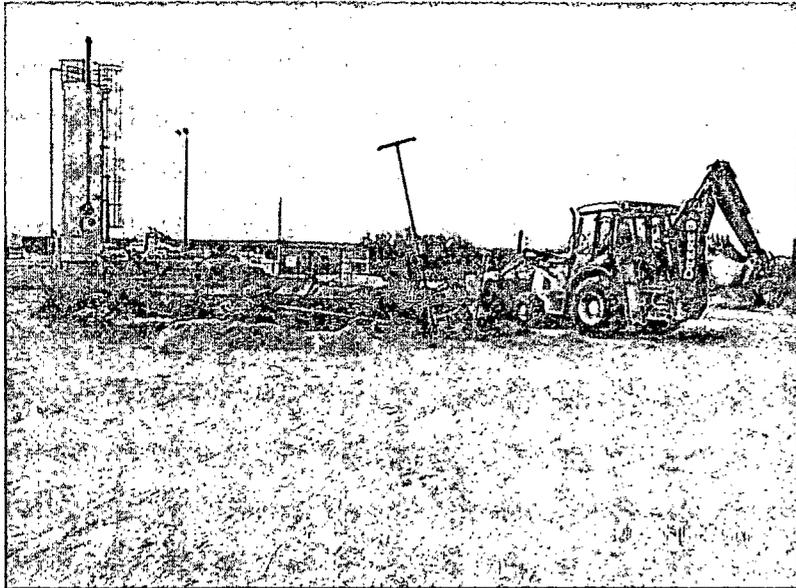
Scraping site, facing west

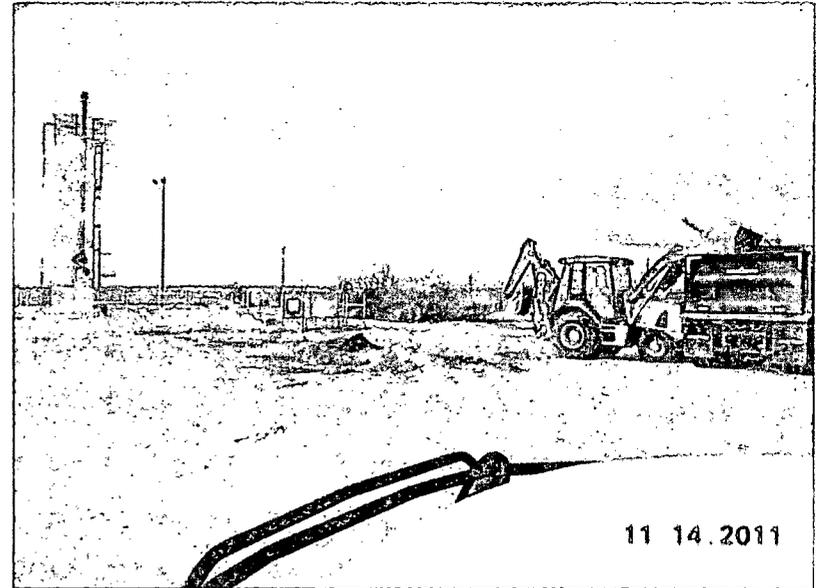
Exporting soil, facing southwest

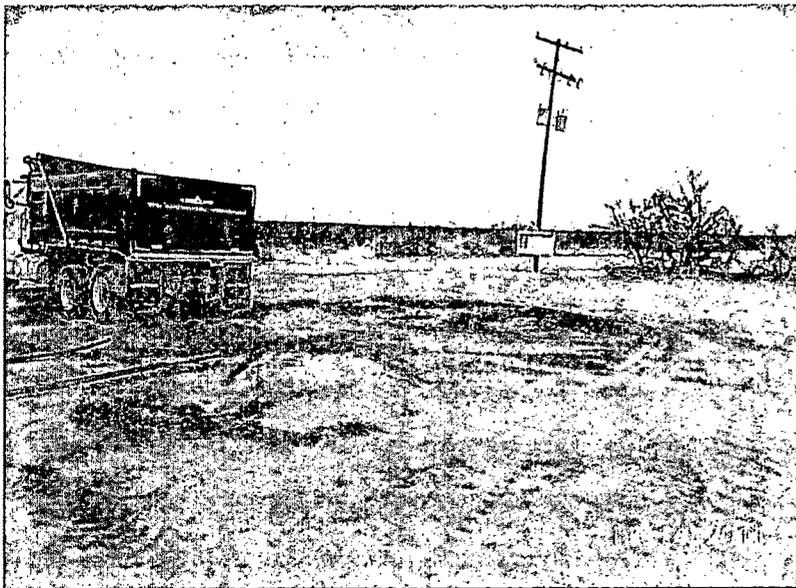
Completed scrape, facing northwest

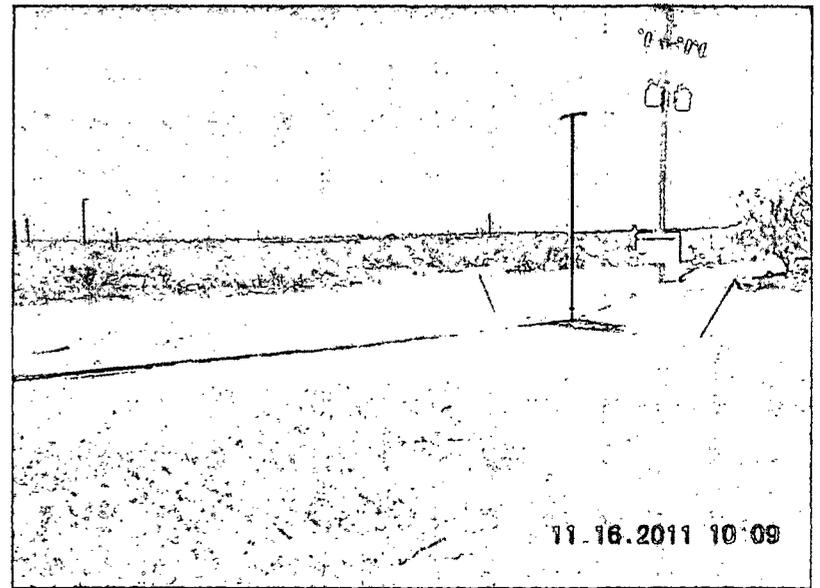
Completed site, facing northwest

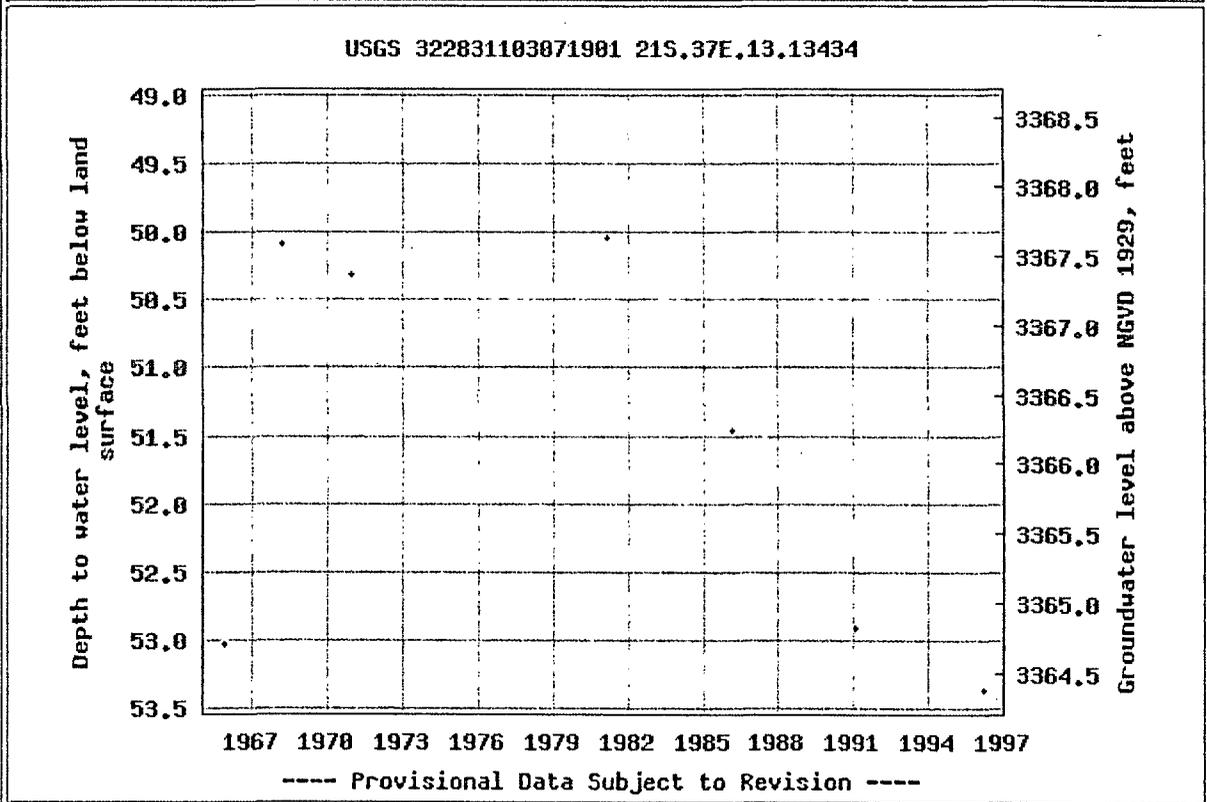
USGS 322831103071901 21S.37E.13.13434

Lea County, New Mexico
 Hydrologic Unit Code 13070007
 Latitude 32°28'45", Longitude 103°07'21" NAD27
 Land-surface elevation 3,417.70 feet above NGVD29
 The depth of the well is 65 feet below land surface.
 This well is completed in the Alluvium, Bolson Deposits and Other Surface Deposits (110AVMB) local aquifer.

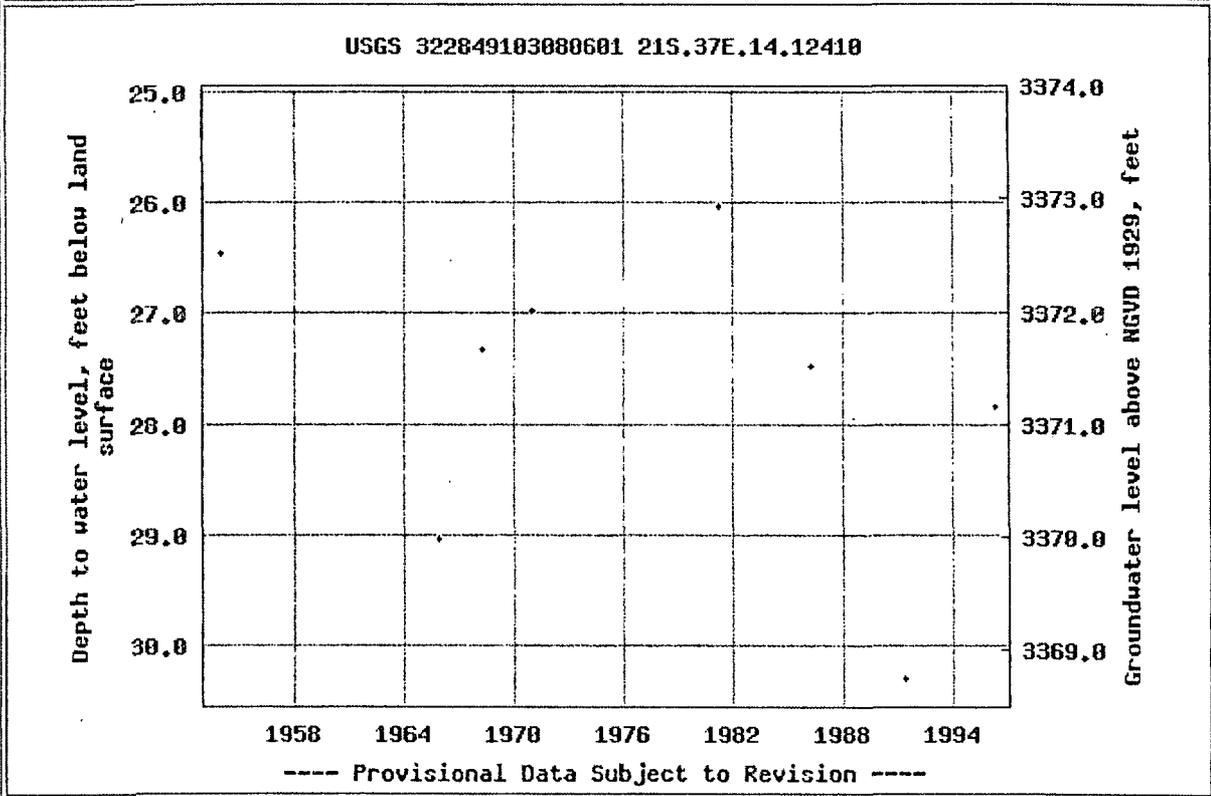
USGS 322849103080601 21S.37E.14.12410

Lea County, New Mexico
 Hydrologic Unit Code 13070007
 Latitude 32°29'01", Longitude 103°08'06" NAD27
 Land-surface elevation 3,399.00 feet above NGVD29
 The depth of the well is 48 feet below land surface.
 This well is completed in the Alluvium, Bolson Deposits
 and Other Surface Deposits (110AVMB) local aquifer.

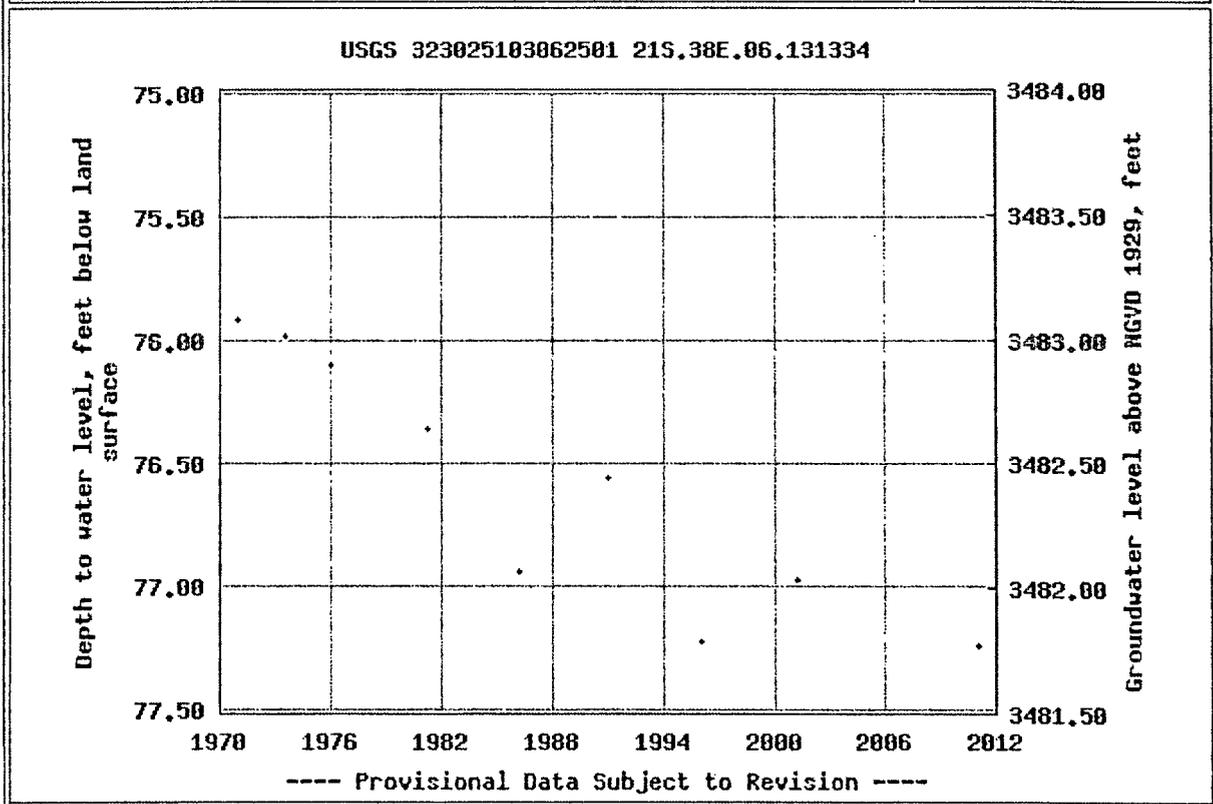
USGS 323025103062501 21S.38E.06.131334

Lea County, New Mexico
 Hydrologic Unit Code 13070007
 Latitude 32°30'35.3", Longitude 103°06'26.1" NAD83
 Land-surface elevation 3,559.00 feet above NGVD29
 The depth of the well is 90 feet below land surface.
 This well is completed in the Ogallala Formation (121OGLL) local aquifer.
