Release Notification and Corrective Action

## Warn State A/C 2 #19

## Closure Report

**RE: TERMINATION REQUEST**

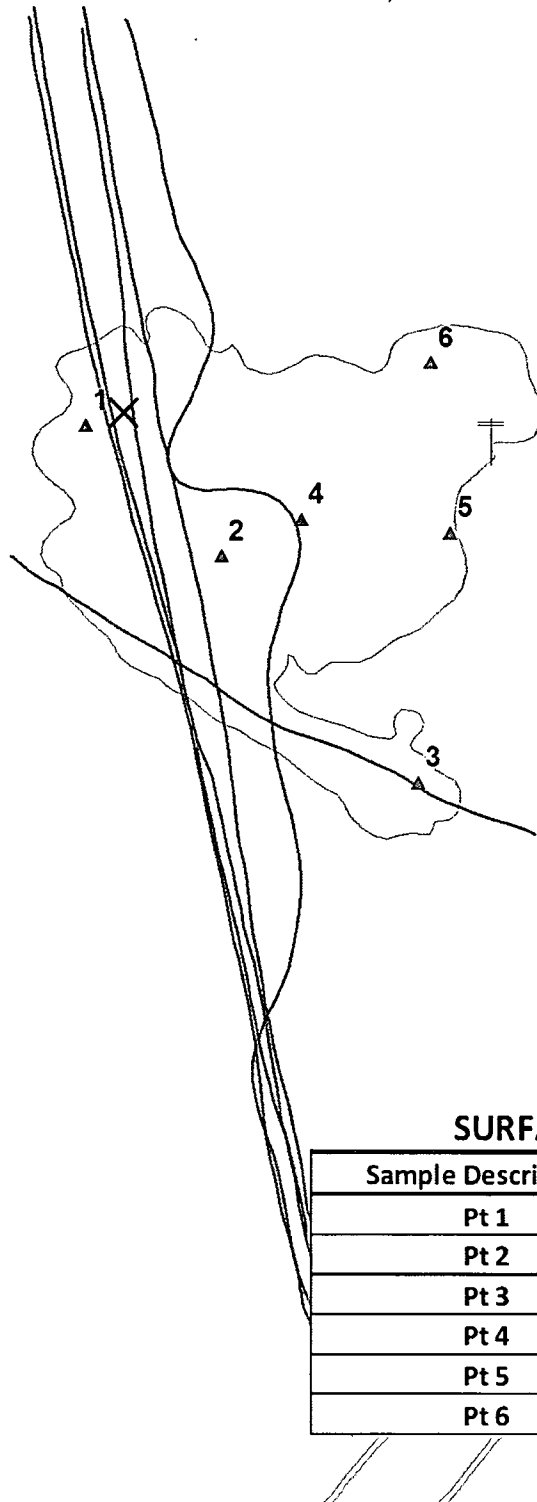
**Figure 1**

On September 7, 2011, RECS personnel initiated work on the Warn State A/C 2 #19 (Figure 1). Surface soil samples were collected and field tested for chloride. Headspace measurements were also taken in the field using a Photo Ionization Detector (PID). The samples were submitted to a commercial laboratory for chloride and TPH (GRO/DRO) analyses (Appendix C). Chloride ranged from 11,000 ppm (parts per million or mg/kg) to 39,600 ppm. GRO ranged from <250 ppm to 7,670 ppm and DRO ranged from <250 ppm to 79,500 ppm.

Sample Description	Cl-	GRO	DRO
Pt 1	11,000	7,670	79,500
Pt 2	26,800	<5000	41,900
Pt 3	22,400	<250	<250
Pt 4	27,200	4,530	32,700
Pt 5	26,000	<1250	10,200
Pt 6	39,600	<250	<250

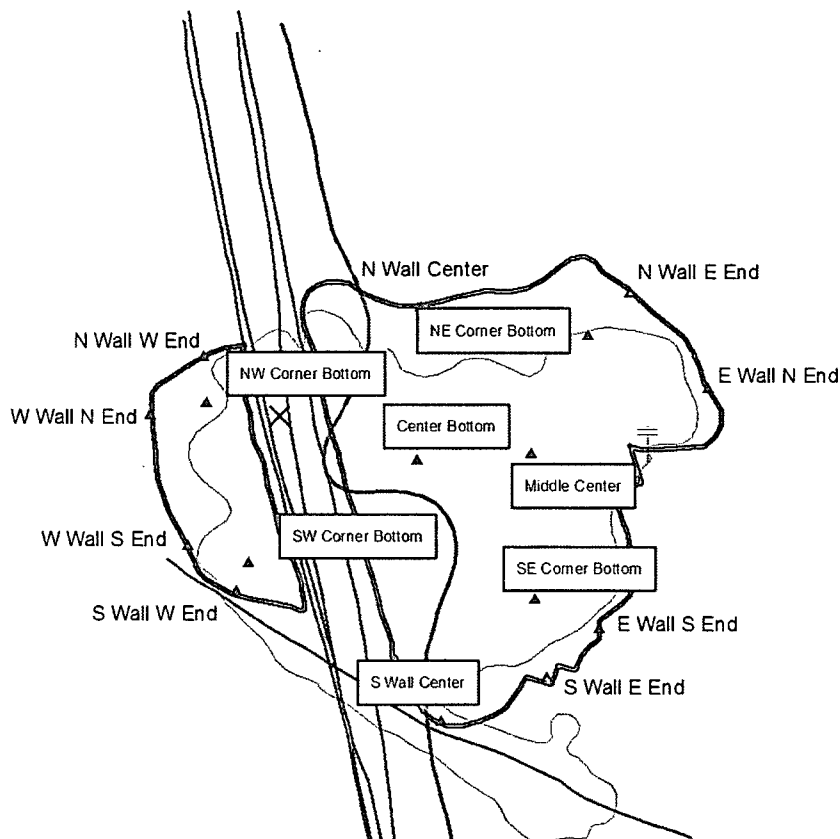
**Figure 2**

On September 14, 2011, RECS personnel collected soil samples from the final excavation (Figure 2). Representative grab samples were collected from the excavation walls and the excavation floor, and were submitted to a commercial laboratory for chloride and TPH (GRO/DRO) analyses (Appendix C). Chloride did not exceed 272 ppm in the wall samples and 304 ppm in the floor samples. TPH was 233 ppm at the N Wall E End and <10.0 ppm in the remaining samples.

Sample Description	Cl-	GRO	DRO
Southwest Corner Bottom	192	<10	<10
Northeast Corner Bottom	176	<10	<10
Center Bottom	304	<10	<10
Southeast Corner Bottom	176	<10	<10
Northwest Corner Bottom	272	<10	<10
Middle Center	210	<10	<10
North Wall Center	176	<10	<10
North Wall East End	32	<50	233
North Wall West End	16	<10	<10
East Wall South End	80	<10	<10
South Wall Center	192	<10	<10
South Wall East End	112	<10	<10
East Wall North End	272	<10	<10
South Wall West End	256	<10	<10
West Wall North End	176	<10	<10
West Wall South End	112	<10	<10

- ▲ SAMPLE POINTS
- T ELECTRICAL POLE
- X SOURCE OF LEAK
- LEASE ROAD EDGE
- POLY LINE
- STEEL LINE
- FINAL EXCAVATION (4,557 sq ft)
- LEAK AREA (4,825 sq ft)

Impacted soils were removed to a NMOCD approved disposal facility. A small area beneath several steel and poly flow lines could not be fully excavated due to extreme soil compaction and

the inability of equipment to safely access the space between steel lines. The excavation was backfilled with clean soil and contoured to the surrounding area. See Appendix B for photographs of field activities.

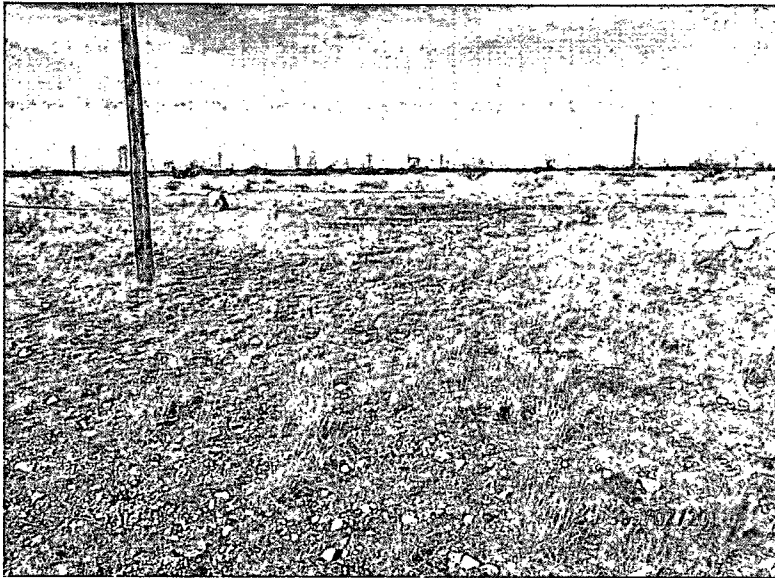
Initial release, facing north

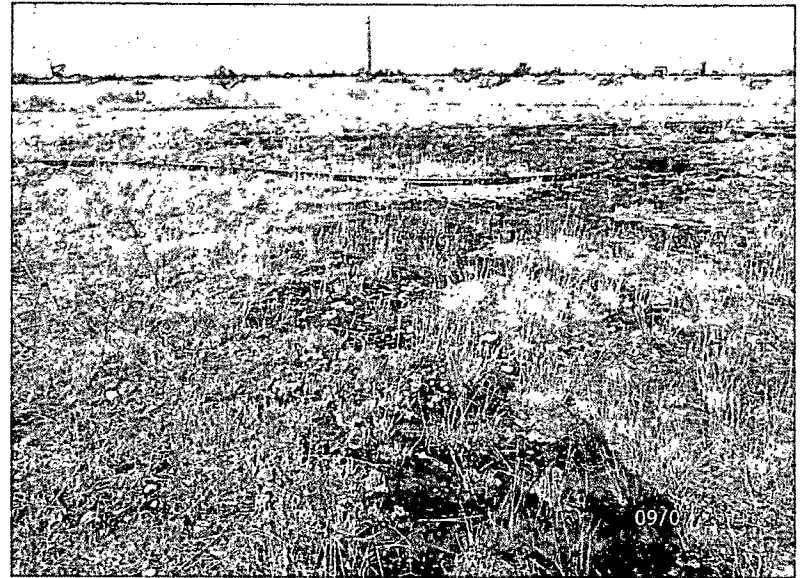
Initial release, facing west

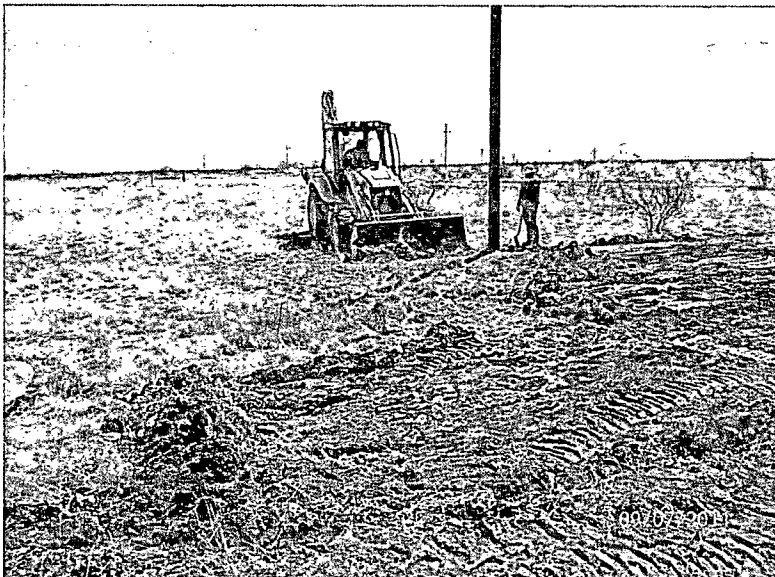
Excavating leak, facing east

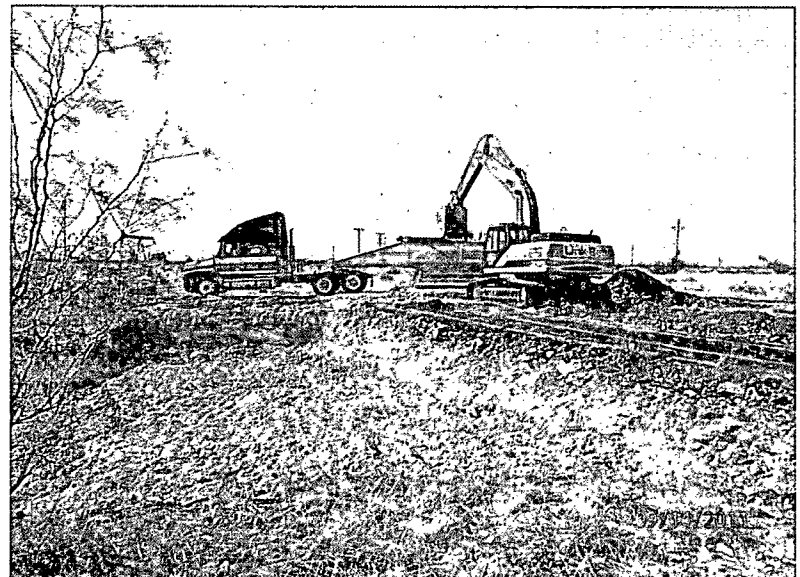
Exporting soil, facing south

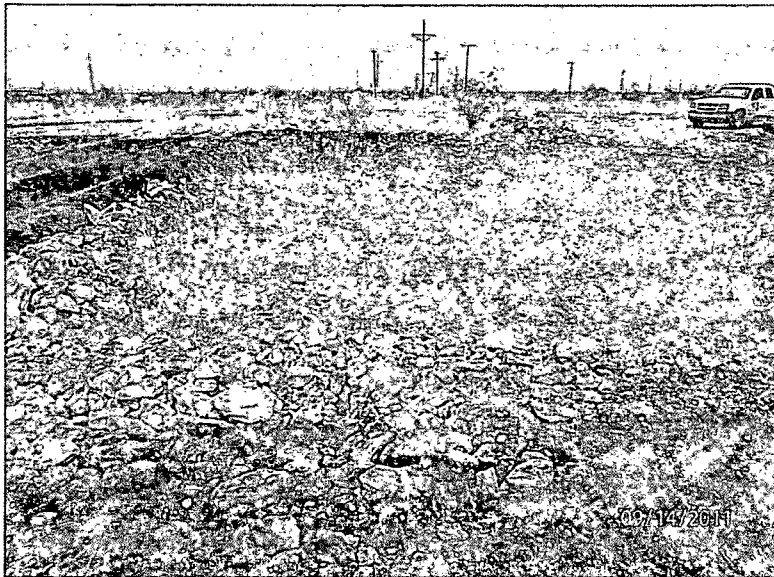
Final excavation, facing north

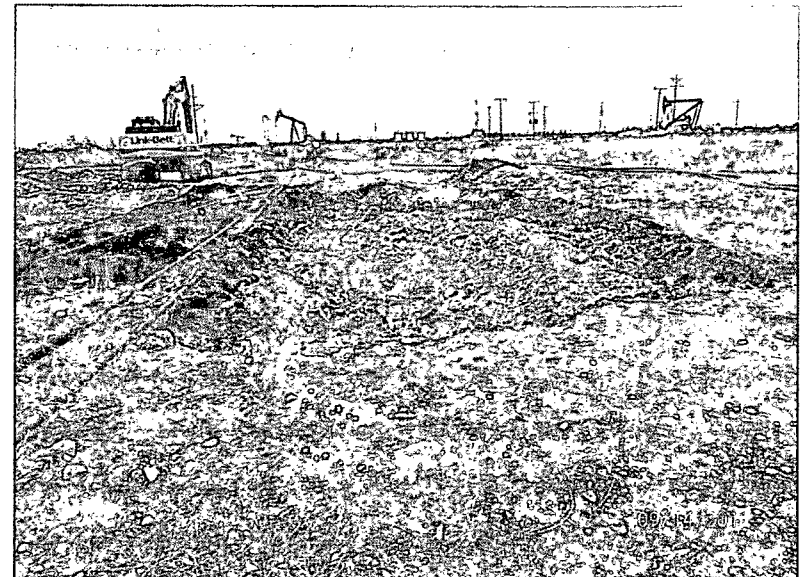
Final excavation, facing south

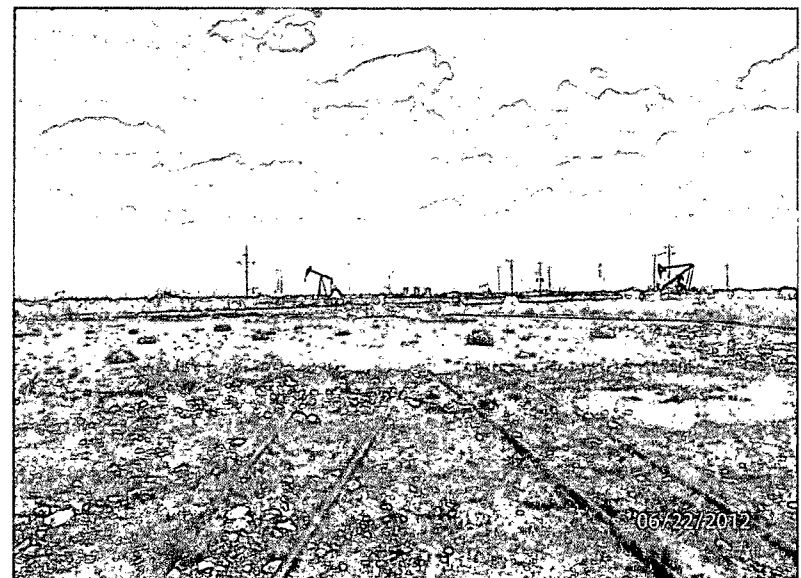
Site backfilled, facing south
