NEDU Pilot Project Battery #1

Closure Report

Release Date: September 12, 2011

**RE: TERMINATION REQUEST
Apache – NEDU Pilot Project Battery #1 AD
UL/D sec. 2 T21S R37E
API No. 30-025-39915**

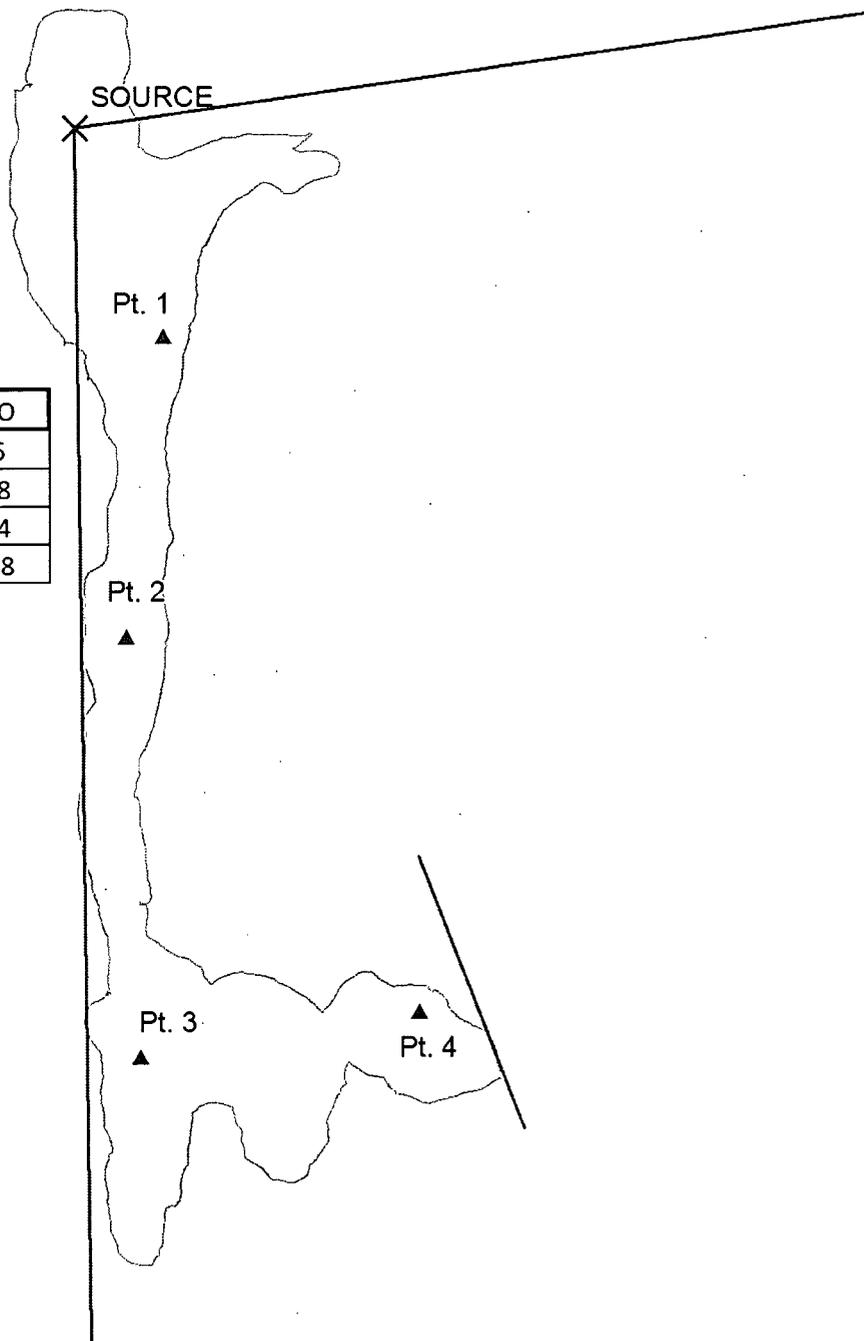
Site Plat

On September 9, 2011, RECS personnel initiated work on the NEDU Pilot Project Battery #1 (Figure 1). Surface soil samples were collected and field tested for chloride. Headspace measurements were also taken in the field using a Photo Ionization Detector (PID). The samples were submitted to a commercial laboratory for chloride and TPH analyses (Appendix C). Chloride ranged from 880 ppm (parts per million or mg/kg) to 2,120 ppm. TPH ranged from 49.8 ppm to 701 ppm.

INITIAL SAMPLING LAB DATA

Sample Description	Cl-	GRO	DRO
Point #1 Surface	880	<10.0	76
Point #2 Surface	1520	13	688
Point #3 Surface	2120	62.5	284
Point #4 Surface	1420	<10.0	49.8

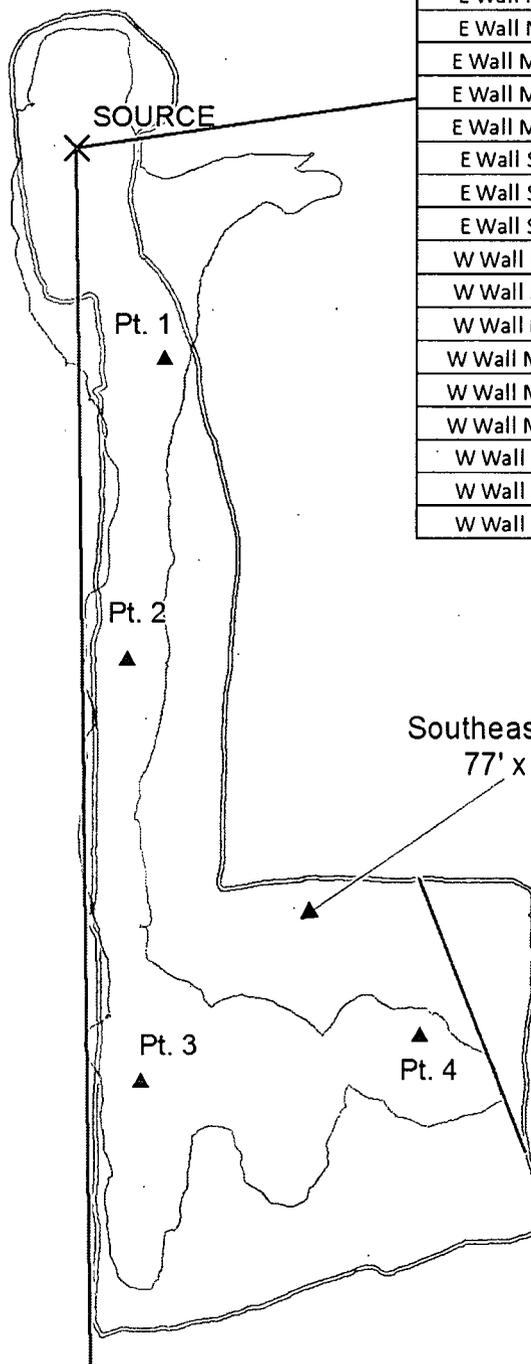
The pasture area to the southeast was excavated to 9' below ground surface (bgs). On September 20, 2011, RECS personnel collected and field tested final samples from the excavation (Figure 2). The junction area and right-of-way to the south were excavated to 6' bgs. On September 21-22, 2011, RECS personnel similarly collected and field tested final samples from the excavation (Figure 3). Representative grab samples from the floor and walls of both excavations were submitted to a laboratory for chloride analysis. The floor samples did not exceed 176 ppm. The west wall of the excavations remained narrowly inside the affected area in order to maintain a

SOUTHEAST EXCAVATION LAB DATA

Sample Description	Cl-
E Wall N End @ 3'	<16
E Wall N End @ 6'	<16
E Wall N End @ 9'	<16
E Wall Middle @ 3'	16
E Wall Middle @ 6'	<16
E Wall Middle @ 9'	16
E Wall S End @ 3'	<16
E Wall S End @ 6'	<16
E Wall S End @ 9'	16
W Wall N End @ 3'	704
W Wall N End @ 6'	576
W Wall N End @ 9'	448
W Wall Middle @ 3'	1040
W Wall Middle @ 6'	3920
W Wall Middle @ 9'	2320
W Wall S End @ 3'	16
W Wall S End @ 6'	16
W Wall S End @ 9'	16

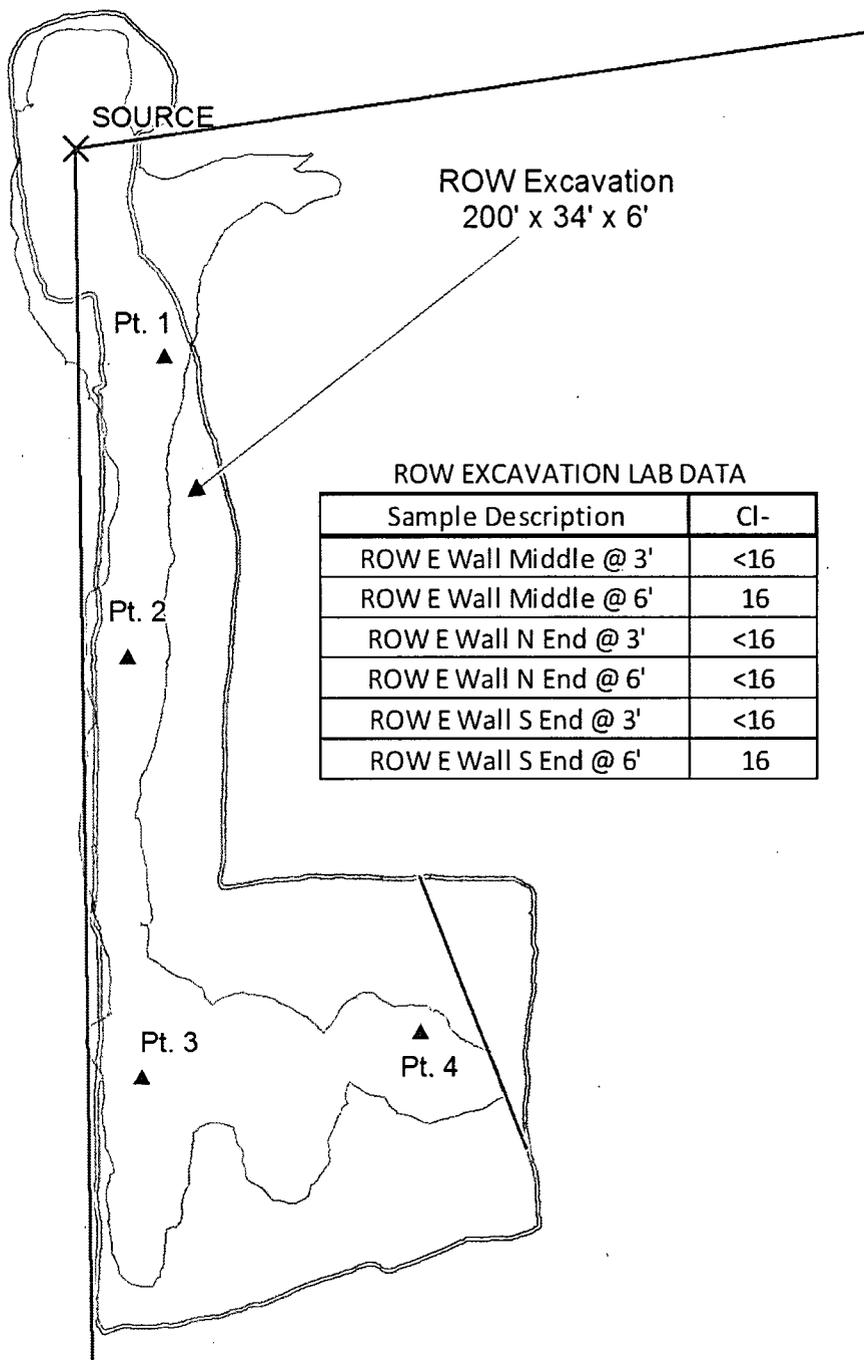
safe working distance from the Apache pipeline running to the south. Consequently, the west wall samples exceeded 48.0 ppm at four (4) sample points. In these 4 west wall samples, chloride ranged from 608 ppm to 3,920 ppm (Appendix C).

ROW EXCAVATION LAB DATA

Sample Description	Cl-
ROW N Wall Middle 3'	<16
ROW N Wall Middle 6'	<16
ROW N Bottom	<16
ROW S Bottom	16
ROW Middle Bottom	16
ROW W Wall S End 3'	992
ROW W Wall S End 6'	896
ROW W Wall Middle 3'	608
ROW W Wall Middle 6'	1170
ROW W Wall N End 3'	<16
ROW W Wall N End 6'	64

Sample Description	Cl-
ROW E Wall Middle @ 3'	<16
ROW E Wall Middle @ 6'	16
ROW E Wall N End @ 3'	<16
ROW E Wall N End @ 6'	<16
ROW E Wall S End @ 3'	<16
ROW E Wall S End @ 6'	16

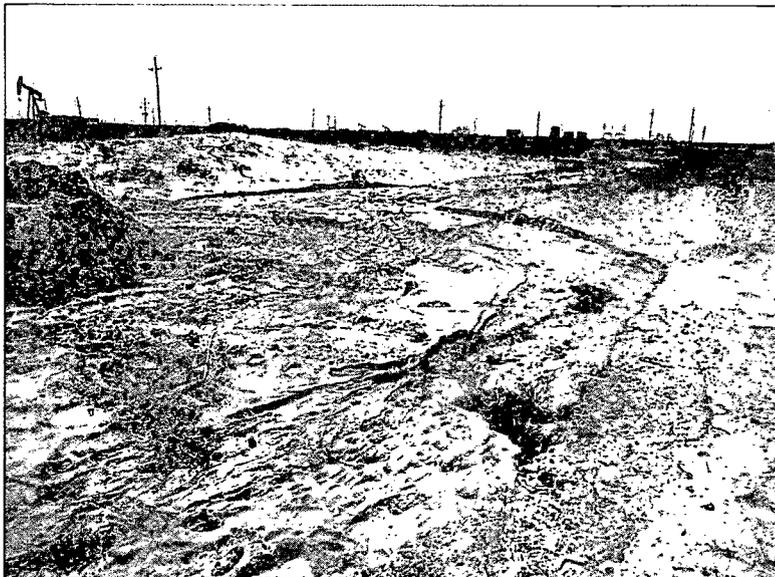
Initial release, facing south

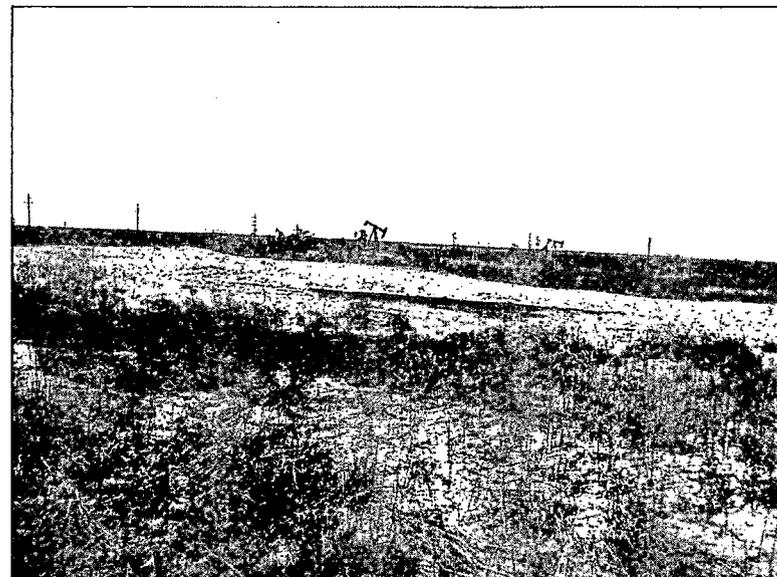
Initial release, south end, facing west

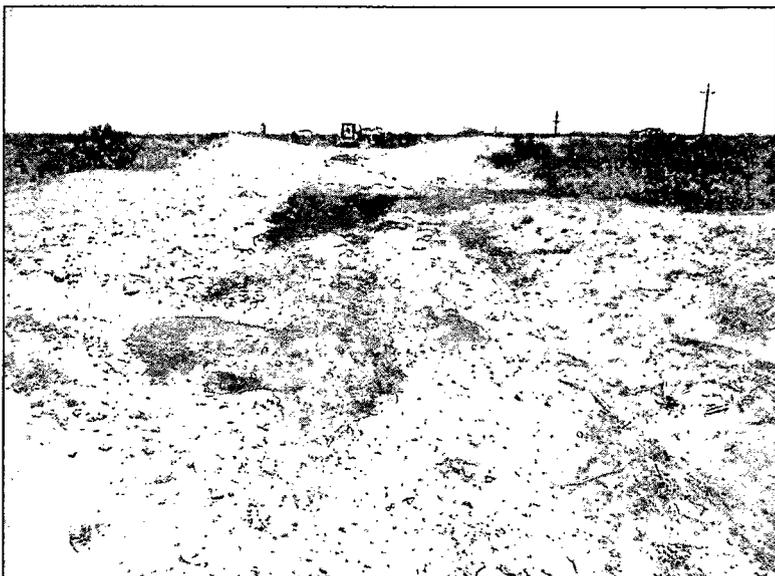
Initial release, facing north

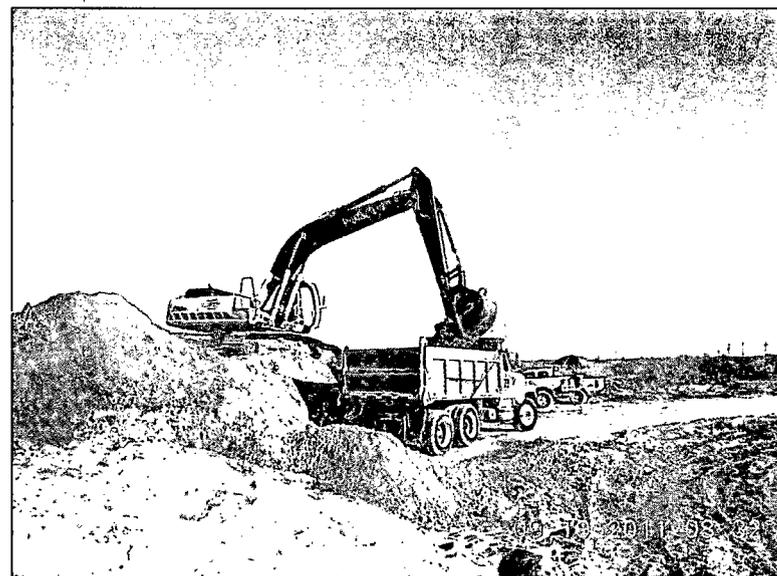
Exporting soil, facing north

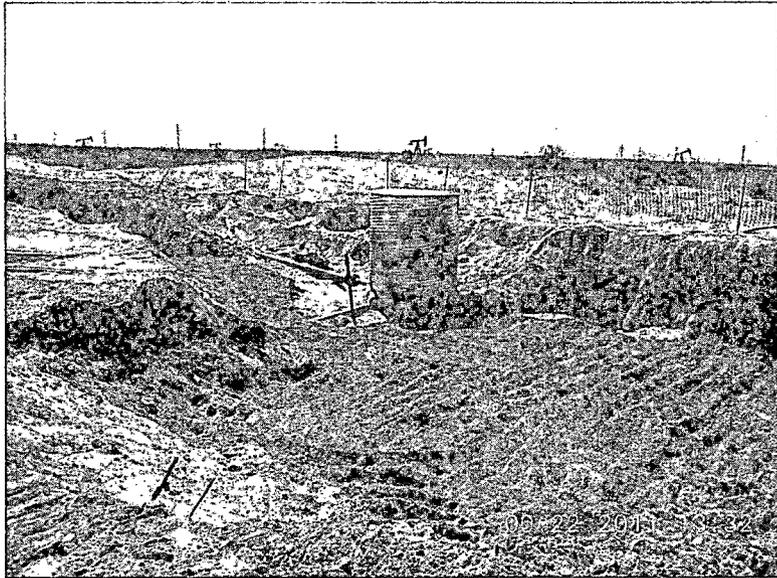
Final excavation at source, facing west 9/22/2011

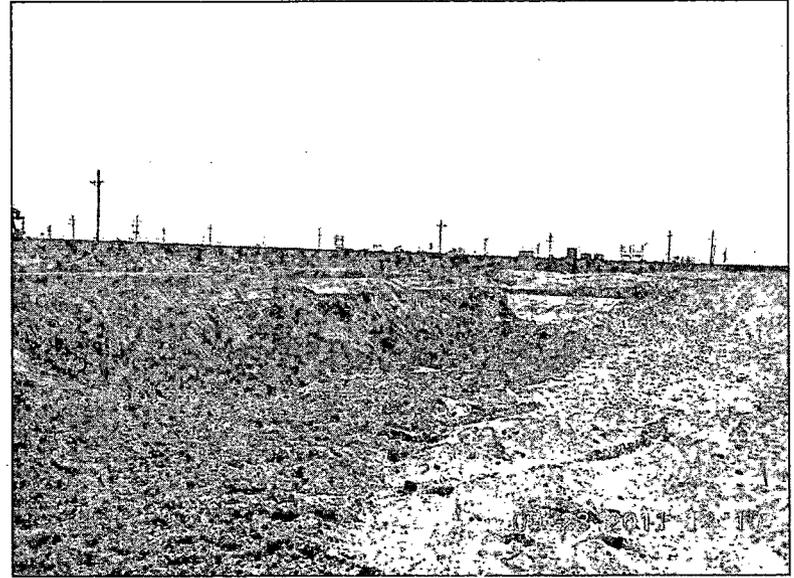
Final excavation, facing south 9/23/2011

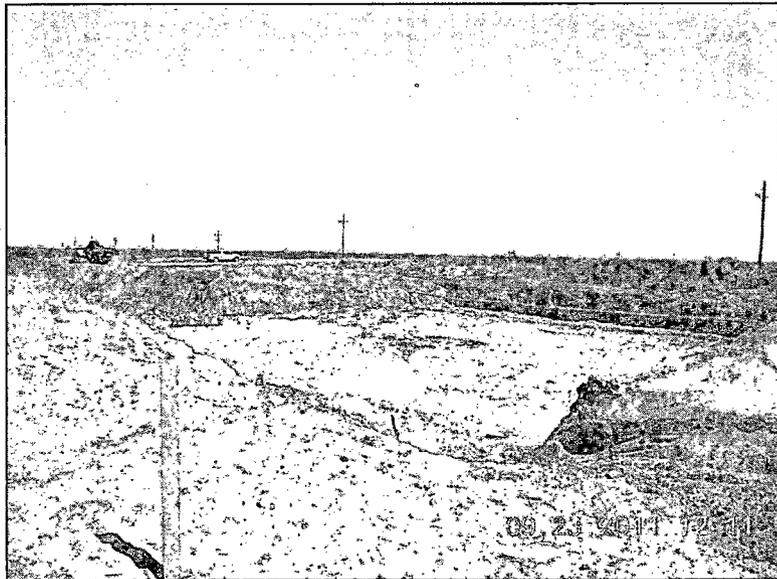
Final excavation, facing north 9/23/2011

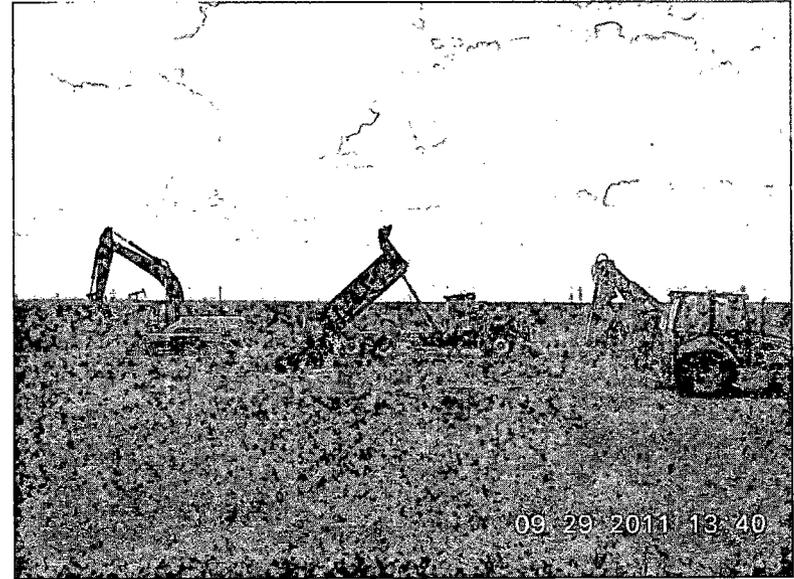
Importing backfill, facing west 9/29/2011

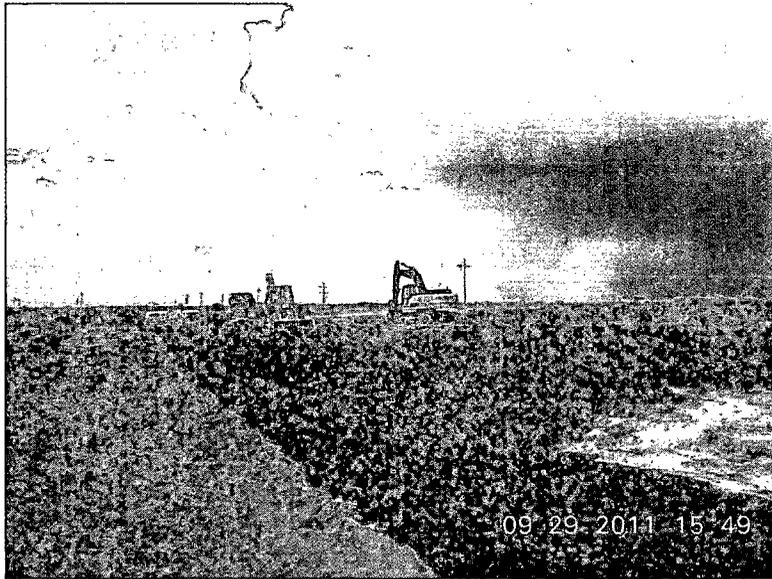
Backfilling excavation, facing north

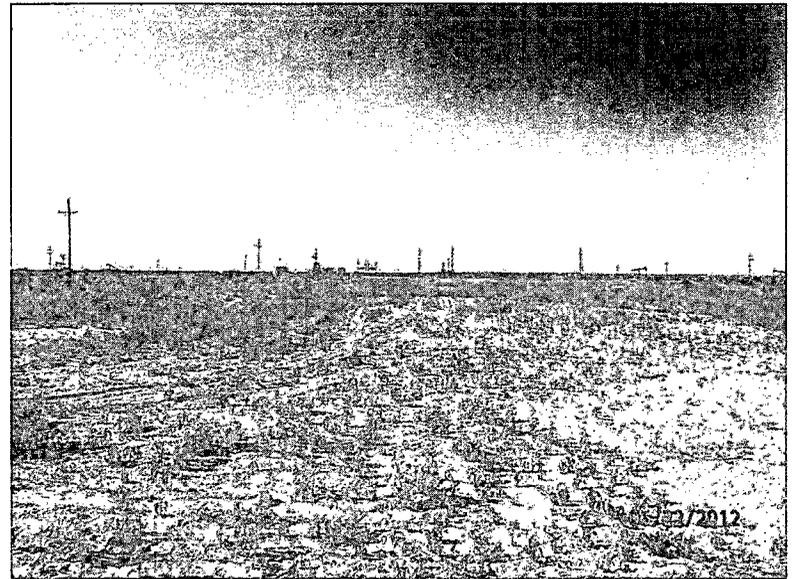
Site complete, facing south
