WBDU #12

Termination Request

RE: Termination Request

Apache Corporation – WBDU #12

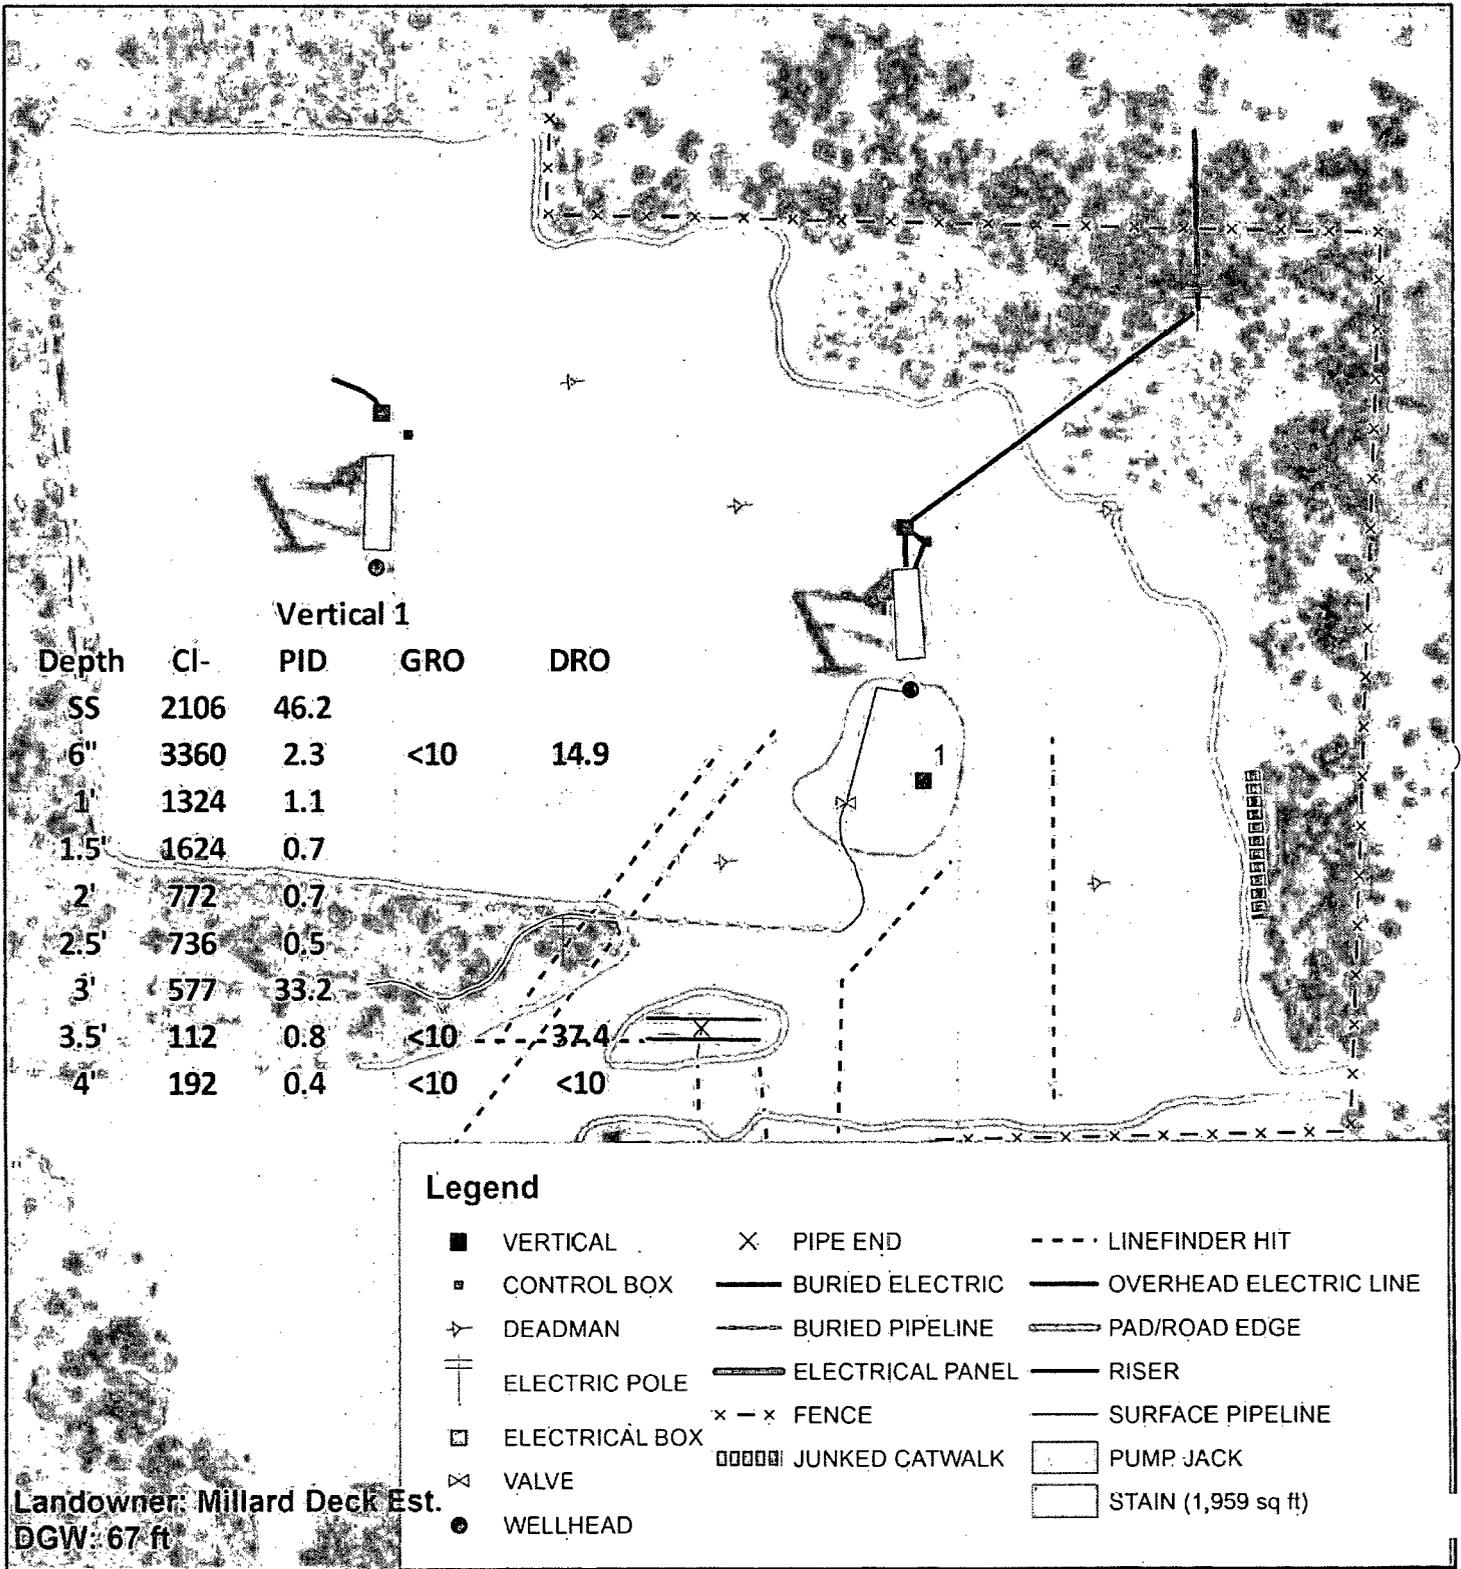
Figure 1

RECS personnel were on site beginning on January 7th, 2014 to assess the release. The release was GPS mapped and photographed. On January 10th, 2014, a vertical was installed in the release area to a depth of 4 ft bgs (Figure 1). Samples were taken every 6 inches and field tested for chlorides and organic vapors. Representative samples from the vertical were taken to a commercial laboratory for analysis (Appendix B). Laboratory chloride values dropped to below 250 mg/kg starting at 3.5 ft bgs with a reading of 112 mg/kg at 3.5 ft bgs and a reading of 192 mg/kg at 4 ft bgs. Gasoline Range Organics (GRO) and Diesel Range Organics (DRO) were below regulatory standards at all depths.

Vertical Data

A Corrective Action Plan (CAP) was sent to NMOCD on January 31st, 2014 and approved on February 5th, 2014. Based on the vertical laboratory readings the CAP recommended that the site be excavated to a depth of 3.5 ft bgs. The excavation would remain away from the wellhead for safety reasons. The excavated soil would be taken to a NMOCD approved facility for disposal. Clean soil would be imported to the site to serve as backfill and the site will be contoured to the surrounding location.

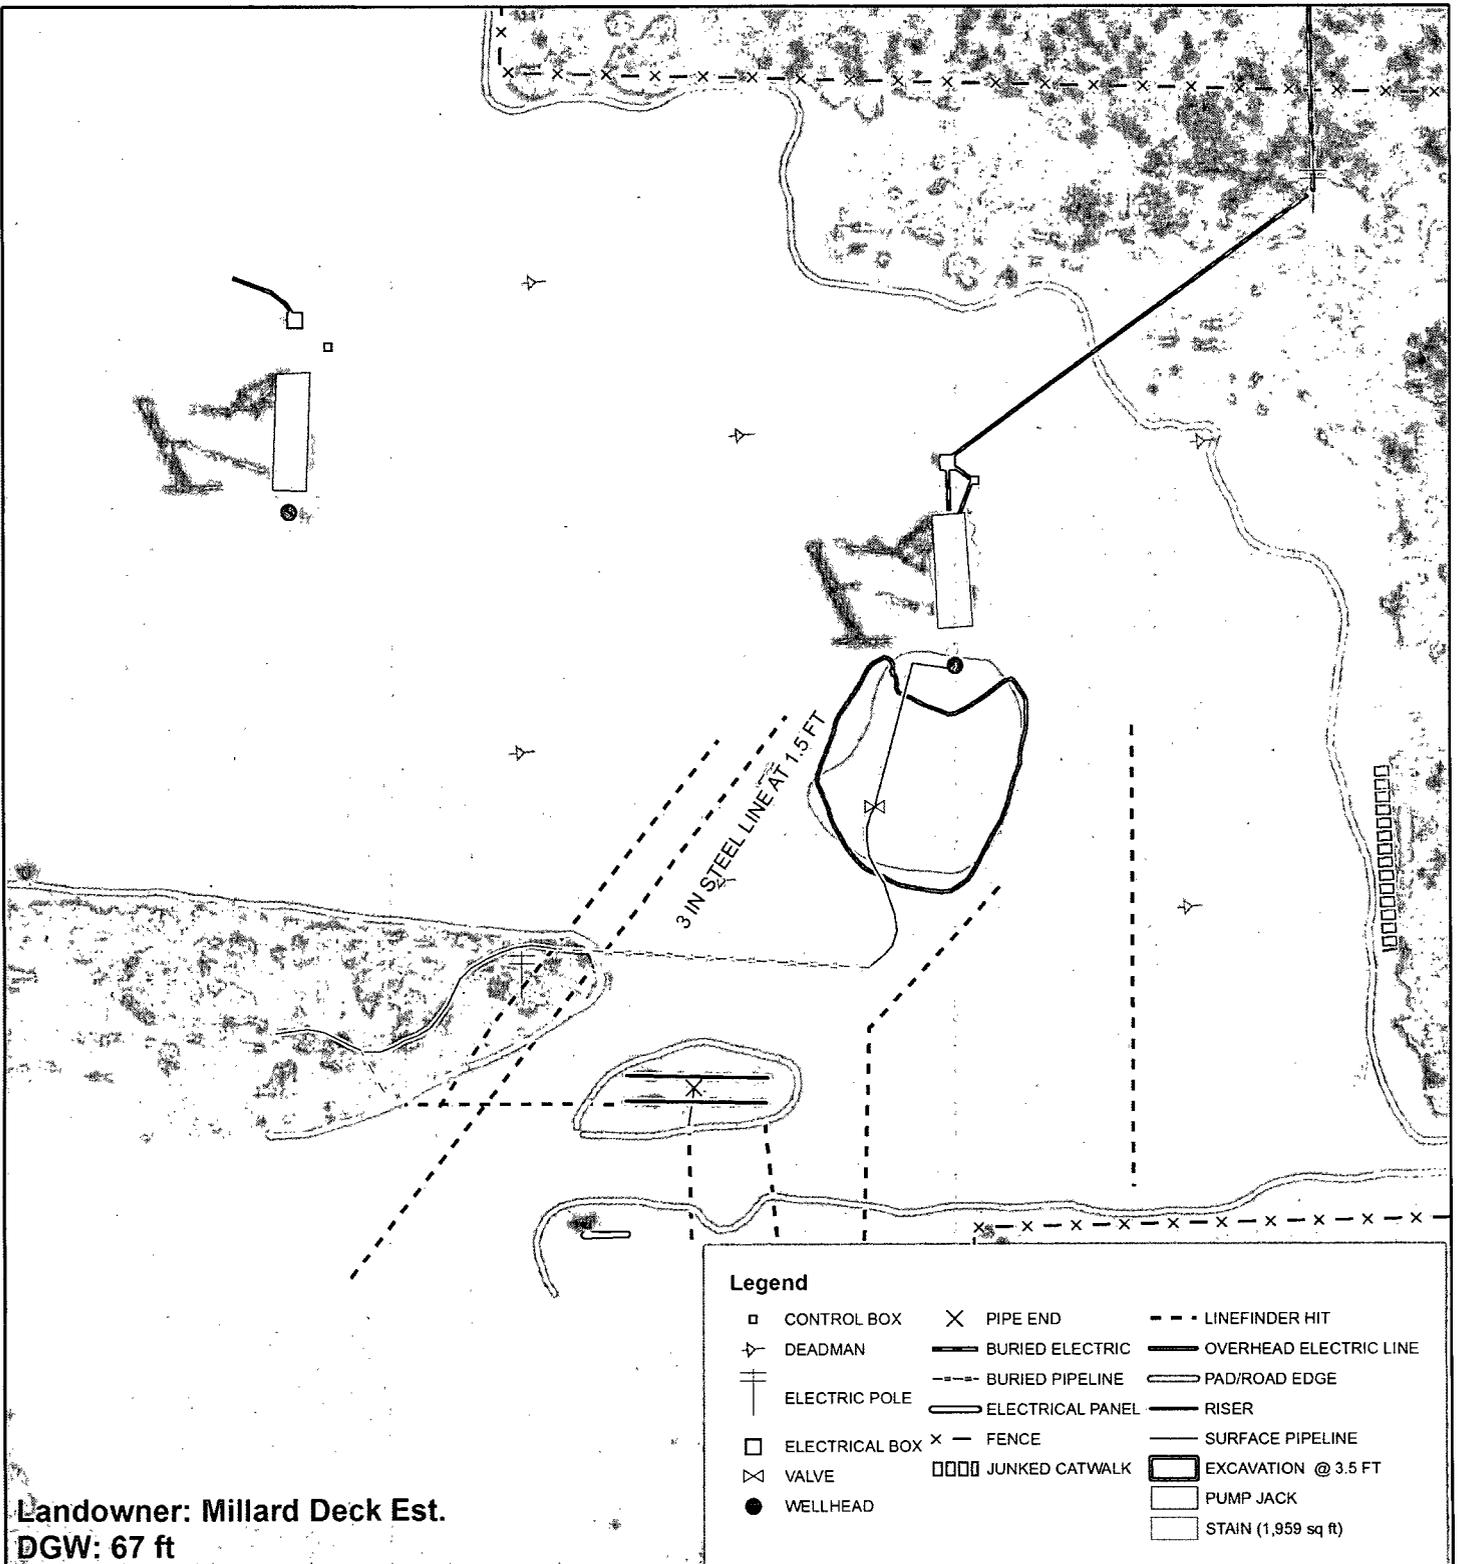
Figure 2

CAP work began at the site on February 10th, 2014. The area was line spotted using a hydrovac to prevent line strikes. The release area was excavated 3.5 ft bgs and 386 yards of contaminated soil was taken to a NMOCD approved facility for disposal (Figure 2). A total of 348 yards of clean caliche was imported to the site to serve as backfill. The site was backfilled and contoured to the surrounding pad.

Excavation Data

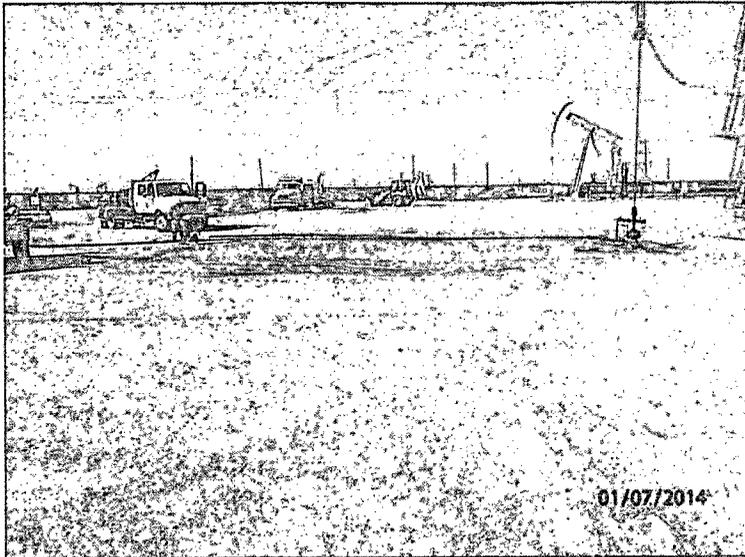
On January 7th, 2014, Apache discovered a release on the well pad from a poly flow line. The poly line released a total of 3 barrels of oil and 5 barrels of produced water over 1,959 square feet of lease pad. The well was shut in and a vacuum truck was called to the site and recovered 3 barrels of oil and 4 barrels of produced water. Apache sent an initial C-141 to NMOCD on January 29th, 2014, for their approval (Appendix A).

Initial release photo, facing west

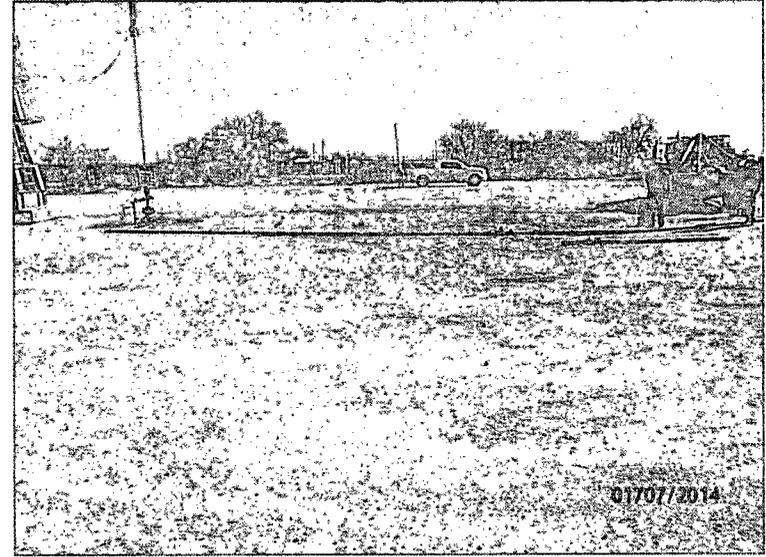
Initial release photo, facing east

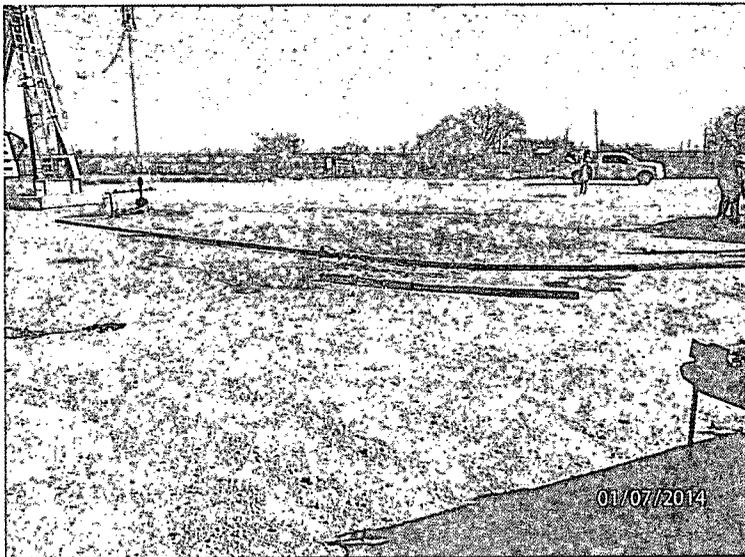
Initial release area, facing northeast

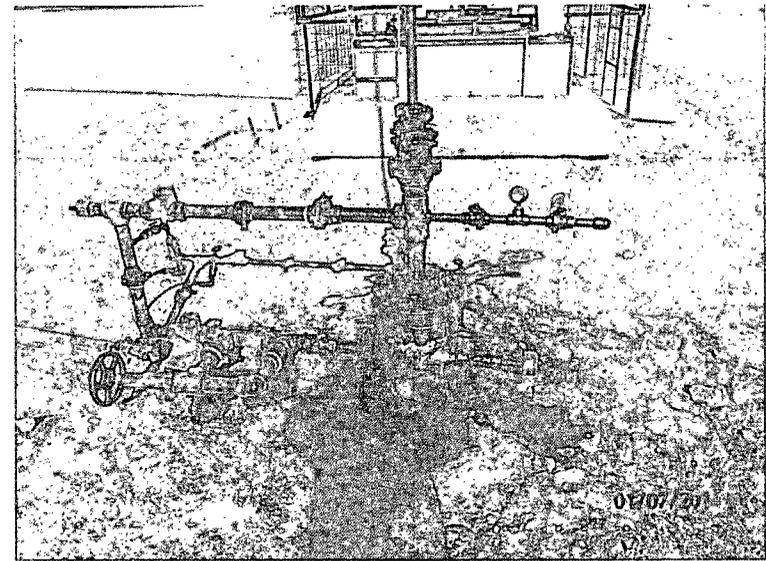
Describe Cause of Problem and Remedial Action Taken.*
Due to inclement weather, the poly flow line ruptured on the well pad. The well was shut in and a vacuum truck was dispatched to recover fluid. The line was repaired.

Source of release, facing north

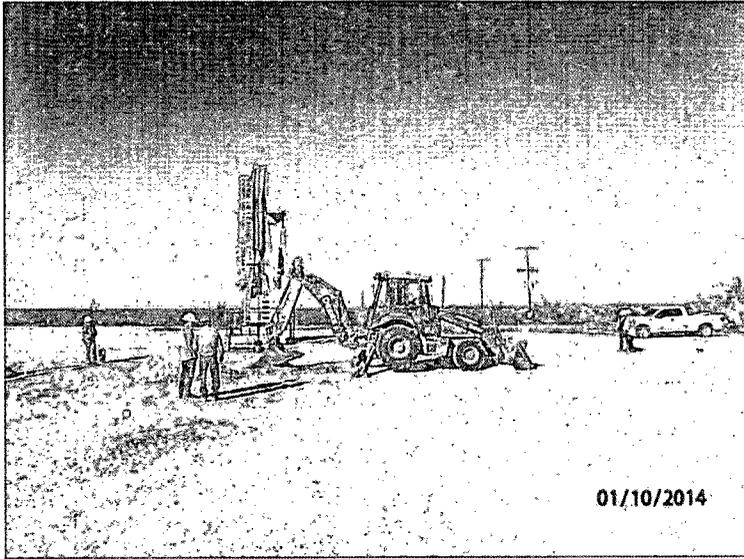
Installing vertical at the site, facing north 1/10/14

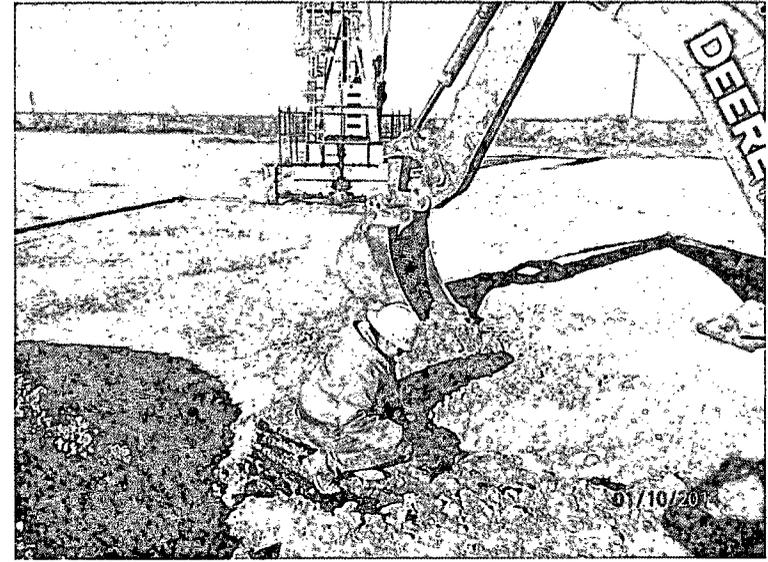
Sampling the vertical, facing north 1/10/14

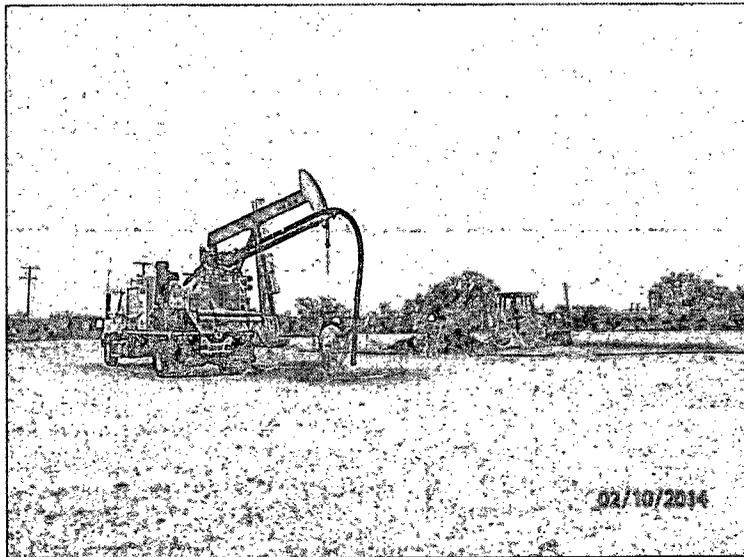
Line spot using a hydrovac, facing northeast 2/10/14

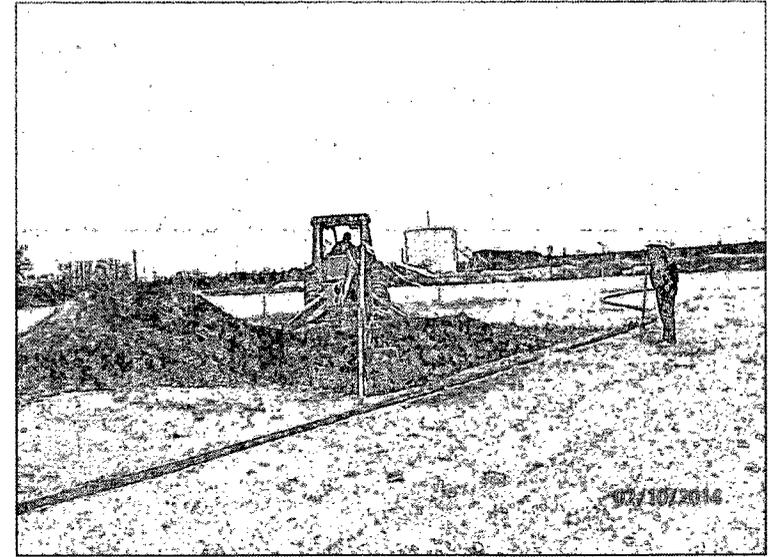
Excavating site, facing southeast 2/10/14

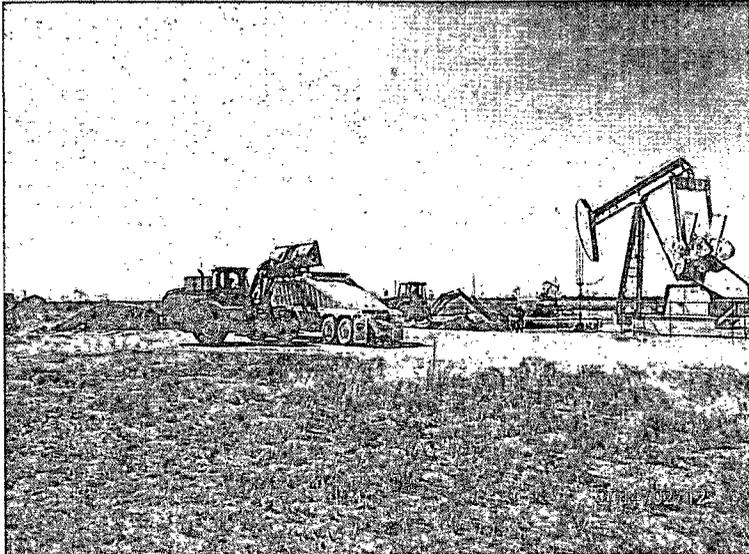
Exporting soil, facing southwest

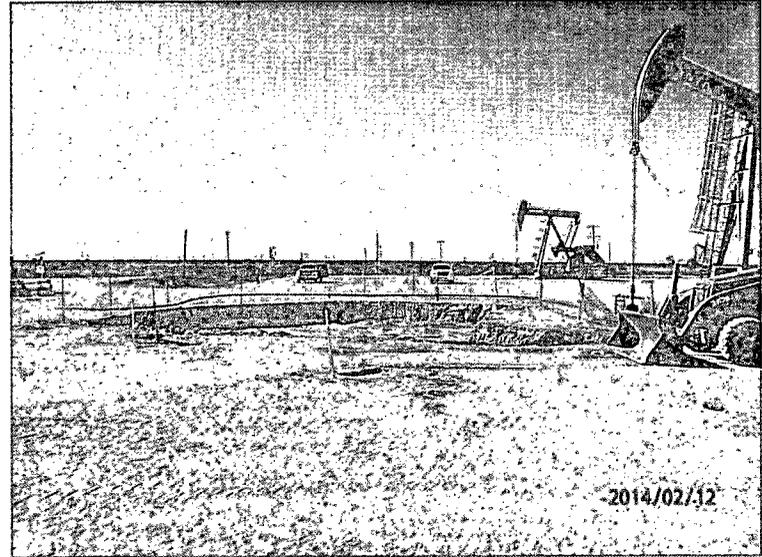
Excavation completed, facing west

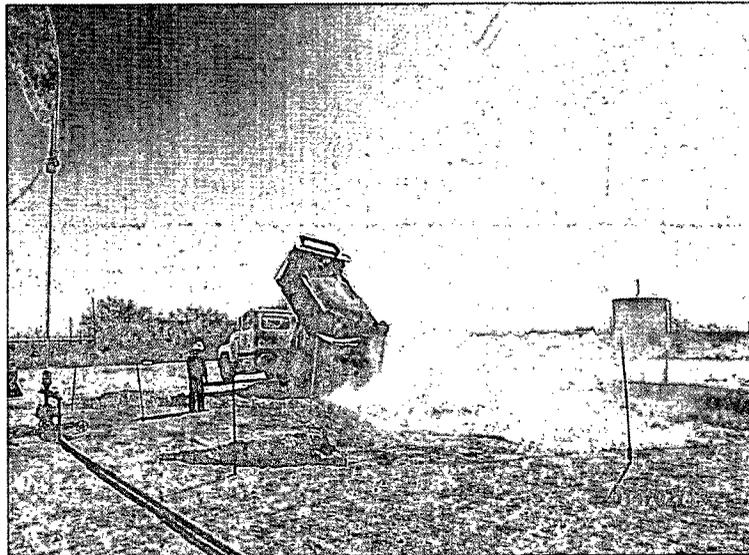
Importing soil, facing southeast

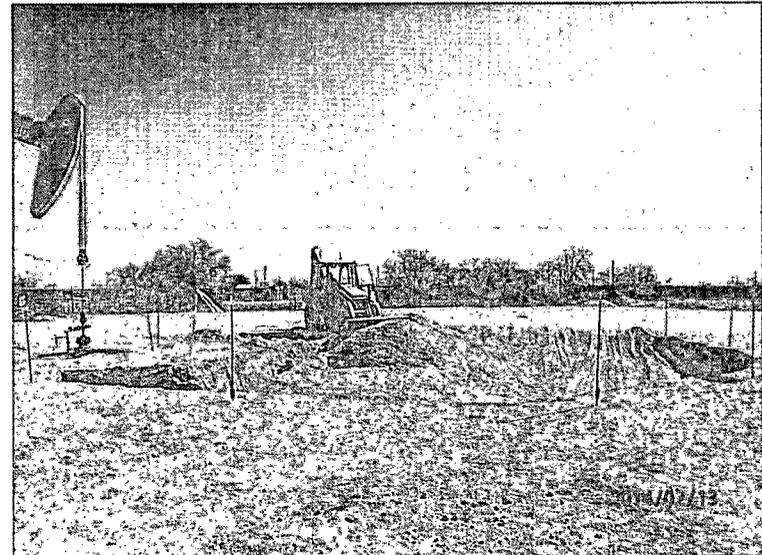
Backfilling site, facing east

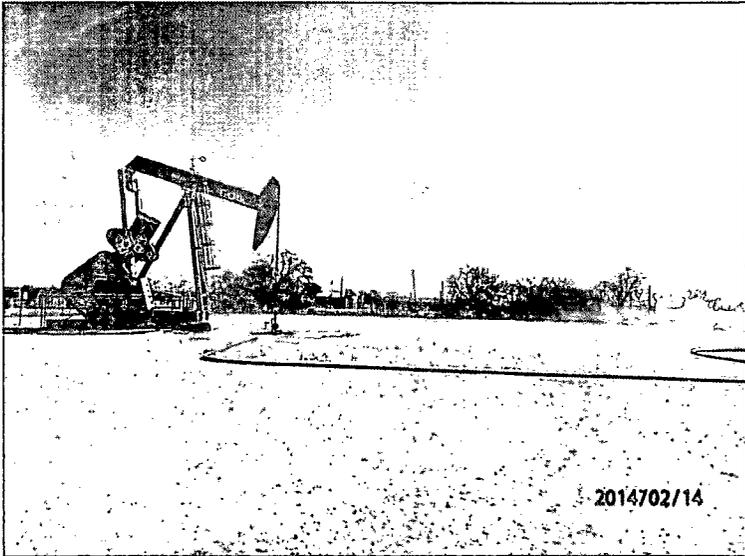
Site completed, facing east

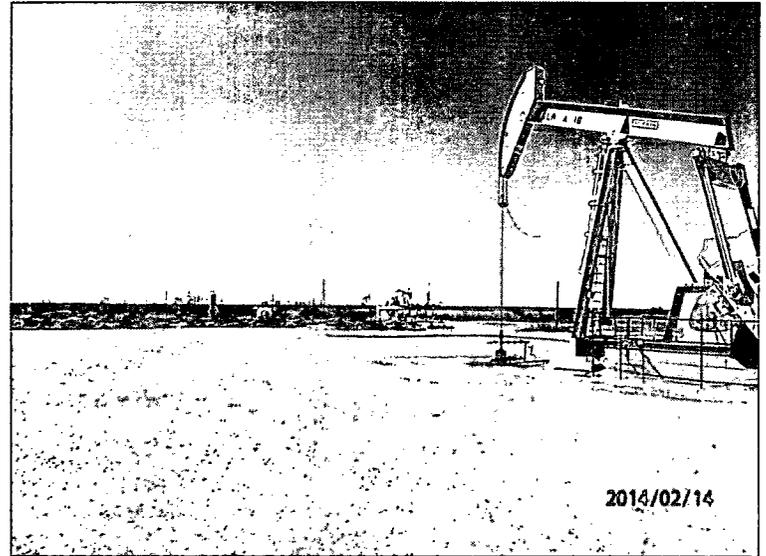
Site completed, facing southwest
