NMGSAU #206

Closure Report

Rice Environmental Consulting & Safety

**RE: TERMINATION REQUEST
Apache – NMGSAU #206 AD
UL/F sec. 18 T19S R37E**

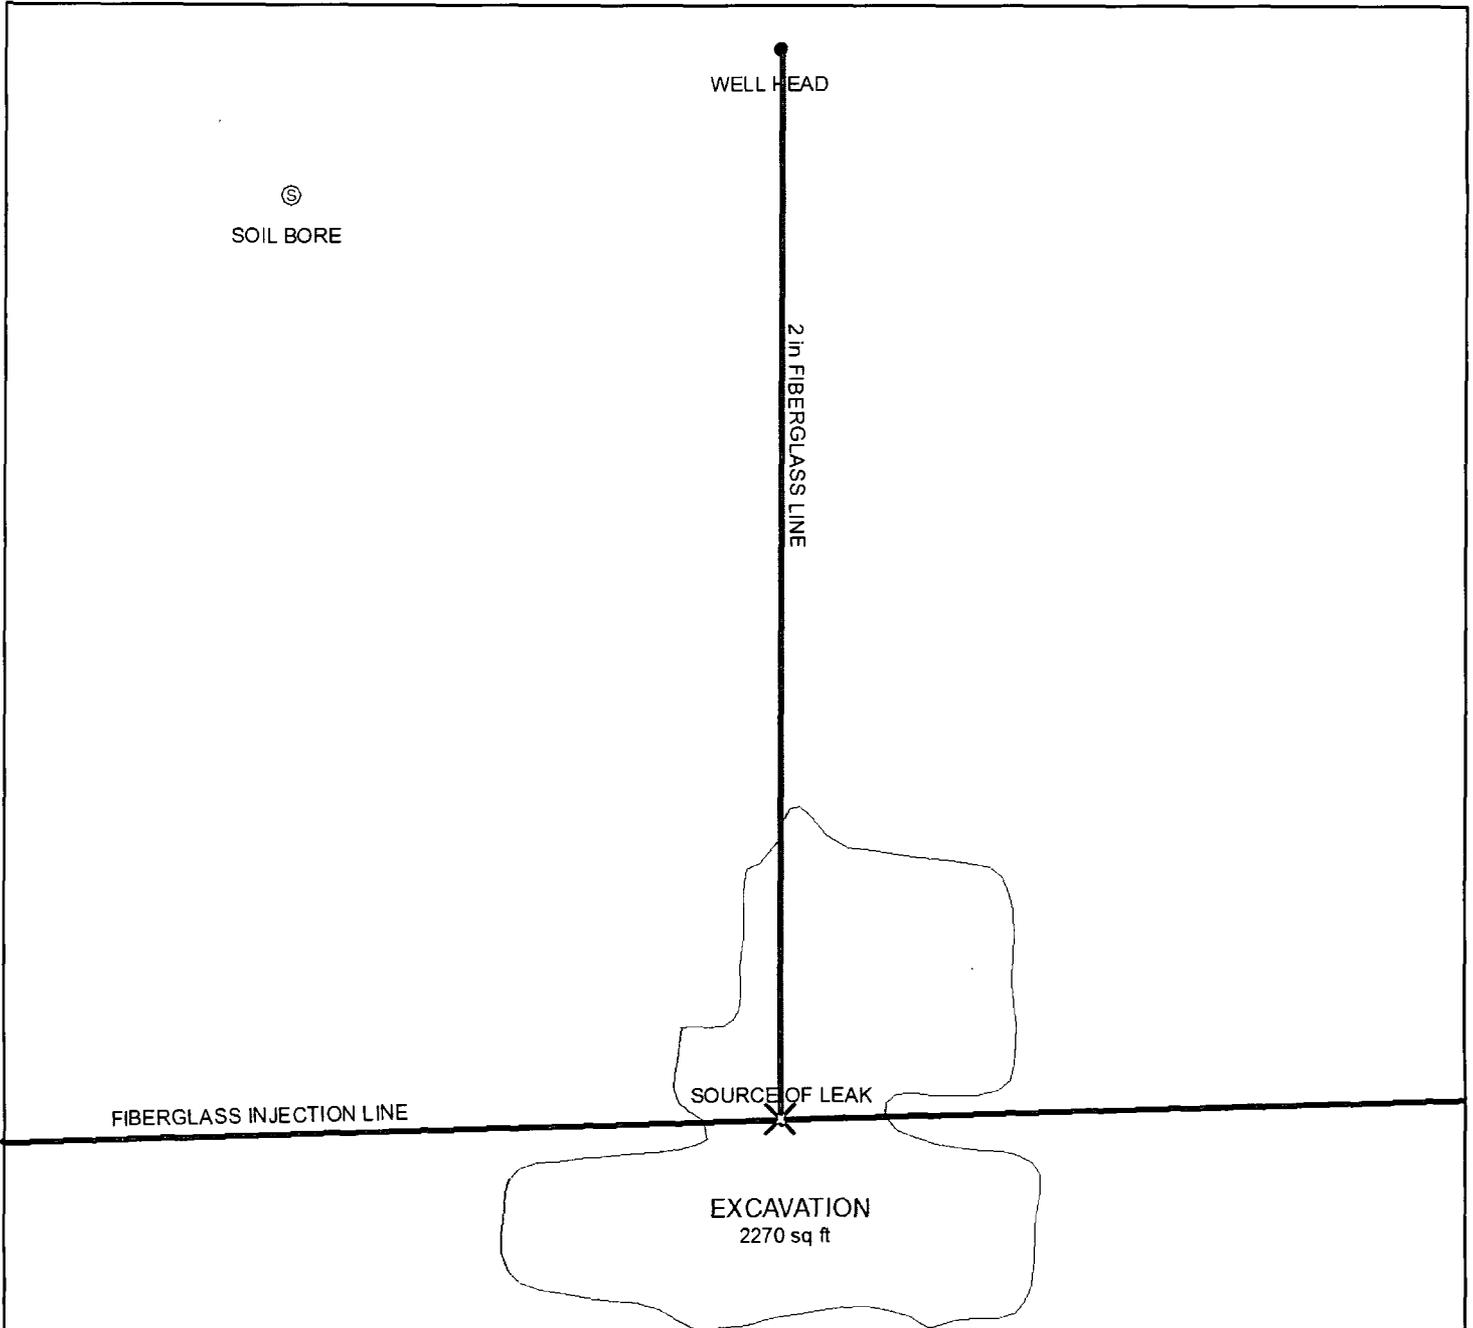
Site Plat

On June 29, 2011, a 65 ft. soil bore was drilled southwest of the well location (Figure) to determine depth of groundwater at the site. RECS personnel used a Heron Water Level Meter to verify any accumulation of groundwater. Water was detected within the borehole at the total depth of 56 ft. bgs. On July 1, 2011, RECS personnel plugged the borehole to ground surface with bentonite (Appendix B).

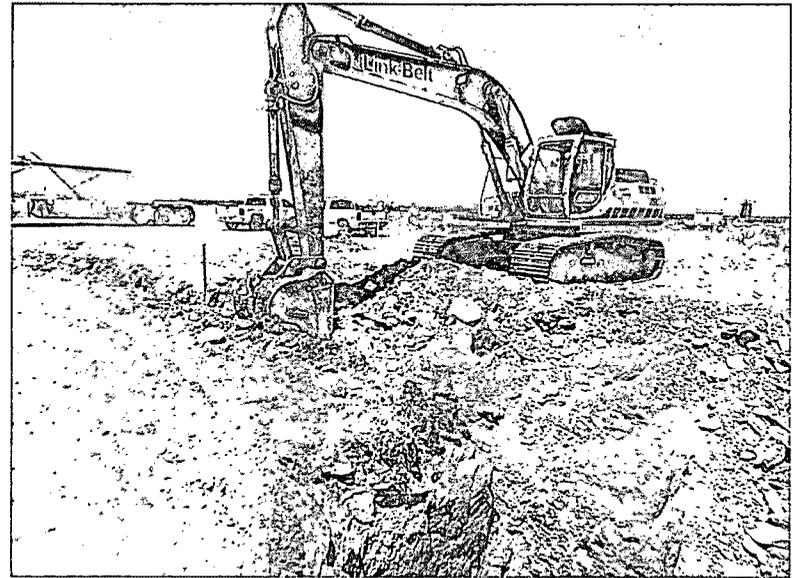
Excavating leak, facing north

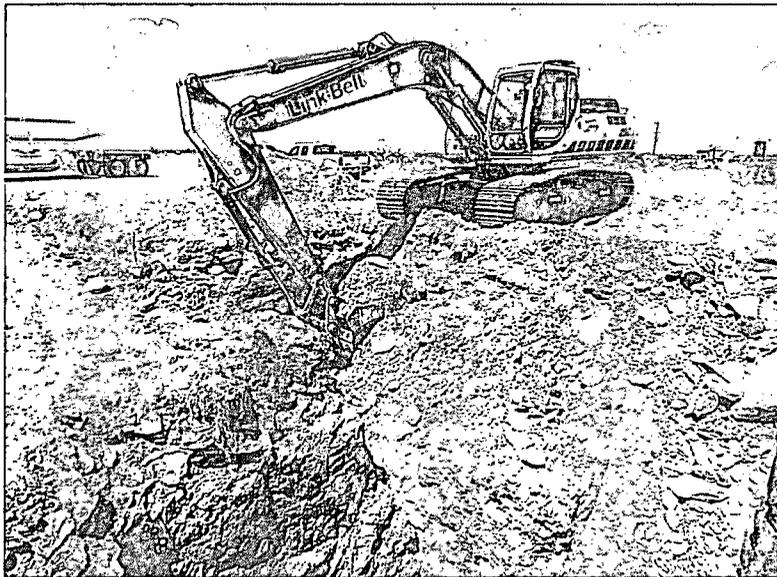
Excavating leak, facing east

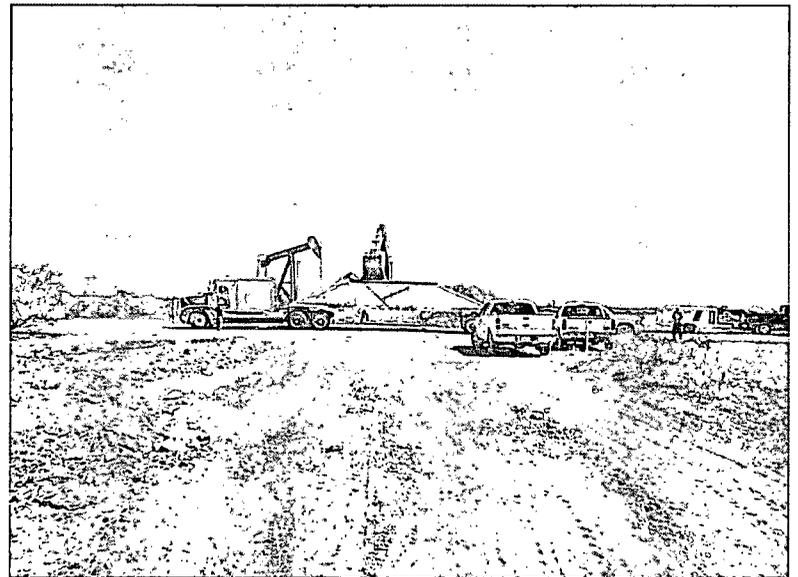
Removing spoil pile, facing north

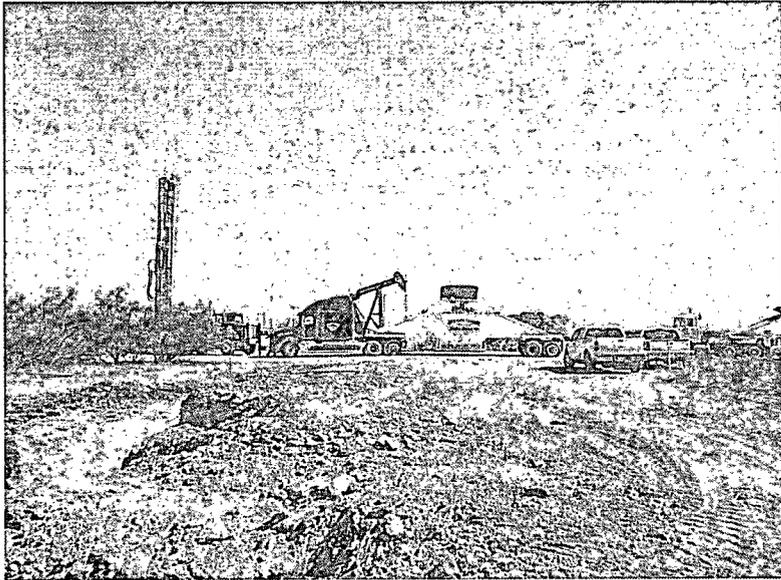
Drilling soil bore, facing northwest

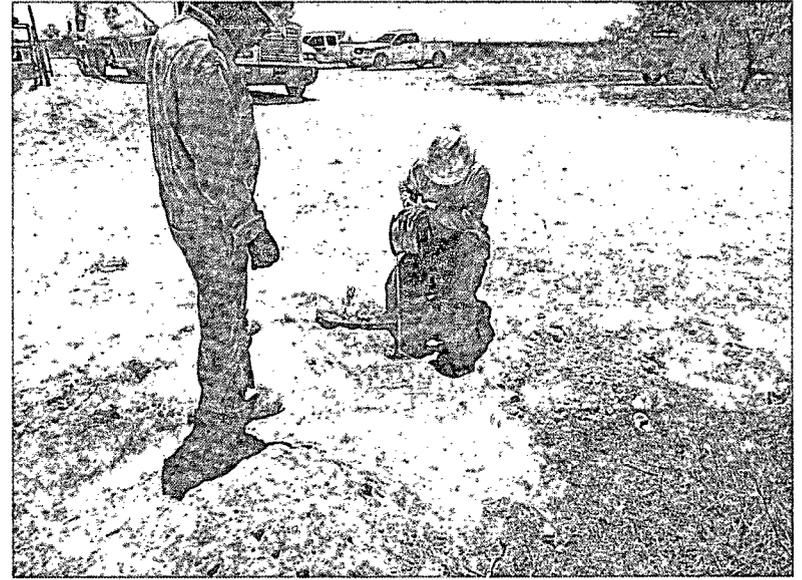
Checking for water,

On June 29th, 2011, RECS personnel drilled an observational well at the Apache NMGSAU #206 AD to a depth of 65 ft. On the same day, I supervised RECS personnel checking for water accumulation within the borehole using a Heron depth to water meter. The meter indicated water had accumulated within the borehole at the total depth of 56 ft.

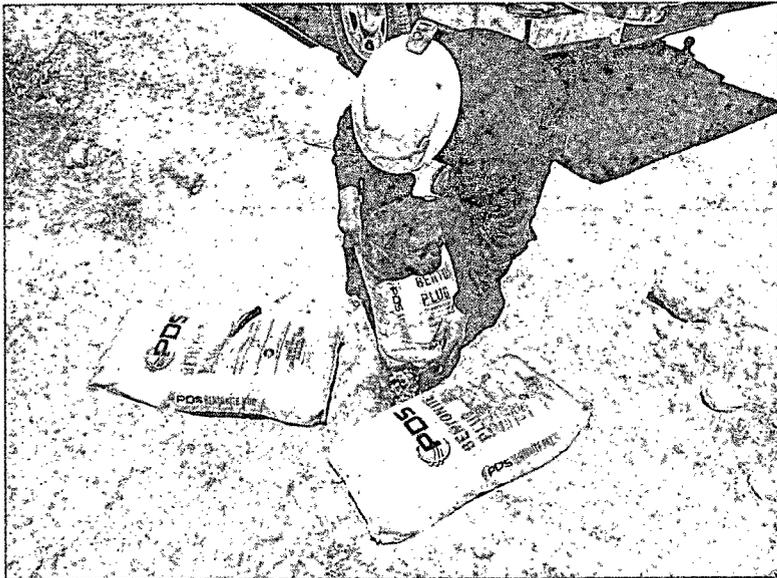
Plugging soil bore, facing north

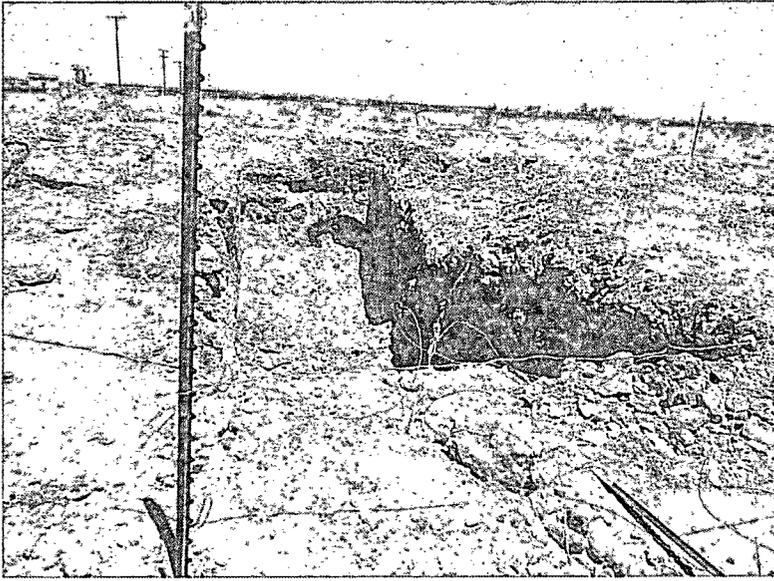
Final excavation, facing west

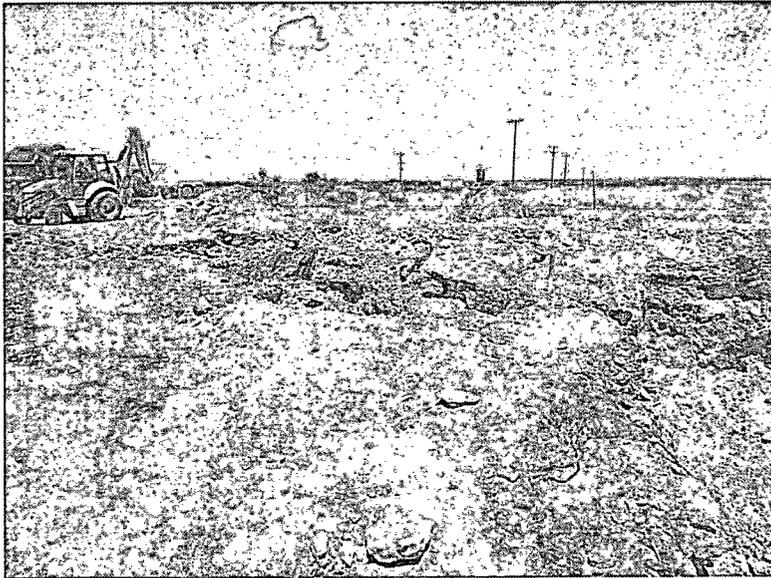
Final excavation, facing northwest

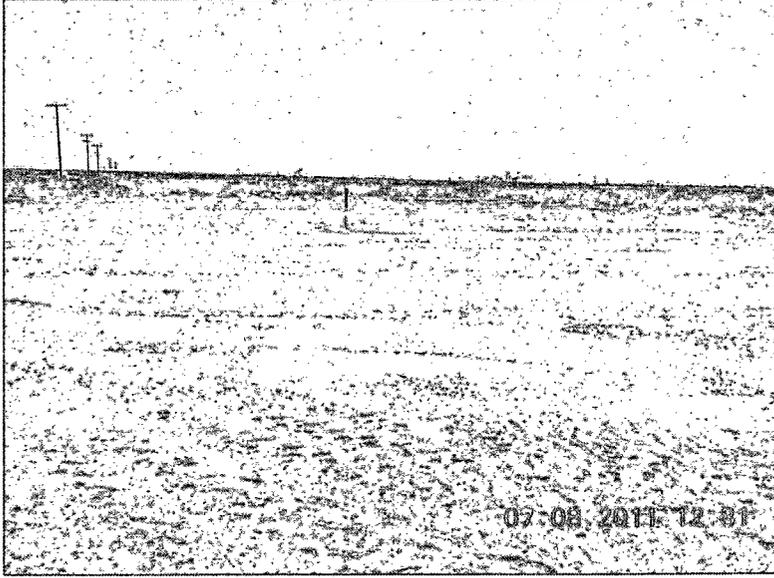
Site backfilled, facing south

A total of 1,416 cubic yards of impacted soil was removed from the excavation and transported to a NMOCD approved facility for disposal. The excavation was backfilled with clean imported

caliche totaling 1,572 cubic yards and contoured to the surrounding area. See Appendix C for photographs of field activities.
