Release Notification and Corrective Action

NEDU #348

Closure Report

**RE: TERMINATION REQUEST
Apache – NEDU #348 AD
UL/A sec. 10 T21S R37E
API No. 30-025-39583**

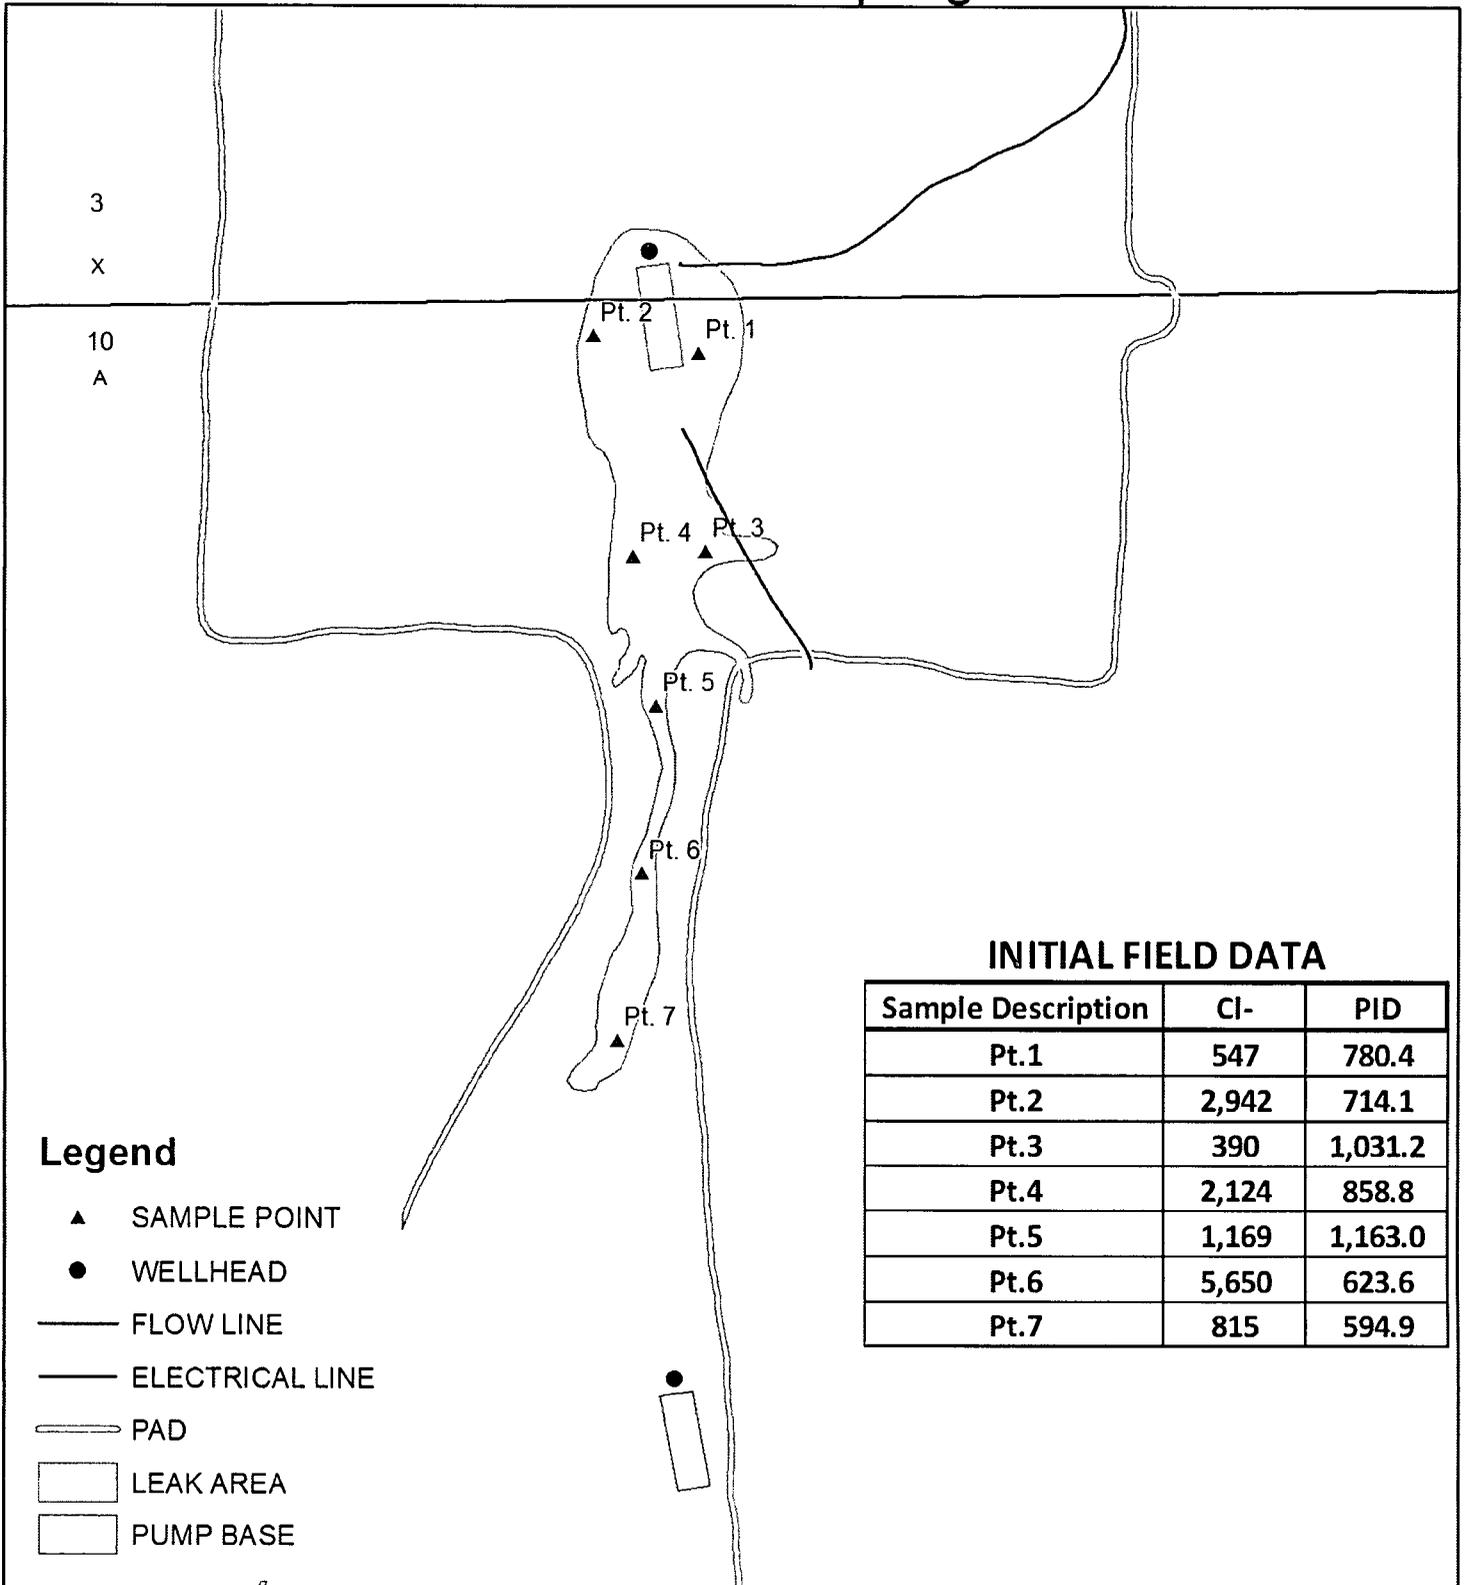
Figure 1

Initial Field Sampling Data

INITIAL FIELD DATA

Sample Description	Cl-	PID
Pt.1	547	780.4
Pt.2	2,942	714.1
Pt.3	390	1,031.2
Pt.4	2,124	858.8
Pt.5	1,169	1,163.0
Pt.6	5,650	623.6
Pt.7	815	594.9

On October 18, 2011, RECS personnel initiated work on the NEDU #348. Surface soil samples were collected and field tested for chloride. Headspace measurements were also taken in the field using a Photo Ionization Detector (PID) (Figure 1). RECS personnel collected and similarly field tested additional samples as excavation of the leak proceeded.

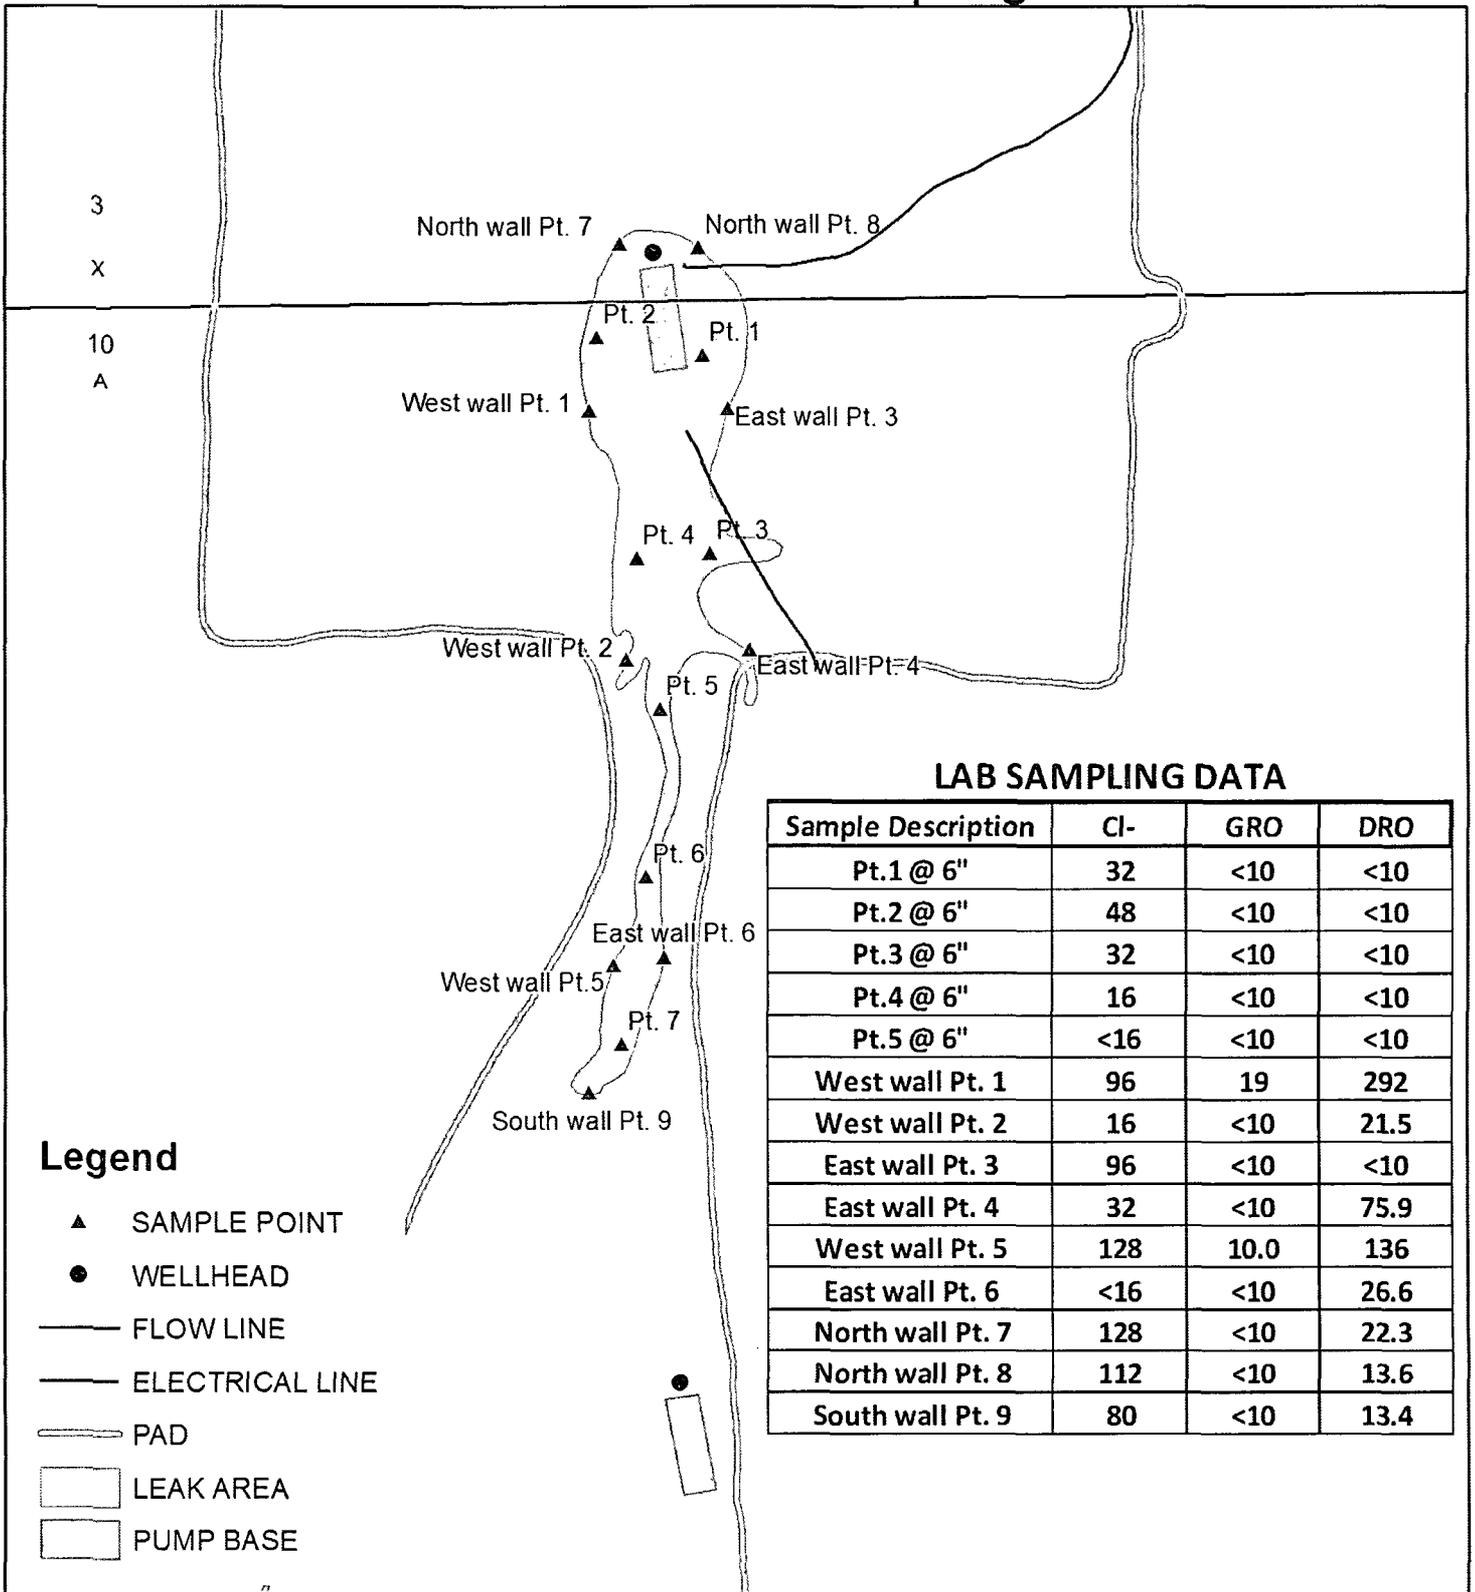
Figure 2

Final Excavation Sampling Data

On October 19, 2011, RECS personnel collected soil samples from the final shallow excavation (Figure 2). Representative grab samples were collected from the excavation edges and the excavation floor, and submitted to a commercial laboratory for chloride and TPH (GRO/DRO) analyses. In all samples, chloride did not exceed 128 ppm, and TPH did not exceed 311 ppm (Appendix C).

Impacted soils were removed from the excavation and transported to a NMOCD approved disposal facility. The excavation was backfilled with clean caliche and contoured to the surrounding area. See Appendix B for photographs of field activities.

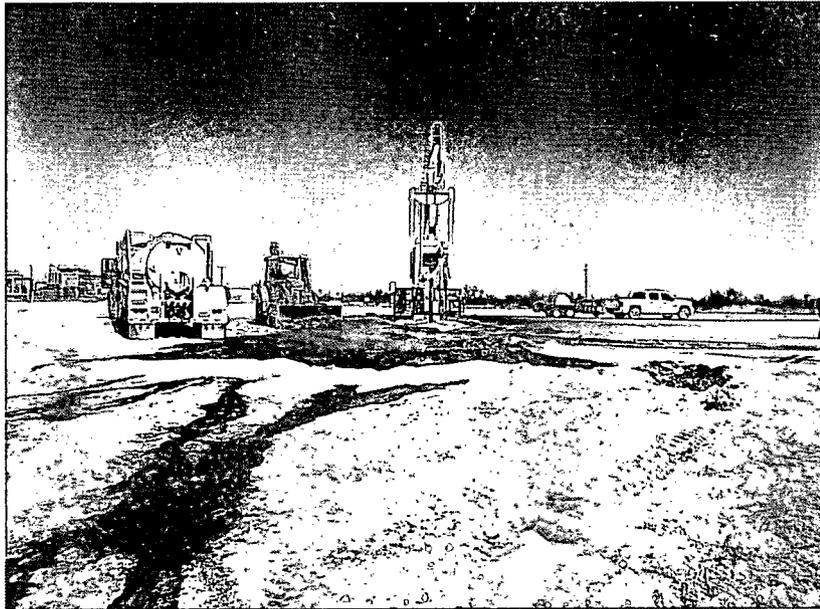
Initial release, facing north

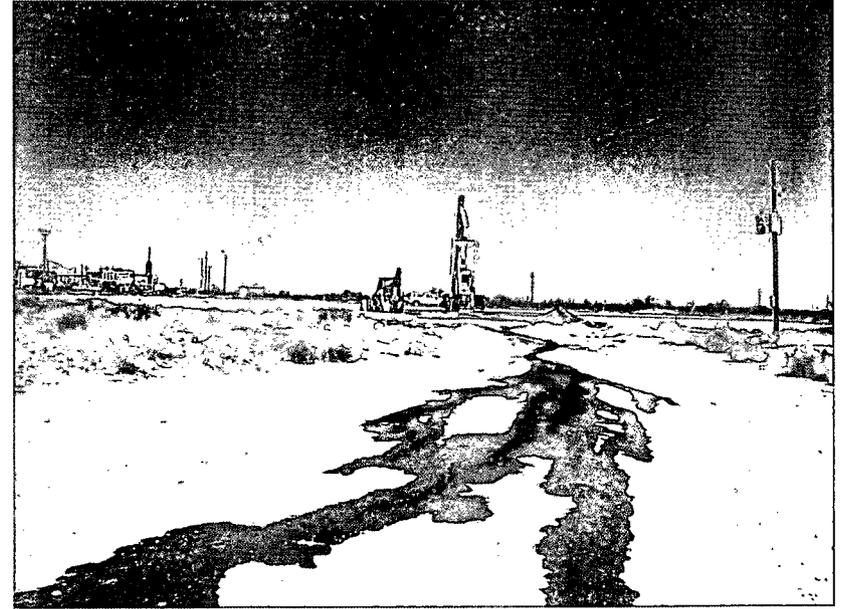
Initial release, facing north

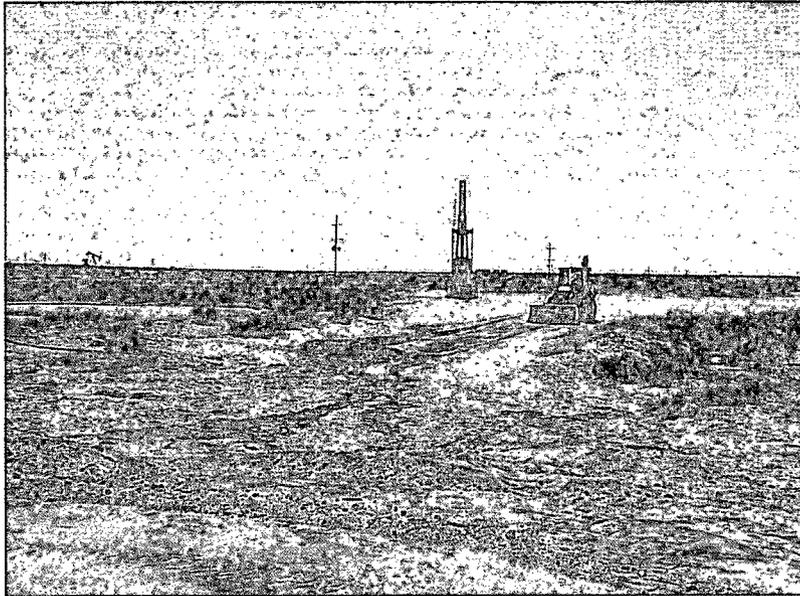
Scraping, facing south

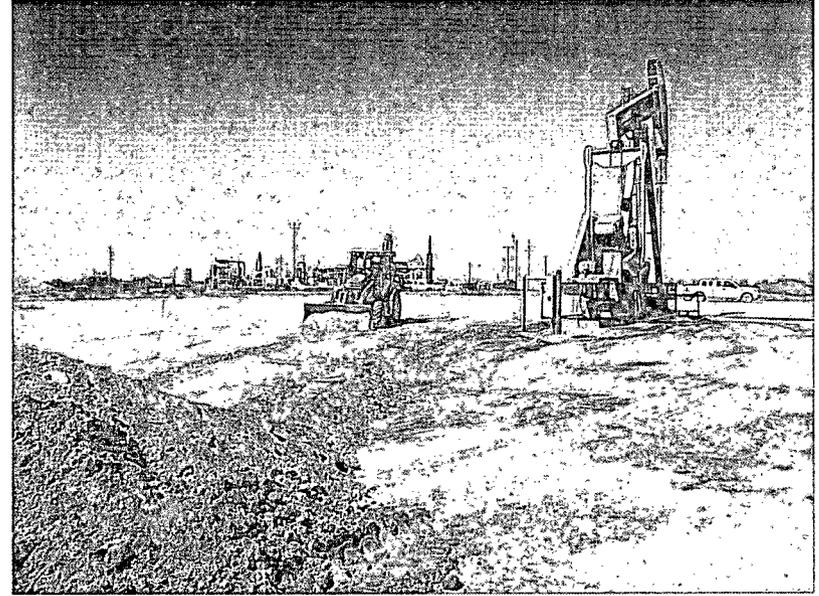
Scraping, facing northwest

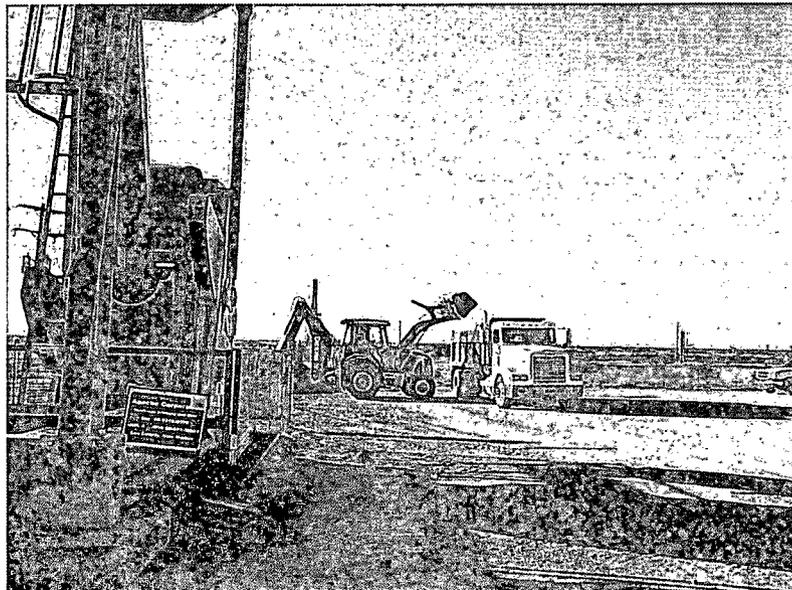
Exporting soil, facing south

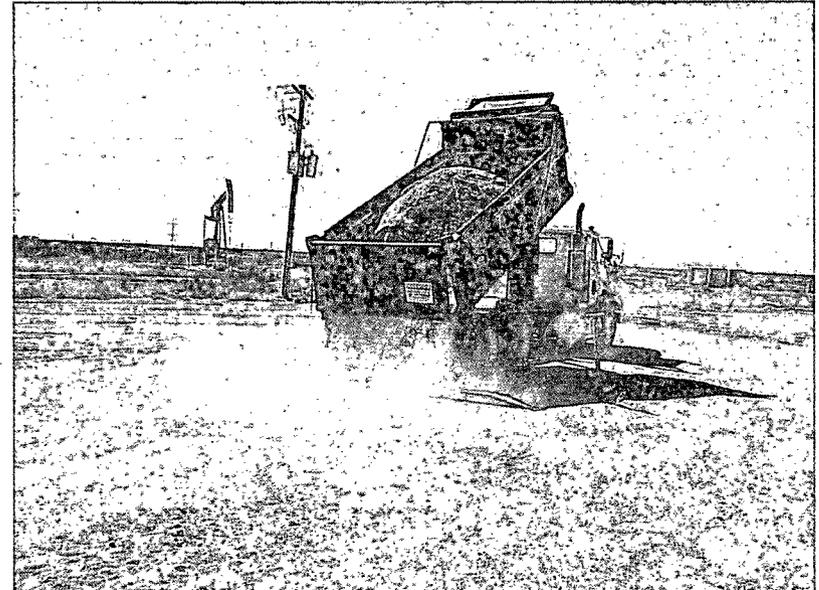
Importing soil, facing southwest

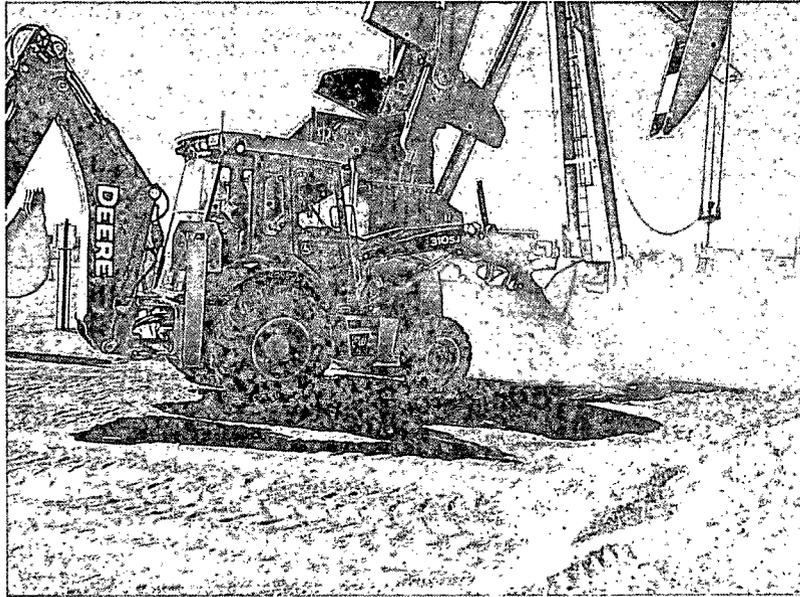
Backfilling, facing east

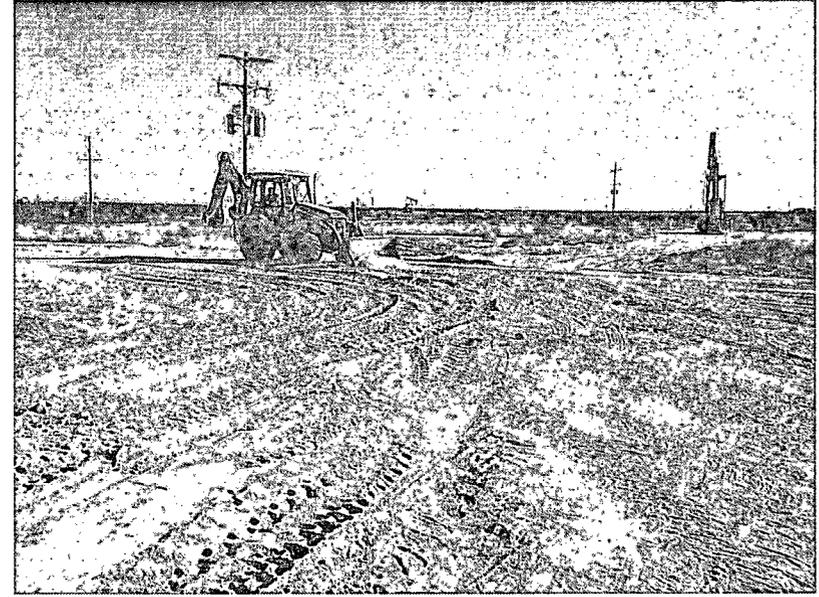
Backfilling, facing southeast

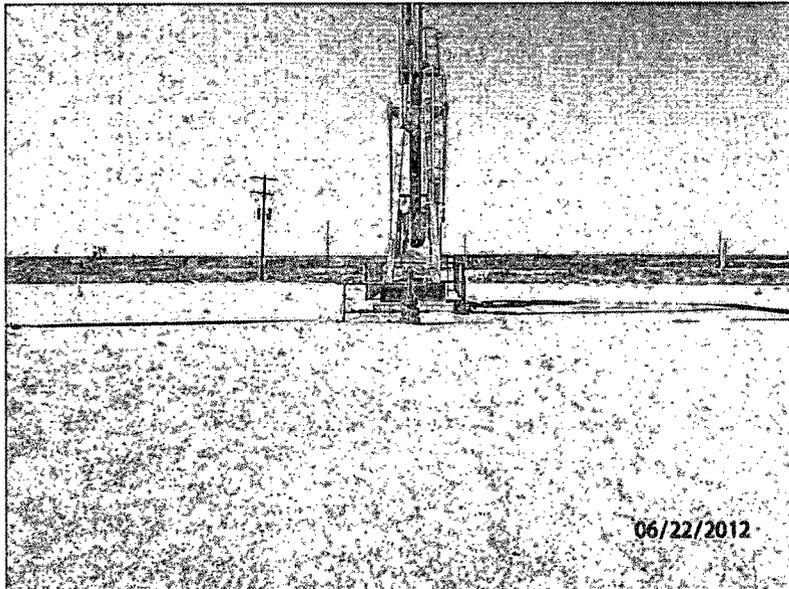
Site complete, facing south

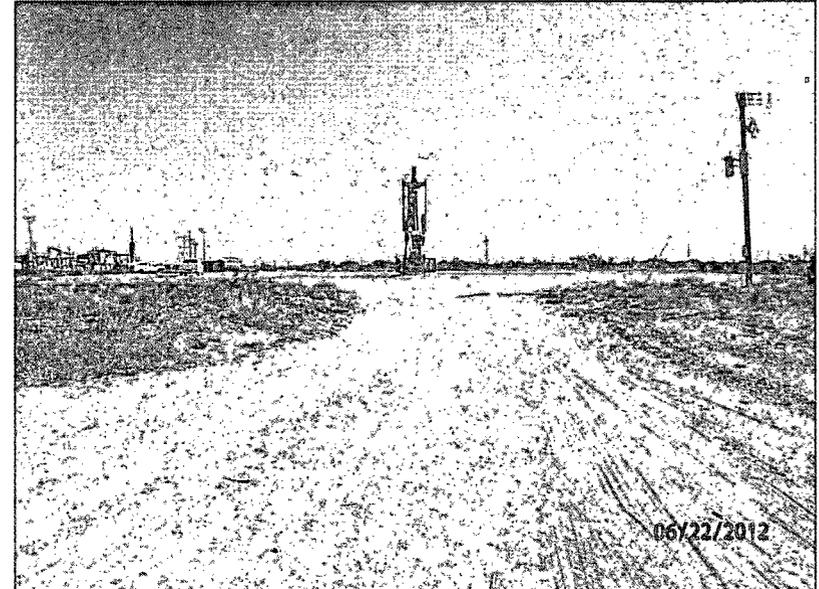
Site complete, facing north
