## NEDU #220

# Termination Request

API 30-035-06358

**RE: Termination Request  
Apache Corporation  
NEDU #220: UL/J sec. 2 T-21-S R-37-E  
API No. 30-025-06358**

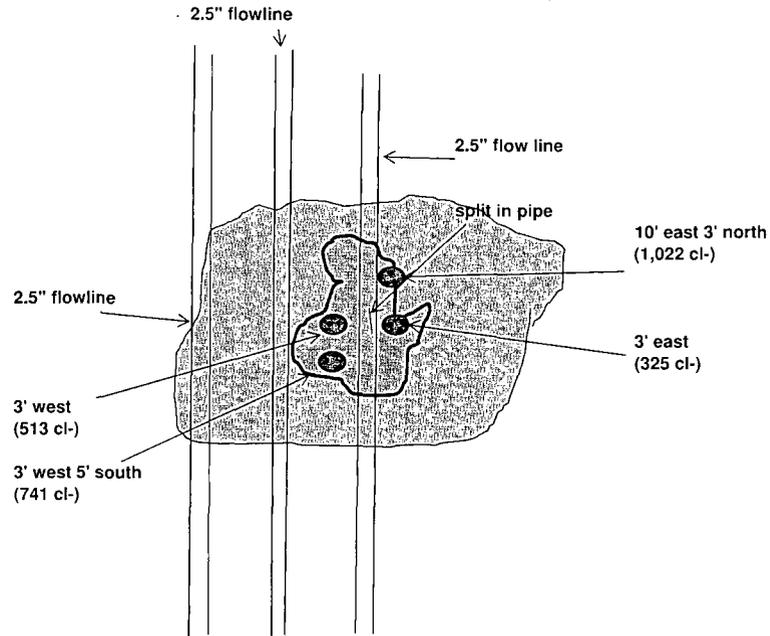
Figure

APACHE NEDU #220 A. D.  
FLOWLINE DISCHARGE

Key	
	Discharged area
	EXCAVATED AREA
	SAMPLE POINTS
	FLOW LINES

DISCHARGED AREA DIMENSIONS 14'X22'  
EXCAVATED AREA DIMENSIONS 30'X45'

308 sq ft

The release encumbered 308 sq ft of pasture land. RECS personnel were on site beginning on March 18<sup>th</sup>, 2011 to sample the surface of the release. Four points were sampled and field tested for chlorides (Figure). The site was excavated to a depth of 13 ft bgs, where a fiberglass line was encountered. The walls and bottom of the excavation were field tested for chlorides and hydrocarbons and representative samples were taken to a commercial laboratory for analysis (Appendix B).

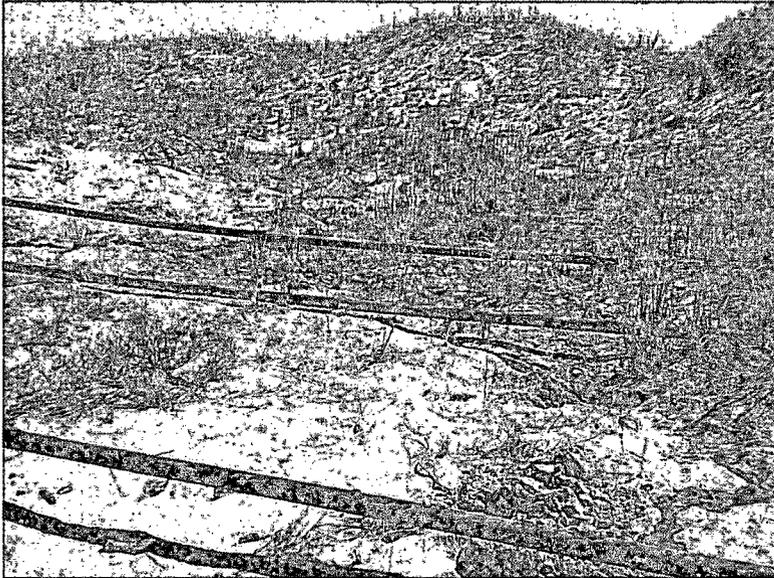
3/18/11

Initial release area, facing east

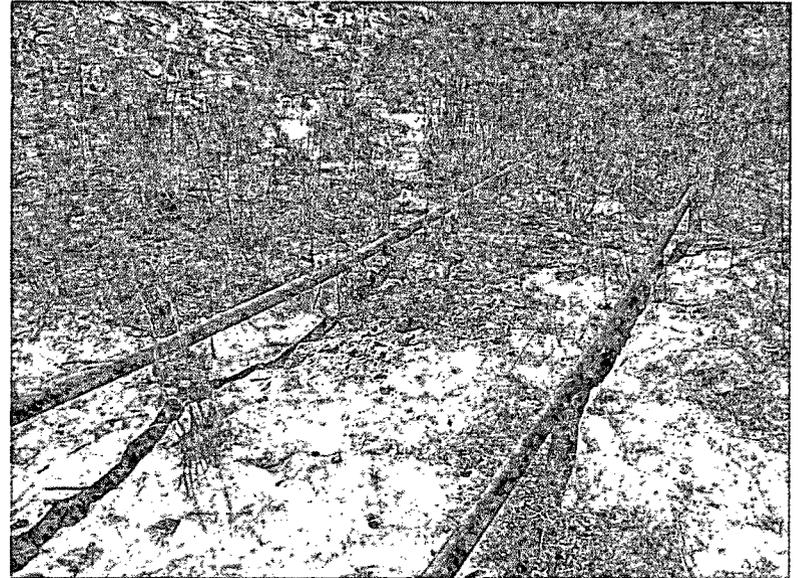
3/18/11

Initial release area, facing south

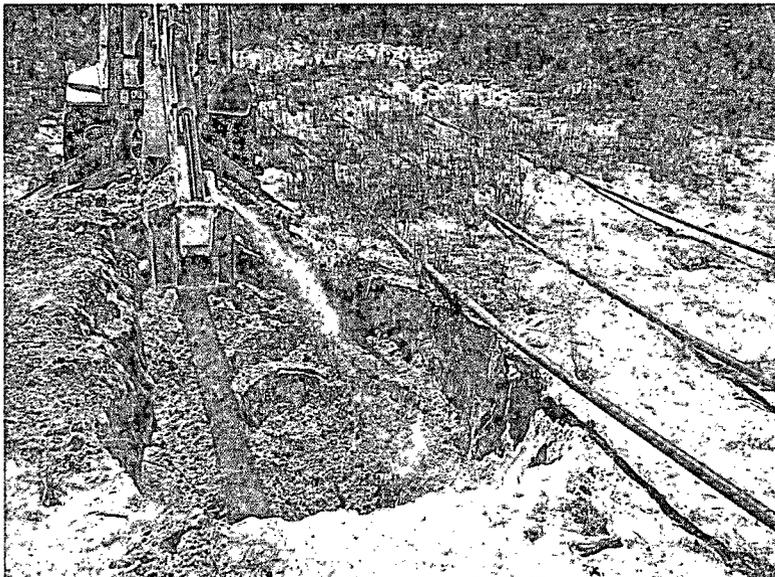
3/21/11

Excavating release area, facing south

A total of 456 cubic yards of soil was excavated from the site and disposed of at a NMOCD approved facility. The excavation was then backfilled with 504 cubic yards of clean, imported soil and contoured to the surrounding location.

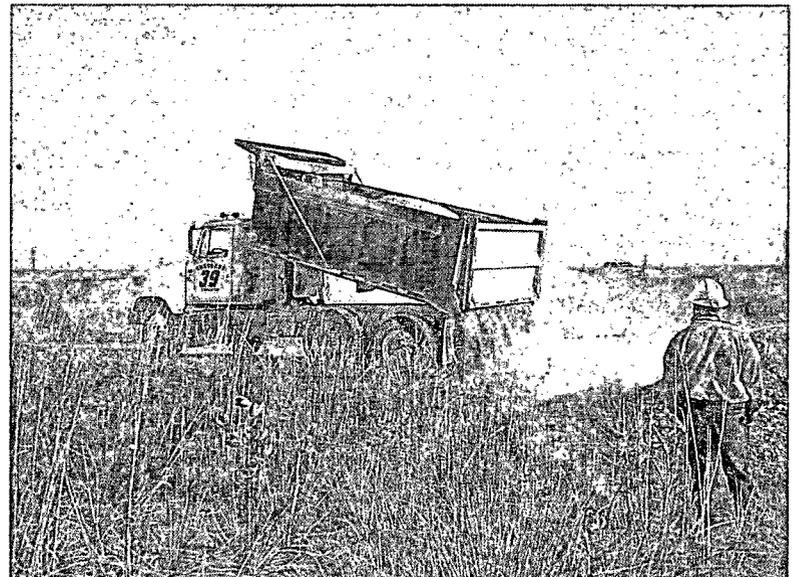
3/21/11

Importing caliche to make road

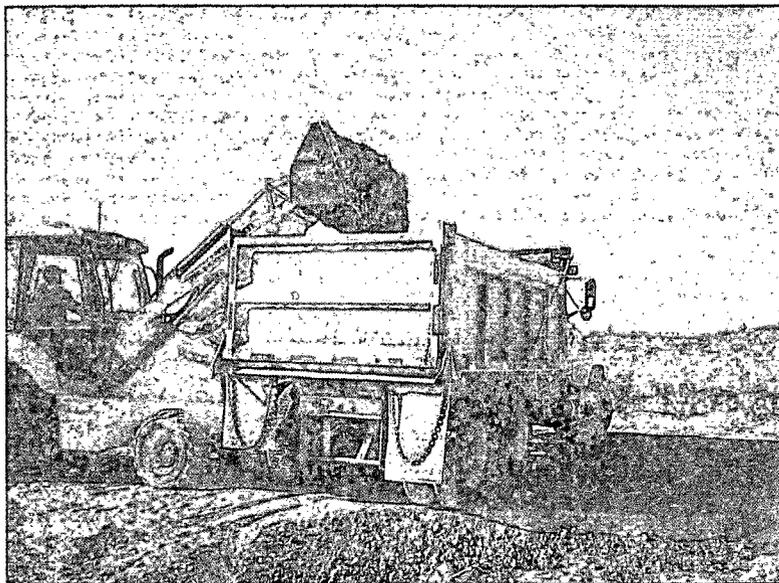
3/22/11

Exporting soil, facing south

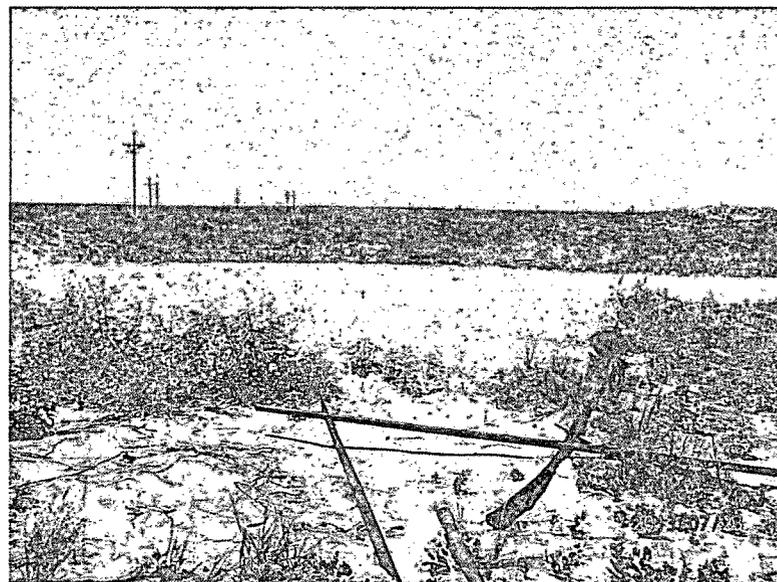
7/23/13

Site backfilled, facing south
