## White Owl Battery

## Closure Report

API 30-025-36689

**RE: TERMINATION REQUEST  
Apache – White Owl Battery AD  
UL/D sec. 2 T20S R38E  
API No. 30-025-36689**

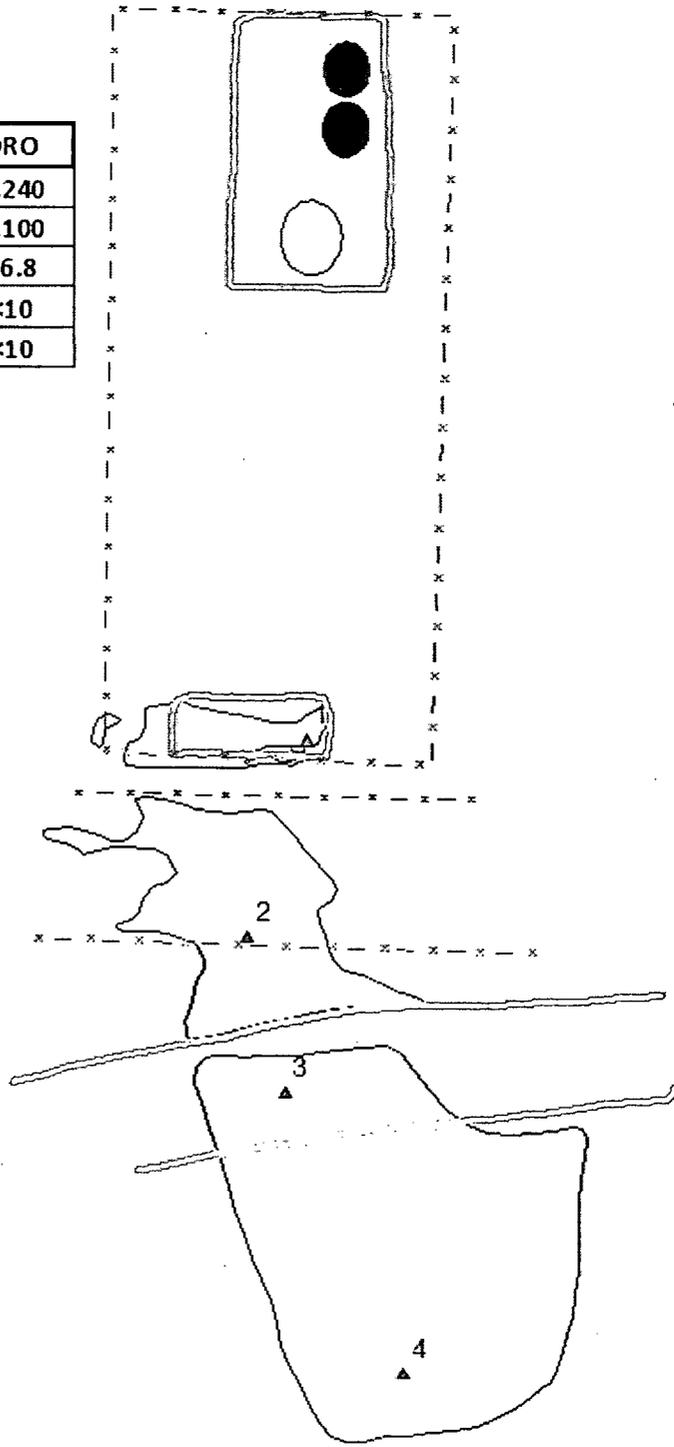
### Figure 1

On December 6, 2011, RECS personnel initiated work on the White Owl Battery (Figure 1). Surface soil samples were collected and field tested for chloride. Headspace measurements were also taken in the field using a Photo Ionization Detector (PID). The samples were submitted to a commercial laboratory for chloride and TPH (GRO/DRO) analyses (Appendix C). Chloride ranged from <16.0 ppm (parts per million or mg/kg) in the overspray area to 5,730 ppm within the bermed area. TPH ranged from <10.0 ppm in the overspray area to 13,080 ppm in the area immediately south of the berm.

## INITIAL SAMPLING LAB DATA

Sample Description	Cl-	GRO	DRO
PT1 surface	5,730	2,000	2,240
PT2 surface	1,170	5,980	7,100
PT3 surface	80	<10	26.8
PT3 @ 6"	96	<10	<10
PT4 surface	<16	<10	<10

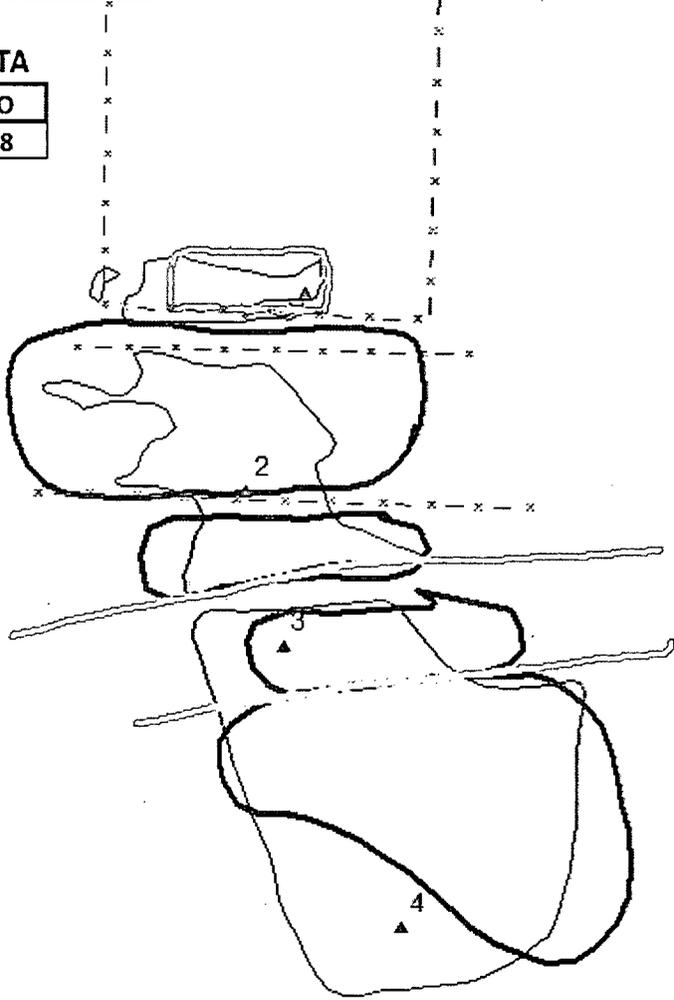
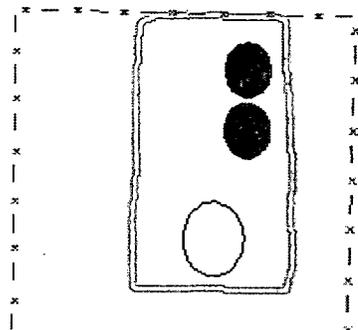
## Figure 2

The stain surrounding Pt.2 was scraped approximately 6 inches below ground surface (bgs). On December 12, 2011, RECS personnel collected and field tested a representative composite sample from the bottom of the scrape (Figure 2). The sample was submitted to a laboratory for chloride and TPH analyses and contained 32.0 ppm chloride and 66.3 ppm TPH (Appendix C).

The stain within the berm was hand excavated 6 to 8 inches bgs. On December 13, 2011, RECS personnel collected and field tested a sample from the bottom of the excavation at Pt. 1 (Figure

2). The sample was submitted to a laboratory for chloride and TPH analyses and contained 160 ppm chloride and 20.8 ppm TPH (Appendix C).

## EXCAVATION AT PT. 2 LAB DATA

Sample Description	Cl-	GRO	DRO
5 Scrape 6-8" 5 Pt Btm Comp	32	<10	66.3

## EXCAVATION WITHIN BERM LAB DATA

Sample Description	Cl-	GRO	DRO
Pt 1 Inside Berm	160	<10	20.8

The stain surrounding Pt. 3 and Pt. 4 was also scraped. Impacted soils were removed from the excavations and transported to a NMOCD approved disposal facility. The berm area excavation was backfilled with clean caliche and leveled. See Appendix B for photographs of field activities.

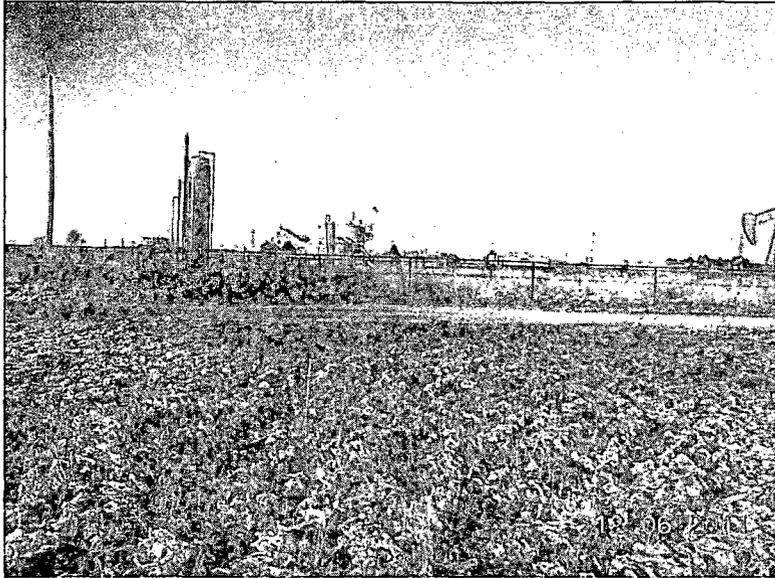
Initial release, facing north

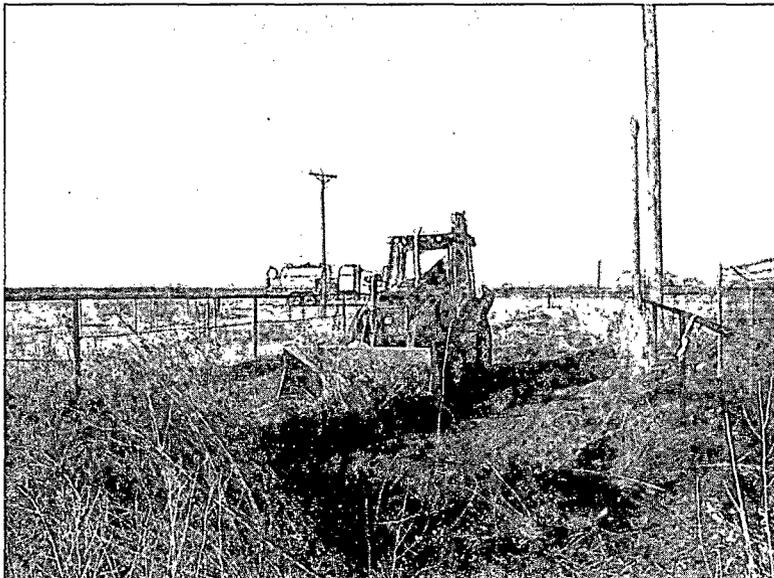
Scraping leak, facing west

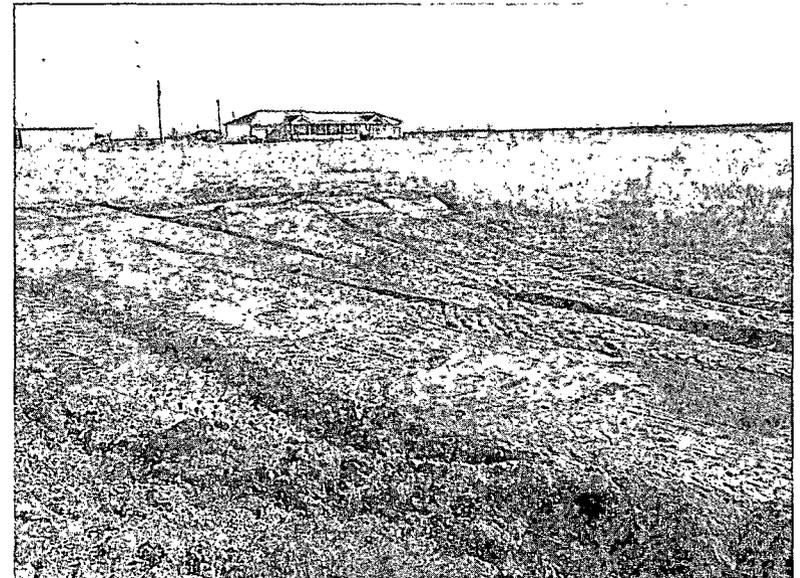
Scraped overspray area, facing southeast

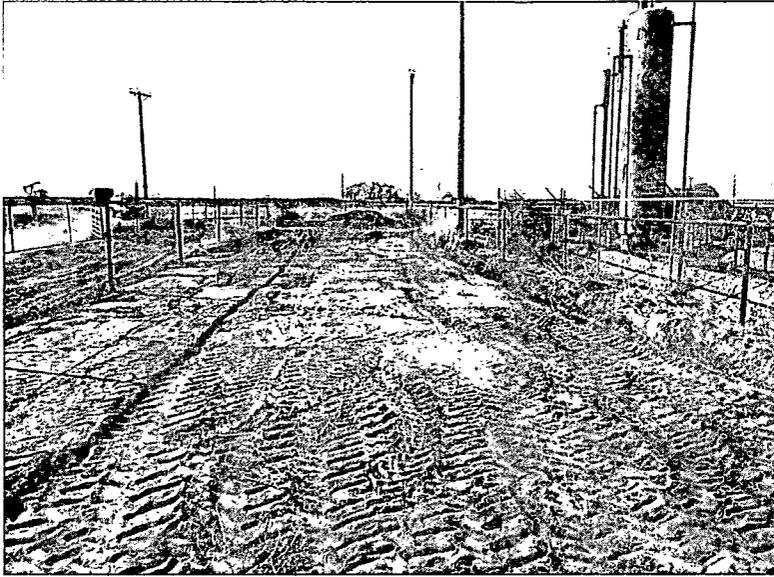
Leak scraped, facing west

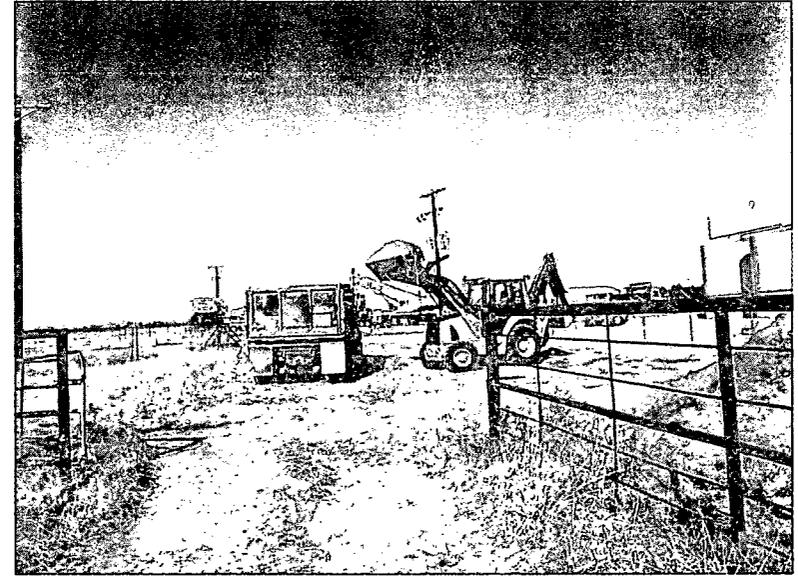
Exporting soil, facing north

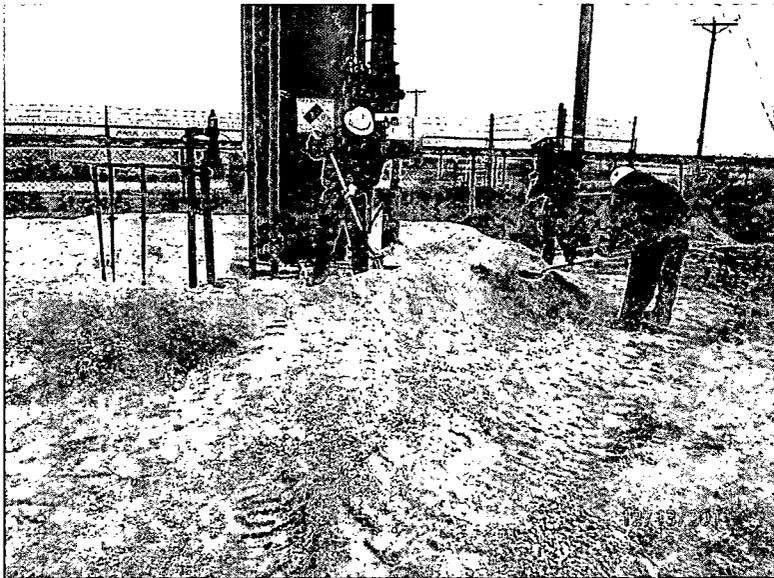
Repairing berm, facing south

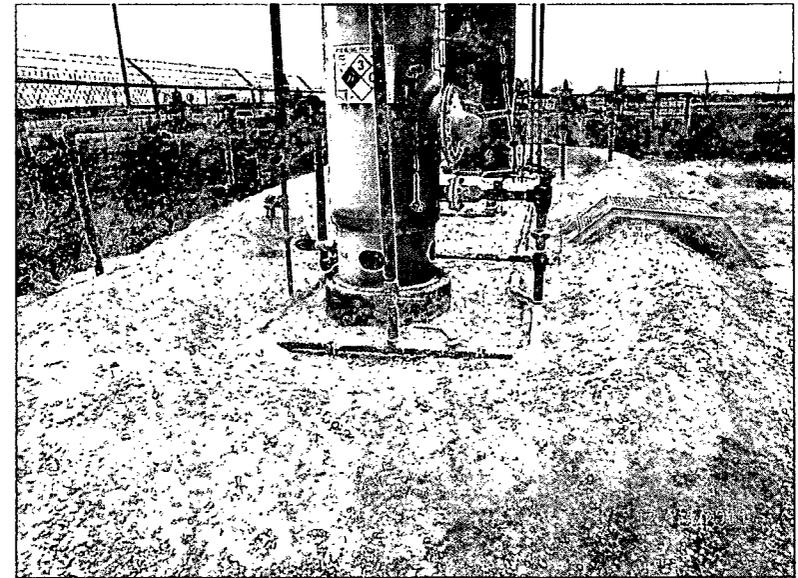
Site complete, facing west
