Release Notification and Corrective Action

LG Warlick C Battery

Termination Request

RE: Termination Request

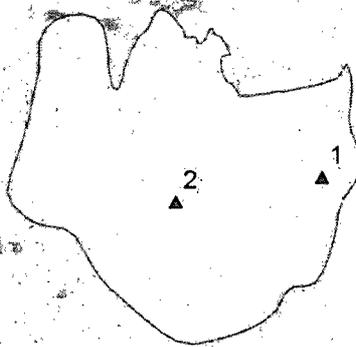
Figure 1

Initial Sampling Data

Initial Field Data

CI-	PID
Point 1 Surface	786	557
Point 2 Surface	205	202.8

- ▲ SAMPLE POINTS
- STAIN (5,634 sq ft)

RECS was on site beginning on November 18th, 2013 to assess the release. Soil samples were taken at two points within the release and field tested for chlorides and organic vapors (Figure 1). Based on the field data, the area within the battery was scraped down six inches and a sample of the bottom of the scrape was taken to a laboratory for analysis (Figure 2). The laboratory returned results of non-detect for all constituents (Appendix B). The area on the lease road was also scraped down 6 inches. A 5 point composite of the bottom of the scrape was taken to a commercial laboratory for analysis and returned a chloride value of 80 mg/kg, a Gasoline Range Organics (GRO) value of non-detect and a Diesel Range Organics (DRO) value of 52.4 mg/kg.

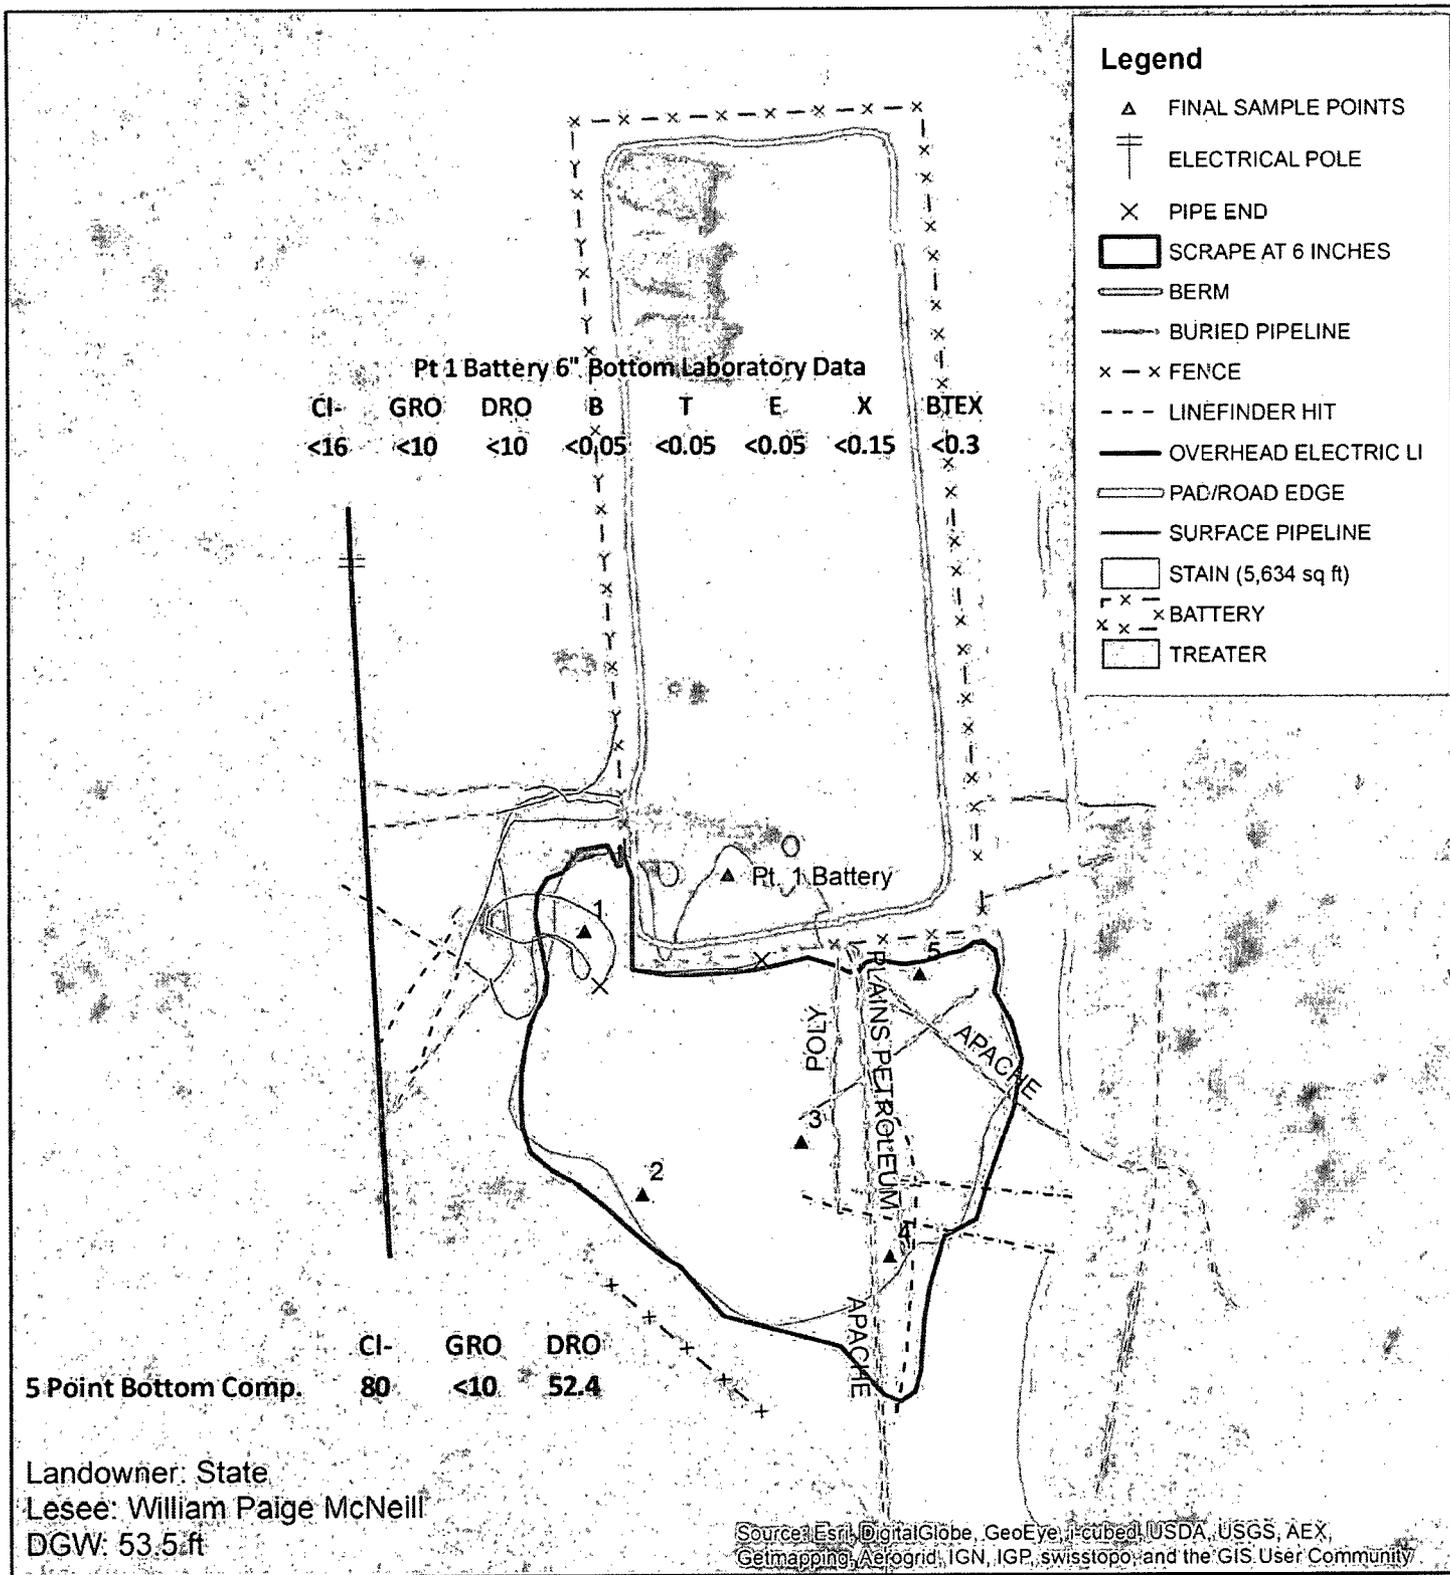
Figure 2

Excavation Data

- Legend**
- ▲ FINAL SAMPLE POINTS
 - ⊥ ELECTRICAL POLE
 - × PIPE END
 - ▭ SCRAPE AT 6 INCHES
 - ▬ BERM
 - BURIED PIPELINE
 - × - × FENCE
 - - - LINEFINDER HIT
 - OVERHEAD ELECTRIC LI
 - ▬ PAD/ROAD EDGE
 - SURFACE PIPELINE
 - ▭ STAIN (5,634 sq ft)
 - ⊥ × BATTERY
 - ▭ TREATER

The contaminated soil was taken to a NMOCD approved facility for disposal. A total of 36 yards of clean caliche was imported to the site to serve as backfill. The site was backfilled and contoured to the surrounding location.

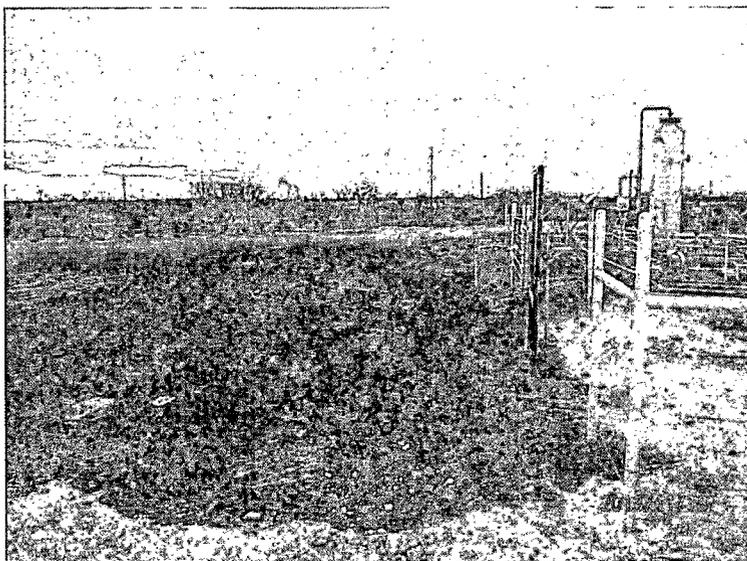
Initial release area, facing west

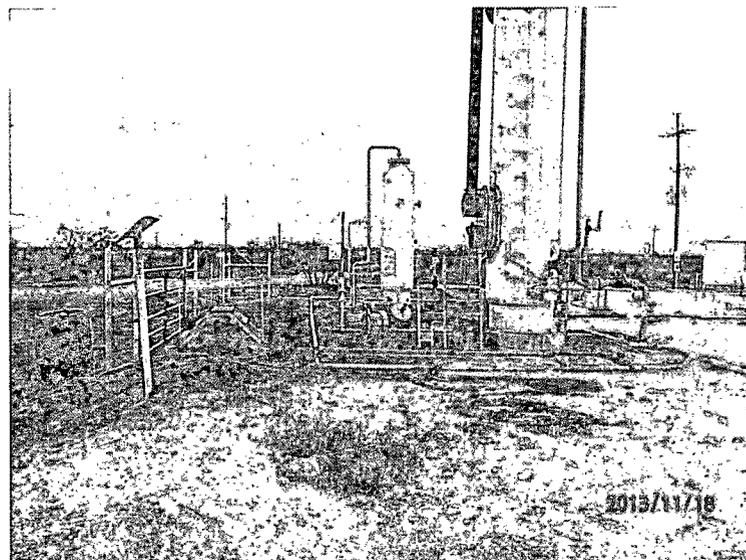
Initial release area, facing west

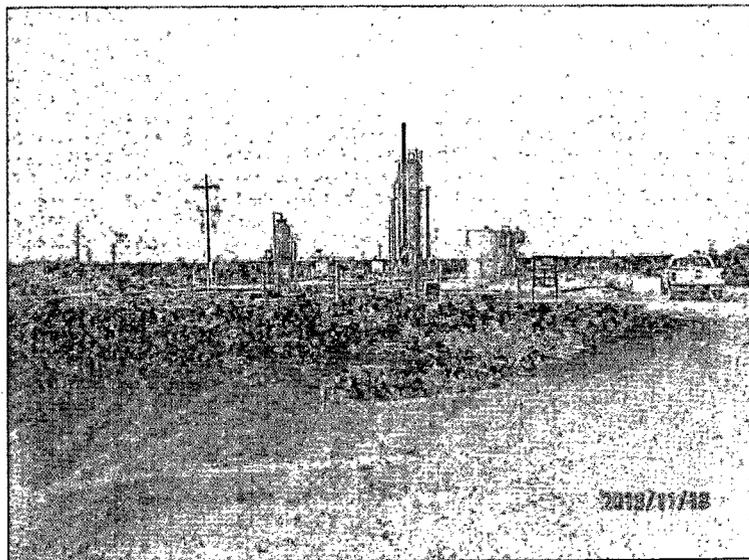
Initial release area, facing northwest

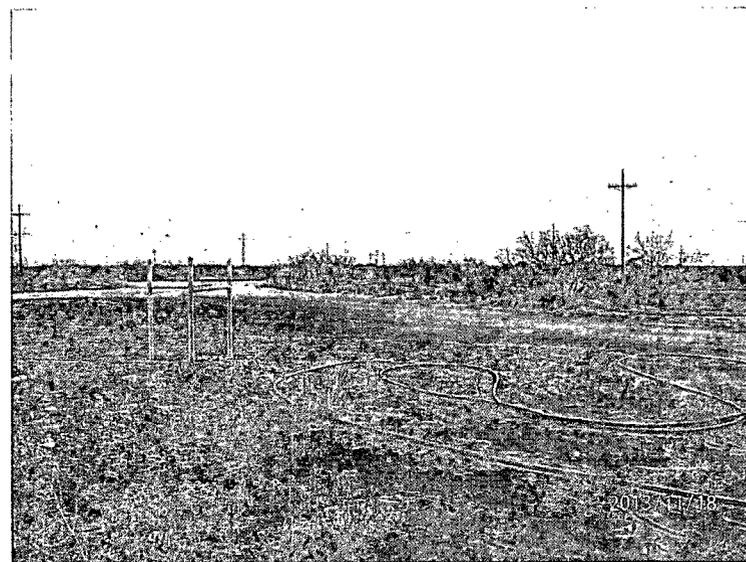
Initial release area, facing south

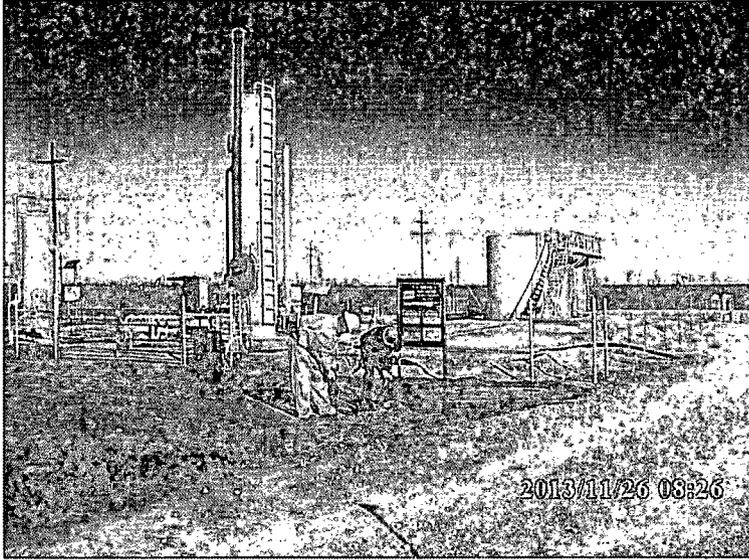
Spotting lines, facing northwest

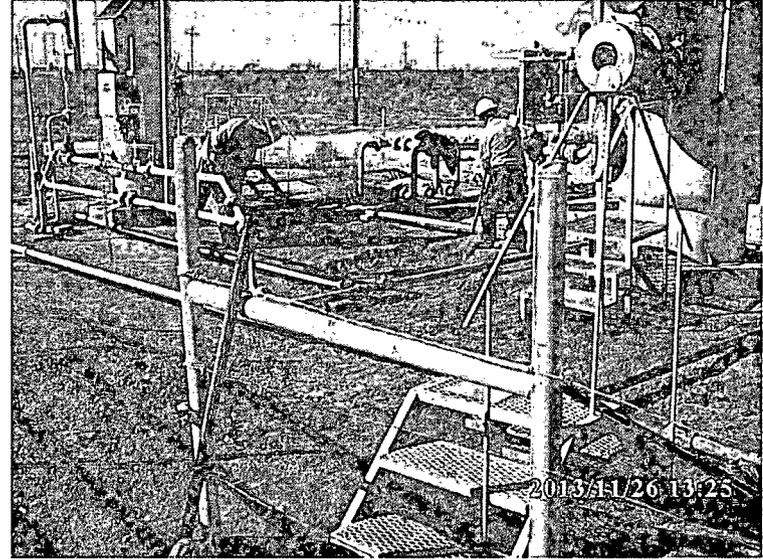
Hand shoveling in battery, facing northwest 11/26/13

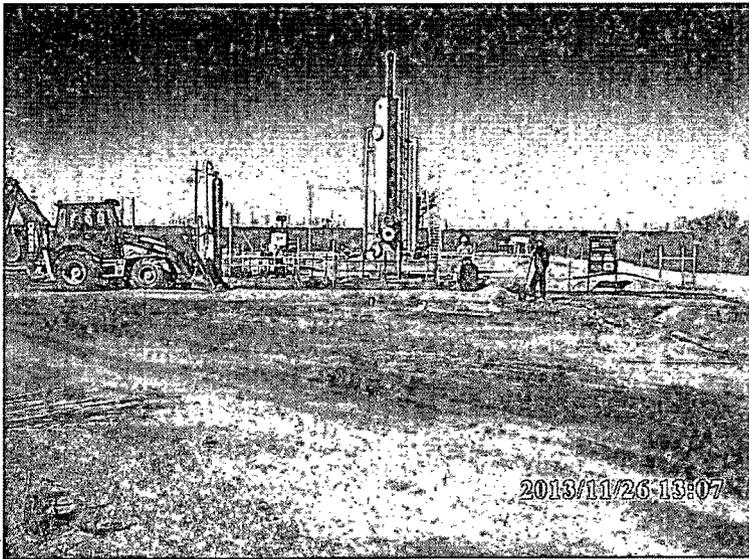
Scraping outside the battery, facing north

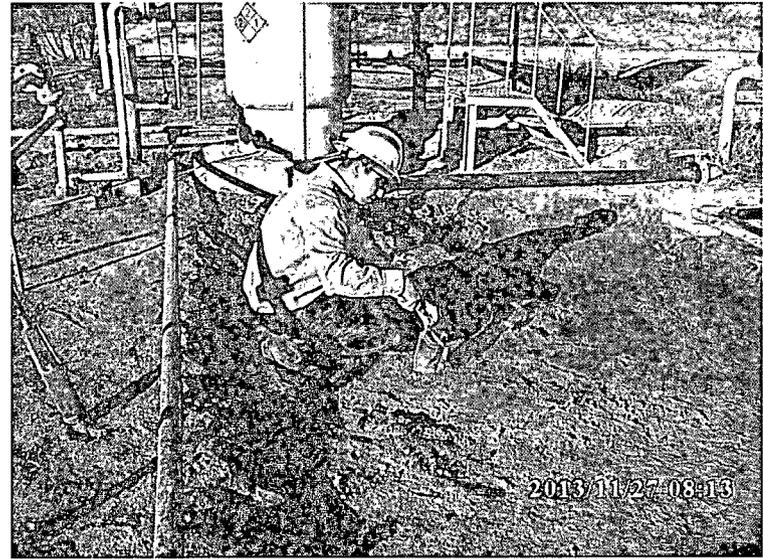
Sampling scrape inside battery, facing west 11/27/13

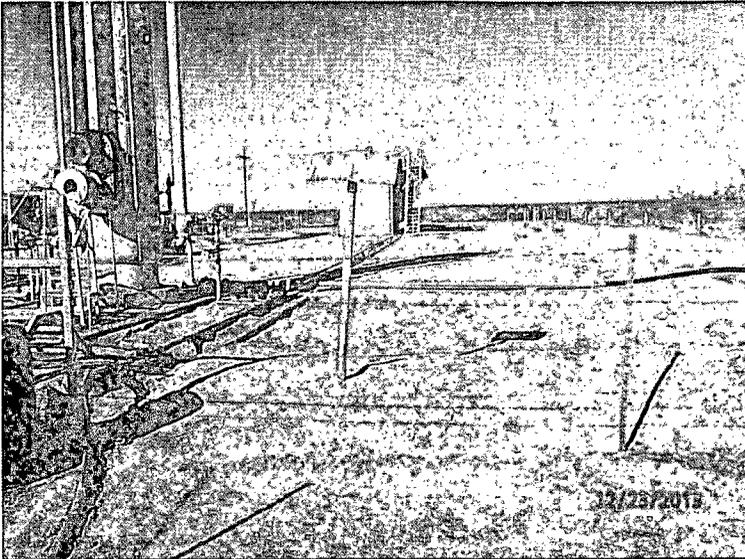
Scrape completed in the battery, facing north 12/23/13

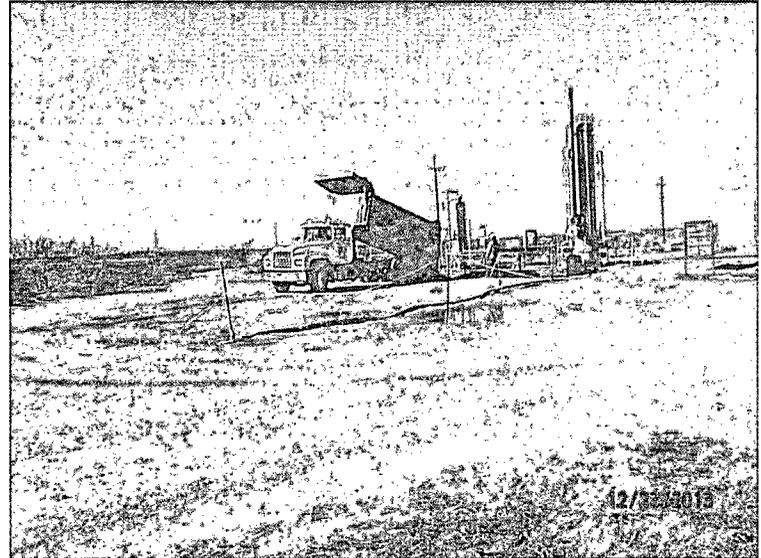
Importing caliche, facing west

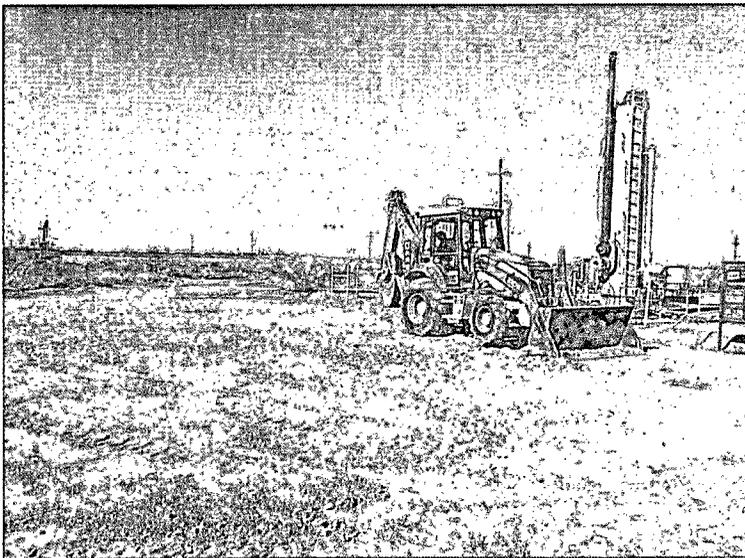
Backfilling lease road, facing northwest

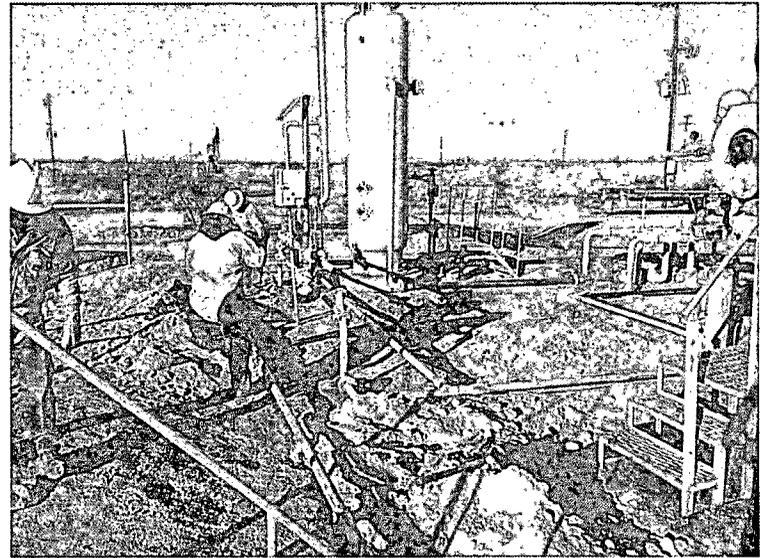
Backfilling battery, facing northwest

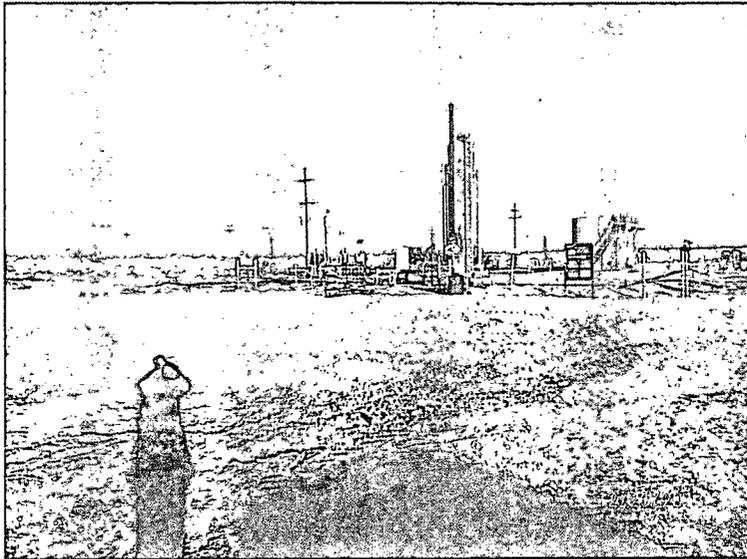
Backfill of lease road completed, facing northwest
12/26/13

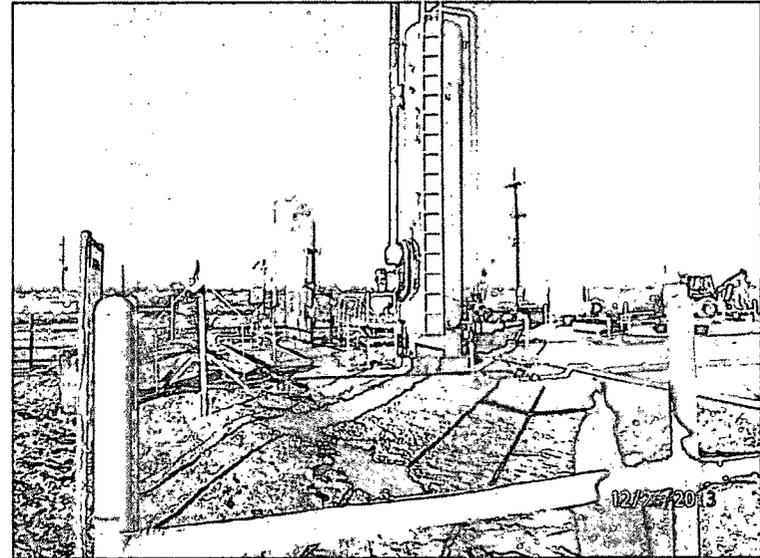
Backfill of battery completed, facing northwest
12/26/13
